## COLORADO CULTURAL RESOURCE SURVEY

### Architectural Inventory Form

1. Resource number: **5BL7977**
2. Temporary number: **N/A**
3. County: **Boulder**
4. City: **Louisville**
5. Historic building name: **Wilson House**
6. Current building name: **Wilson House**
7. Building address: **616 LaFarge Avenue**
8. Owner name: **Michael R. Wilson & Pamela Reeves**  
Owner address: **616 LaFarge Avenue**  
**Louisville, CO 80027**

48. Report title: **"Old Town" Louisville Historical Building Survey**

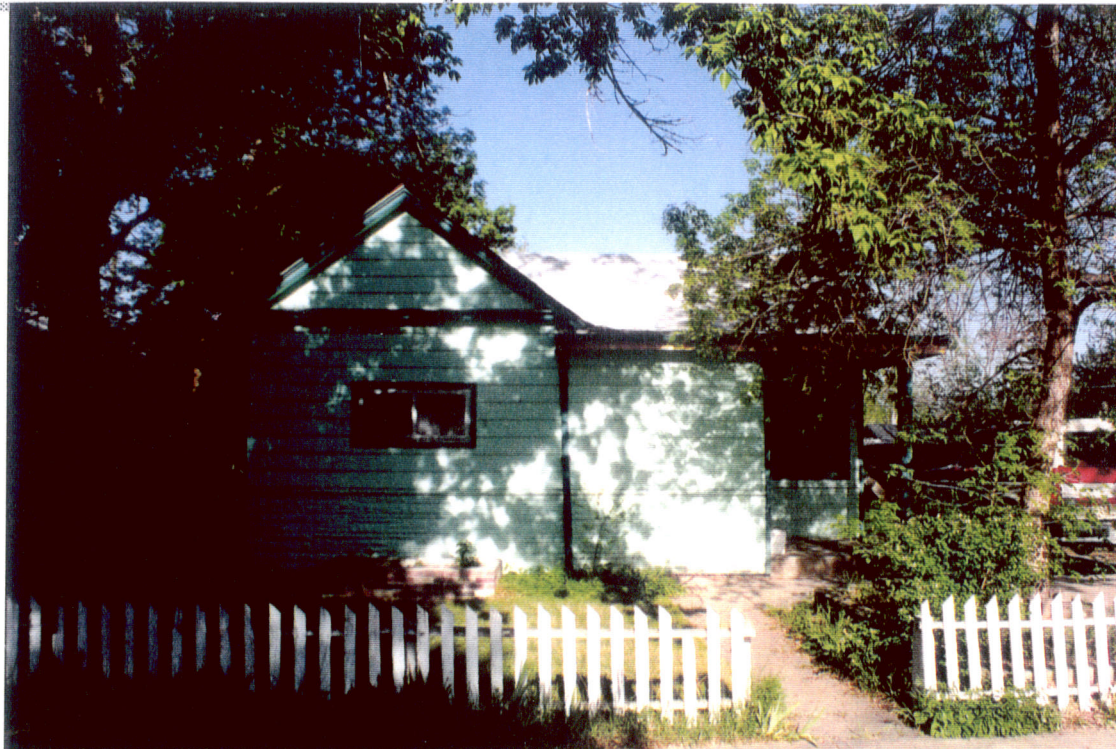
This wood-frame house is supported by a low concrete foundation, and features green horizontal siding exterior walls. Green color aluminum siding, in a faux stone pattern, appears on the lower wall surface on the facade (west elevation). The intersecting gables roof has boxed eaves, and is covered with grey asphalt shingles. A non-original red brick chimney is located on the exterior of the south elevation. All of the windows have been altered from the original, and include 1x1 horizontal sliders, and 3-light fixed-panes, set in metal frames. The building's primary entrance is located at the south end of the facade, on the west elevation. Here, a wood-paneled door, with a white metal storm door, opens onto a 2-step concrete porch. The porch is covered by a shed roof, with a 6" by 6" wood post support. A large two-story gabled addition has been built onto the house's east (rear) elevation. An earlier one-story gabled addition is located between the two-story addition and the original portion of the house. A glass-in-wood-frame atrium door opens onto a large wood deck from the two-story addition on the building's east elevation.

This house has been extensively remodeled, and two large additions have been built onto the original east elevation, resulting in a almost complete loss of integrity. This building is no longer able to convey a sense of its historic significance.
