# Coal Creek

GOLF COURSE

## Golf Course Improvement Plan

December 19, 2011

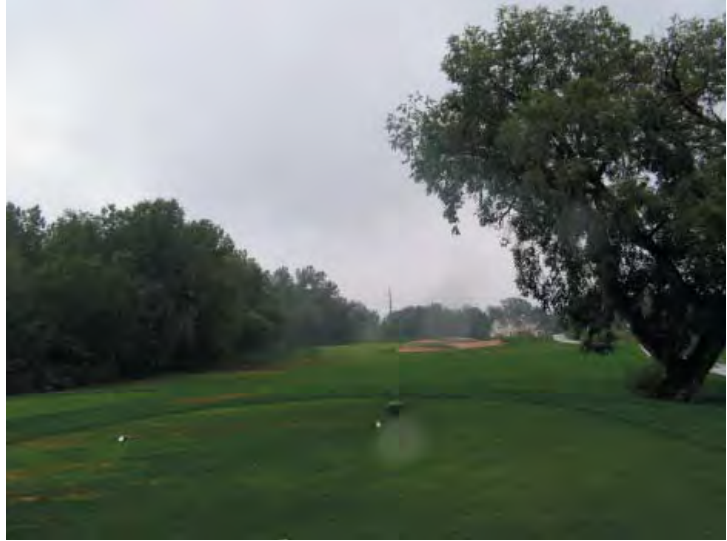
*Restricted sightline at hole 17 tee.*

Our recommendation would be to implement a tree removal and replacement program whereby poorly positioned, short-lived or structurally compromised trees would be selectively removed to improve safety, reduce maintenance, improve playability and allow for the establishment of more-desirable, longer-lived trees. Trees which are good for golf courses include Oak, Hickory, Catalpa, Sugar Maple, Red Maple, American Elm (disease resistant), American Linden, Ginko, Hackberry and Pine. Care must be taken to allow for adequate space at maturity. Trees which drop fruit, have thorns or have shallow root systems are generally poor choices for golf courses. These may include, Spruce, Silver Maple, Norway Maple, Cottonwood, Poplar, Walnut, Locust, Ash, Apple, Russian Olive and Willow.

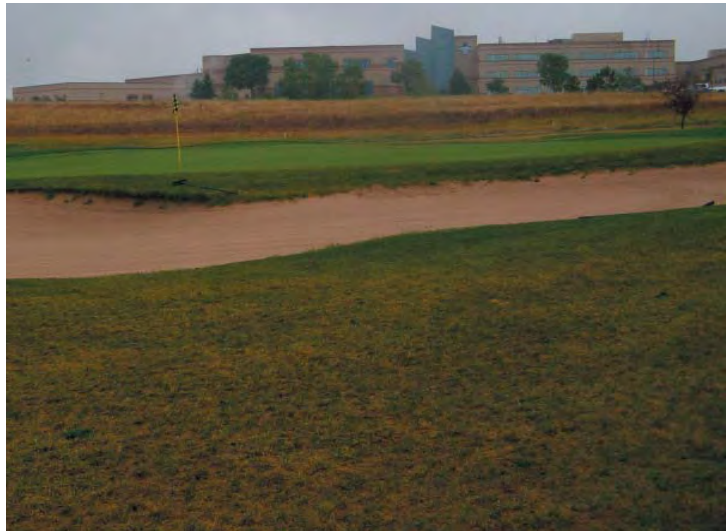
*The addition of trees behind hole 15 green would aid in blocking view to buildings.*

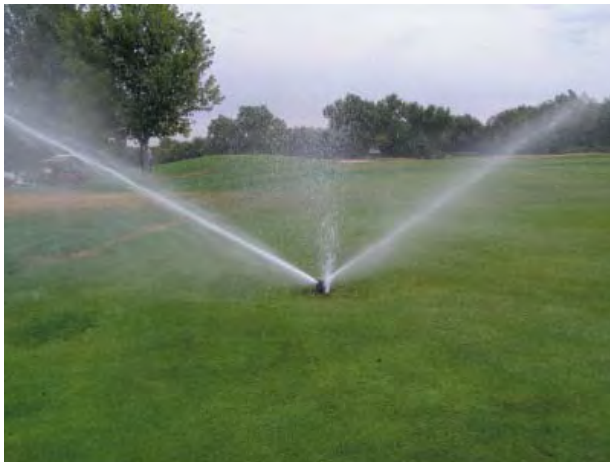
Leaking irrigation head.

Immediate improvements to coverage and turf quality could be made by individually inspecting and adjusting or repairing each head to insure that it is functioning properly. Worn out or broken heads should be replaced with new heads. This is only a temporary measure as the poor spacing and continued failure is an on-going issue. In addition, the existing 25 horsepower booster pump near 18 green should be repaired so as to provide adequate pressure on holes 15 and 16.

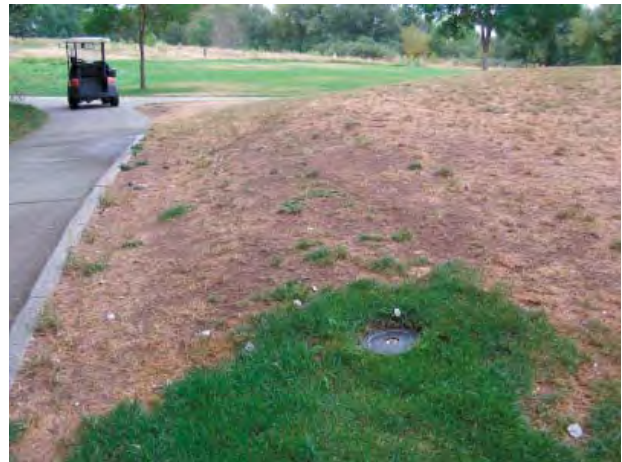
Broken irrigation head.

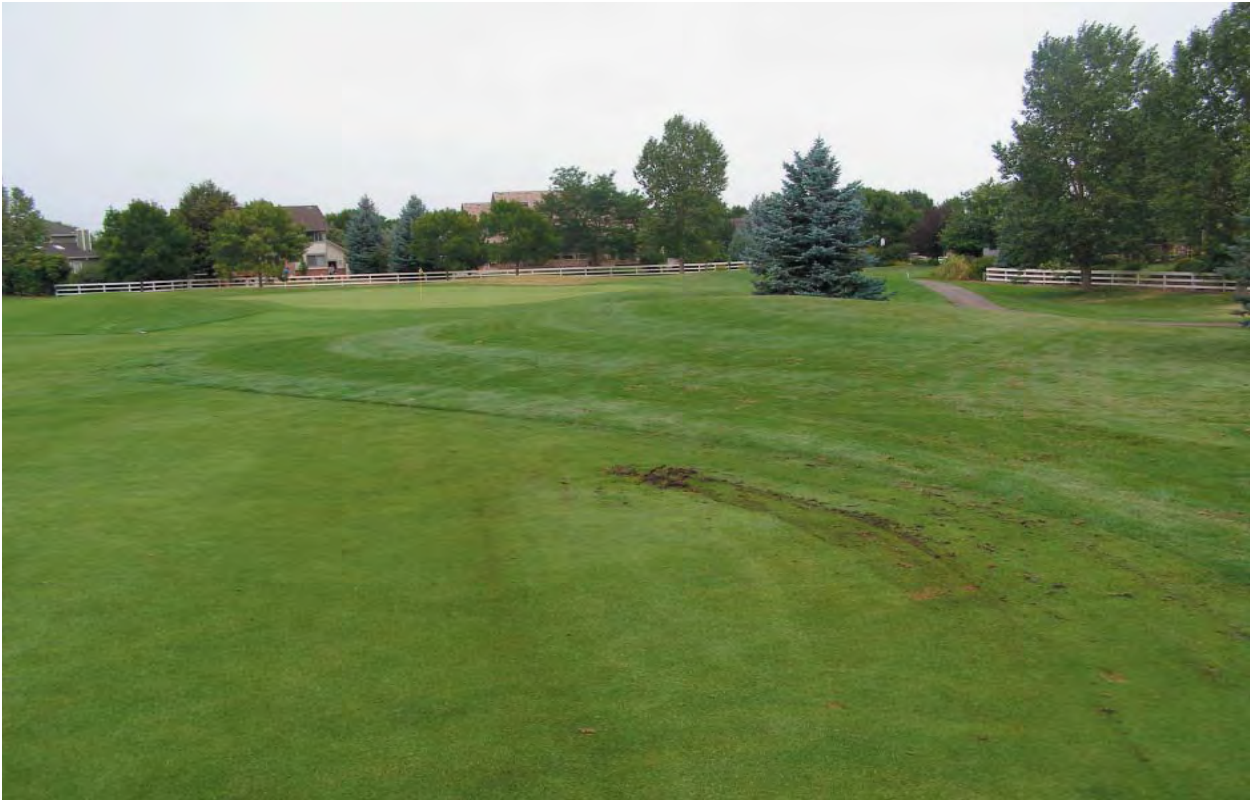
*Overwatering in fairway.*

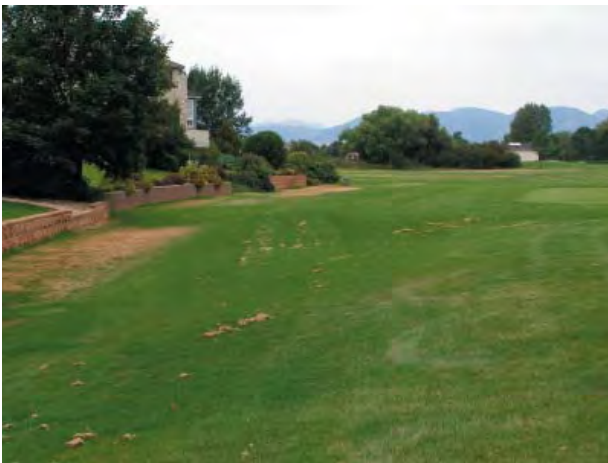
*Poor irrigation coverage at residential property line.*

Future improvements should include the installation of an entirely new irrigation system including piping, heads, valves and control wiring. The installation of a new irrigation system should improve overall course conditioning, minimize water usage and reduce unnecessary labor required to maintain and repair the system. See the attached detailed irrigation assessment prepared by Irrigation Technologies.

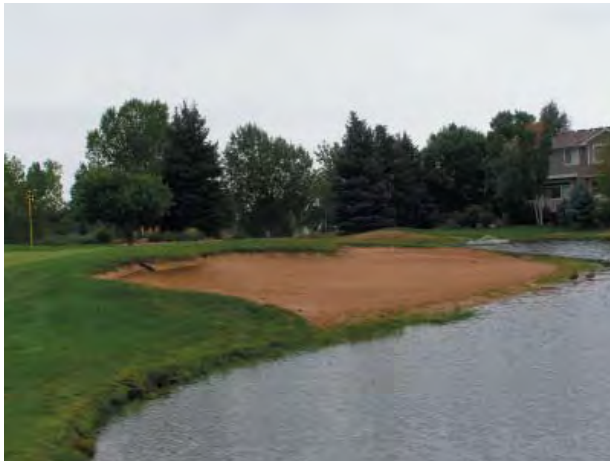
*Beach bunker is difficult to maintain on Hole 2.*

It is our recommendation that a complete renovation of the bunkers be undertaken to 1.) eliminate obsolete or out-of-play bunkers, 2.) reduce overall maintenance and repair by eliminating erosion and wash outs, 3.) improve playability and visual interest, 4.) define the individual holes strategically and 5.) restore the original design integrity. As indicated on the master plan, some bunkers will be removed or relocated, some will be reconstructed and some new bunkers will likely be added. By redesigning and reconstructing the existing bunkers and selectively adding new bunkers, it is our belief that Coal Creek Golf Course will provide a more enjoyable golfing experience for golfers of all ages and abilities while, at the same time, minimizing the time and expense of repairing and maintaining the golf course.

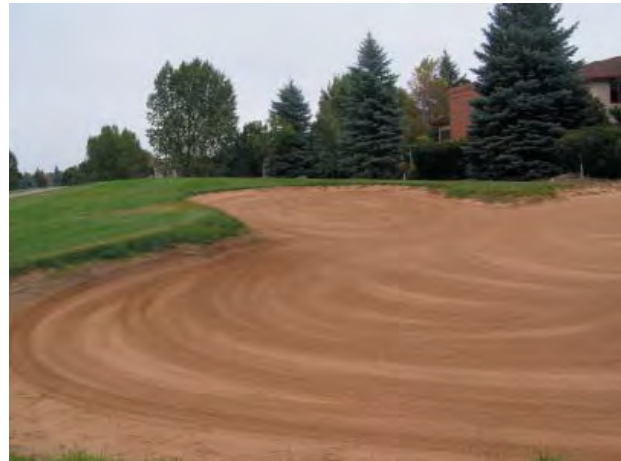
Bunkers are also often times one of the highest maintenance issues on a golf course. Over the years, the bunkers at Coal Creek have been edged so that the bunkers are now considerably larger than the original bunkers and the “capex” or faces now have nearly vertical slopes on which it is difficult to maintain sand. As the faces get edged and the native soils erode into the bunker, the sand becomes contaminated so that it is no longer able to drain properly. Earlier this year, the sand in the bunkers was replaced with new sand. However, this is only a short-term, temporary fix since the faces are still eroding.

*Collapsing bunker face & contaminated sand.*

It is important to note that, upon completion of the bunker renovation, the City should avoid the use of mechanical bunker raking in order to minimize damage to the bunker faces & contamination of sand. We envision the new bunkers as similar in character to the original bunker style but slightly smaller and easier to maintain without mechanized raking.

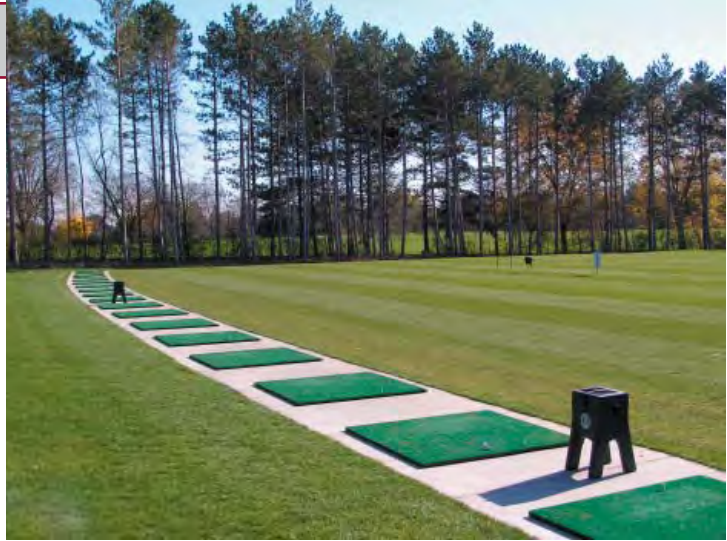
*Expanded turf tee & concrete tee line would increase revenue potential & improve turf quality.*

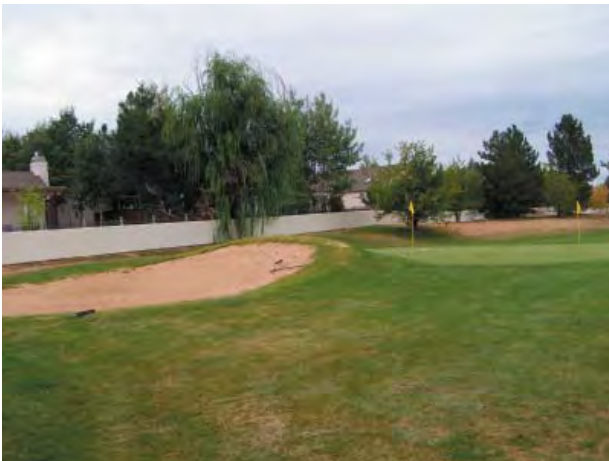
*Short game area is undersized & difficult to maintain.*

The practice bunker and short-game area are in poor condition and have become difficult to maintain due to years of use and edging. The practice bunker should be reconstructed to reduce the size and to provide for ease of maintenance. The chipping green and adjoining chipping areas should be re-graded and enlarged to provide for improved drainage, ease of mowing and increased usage

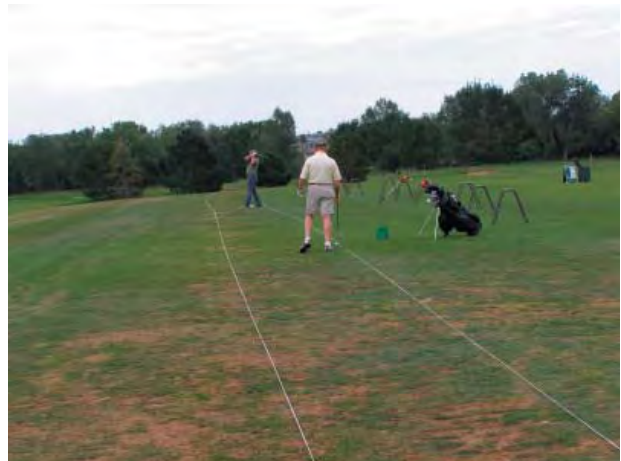
*Poor turf condition from lack of irrigation & undersized tee.*

The irrigation coverage at the range, and particularly at the perimeter of the range, is inadequate. Improved irrigation would provide better turf recovery at the tee and would aid in slowing balls hit towards nearby houses or towards No. 1 fairway.

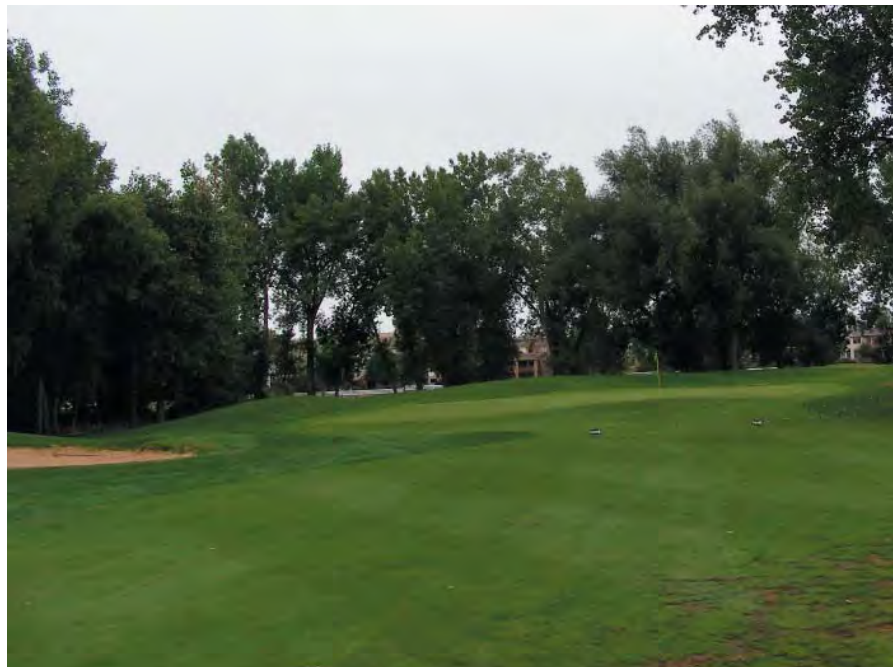
*Patchwork turf from poor drainage & compaction.*

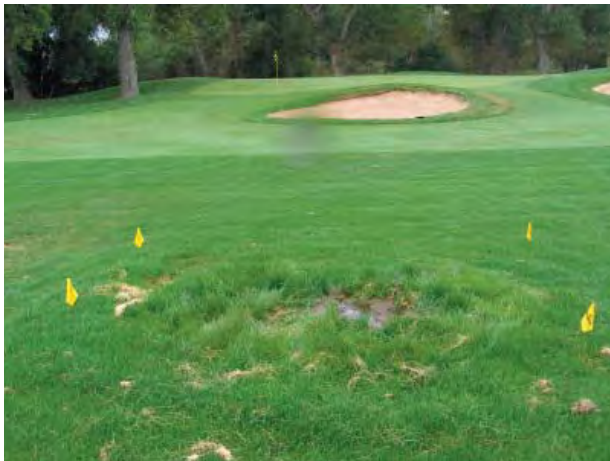
*Drainage issue on Hole 5.*

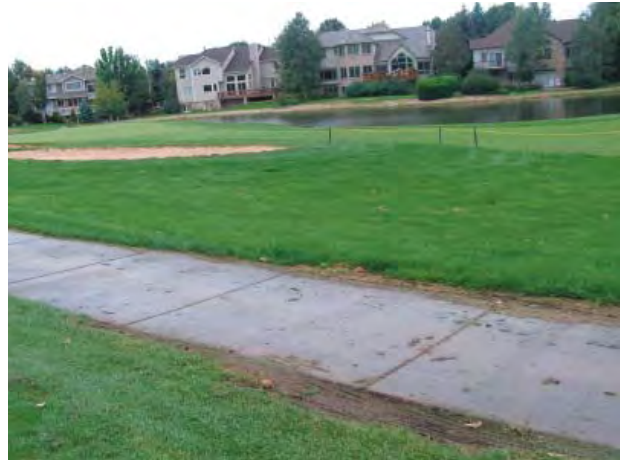
*Cart paths are too narrow.*

Our recommendation would be to widen cart paths at tees and greens to eliminate dead turf, standing water and “pot holes” which are unsightly and can be unsafe for golfers.

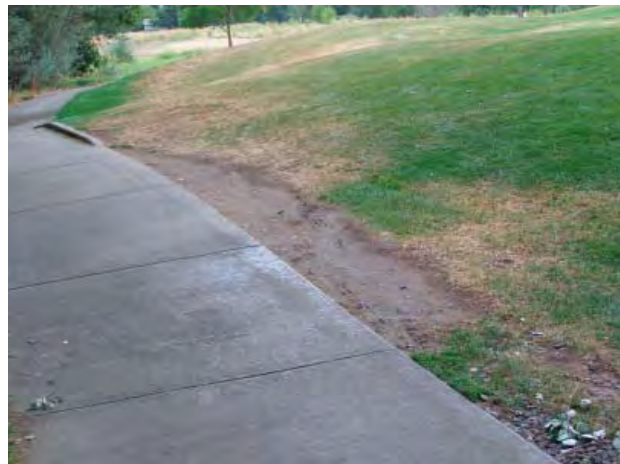
*Typical wear at tees & green.*

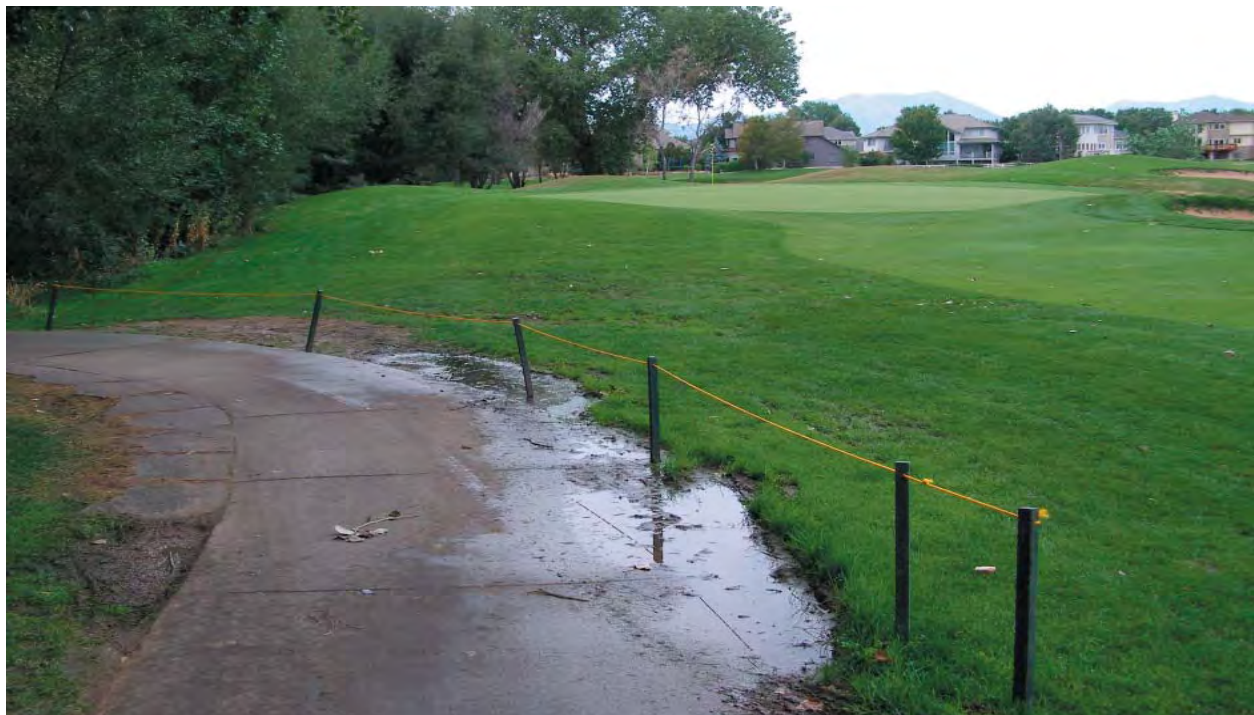
*Drainage & wear from carts & foot traffic at hole 6 green.*

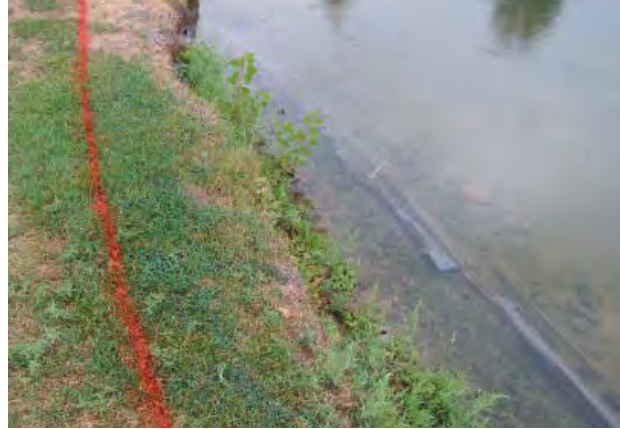
*Compromised pond liner on hole 11.*

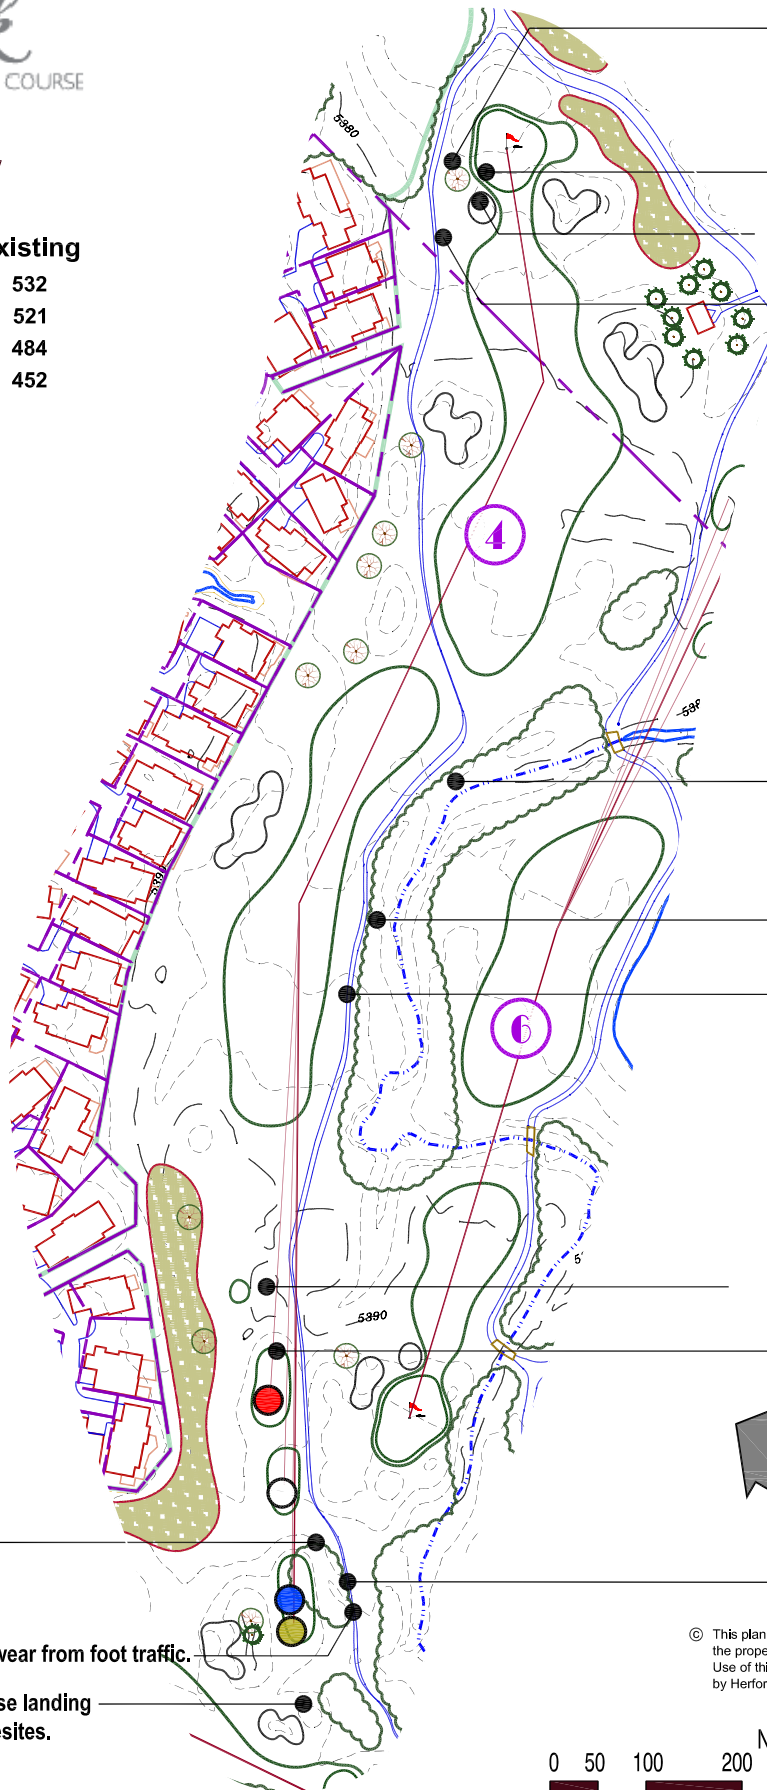
Tile for green drainage is plugged with tree roots.

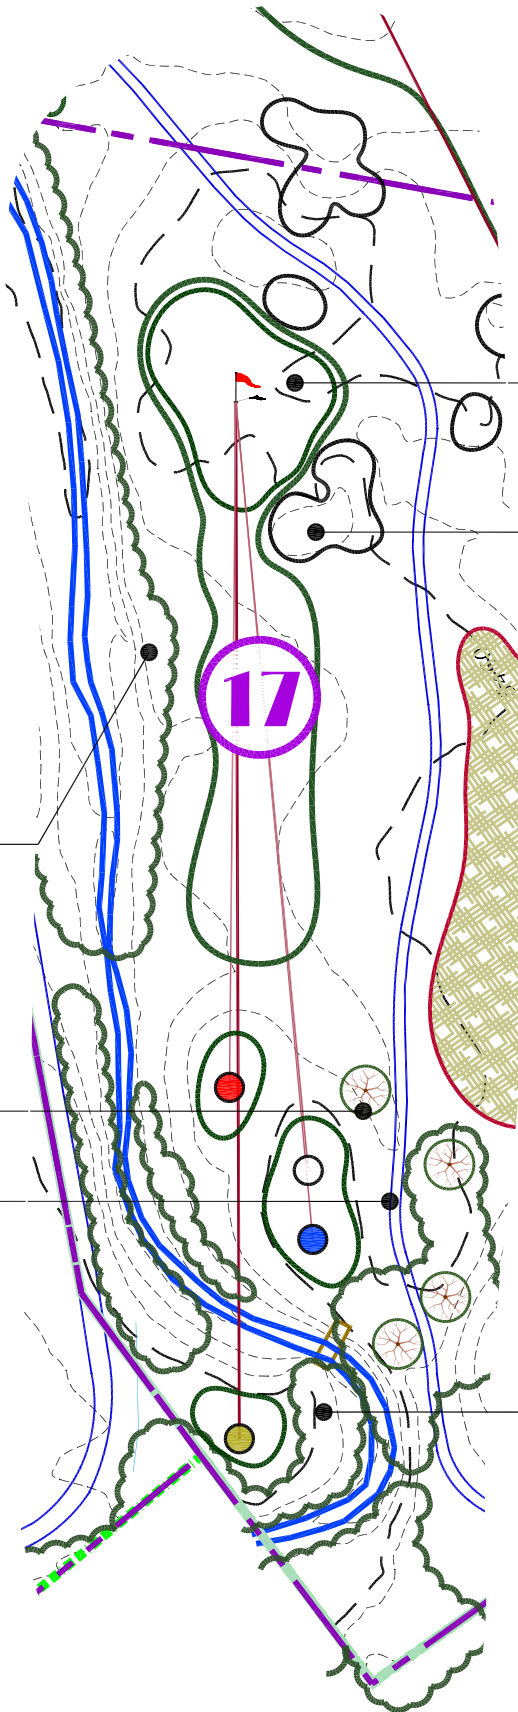
- Bunker face is eroded & sand contaminated.

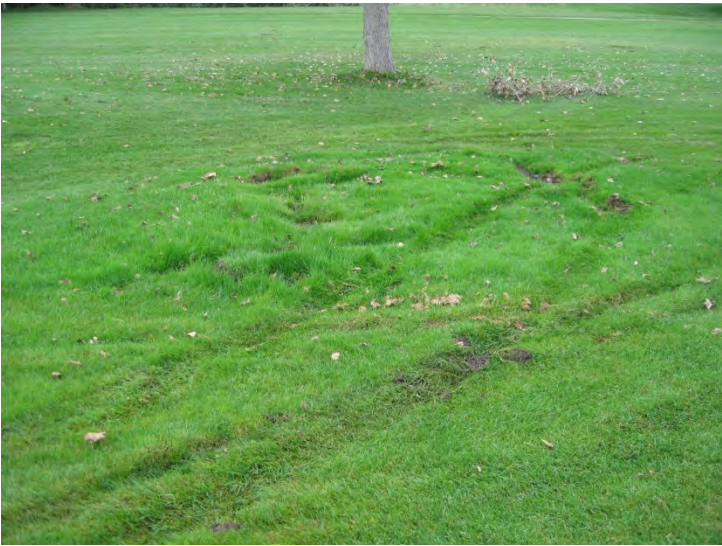
Picture 1. Heads too close to each other create a wet area

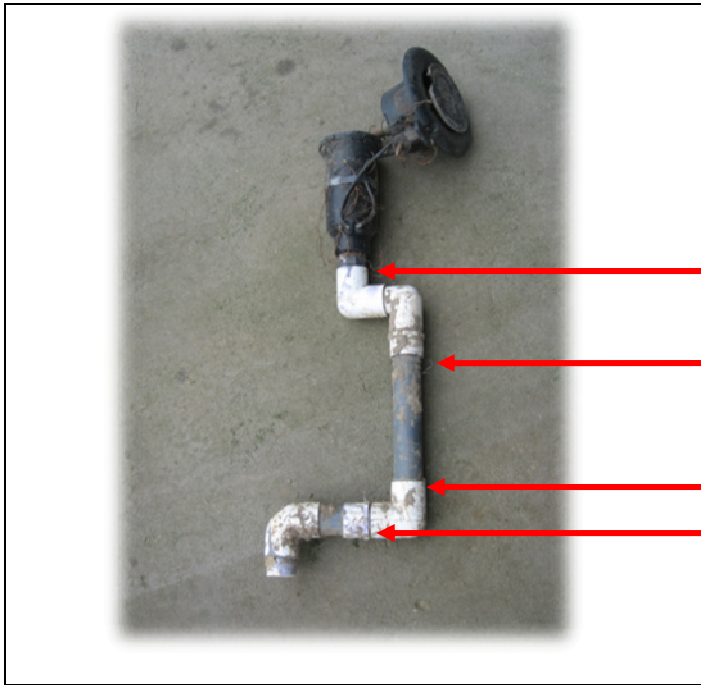
The original swing joint that was installed is a combination of good and bad. The good, o-ring elbows with acme threads. The bad, there are several solvent weld glue joints that are failing (picture 2). Many of the heads that have standing water are swing joints that are leaking. The solution to this problem is to install a unitized sing joint (no glue joints) when a leaking swing joint is discovered.

Arrows indicate glue joints and where leaks have occurred on the swing joint

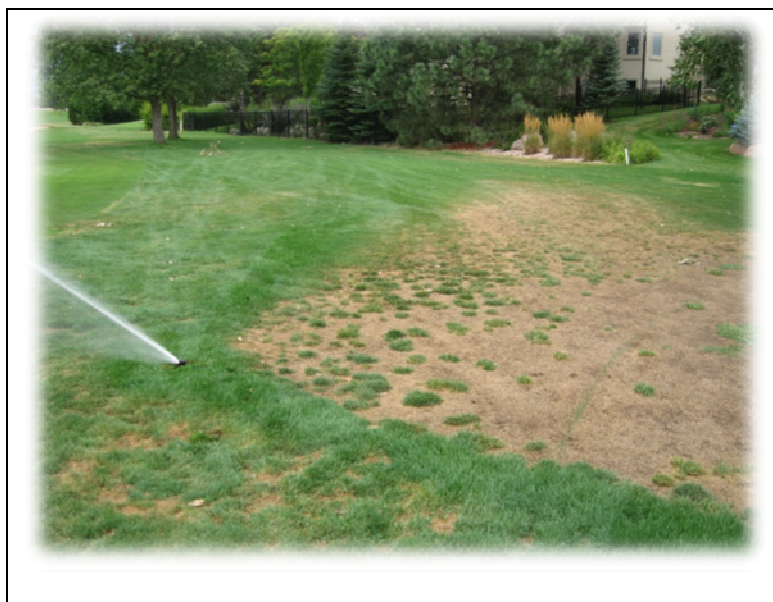
Picture 12. Part circle head with low turf quality behind the head

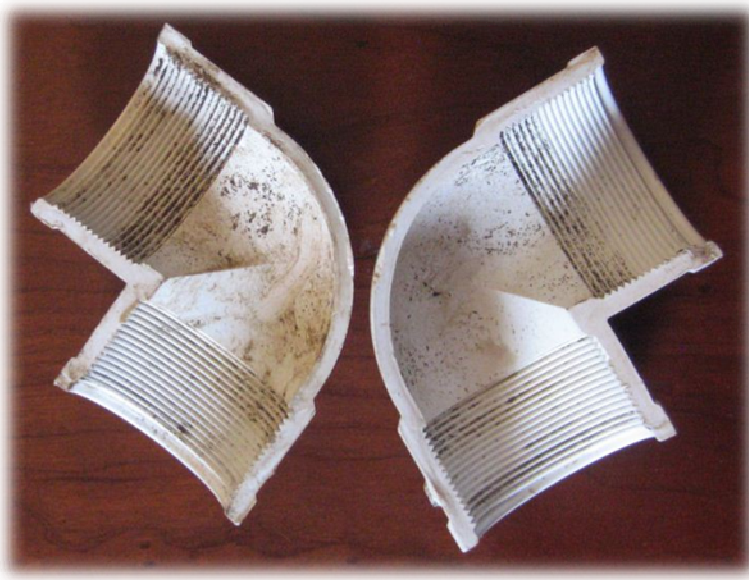
Split Sch 40 elbow

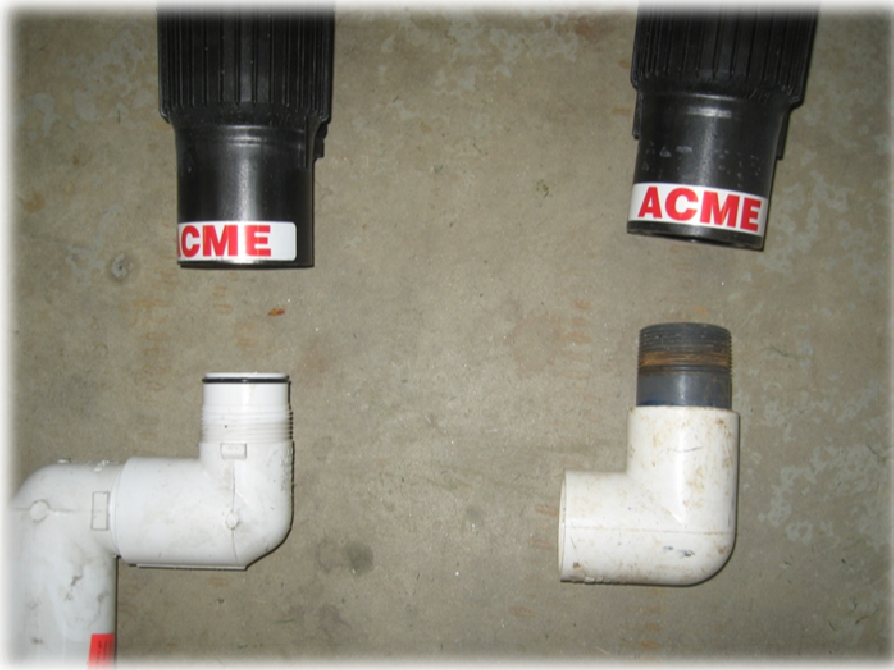
Unitized swing joint (left), swing joint with solvent weld fittings (right)

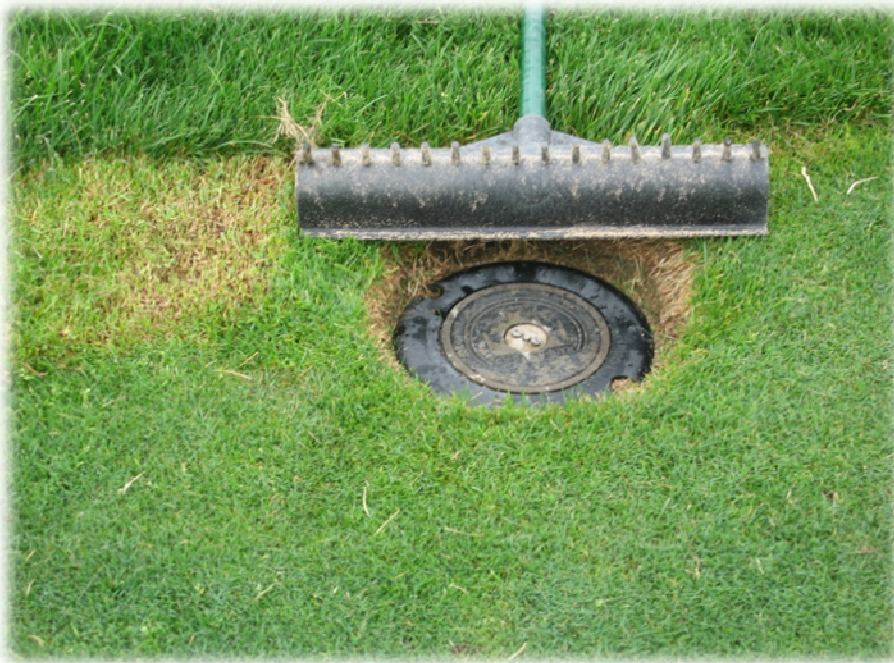
Head set too low, will affect performance

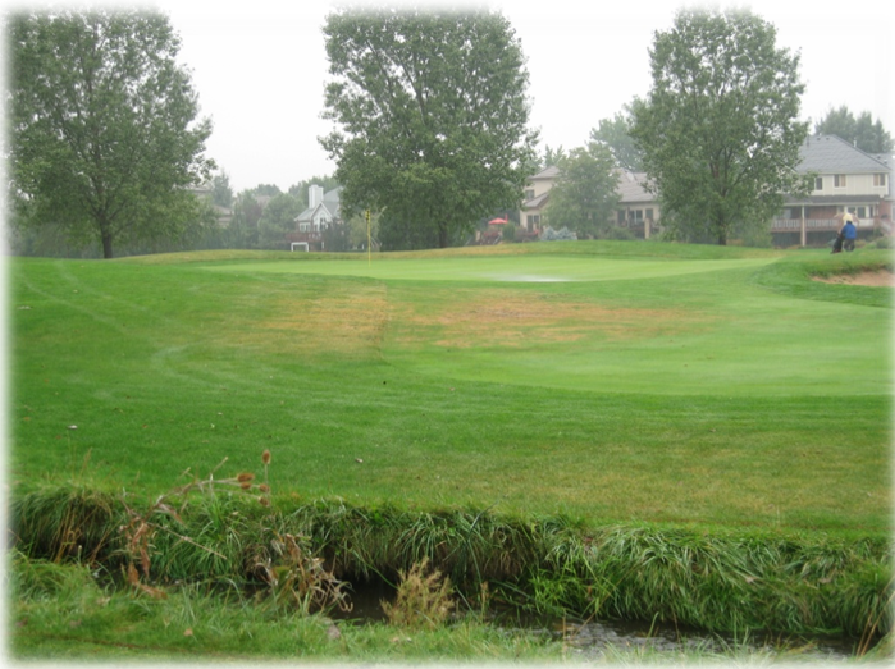
Multiple heads on one station, one head is in a shaded area, one in a sunny area, can't control the water for the two different water requirements.

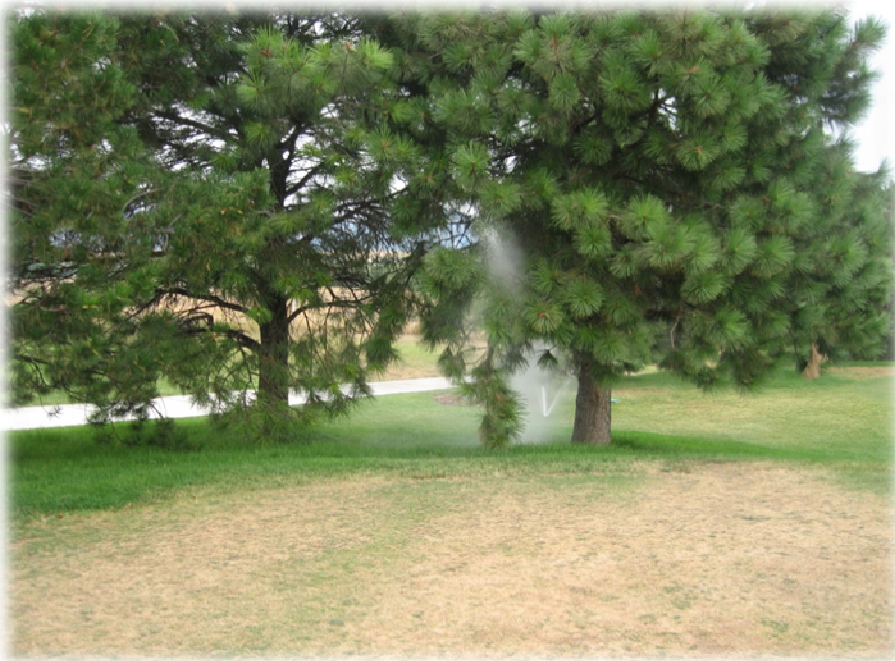
Trees blocking the sprinkler stream = dead turf – 16 tees

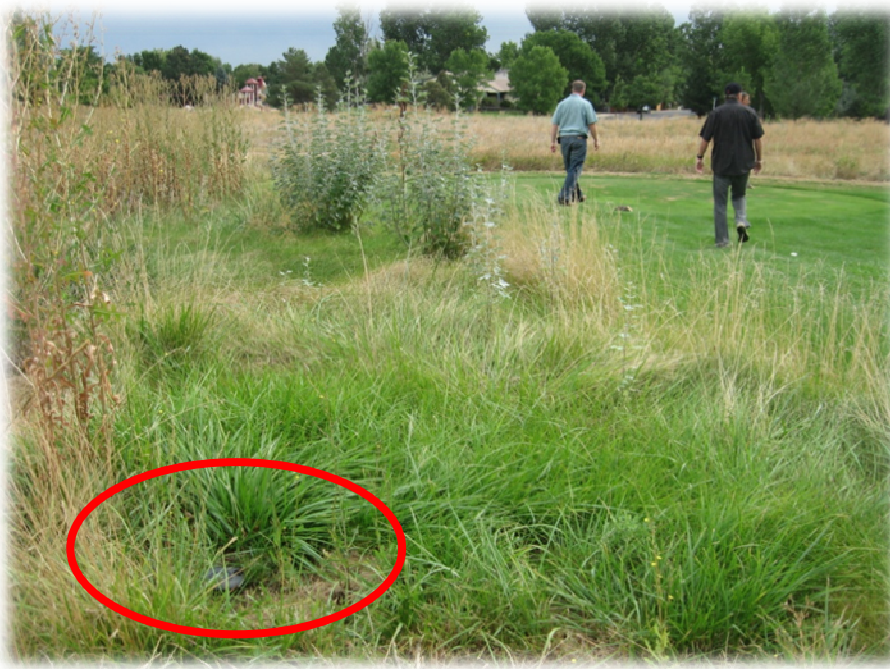
Sprinkler head outside of the formal grass limits, impacts sprinkler performance, wastes water

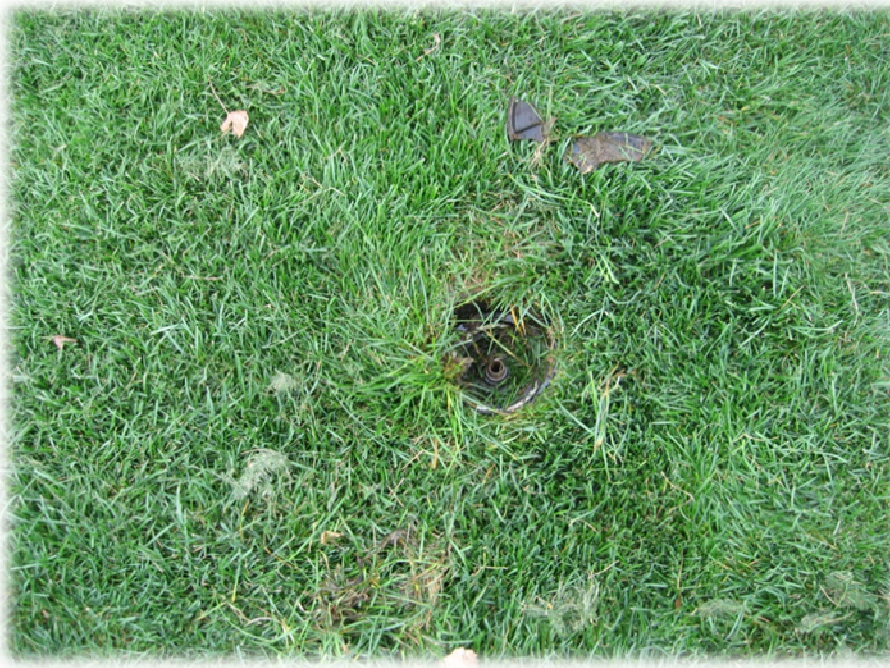
Broken head needs to be repaired

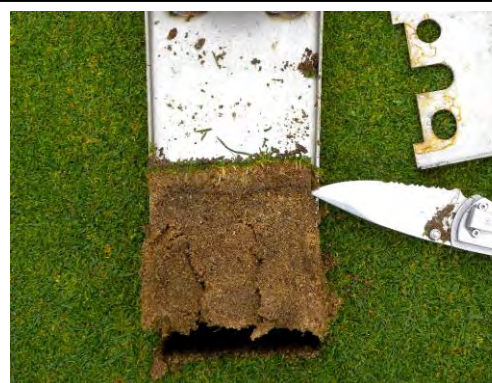
Layer near the top of green No. 1 shows need for aeration to disrupt the organic matter to improve water infiltration and turf health.

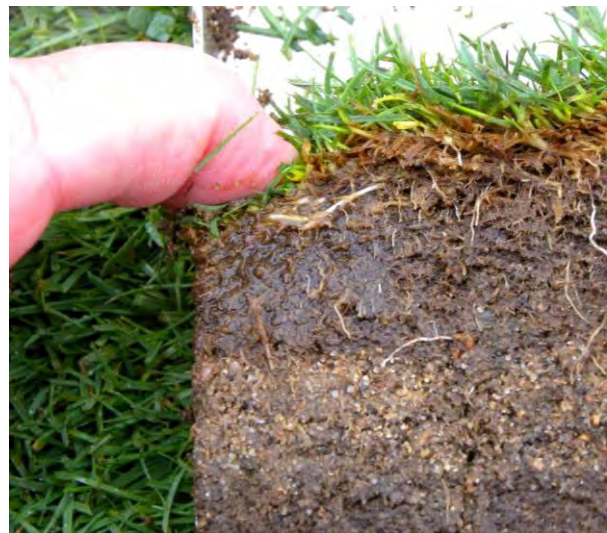
Gently pressing on the organic layer at the top of the turf on No.4 approach, demonstrates the water holding ability of too much thatch.

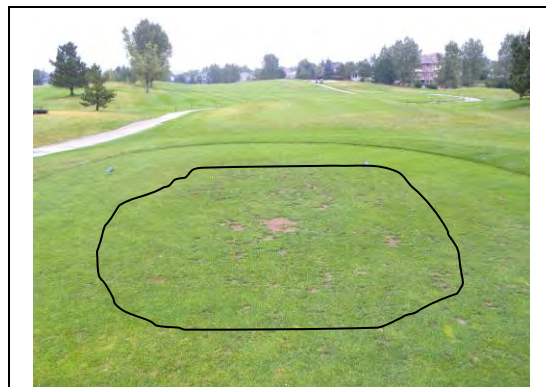
Winter damage is still visible from golfer traffic. Staffing should be adequate to not only monitor where golfers play from in the winter, but also to have time and equipment to repair these areas in spring.
