## HISTORIC STRUCTURAL ASSESSMENT 600 LINCOLN AVE., LOUISVILLE, COLORADO

DECEMBER 10, 2021

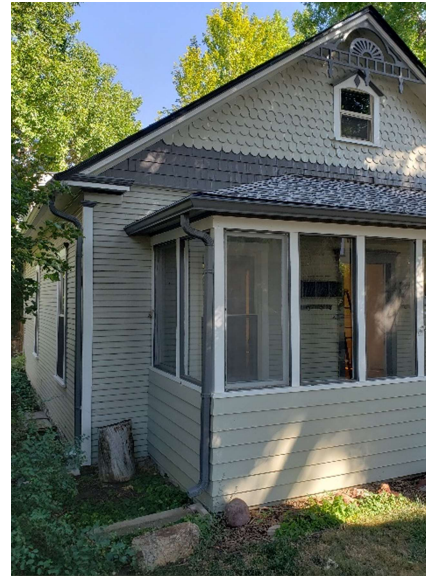
*Minimal difference between top of grade and top of foundation at west side of house*

The overall site grading is in fair condition. No signs of damage caused by poor or negative drainage was observed. Ideally, the grading around the house should be a minimum of six inches below the top of the foundation and slope away from the foundation for at least the first five feet. Due to the nature of the lot, it is unrealistic that these requirements may be achieved around the entire house. It may be possible for this condition to be met with significant grade alterations towards the rear of the house, but this is not possible around the western portion of the house due to the relatively flat grade near the top of the foundation. With no drainage issues or damage observed during the site visit, the existing drainage appears to be performing adequately.

Continue to monitor the drainage around the perimeter of the house. The perimeter should be observed after snow and significant rain events to assess for any areas of pooling water. Additionally, it is recommended that the northeast corner of the house be observed beneath the decking and ground cover to assess the drainage in this area. Temporary removal of deck planks and trimming back of the ground cover may be required for this assessment.

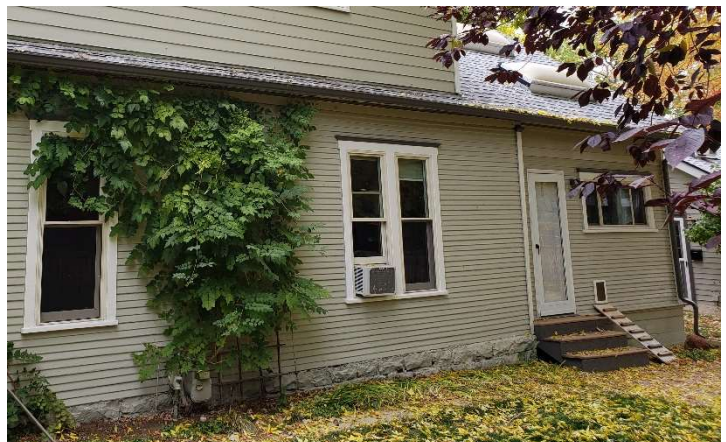
*Exposed foundation increases moving east, but finish materials are in contact with grade in the southeast corner, around the now-enclosed deck*

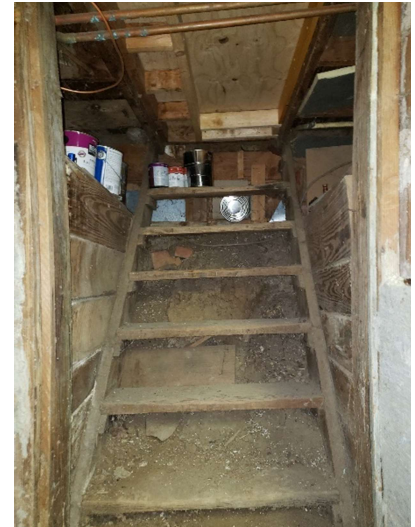
*Access hatch & stairs to basement with boards retaining soil on either side of the stairs. This area is in the crawlspace to the south.*

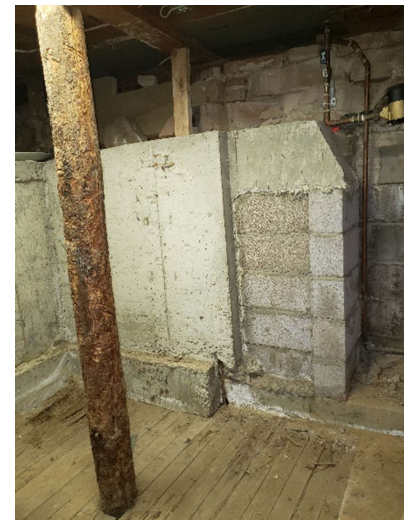
*Stone, concrete, and CMU foundations with exposed footing & wood basement floor*

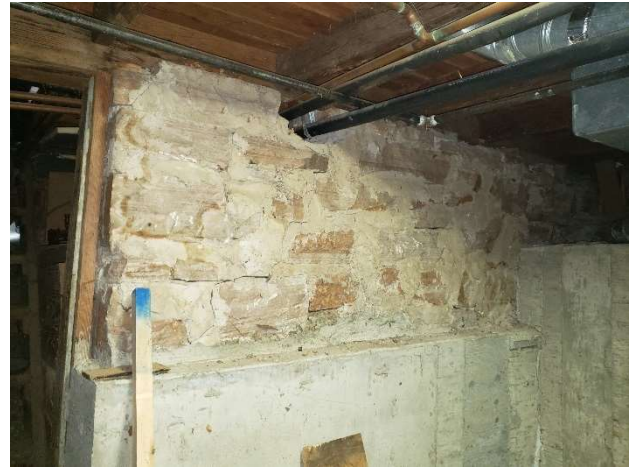
The evaluation of the foundation under the original house structure was limited due to the small basement space and limited visibility into the crawlspace areas. Where observed, the stone foundation was in fair to poor condition. There were no signs of distress apparent on the main or second floors, which suggests that the foundation under the original house is performing adequately. However, the lack of mortar between the stacked stones is cause for concern as it renders the foundation more susceptible to movement and water infiltration. Additionally, when the basement was dug out, the new concrete and CMU walls were placed adjacent or below original walls and were likely not properly designed for lateral earth pressures. It is also unclear how the concrete foundation wall directly beneath the stone foundation on the south side of the basement was constructed without undermining the integrity of the original foundation. Finally, the foundation walls were not built with the intent of adding a second floor to the structure. It does not appear that any additional foundations were created or that the original foundations were braced in order to accommodate the second floor that was added in the 1970's.

*Concrete foundation added beneath original stone foundation. Concrete retaining wall between the basement and crawlspace is seen on the right.*

6. New concrete and CMU retaining walls adjacent and directly below existing stone foundation walls should be further evaluated by a licensed structural engineer for proper earth retainage and support of the load above.

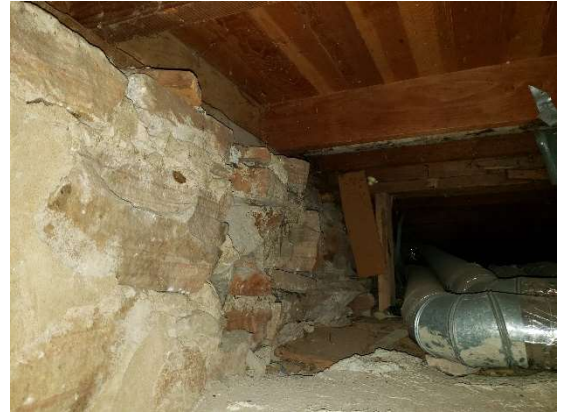
*Original floor framing, sheathing, sill plate, and floor bracing*

The floor joists and sheathing of the original house are in fair condition as 12+ foot spans and 24 inches on-center is at the maximum limits of 2x6 construction. This is likely why intermittent bracing of the floor system has occurred over time and there is a noticeable curvature to the floor in the living room. The center beam and supports in the basement are in poor condition. The beam is lying flat which does not provide resistance against deflection and the columns do not bear on proper footings. The condition of the center beam in the crawlspace could not be determined as analysis was limited due to access.

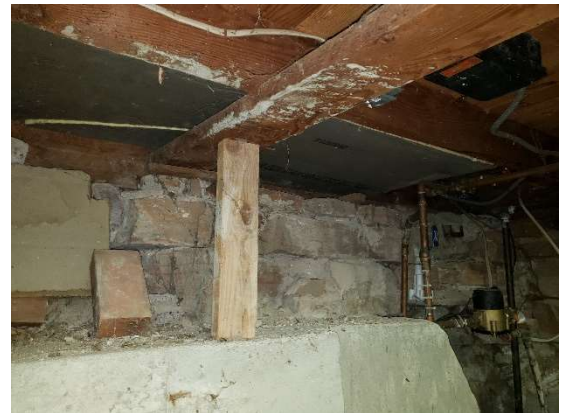
*Flat 2x6 beam & 2x4 column*

5. The floor framing supports in the basement should be replaced as prescribed by a licensed engineer. The flat beam is not adequate and should be replaced and supported with proper columns supported by new footings.

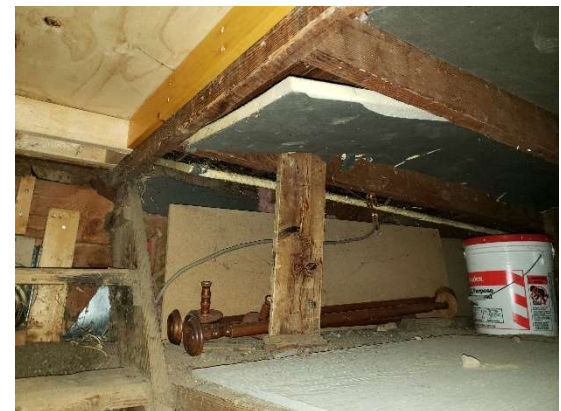
*South deck (now enclosed) floor framing & support*

The floor framing of what used to be the south deck is in fair condition as the members are also at the maximum limits of 2x6 construction. The floor framing of what used to be the north deck could not be determined as analysis was limited due to access.

4. The floor framing of what was originally the south side deck should be replaced and supported on a proper foundation as prescribed by a licensed engineer. This floor should be made flush with the remainder of the main floor.

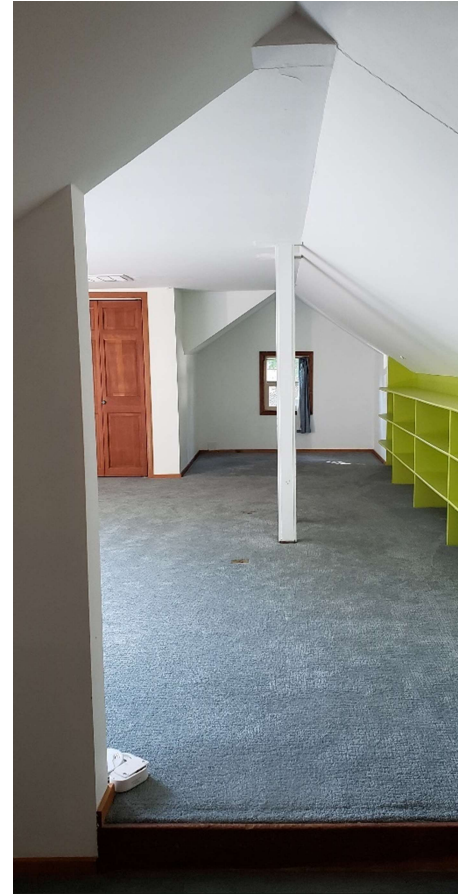
*The ridge beam is not directly supported on either end. The two columns support the center of the ridge beam with the original gable form beyond.*

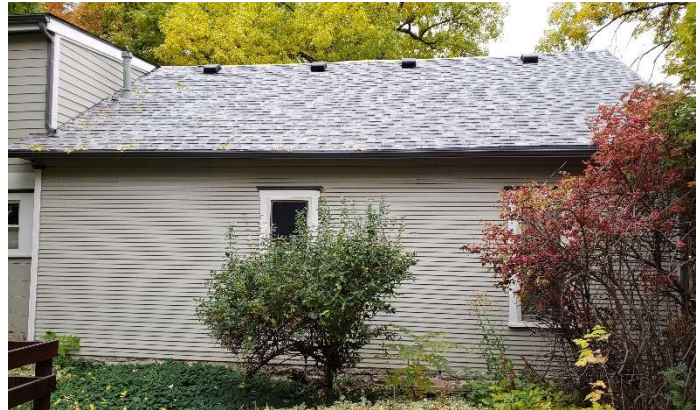
*North side asphalt composite shingle roof and mushroom vents near the ridge*

Consider adding soffit vents to provide adequate attic air circulation with low and high roof venting.

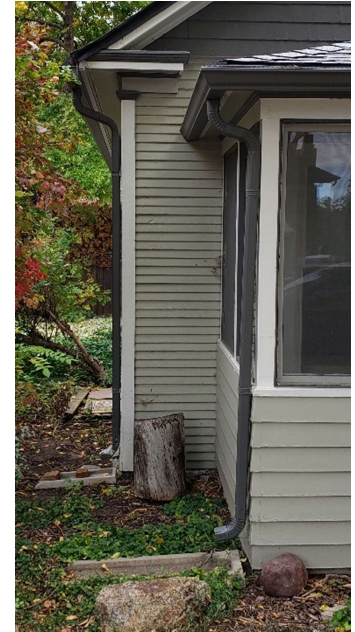
*Gutters, downspouts, & splash blocks*

A round downspout can be seen in the 1948 photograph, on the northeast corner of the covered front porch but it is unclear the style of gutters that were used. Consider replacing the gutters with half-round gutters and the downspouts with round downspouts that are more consistent with historic buildings in the Louisville area.

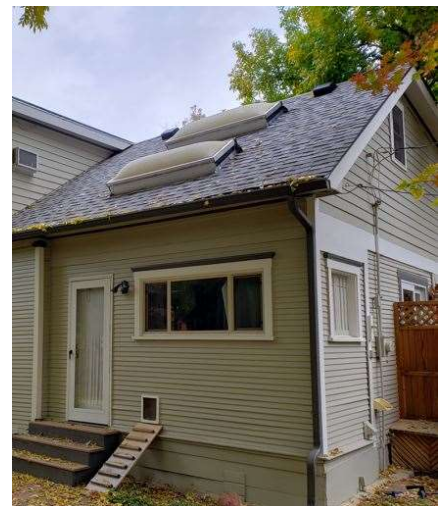
*Curb mounted skylights on south side*

Consider replacing all three skylights with new curb mounted skylights that meet current energy code standards.

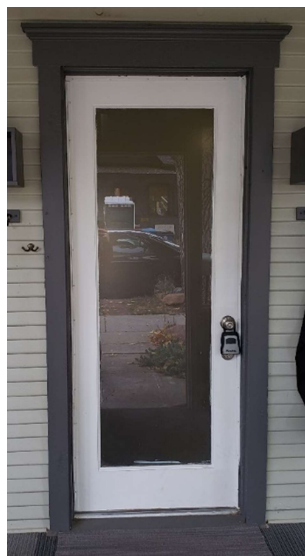
*Front door*

Replace the front door with a stained wood door similar to the original style of the house. There are several examples of front doors throughout the Louisville area that should be used as guidance.

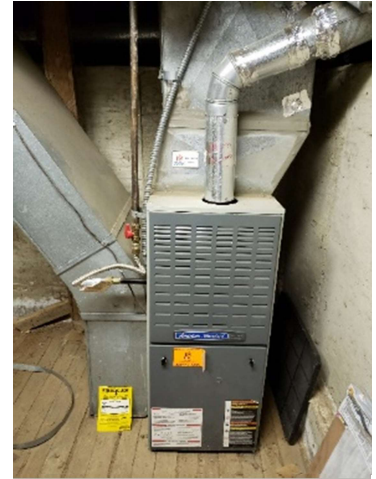
*Furnace located in basement*

Consider replacing the furnace with a high-efficiency unit with a sealed combustion intake / exhaust system.

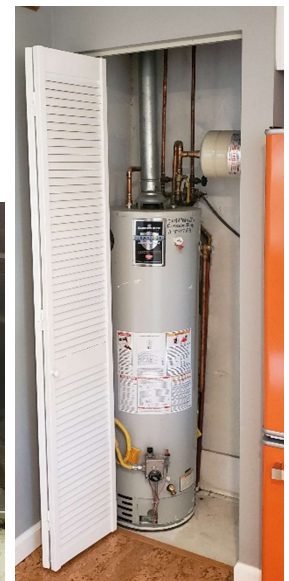
*Water heater in kitchen*

Consider replacing the water heater with a high-efficiency unit with a sealed combustion intake/exhaust system.

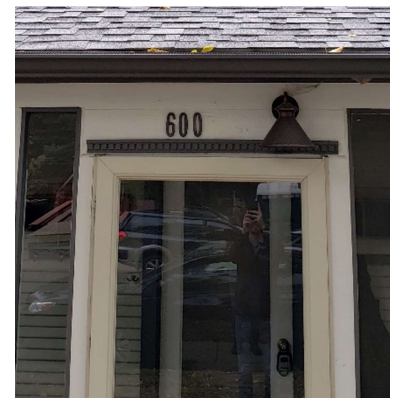
*Wall sconce at sunroom door*

Consider replacing all exterior light fixtures with full cutoff, high-efficiency units.
