## **HISTORIC STRUCTURAL ASSESSMENT** **612 JEFFERSON AVE., LOUISVILLE, COLORADO**

April 1, 2022

DAJ Design conducted an Historic Structural Assessment for the structure located at 612 Jefferson Avenue, Louisville, CO to determine its feasibility as a candidate for historic landmark designation as defined under the Historic Preservation program of the City of Louisville. The structure is a residential property. The City of Louisville Historic Preservation Commission found probable cause that the building may be eligible for landmarking under criteria in section 15.36.050 of the Louisville Municipal Code. Therefore, the Commission approved the Historic Structural Assessment to be paid for by the Louisville Preservation Fund grant.

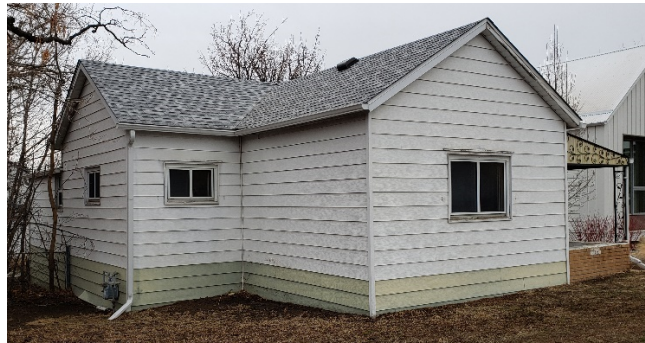
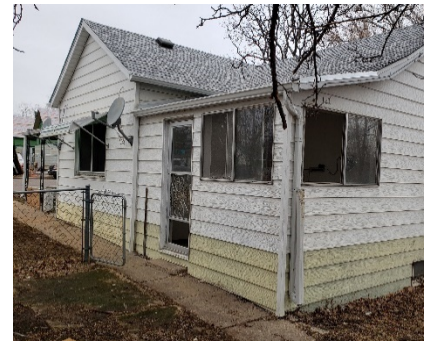
*Grading around the building footprint is apparent in how the siding is tapered where it meets grade.*

The overall site grading is in poor condition, though no signs of damage caused by poor or negative drainage was observed. However, no observations could be made because the existing aluminum siding runs to grade obscuring the top of foundation relative to the top of grade. Ideally, the grading around the house should be a minimum of 6 inches below the top of the foundation and slope away from the foundation for at least the first 5 feet. Due to the nature of the lot, it is unrealistic that these requirements may be achieved.

1. Continue to monitor the drainage around the perimeter of the house. The perimeter should be observed after snow and significant rain events to assess for any areas of pooling water.

2. The top of the foundation relative to the top of grade should be determined around the perimeter of the house. If the top of the foundation is determined to be at or below the existing grade, new grading should occur to bring the grade down below the top of the foundation, as prescribed by a licensed structural engineer.

3. The wood floor framing members including the sill plate, rim board, floor joists, and floor sheathing should be inspected for rot caused by poor drainage. If rot is found in any of these members, the affected flooring should be replaced as prescribed by a licensed structural engineer.

4. All areas where grade slopes towards the house, particularly on the west side of the house, should be regraded to direct water away from the house foundation.

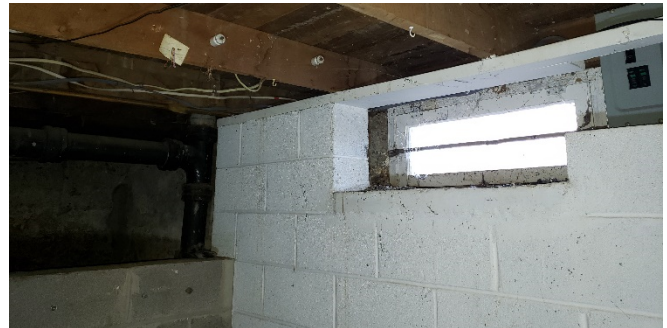
*CMU walls in basement. The east wall runs to the bottom of floor joists and is capped with a 2x sill plate.*

The east CMU wall is in fair condition. This wall supports the east end of the main floor and walls in conjunction with the original east foundation wall that is still present. Similar to the other CMU walls, a footing could not be observed and there do not appear to be any anchor bolts connecting the wall to the sill plate and floor framing. Therefore, this foundation wall is determined to be in fair condition.

1. The basement and crawlspace walls should be observed by a licensed engineer and repaired as needed. The walls are not suitable for additional load resulting from a remodel or addition and should be replaced for new loading.

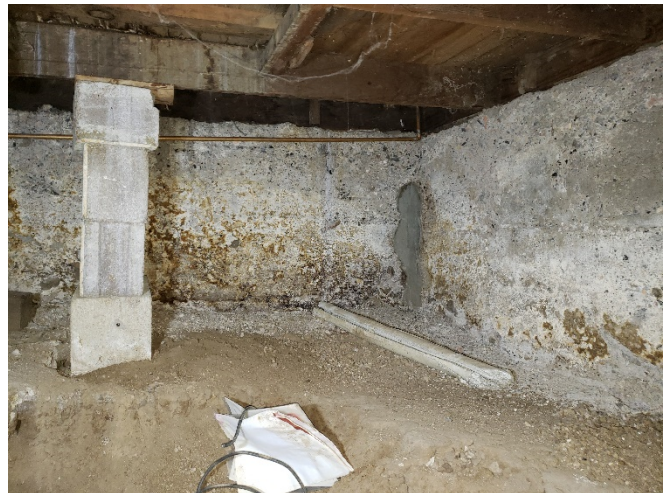
*Concrete foundation in northeast corner of crawlspace.*

The poured concrete perimeter foundation walls are in fair to poor condition. The foundation walls supporting the west side of the house could not be fully analyzed as access was limited. Most of the perimeter foundation walls appear to be in fair condition as they are still fully intact with little to no cracking observed. There are several areas where the concrete has cracked showing signs of failure. The primary area of failure is in the southeast corner of the house where the concrete foundation is severely cracked and deteriorating.

3. The foundation wall in the southeast corner of the house, as well as any other areas where cracking or deterioration has occurred, should be replaced as prescribed by a licensed engineer.

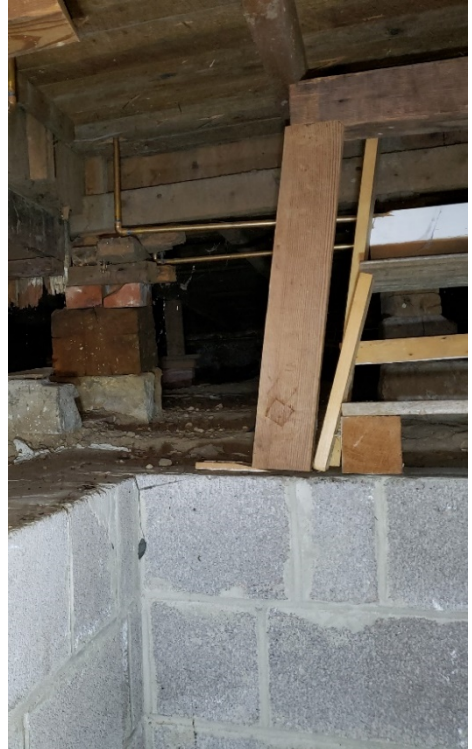
The north, west, and south CMU foundation walls only have a couple of point loads supporting the house structure while their primary purpose is to retain the crawlspace soils. The point loads may have been added later to stiffen the floor structure, but the overall load applied at these locations is minimal. Complete analysis of these walls was not possible as the presence of a footing and its construction could not be determined. Additionally, these walls are not constructed as proper cantilevered retaining walls, though they are performing as such. No signs of failure were observed, and the walls appear level and straight with no signs of weakness. For this reason, these three walls are in fair condition.

*CMU walls between basement and crawlspace.*

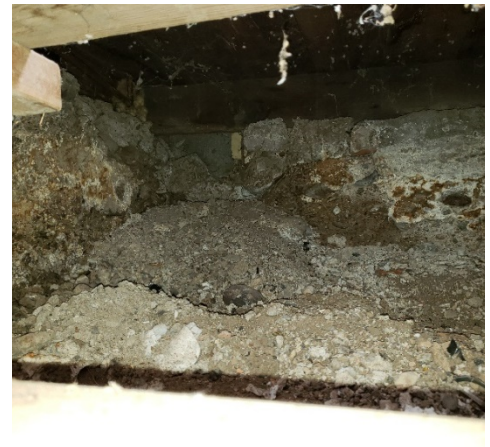
*Failing foundation wall in southeast corner of house.*

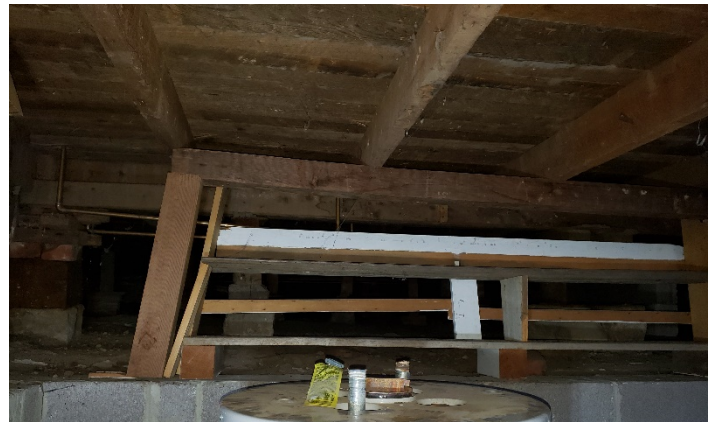
*Floor framing, sheathing, & supports*

The 2x6 floor joists are in good condition and the size of the joists are typical for houses built around the same time in the Louisville area. The joists spanning the long dimension of the house is a-typical for similar houses built around the same time in the Louisville area, though the methods used to brace the floor framing is very common. The joist sizing and spacing do not meet minimum IRC code requirements for today's standards but appear to be performing adequately. The floor on the main level felt sturdy and no floor deflection was observed, indicating that the floor framing is adequate for the current loading.

The floor sheathing that also performs as the finish flooring in most of the house is in fair condition. The flooring appears to be performing adequately, but there are several areas on the main floor that are bulging (likely from excessive supporting from below) and there are a few areas of water damage as observed on the main floor, likely from water being trapped beneath areas where carpet was formerly present. The floor sheathing does not meet minimum IRC code requirements for today's standards but appears to be performing adequately.

1. The floor framing should be observed by a licensed engineer and repaired as needed. Special attention should be given to the connections between the foundation walls, floor joists, beams, and beam supports. The floors are not suitable for additional load resulting from a remodel or addition and should be replaced for new loading.

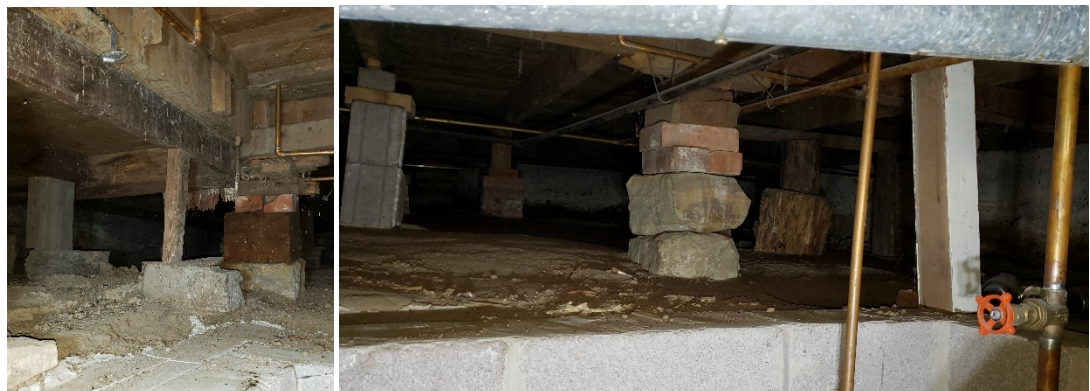
*Various flooring structure support-beams & built-up columns*

The beams supporting the floor joists are in fair to poor condition. The spacing and sizing of the beams appear adequate for the current loads that they are supporting. However, several of the beams are built up of various materials in several locations and none of the beams are properly attached to their supports. The beam sizing, spacing, and spans do not meet minimum IRC code requirements for today's standards but appear to be performing adequately.

The beam joist supports are in fair to poor condition as well. The supports are built of various stacked materials and in several cases the materials used are not appropriate for the supported loads. In most cases, each support bears on concrete or brick instead of soil which is appropriate, but the bricks and concrete units used are various and their capacity to withstand further loading is unknown. The materials, sizing, and construction methods of the beam supports do not meet minimum IRC code requirements for today's standards but appear to be performing adequately.

2. The beams and beam supports should be replaced or reinforced as prescribed by a structural engineer. The best method is to construct new beams and beam supports that support the existing floor joists and remove the existing beams and beam supports as prescribed by a licensed structural engineer. These new supports should bear on footings as prescribed by a licensed structural engineer and located at a depth as specified by a licensed geotechnical engineer.

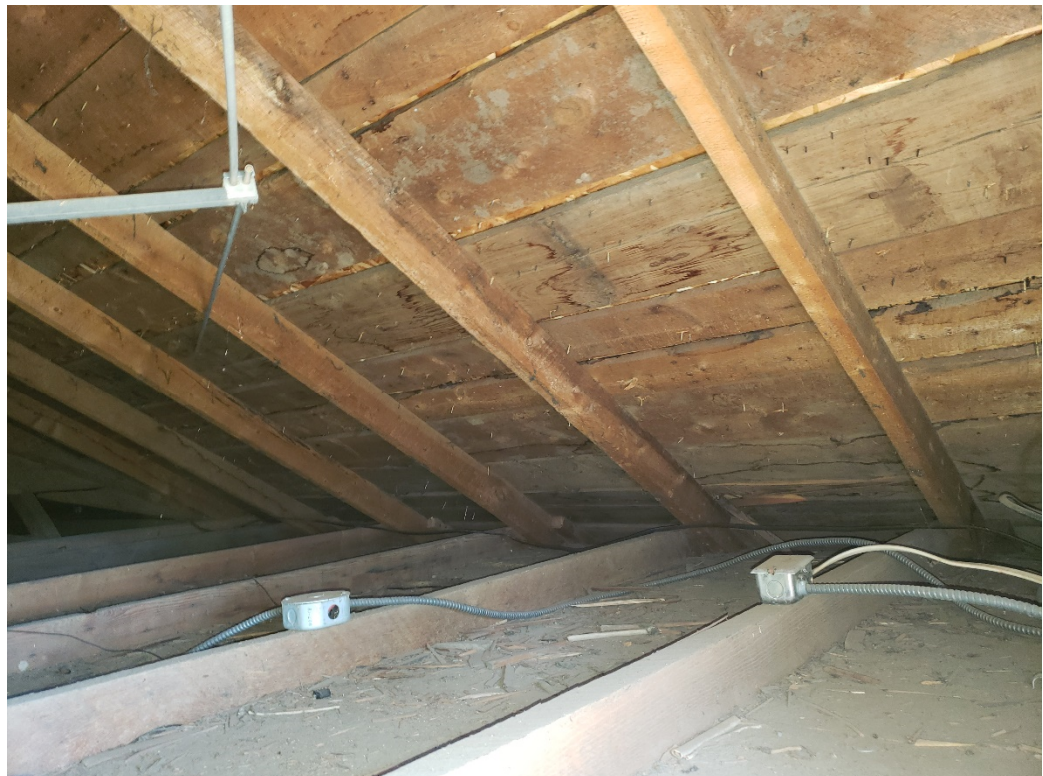
*Roof framing as observed from east gable end access.*

The roof is in fair condition and is constructed of typical materials and methods for houses built around the same time in the Louisville area. There is no evidence of water damage where the roof was able to be observed. There is no evidence of damaged or poor performing rafter or ceiling joists. The covered front porch was observed to be sagging minimally and is in fair condition.

1. Add 2x4 collar ties at 48 inches on-center.
2. Consult with a licensed structural engineer to provide deeper ceiling members and rafters to meet minimum IRC prescriptive roof framing.
3. It is not recommended to add additional roofing materials such as an additional layer of shingles (code allows for up to two layers), or solar panels without the additional structural support mentioned above. Additionally, any energy upgrades, such as increased insulation in the attic, could result in prolonged snow retention on the roof and could ultimately affect roof performance without first completing structural reinforcement.
4. The roof framing over the rear additions and the west facing gable should be investigated to determine if they need additional support.
5. Any repairs to the roof should be coordinated with a licensed structural engineer.

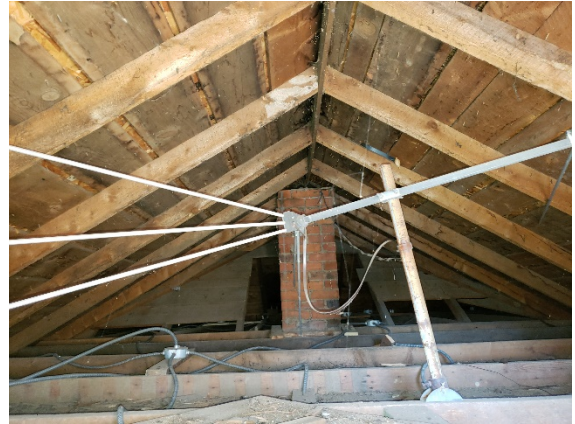
There are no intermediate walls to help support ceiling joists and roof members as needed. As a result, ceiling finish material damage is likely and was observed where the dropped ceiling had been removed. See recommendation below for options to reduce future finish material damage.

*East facing gable roof structure with north-south gable structure beyond. Chimney remnants found in attic space are not present on the main floor nor protruding through the roof.*

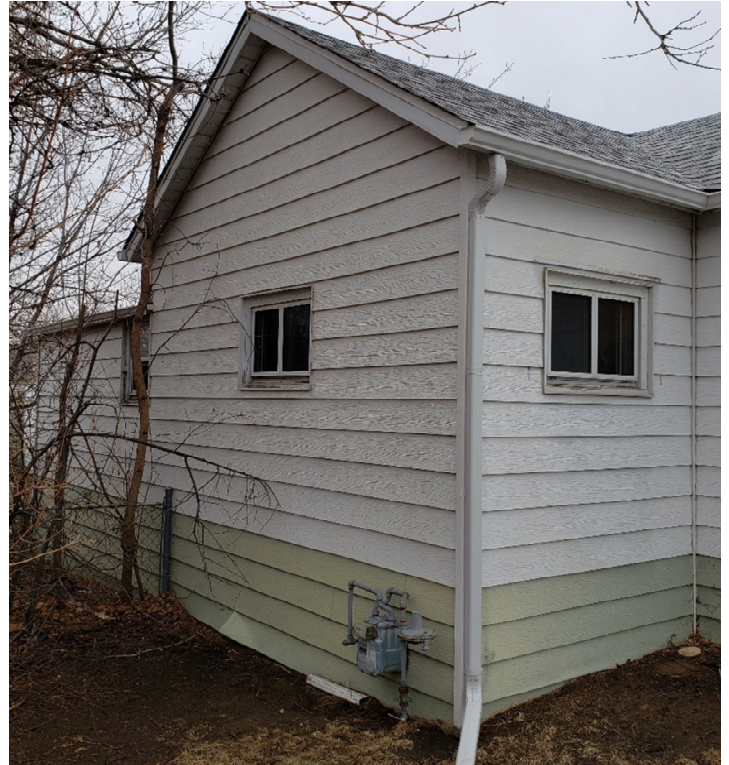
The aluminum siding is in fair condition. There are a few bent or chipped panels and damage was done to the panels around several of the window openings when awnings were attached and then later removed.

*Aluminum siding. One panel is bent near grade on the north side and the siding has been damaged around the west facing window where an awning was removed.*

Investigative deconstruction is recommended in an inconspicuous area to determine what siding exists beneath the aluminum siding. It is likely that the aluminum siding was applied directly over the stucco siding which in turn was likely applied directly over the original wood siding as was common practice in the Louisville area. It is recommended that the aluminum and stucco siding be removed from the entire house. With the removal of this siding, it is likely that the original siding will be exposed. Repair, refinish, or replace the original wood siding.

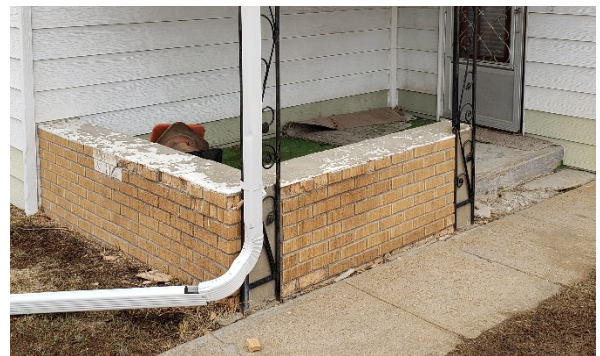
The brick knee-wall is in poor condition as it is crumbling throughout.

The brick wall should be removed and not replaced. Though the wall likely meets the 50-year minimum to be historic, this wall was not original (it does not appear on the 1948 Boulder County Assessor's card image), it is not structural, and does not fall under the period of significance. Removing the brick wall would further improve the front façade's historic integrity as it is not original.

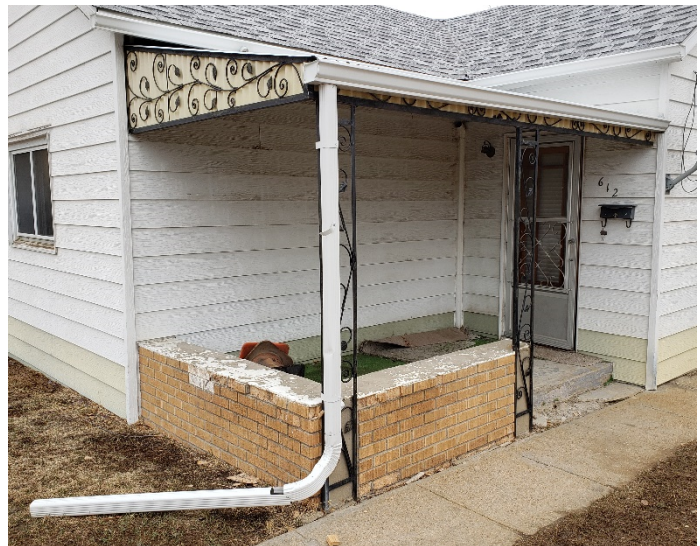
The covered front porch is in poor condition as the concrete slab and brick wall are deteriorating and the steel columns have a few areas where rust has started to appear, primarily where the columns are attached to the brick wall.

*Covered front porch*

Remove the entire covered front porch including the shed roof, steel roof structure and columns, brick wall, and concrete slab. The front porch is not original to the house nor does its construction match any period of significance. Removing the covered front porch would further improve the front façade's historic integrity.

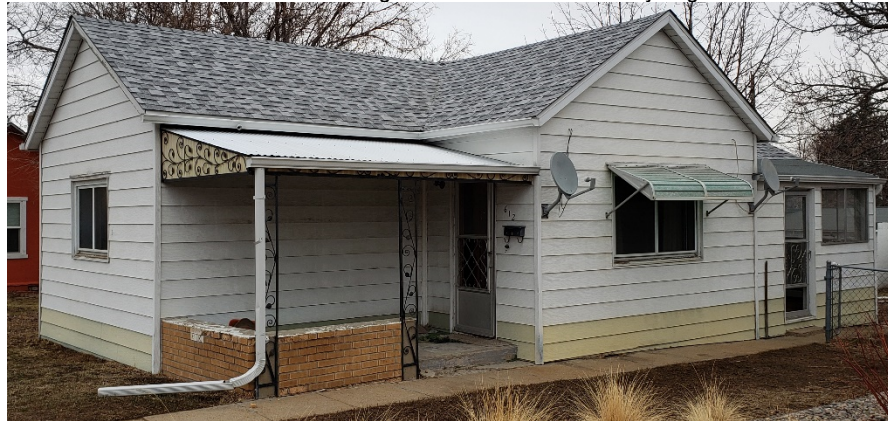
*Asphalt composite shingle roof on main house, corrugated metal roof at the covered front porch.*

The asphalt composition shingle roof, roof vents, and corrugated metal roof are in good condition.

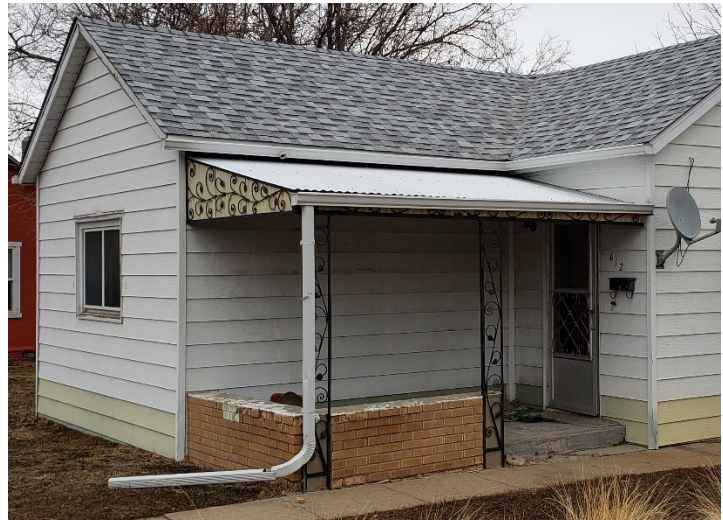
*Upper roof gutters discharge water directly onto covered porch roof.*

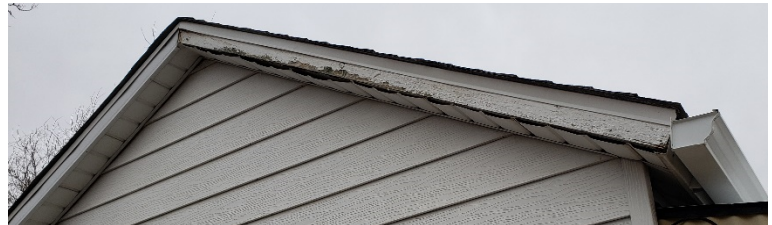
The soffits and fascia are in fair condition. The aluminum fascia on the west gable end is missing, exposing the original barge rafter, and the soffit in this area is sagging.

*Missing fascia & sagging soffit at west gable end. Original barge rafter exposed.*

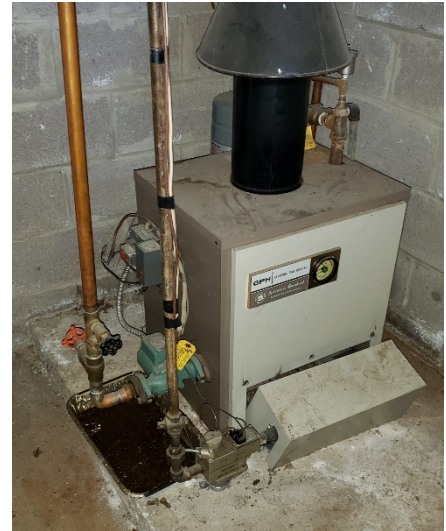
*Gas-fired boiler located in basement.*

1. The boiler should be replaced with a high-efficiency unit with a sealed combustion intake/exhaust system. Once replaced, the existing supply and return lines should be evaluated for any leaks.
2. Consider replacing the baseboard registers with newer, more efficient units.
3. The window mounted air conditioning unit and support structure should be removed for safety concerns.

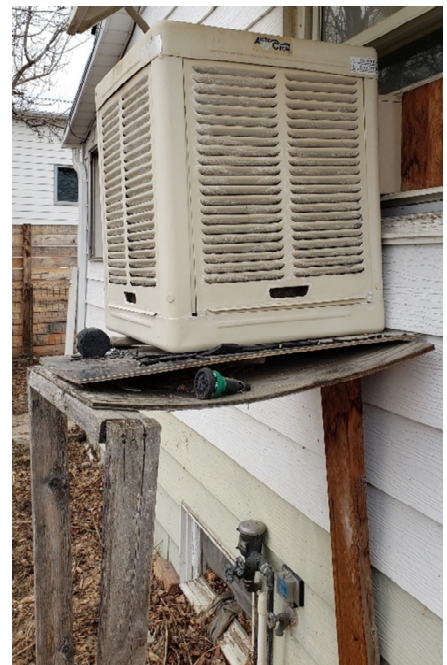
*Window mounted air conditioning unit and makeshift support structure located at east facing kitchen window.*

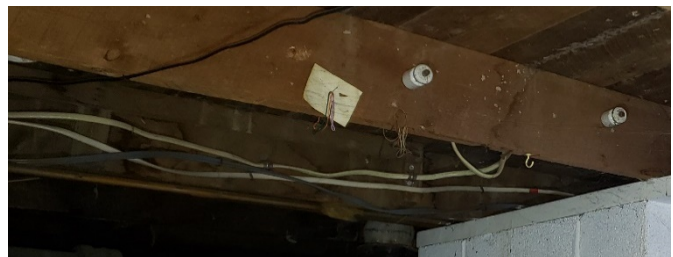
*New romex wiring with abandoned knob-and-tube.*
