**ITEM:** 600 Pine Street Landmark, Alteration Certificate, & Grant Request

**REQUEST:** A request to Landmark 600 Pine Street, and requests for an Alteration Certificate and Preservation and Restoration Grant

# 600 Pine Street

## Historic Structure Assessment

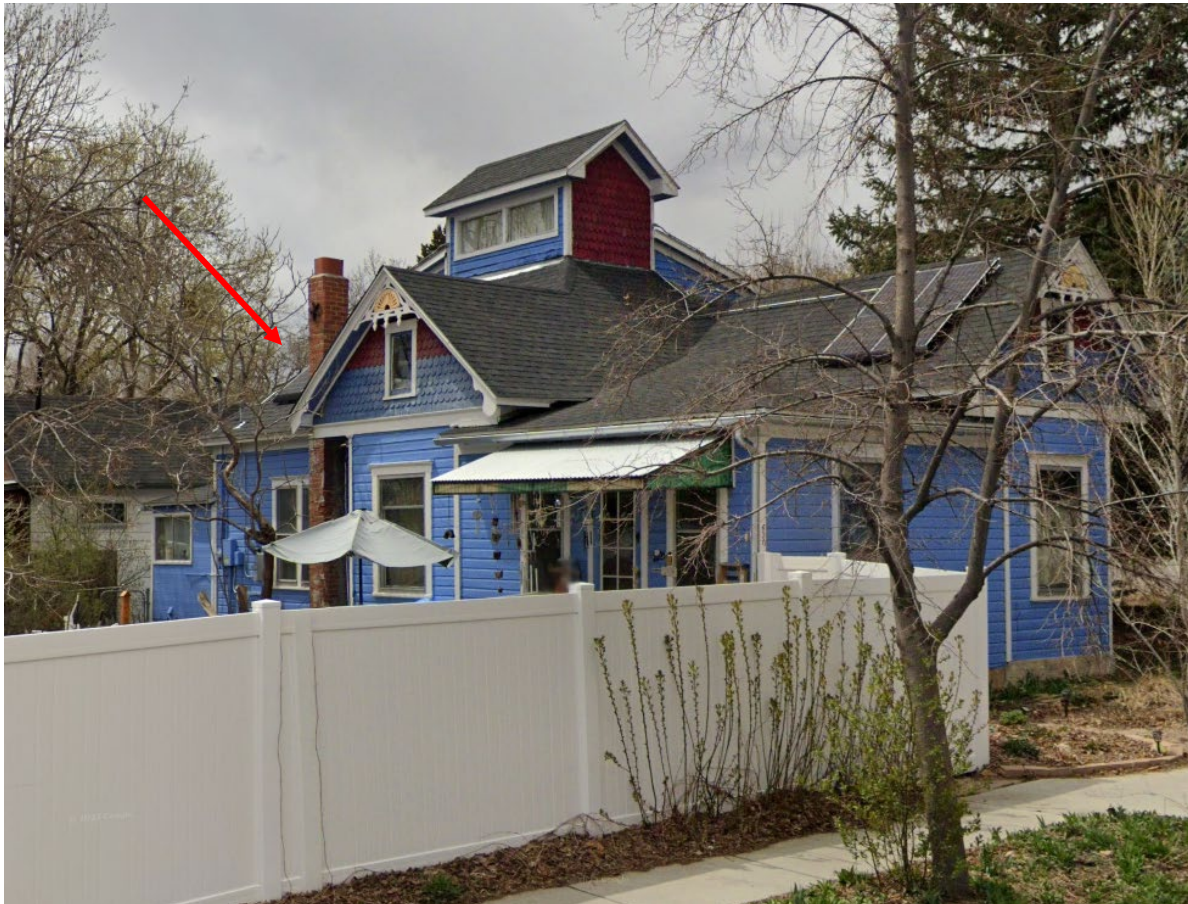
The proposed Alteration Certificate is to repair the existing chimney on the property. The proposal includes breaking down the chimney to the ground level and rebuilding the chimney to the same height using the same brick material as the original.

*Photo of the chimney's location on the subject building.*

| Criteria and Standards | Met? | Evaluation |
|---|---|---|
| 6. <i>The condition of existing improvements and whether they are a hazard to public health and safety.</i> | <b>Yes</b> | The existing conditions of the chimney could provide a hazard because it is currently not structurally sound. |

- A. Chimney.
1. Bricks (500) – including delivery.
  2. Scaffolding setup/breakdown.
  3. Cover solar panels with protective boards.
  4. Take chimney down to ground level.
  5. Haul off brick and rubble.
  6. Create/repair foundation.
  7. Rebuild chimney to same height.
  8. Seal off chimney at top completely.

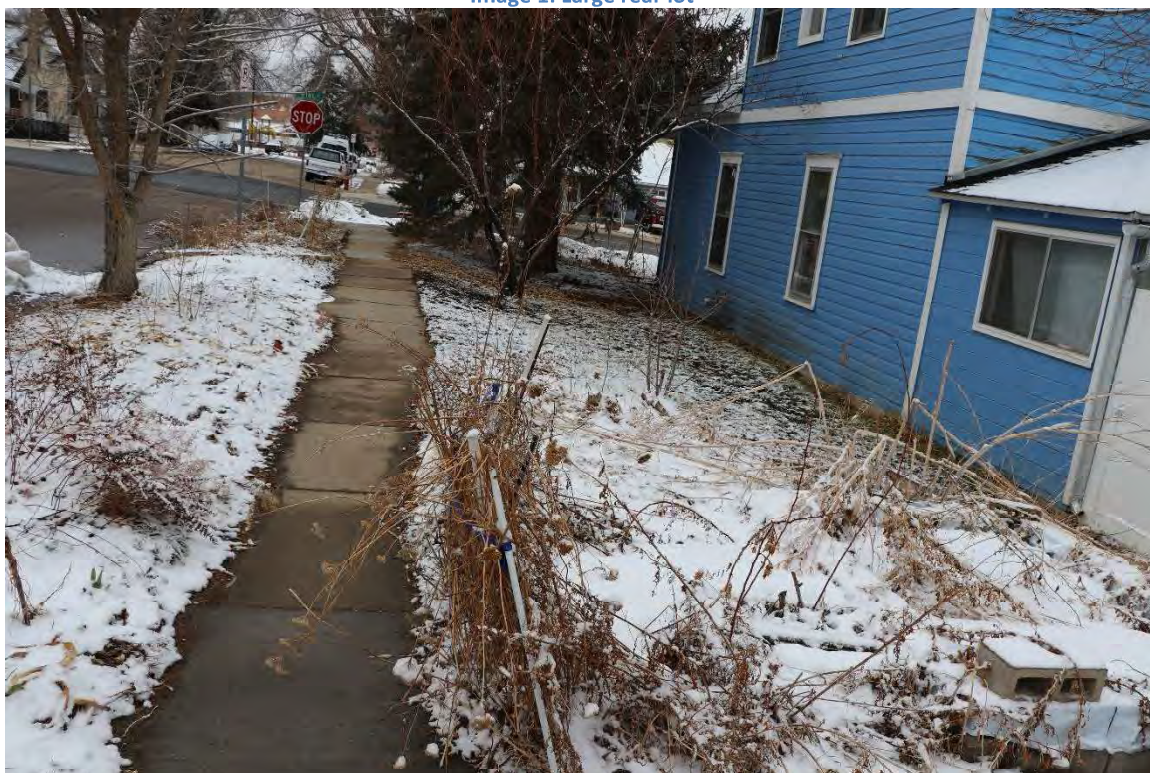
Image 2: Grading. Drainage slopes towards the house on the west elevation

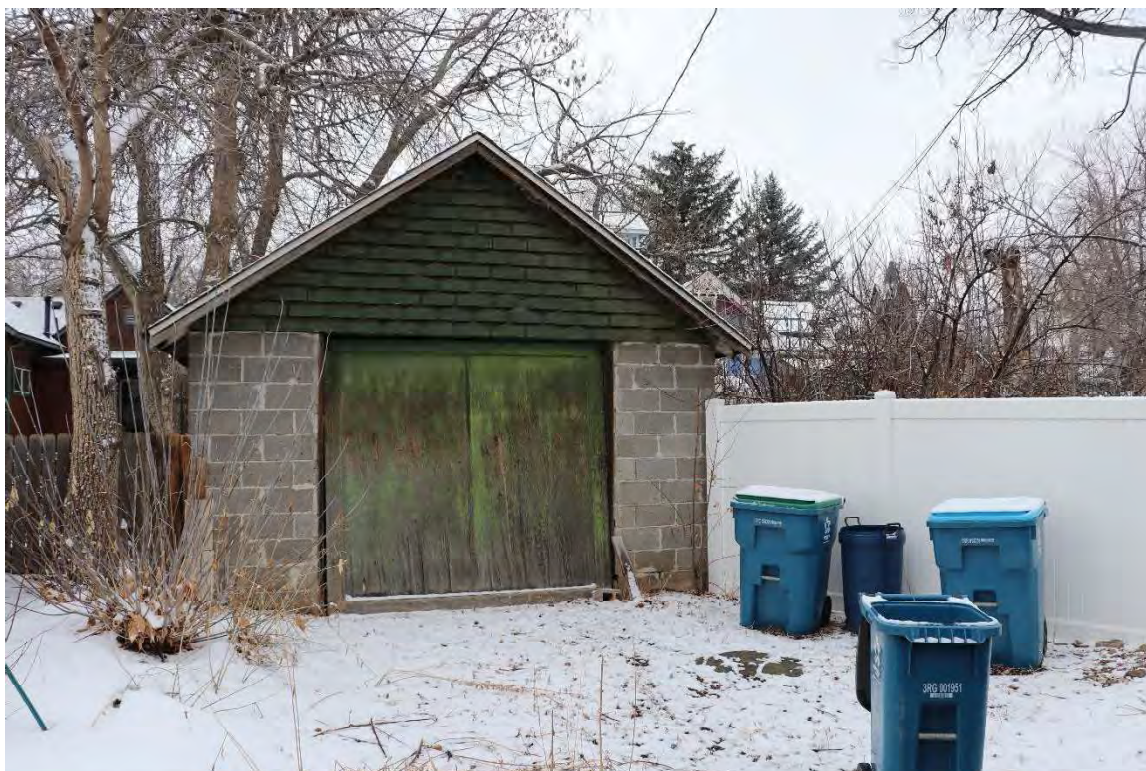
| <i>Element</i> | <i>Description &amp; Condition</i> | <i>Evaluation</i> | <i>Recommendation</i> |
|---|---|---|---|
| Parking | There is street parking along Pine and Grant Streets. An alley on the east provides access to a small one-car concrete block garage | Fair | The garage is in need of maintenance on the garage and pedestrian doors |

Image 3: Parking. Single car garage along alley

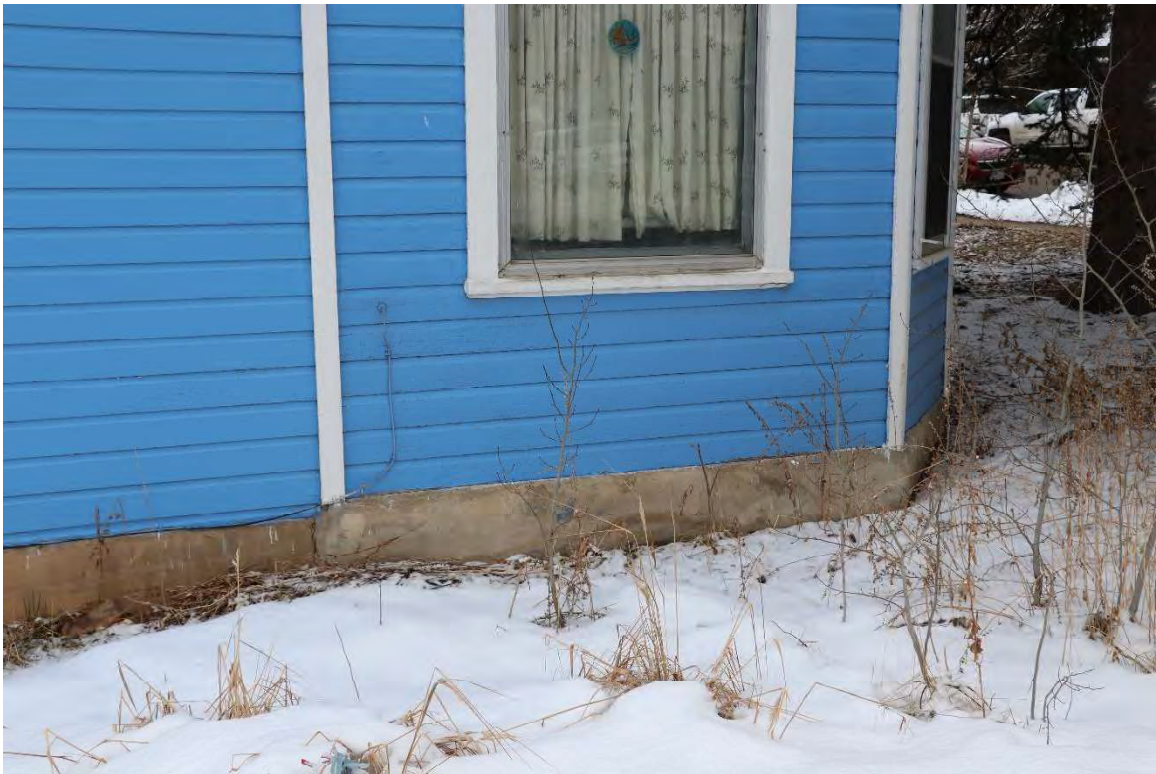
| Brick Cellar Foundation Wall | The foundation between the original structure and the 2 <sup>nd</sup> addition (porch enclosure) has cracked signaling movement. (Structural Assessment) | Poor | Reconstruct the corner of the foundation including the concrete base. Further review of the |

Image 5: Foundation. Seam visible under the addition on the left of the image

interior cellar walls  
should be preformed by a  
qualified mason or  
structural engineer

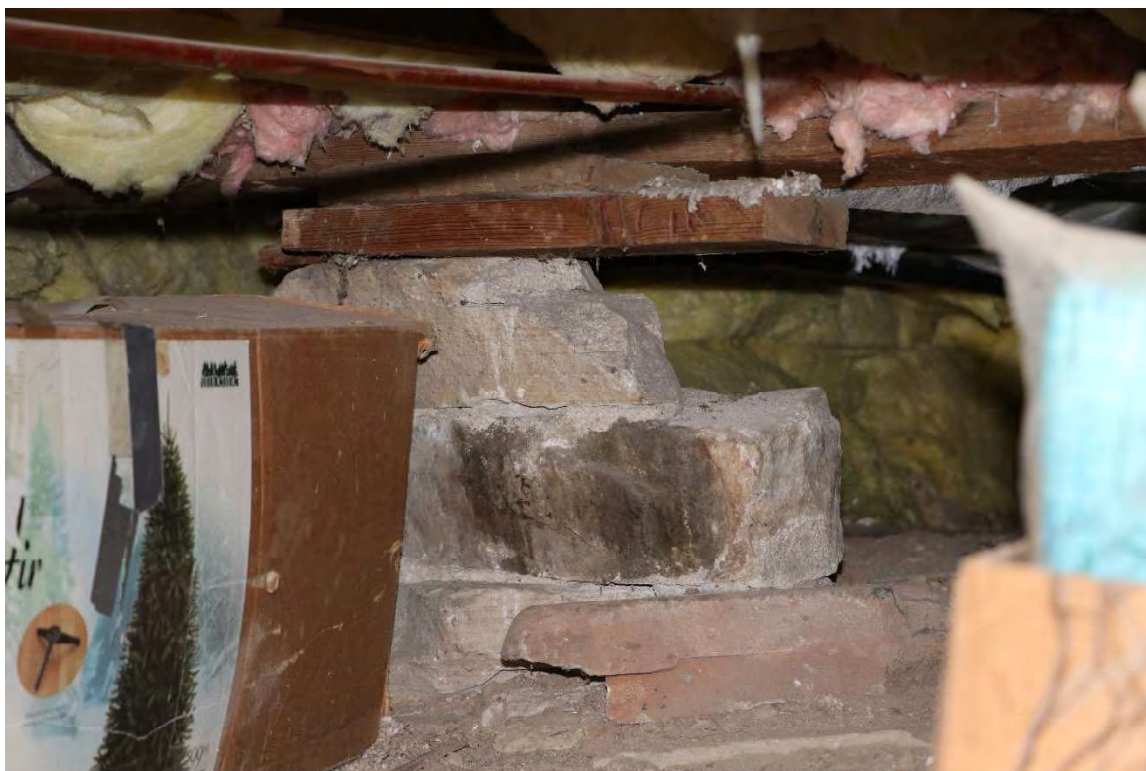
Image 6: Stacked stone partial-span pillar. Note the added wood boards above and the minimal bearing surface

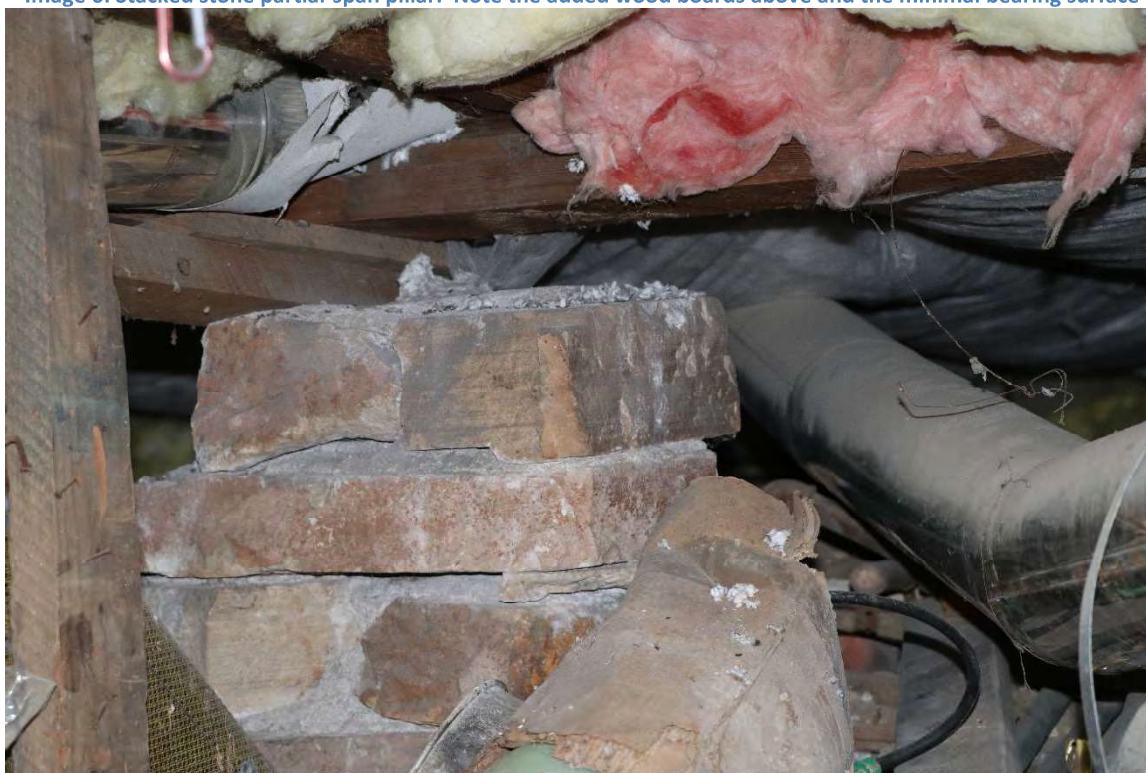
Image 7: Stacked stone pillar. No longer providing support

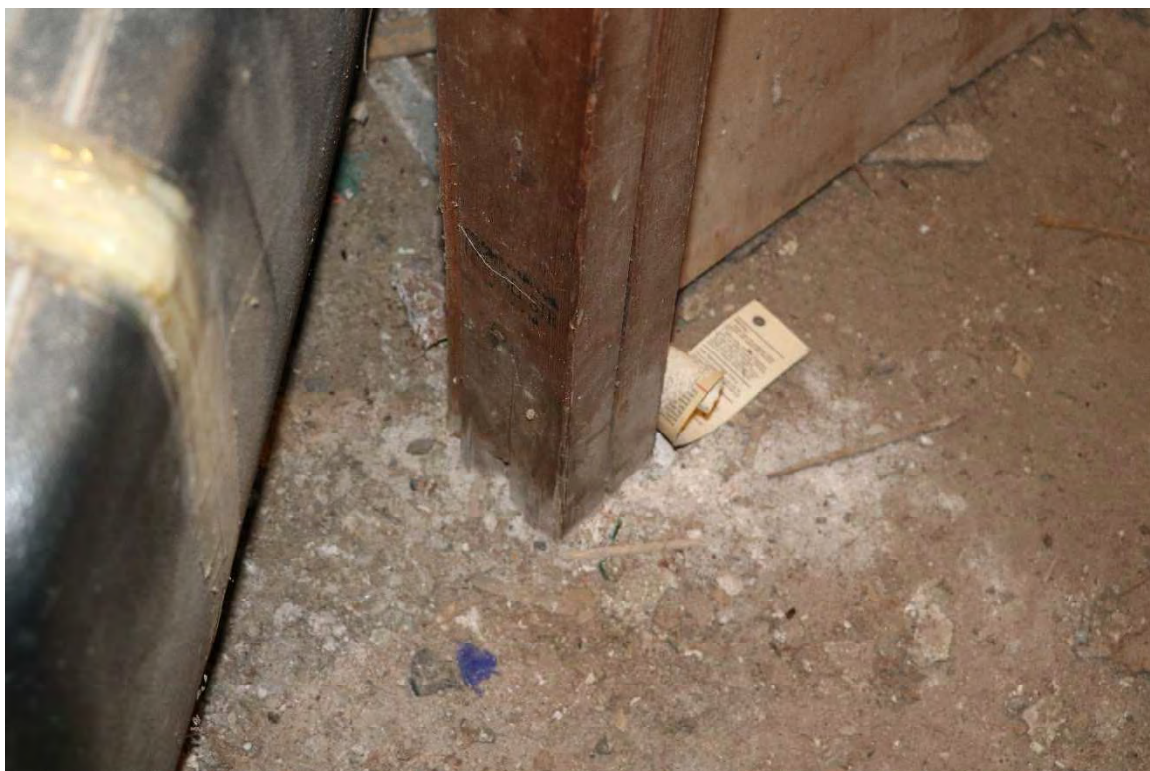
Image 8: Joist support beam. Set directly on the dirt floor

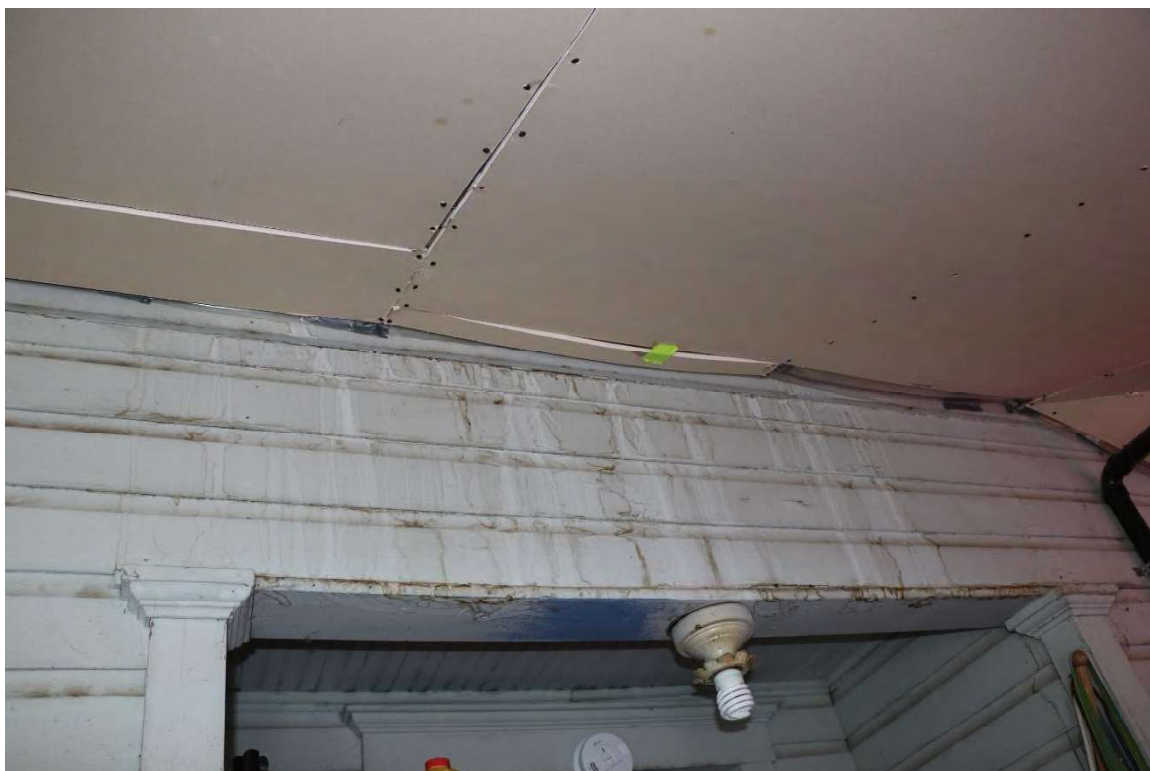
Image 13: South elevation. Note the water staining from water infiltration at the enclosed porch roof /wall junction

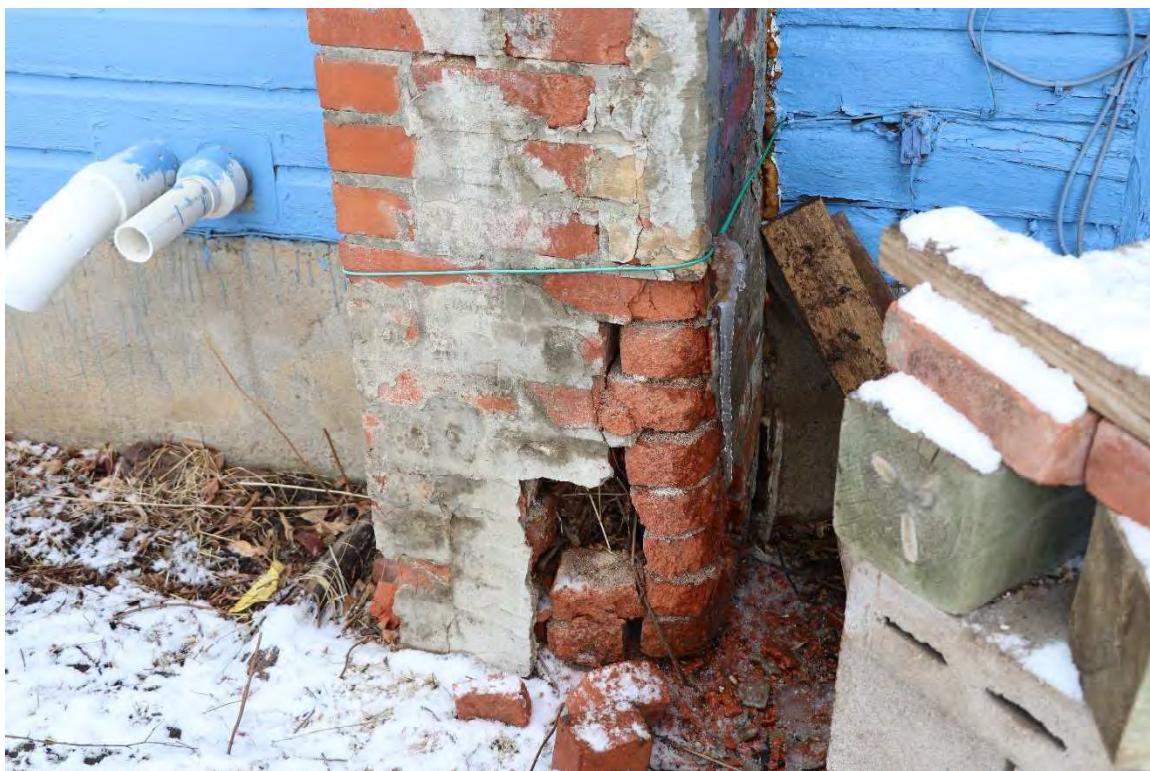
Image 15: Brick chimney base. Advanced deterioration from moisture

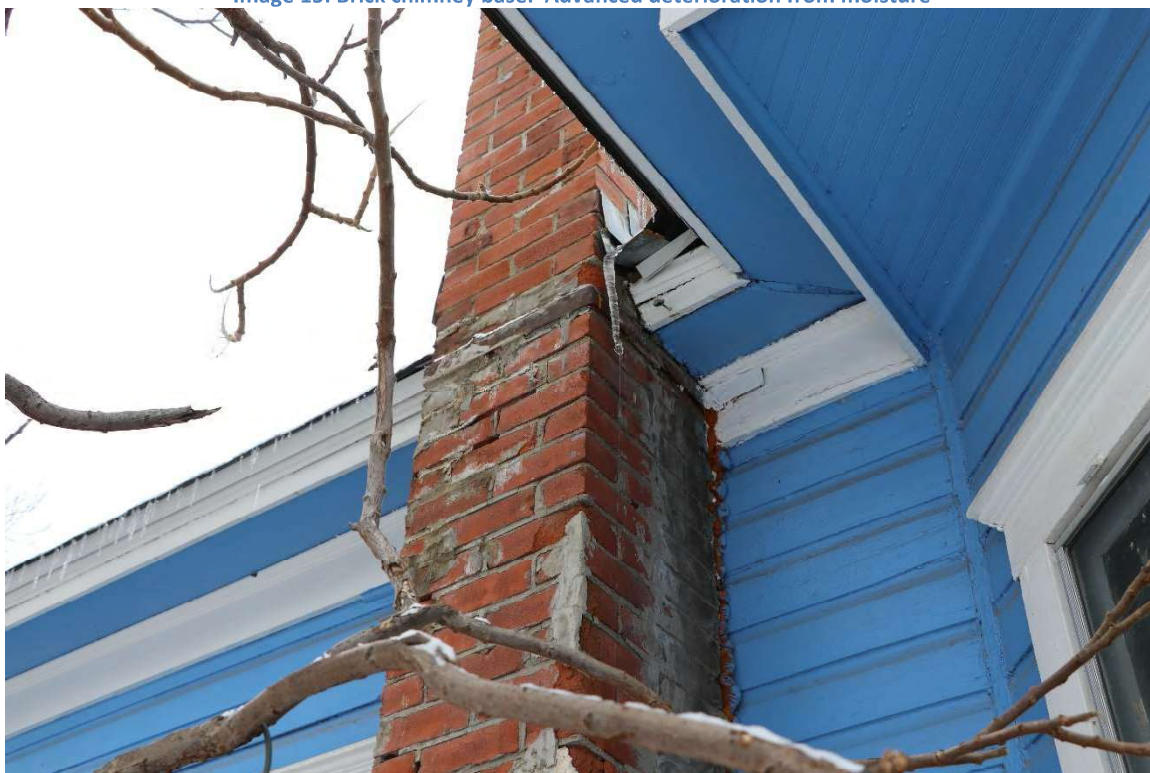
Image 16: Water from the roof drains directly onto the chimney

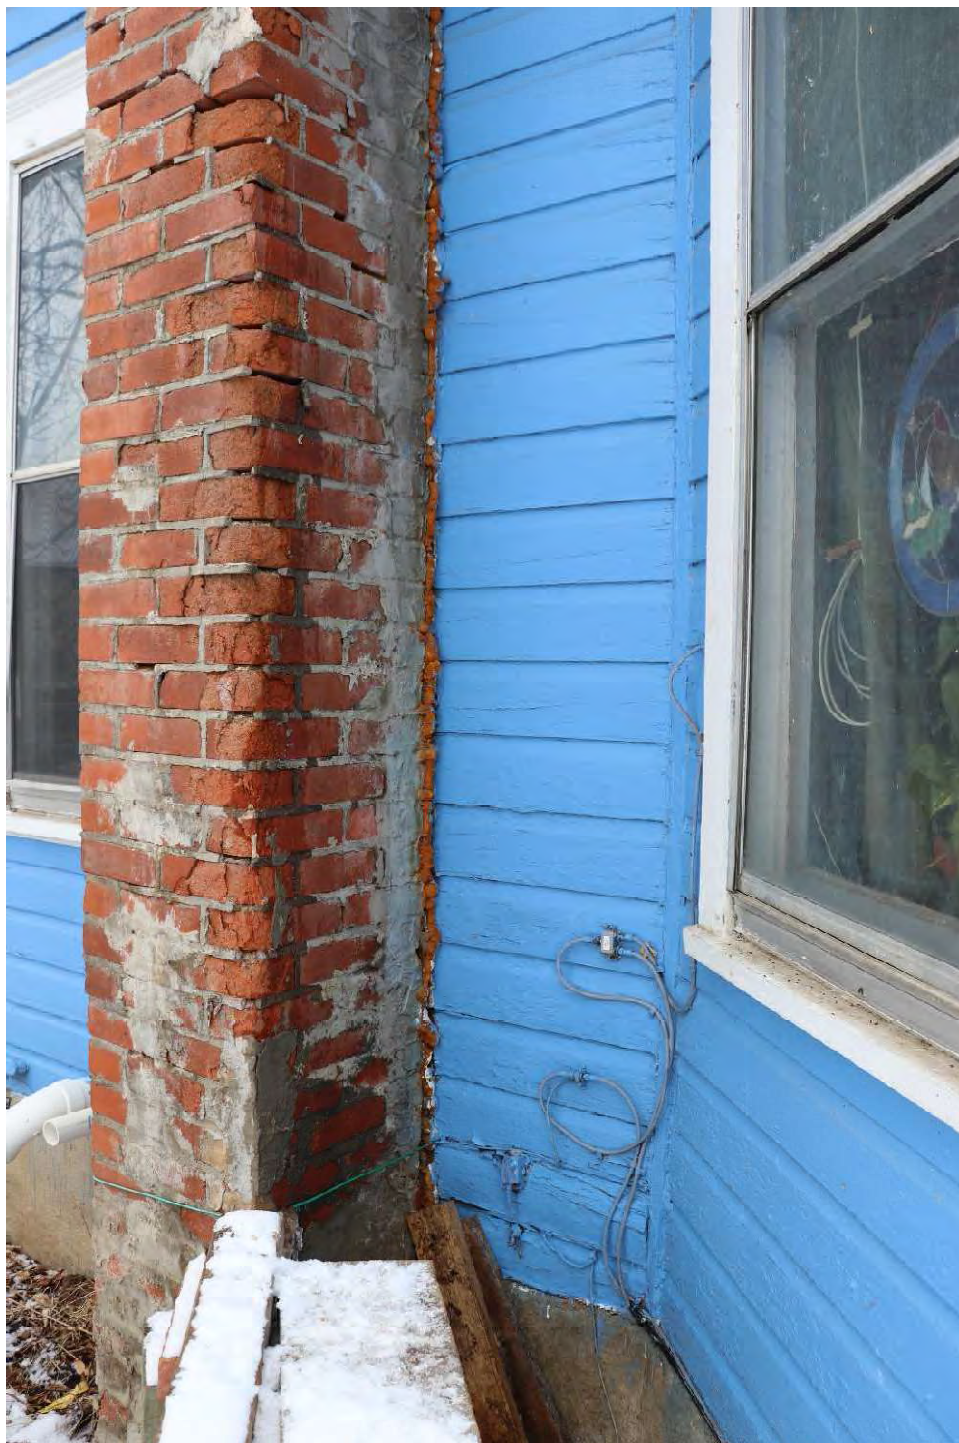
Image 17: Deterioration is evident along the length of the chimney below the roofline

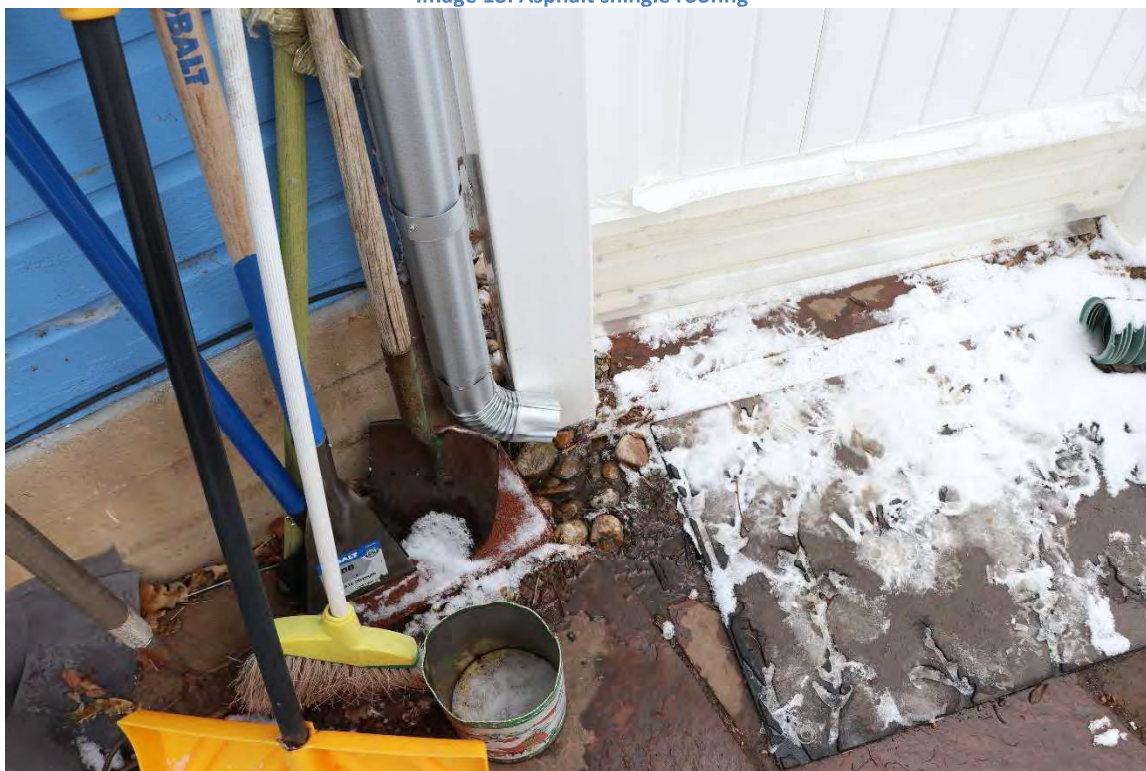
| Element | Description & Condition | Evaluation | Recommendation |
|---|---|---|---|
| Drainage System, Gutters & Downspouts | Gutters are in good condition. Some downspouts discharge water too close to the foundation of the building. | Fair | Extend the downspouts so that water is discharged at least six feet from the foundation and on a grade flowing away from the home |

Image 19: Downspout discharges to near the foundation

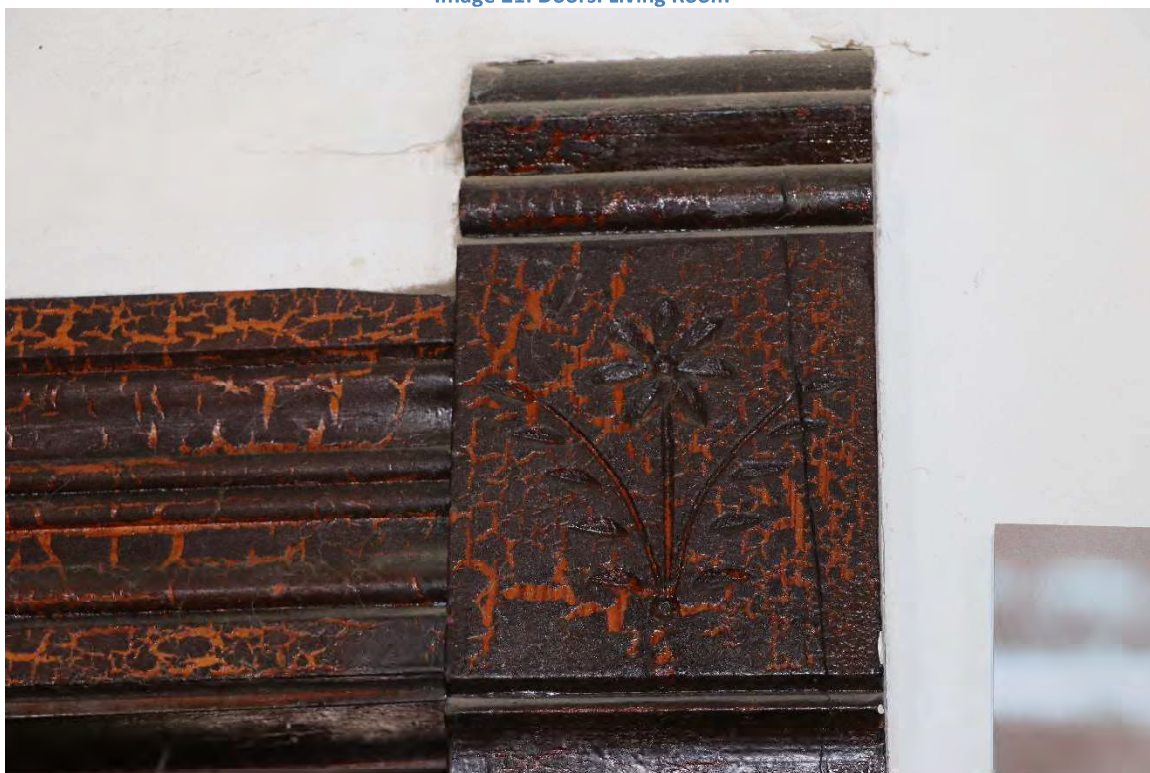
Image 22: Doors. Living room. Shellac deterioration detail

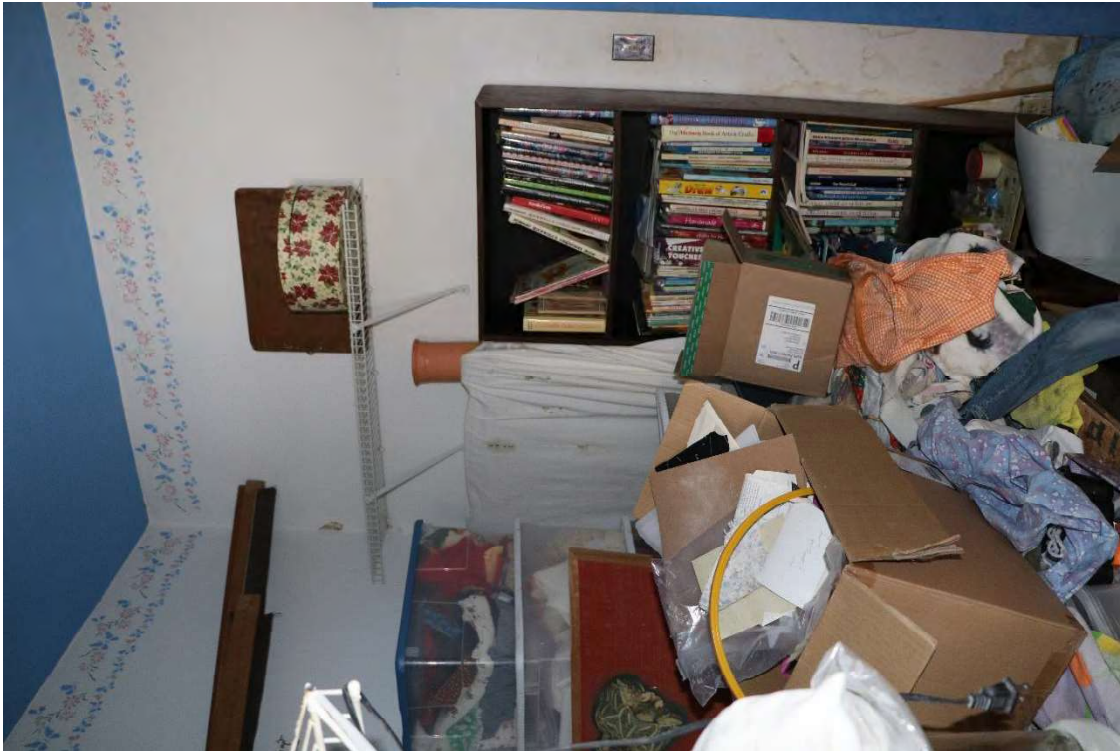
Image 28: Wall finishes. First floor. Typical conditions. Note the water stain by the door casing

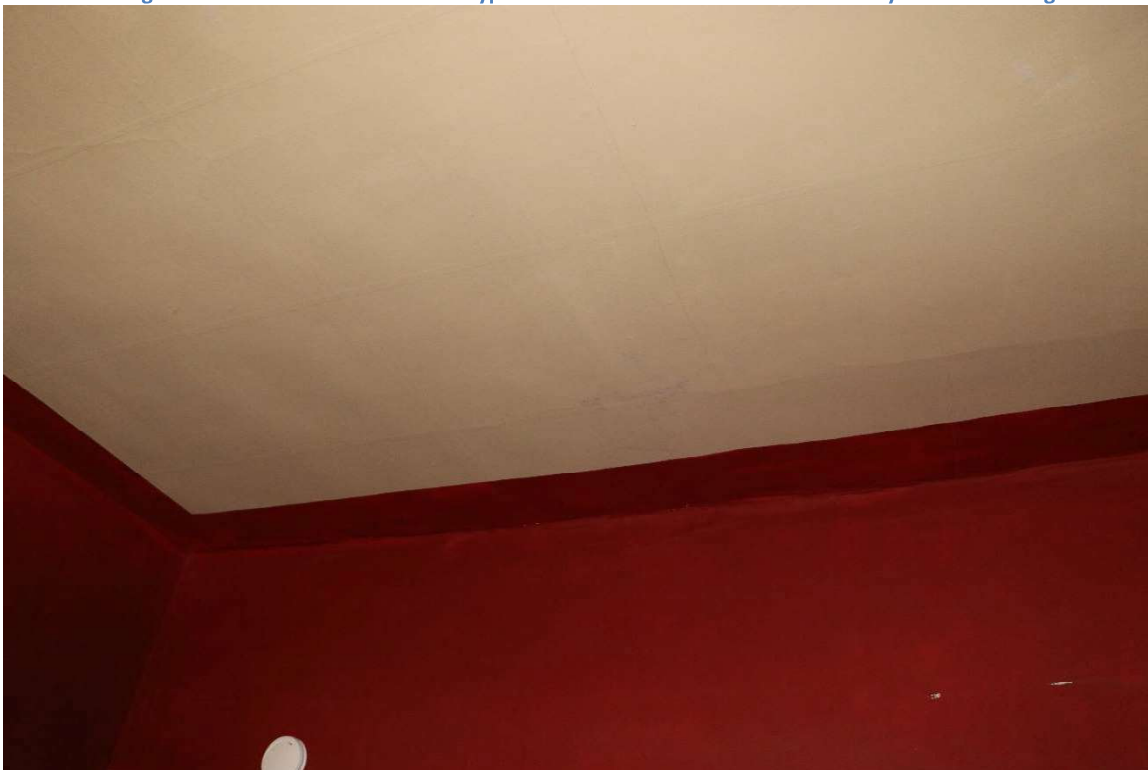
Image 29: Wall finishes. Den. Note the seams which can be seen on both the ceiling and walls. This could be due to over painting over wallpaper or over a fabric system designed to cover plaster cracks

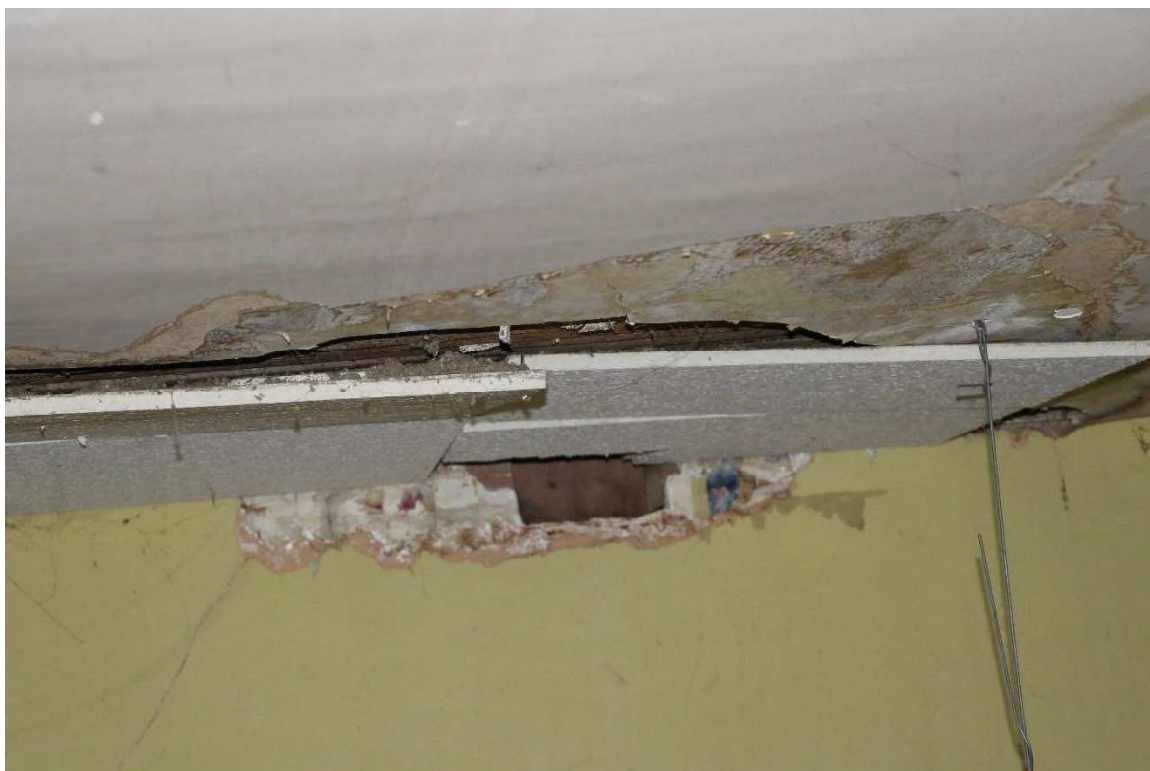
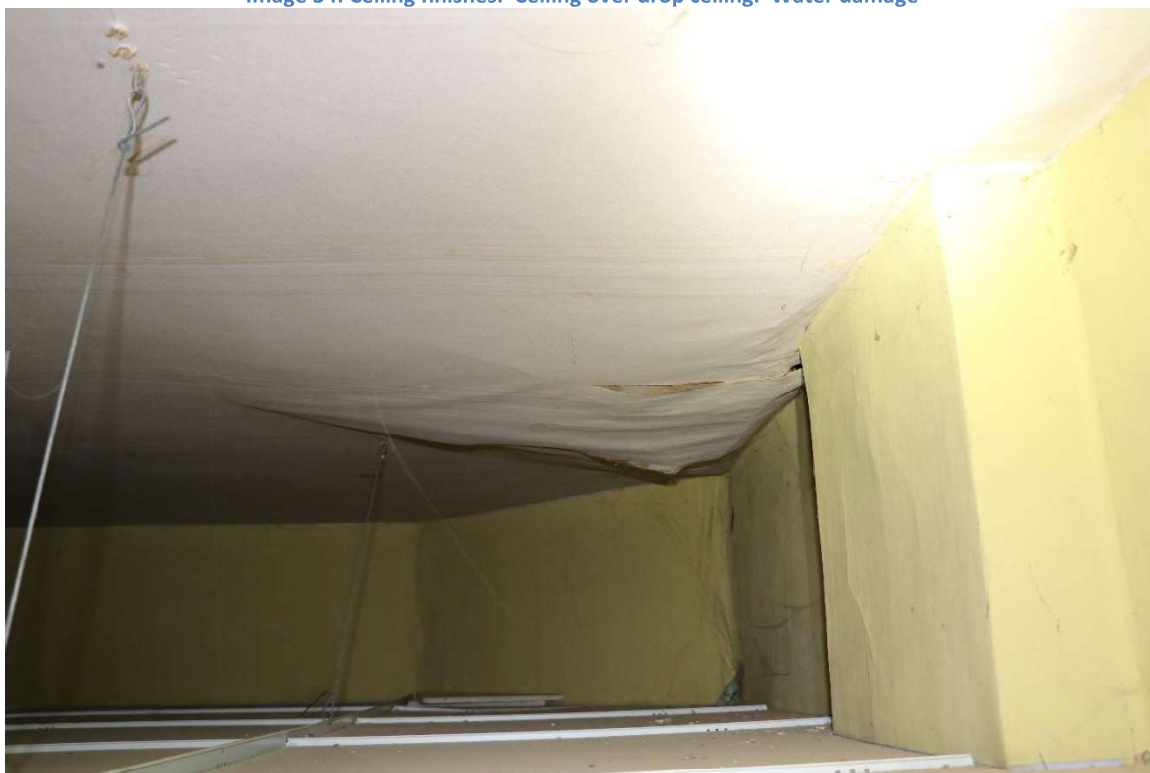
Image 34: Ceiling finishes. Ceiling over drop ceiling. Water damage

Image 35: Ceiling finishes. Ceiling over drop ceiling. Water damage

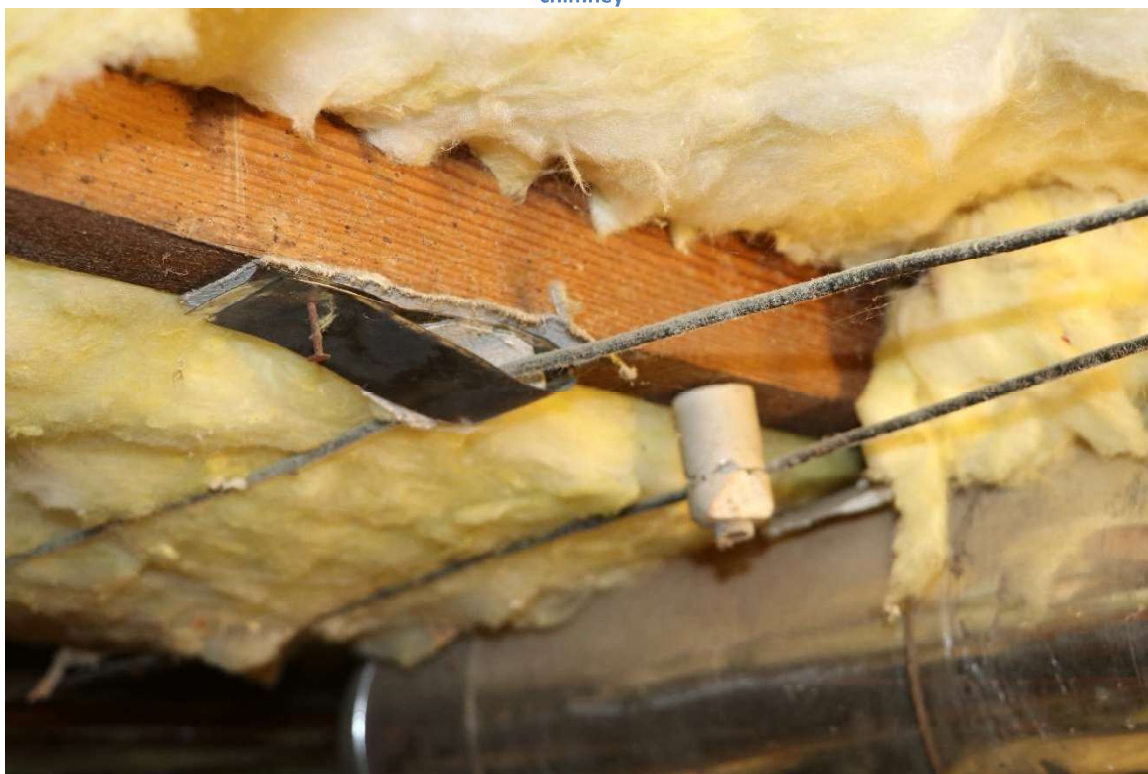
Image 43: Electrical Distribution. Basement. Knob and tube wiring with broken insulator

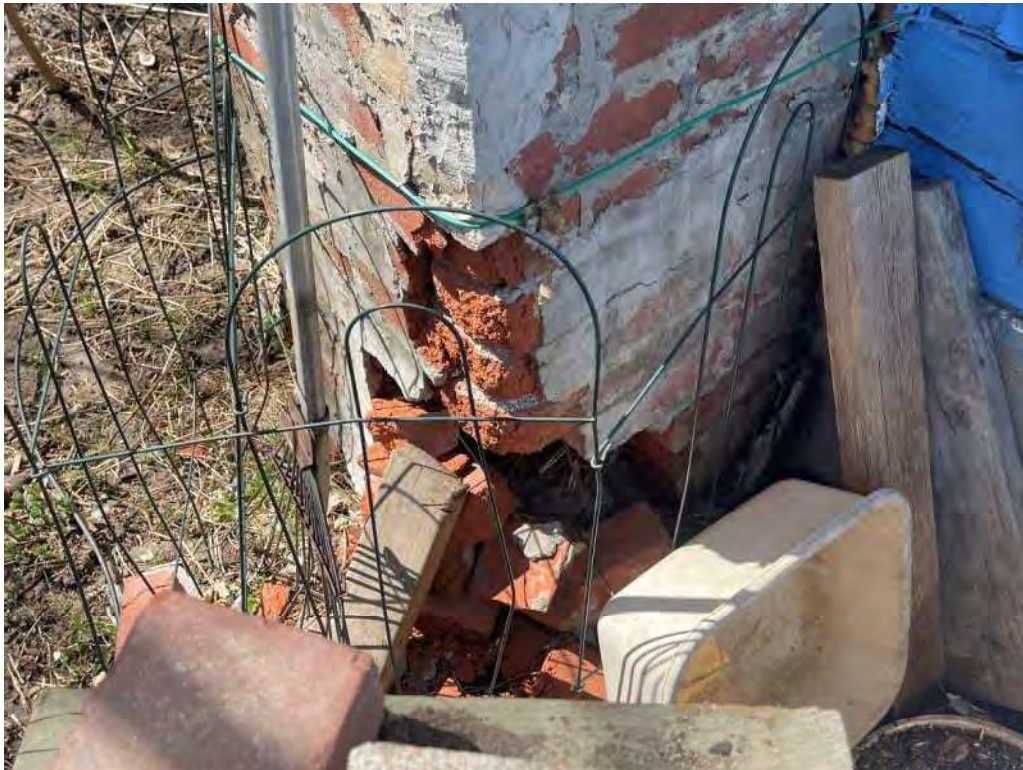
Figure 3: Missing bricks at base of chimney along east elevation

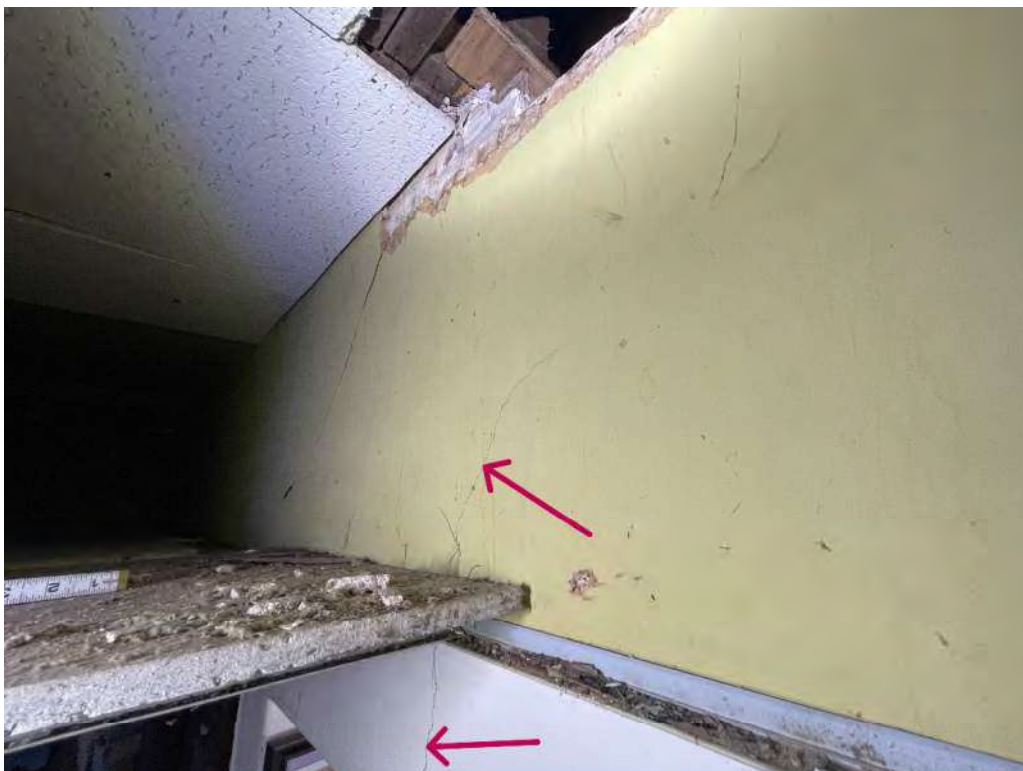
Figure 4: Crack at header between original house and addition

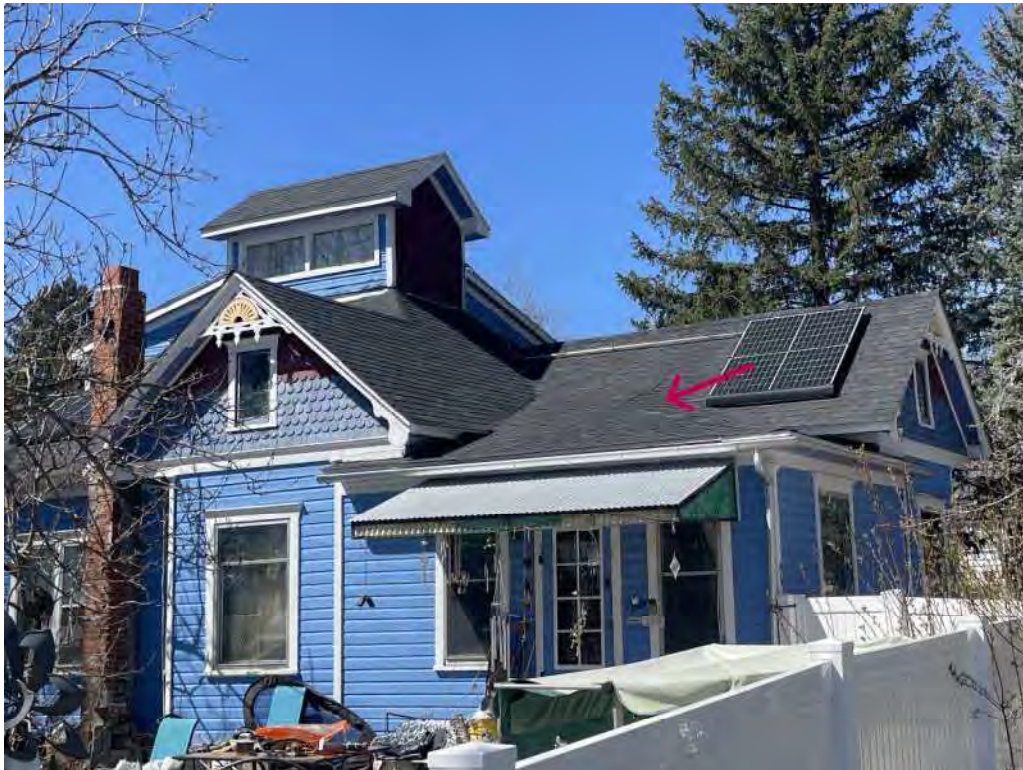
Figure 5: Northeast addition. Note over-framing at roof transition

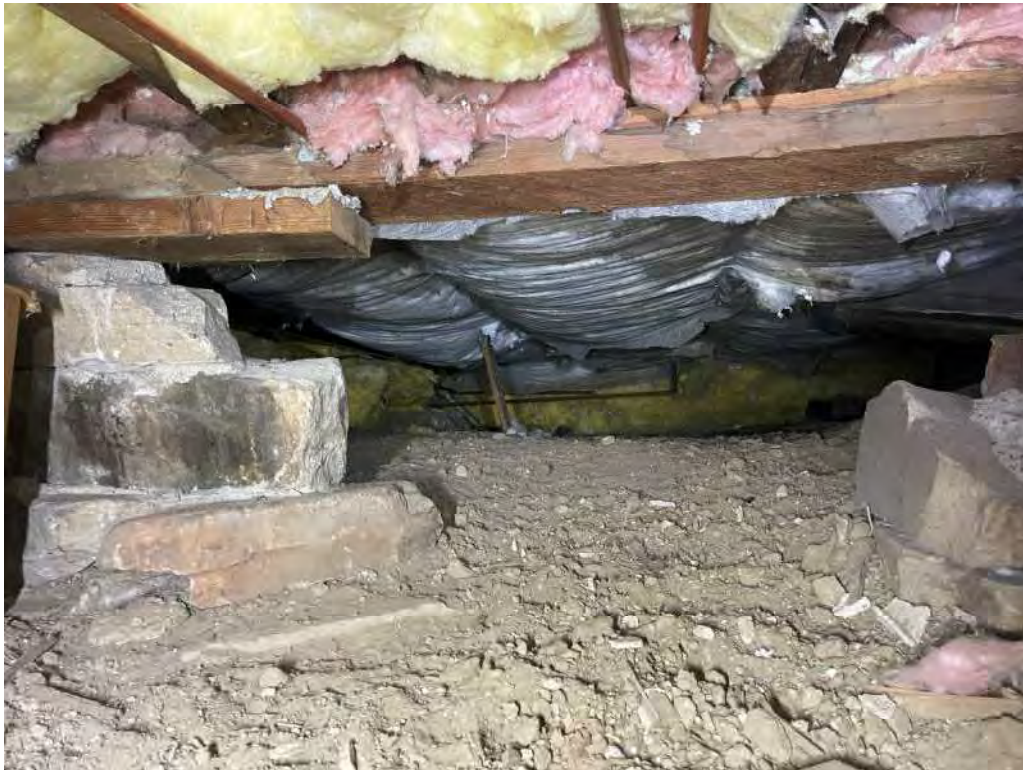
Figure 7: Crawlspace bearing line. Note one (2) 2x oriented flatwise between stone piers

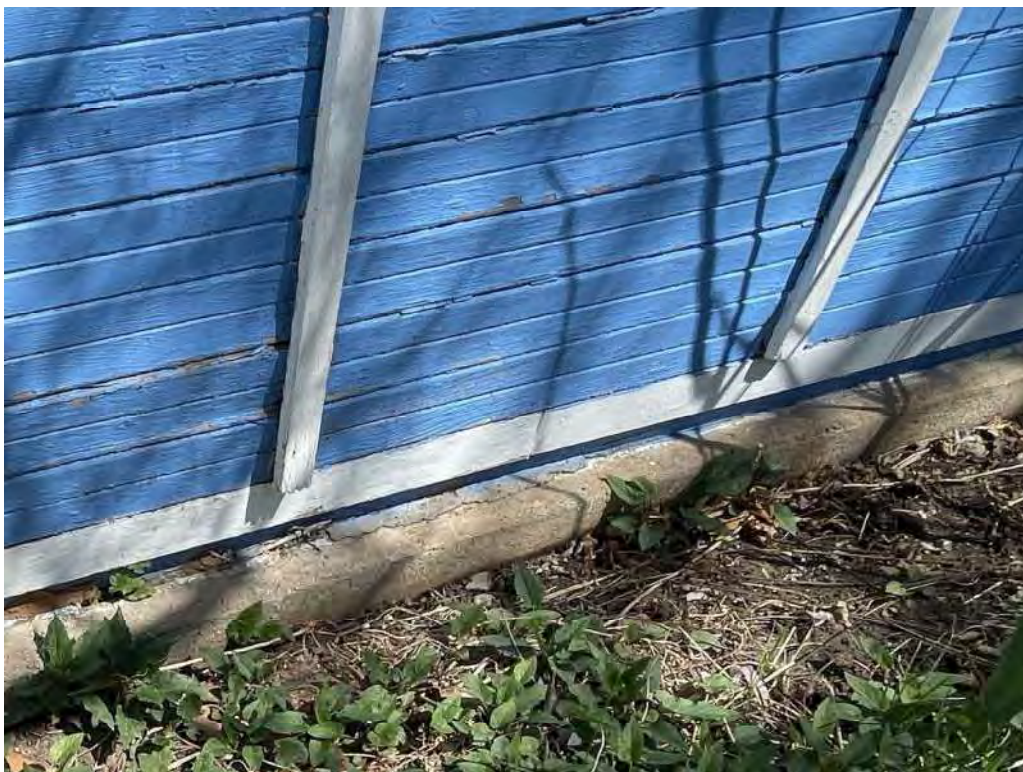
Figure 8: Parge coat over stone masonry foundation and grade proximate to wood framing

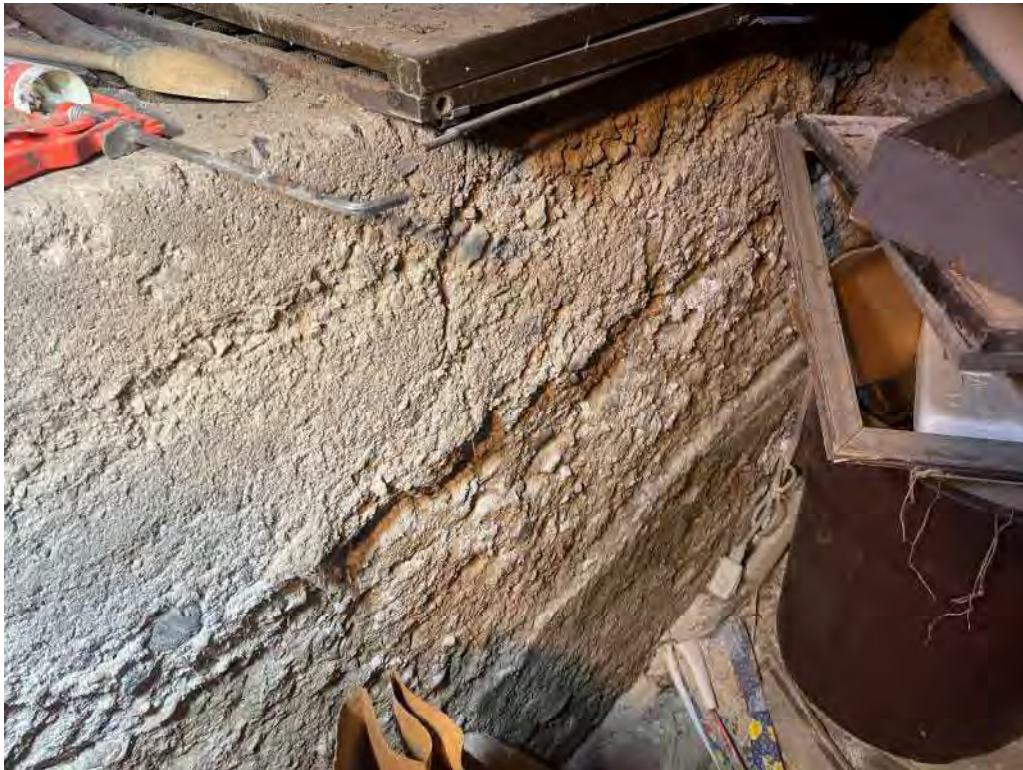
Figure 9: Inside face of concrete retaining wall. Note loss of cement paste and exposed aggregate due to moisture migration

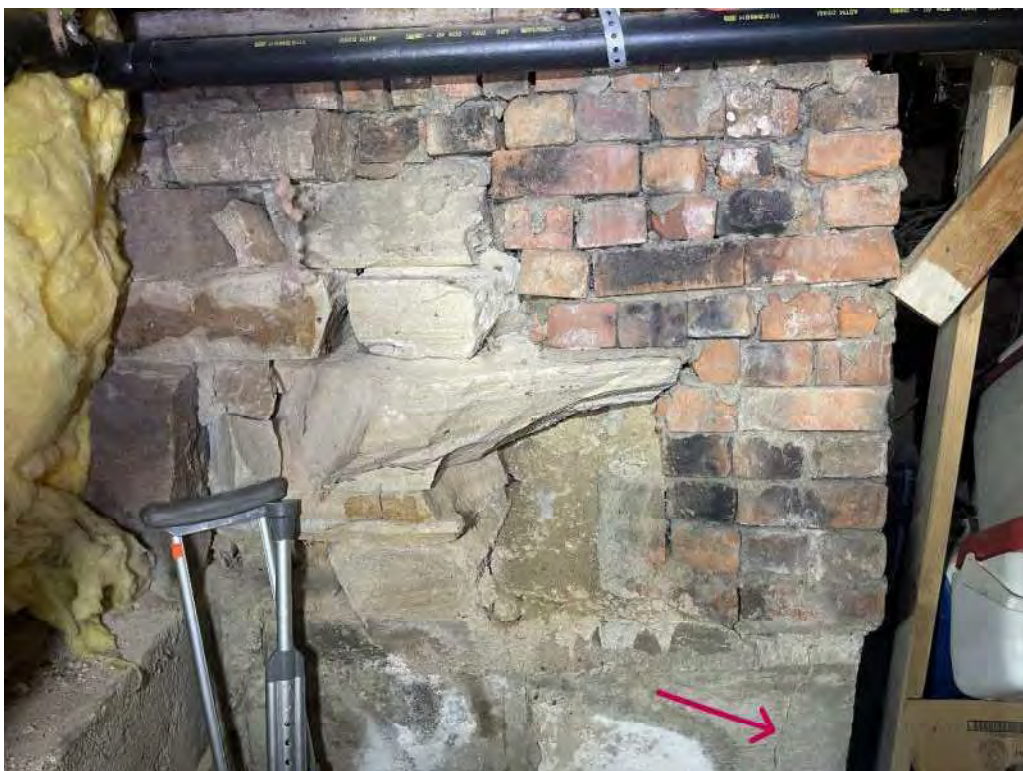
Figure 10: Area of foundation wall at stone to brick interface due for partial reconstruction
