**SUBJECT: LANDMARK DESIGNATION & GRANT REQUEST – 600 PINE ST.**

- i. RESOLUTION NO. 26, SERIES 2025– A RESOLUTION APPROVING A LANDMARK DESIGNATION FOR A HISTORICAL RESIDENTIAL PROPERTY LOCATED AT 600 PINE STREET
- ii. RESOLUTION NO. 27, SERIES 2025 – A RESOLUTION APPROVING A PRESERVATION AND RESTORATION GRANT FOR THE MALCOLM HOUSE LOCATED AT 600 PINE STREET

# 600 Pine Street

## Historic Structure Assessment

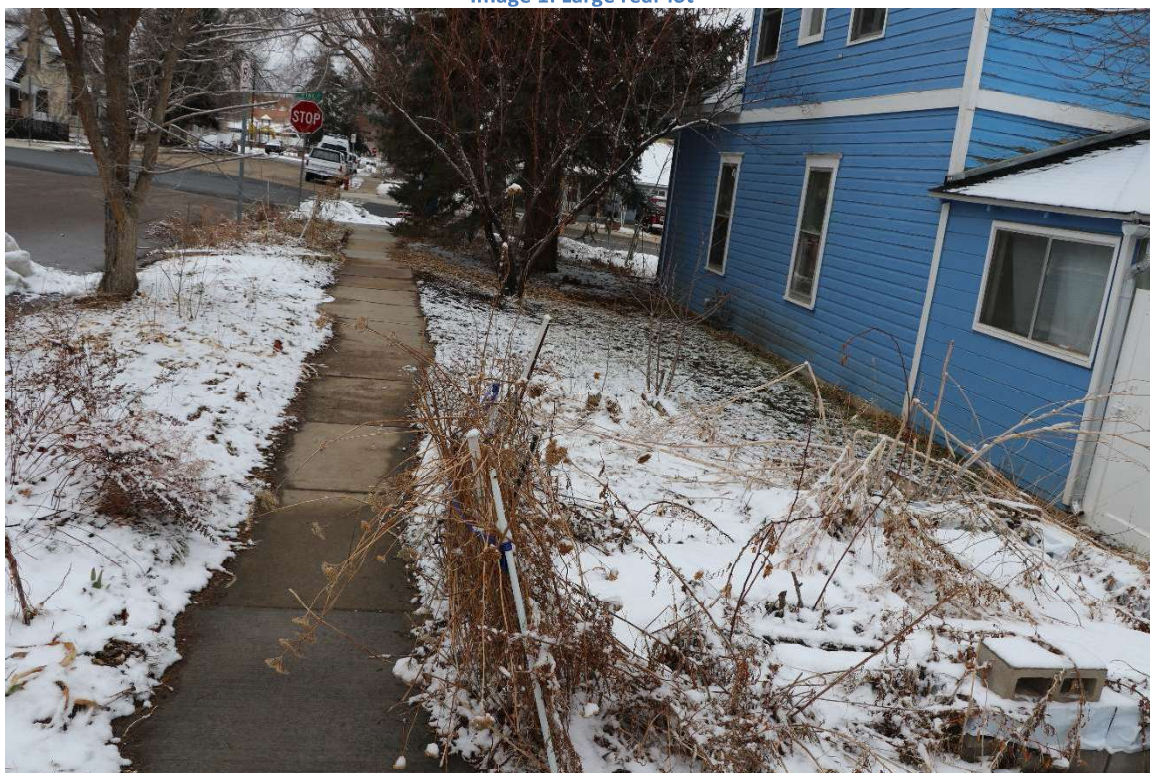
Image 2: Grading. Drainage slopes towards the house on the west elevation

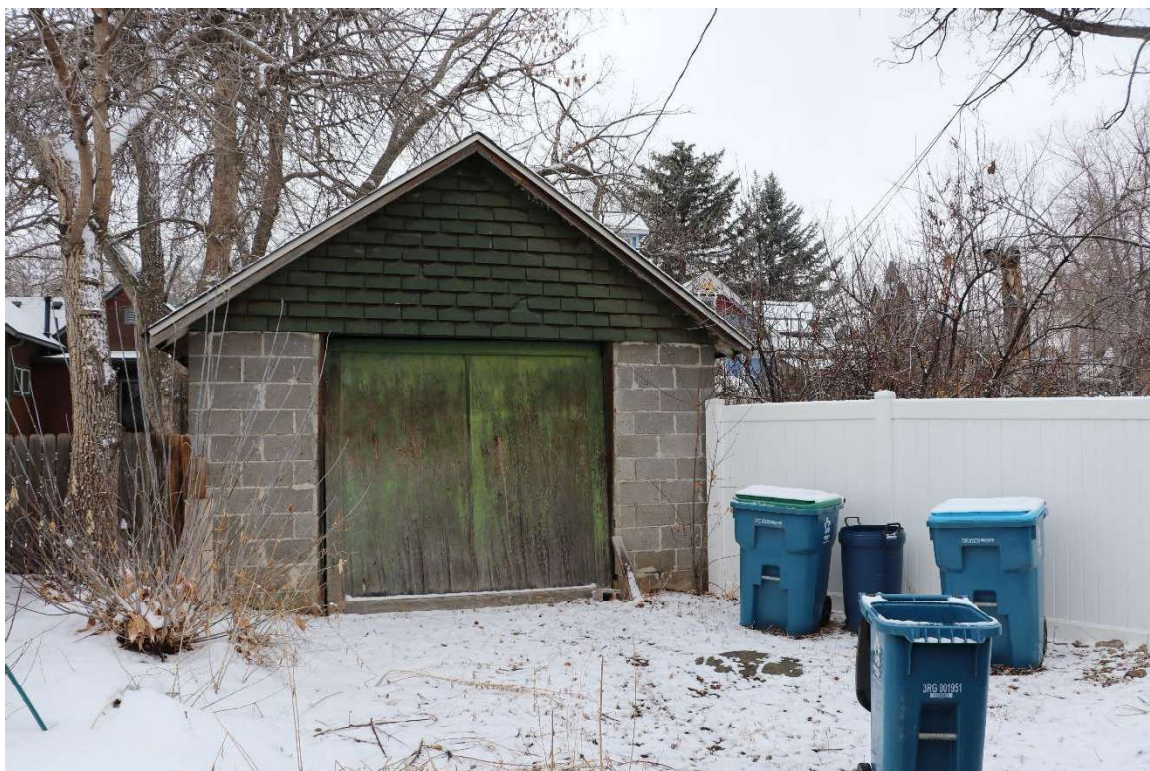
| <i>Element</i> | <i>Description &amp; Condition</i> | <i>Evaluation</i> | <i>Recommendation</i> |
|---|---|---|---|
| Parking | There is street parking along Pine and Grant Streets. An alley on the east provides access to a small one-car concrete block garage | Fair | The garage is in need of maintenance on the garage and pedestrian doors |

Image 3: Parking. Single car garage along alley

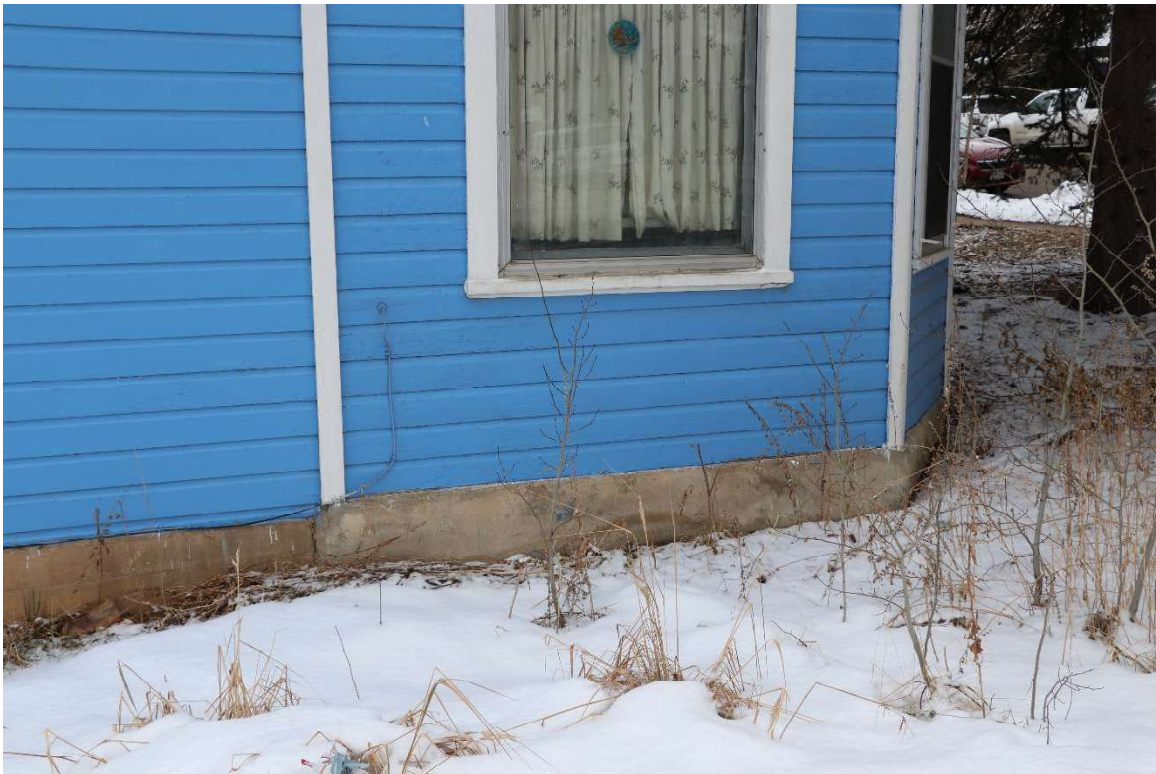
| Brick Cellar Foundation Wall | The foundation between the original structure and the 2 <sup>nd</sup> addition (porch enclosure) has cracked signaling movement. (Structural Assessment) | Poor | Reconstruct the corner of the foundation including the concrete base. Further review of the |

Image 5: Foundation. Seam visible under the addition on the left of the image

interior cellar walls  
should be preformed by a  
qualified mason or  
structural engineer

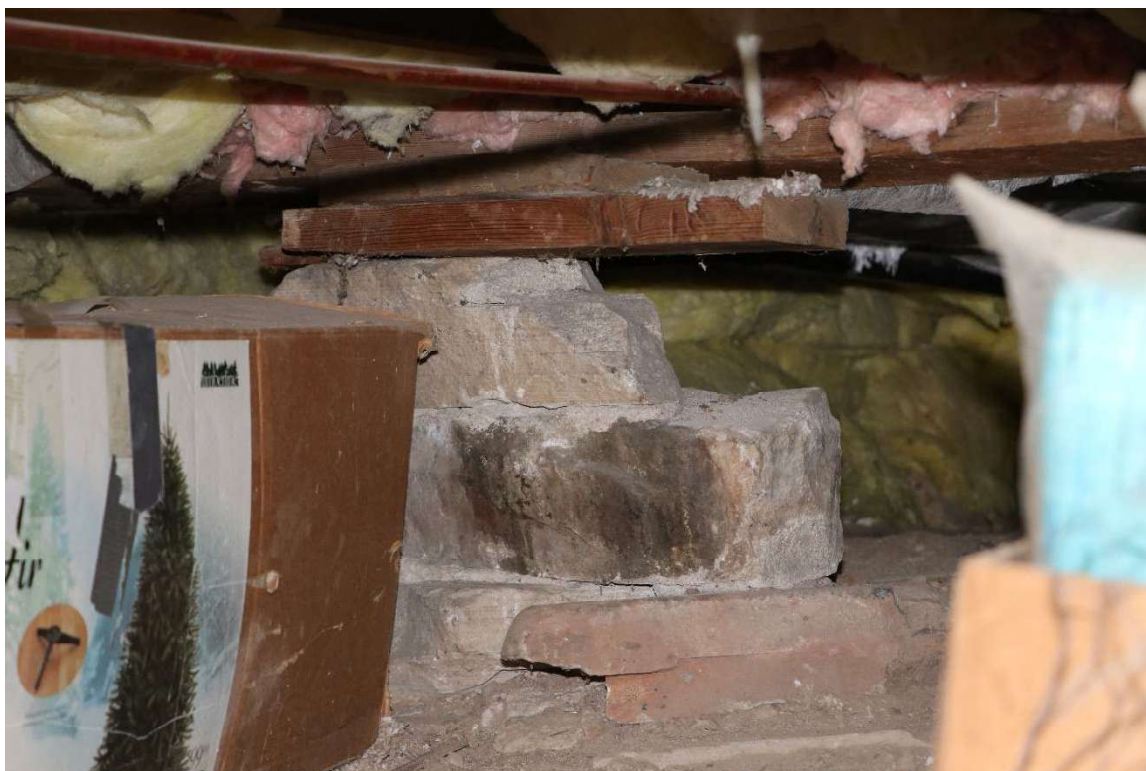
Image 6: Stacked stone partial-span pillar. Note the added wood boards above and the minimal bearing surface

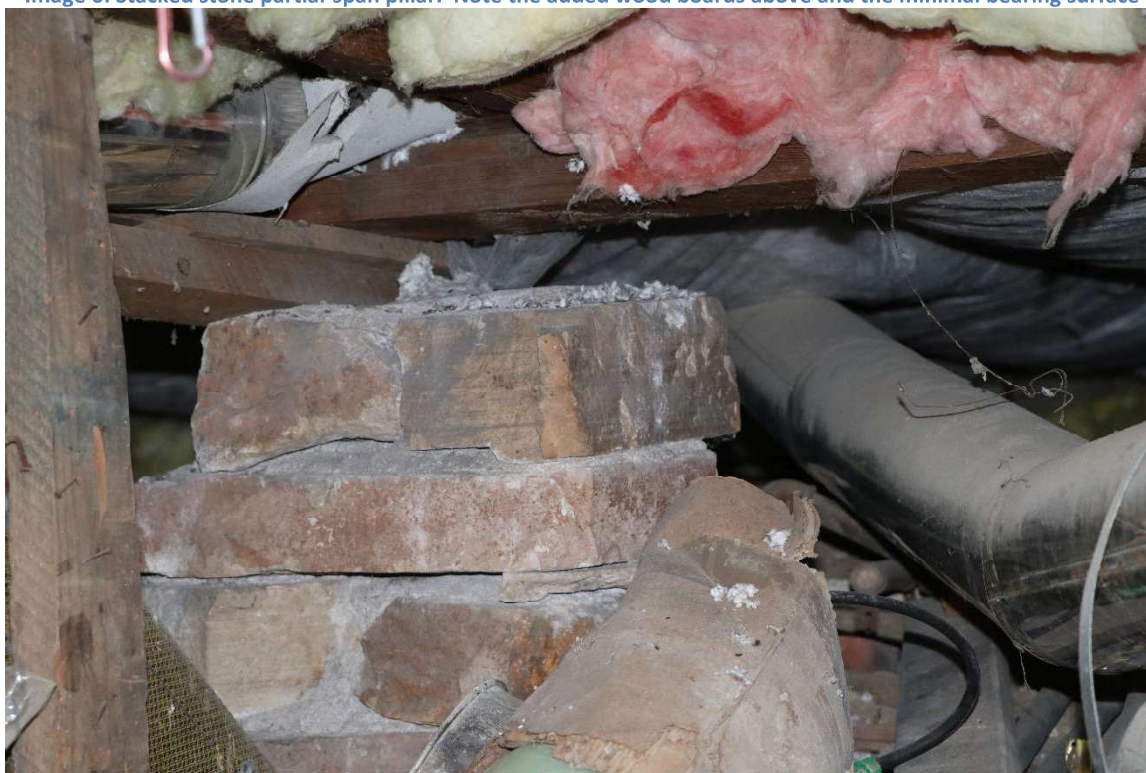
Image 7: Stacked stone pillar. No longer providing support

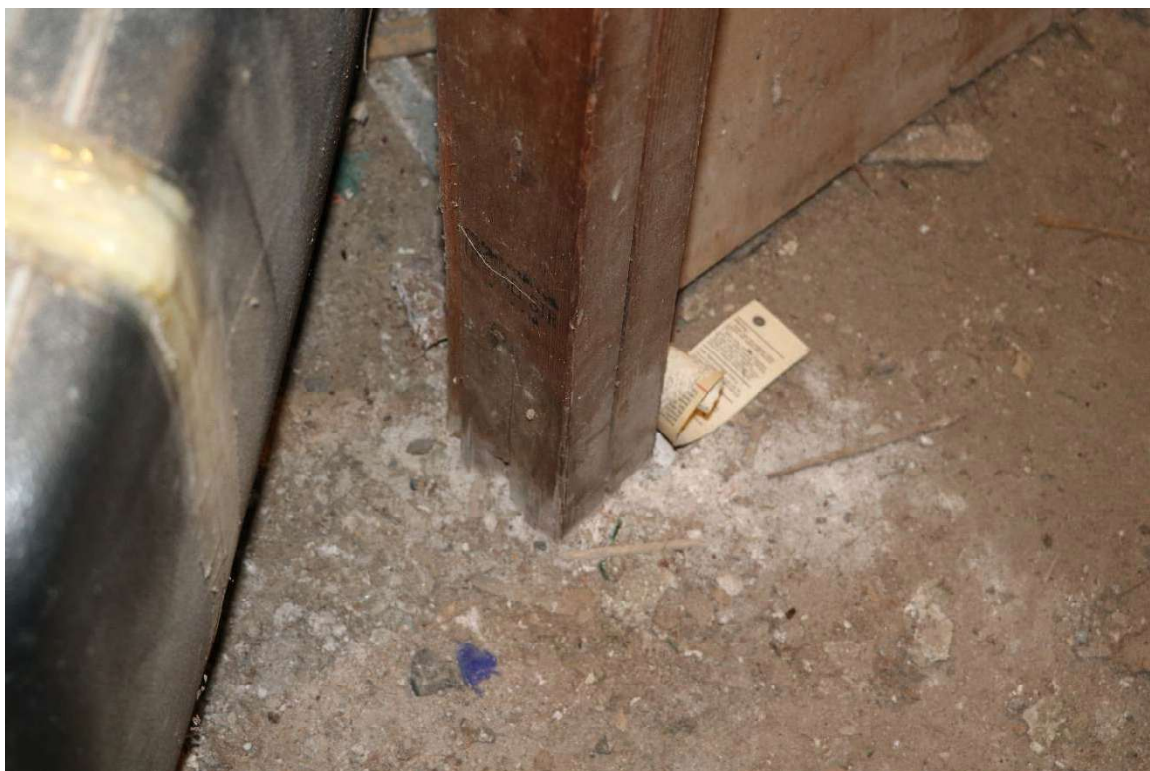
Image 8: Joist support beam. Set directly on the dirt floor

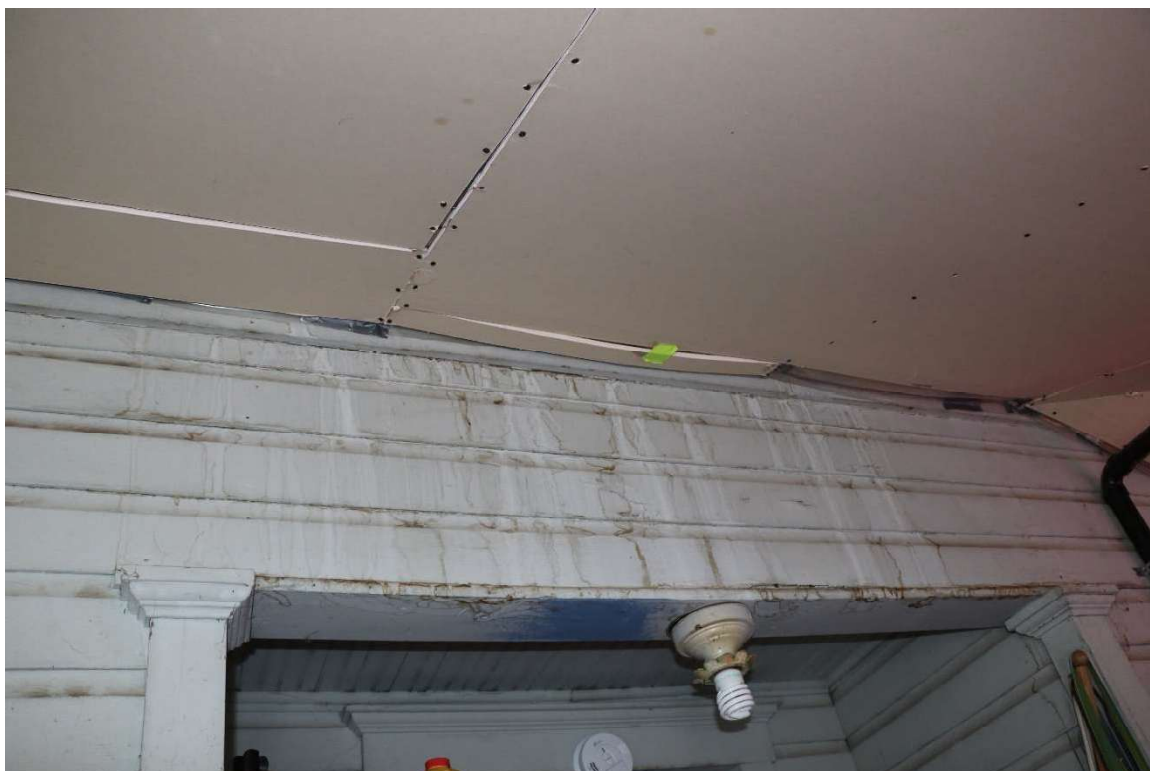
Image 13: South elevation. Note the water staining from water infiltration at the enclosed porch roof /wall junction

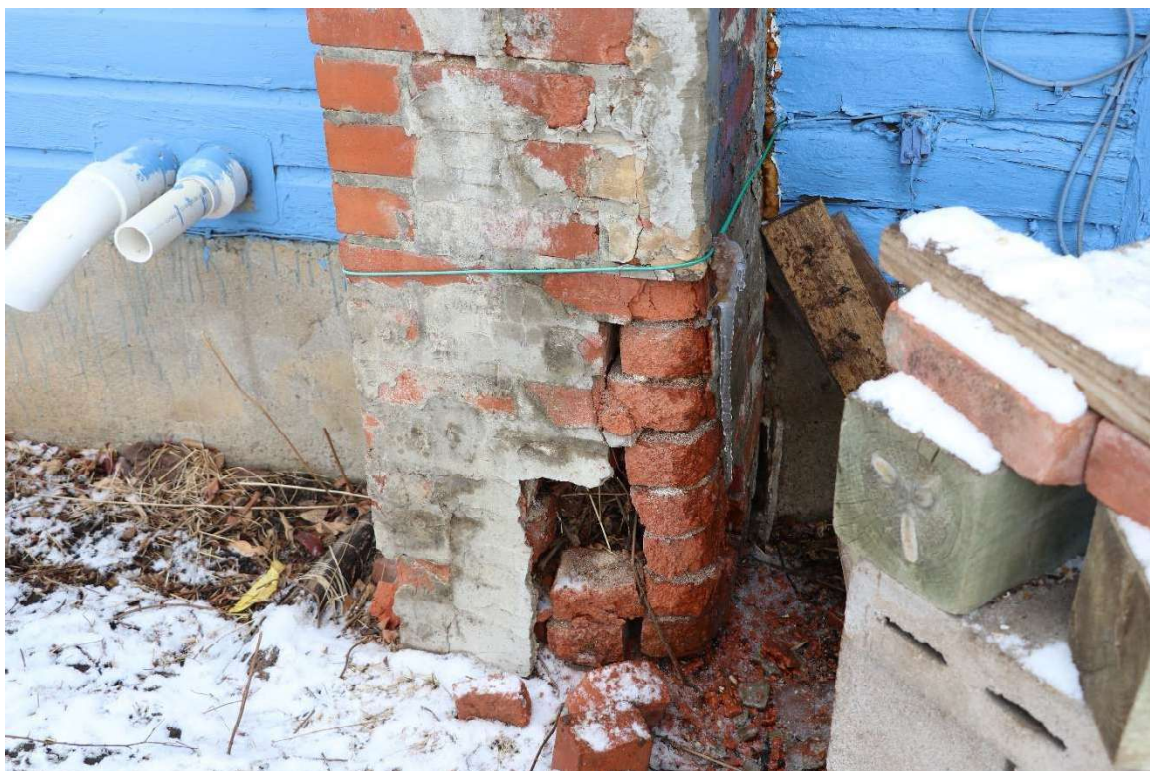
Image 15: Brick chimney base. Advanced deterioration from moisture

- Repairs on existing chimney. Demolish chimney to ground-level and rebuild using similar bricks to existing height.

- A. Chimney.
  - 1. Bricks (500) – including delivery.
  - 2. Scaffolding setup/breakdown.
  - 3. Cover solar panels with protective boards.
  - 4. Take chimney down to ground level.
  - 5. Haul off brick and rubble.
  - 6. Create/repair foundation.
  - 7. Rebuild chimney to same height.
  - 8. Seal off chimney at top completely.

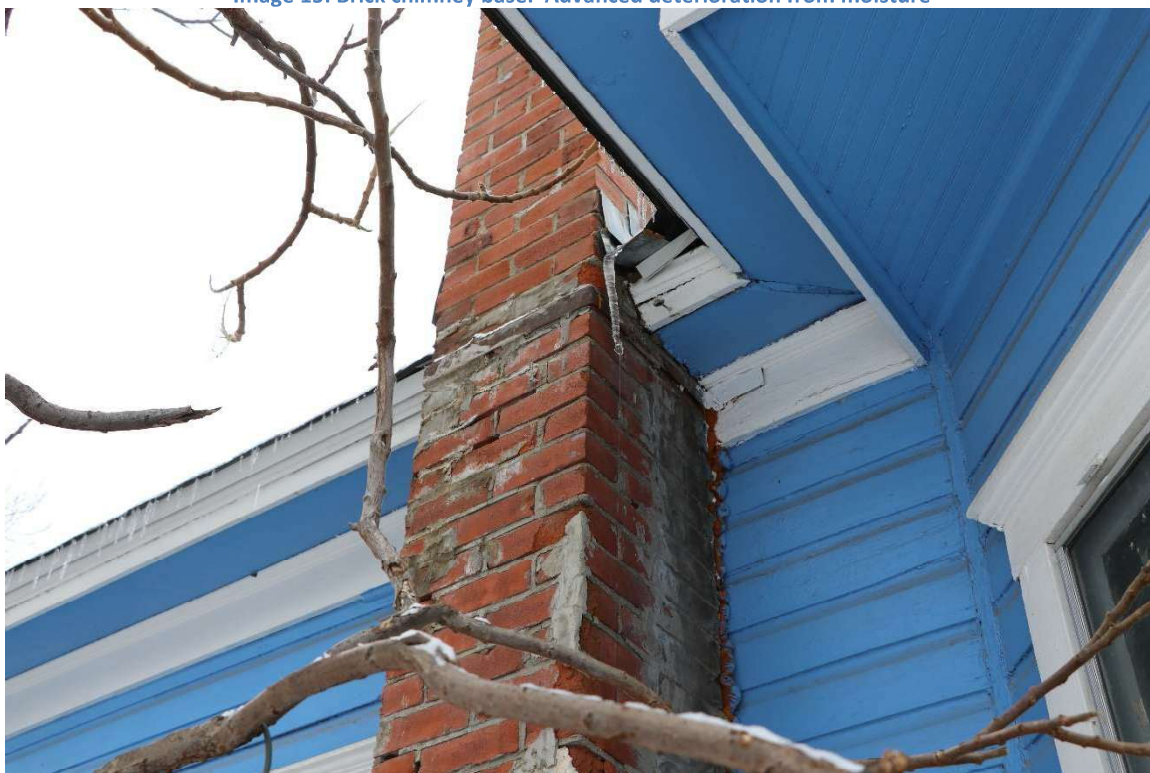
Image 16: Water from the roof drains directly onto the chimney

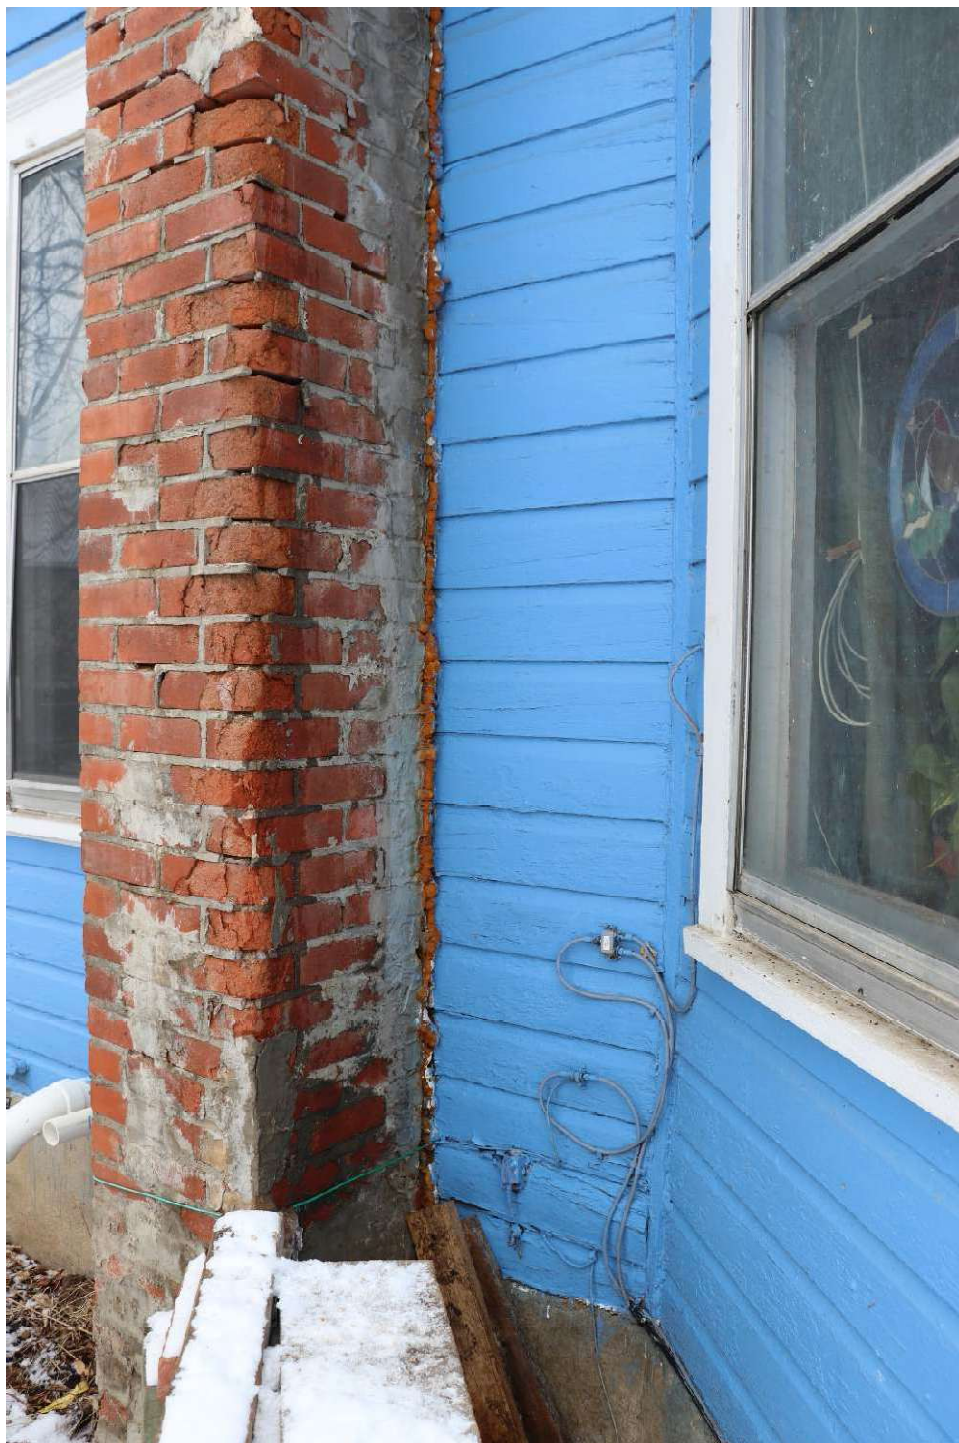
Image 17: Deterioration is evident along the length of the chimney below the roofline

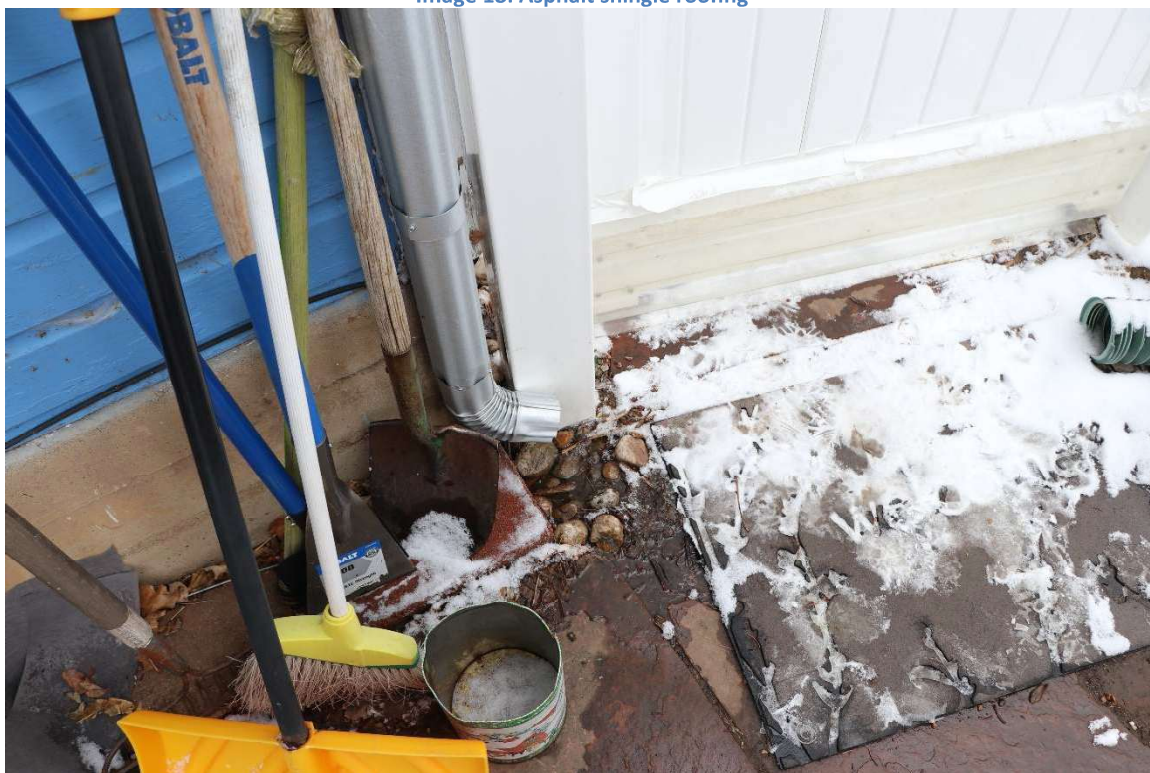
| Element | Description & Condition | Evaluation | Recommendation |
|---|---|---|---|
| Drainage System, Gutters & Downspouts | Gutters are in good condition. Some downspouts discharge water too close to the foundation of the building. | Fair | Extend the downspouts so that water is discharged at least six feet from the foundation and on a grade flowing away from the home |

Image 19: Downspout discharges to near the foundation

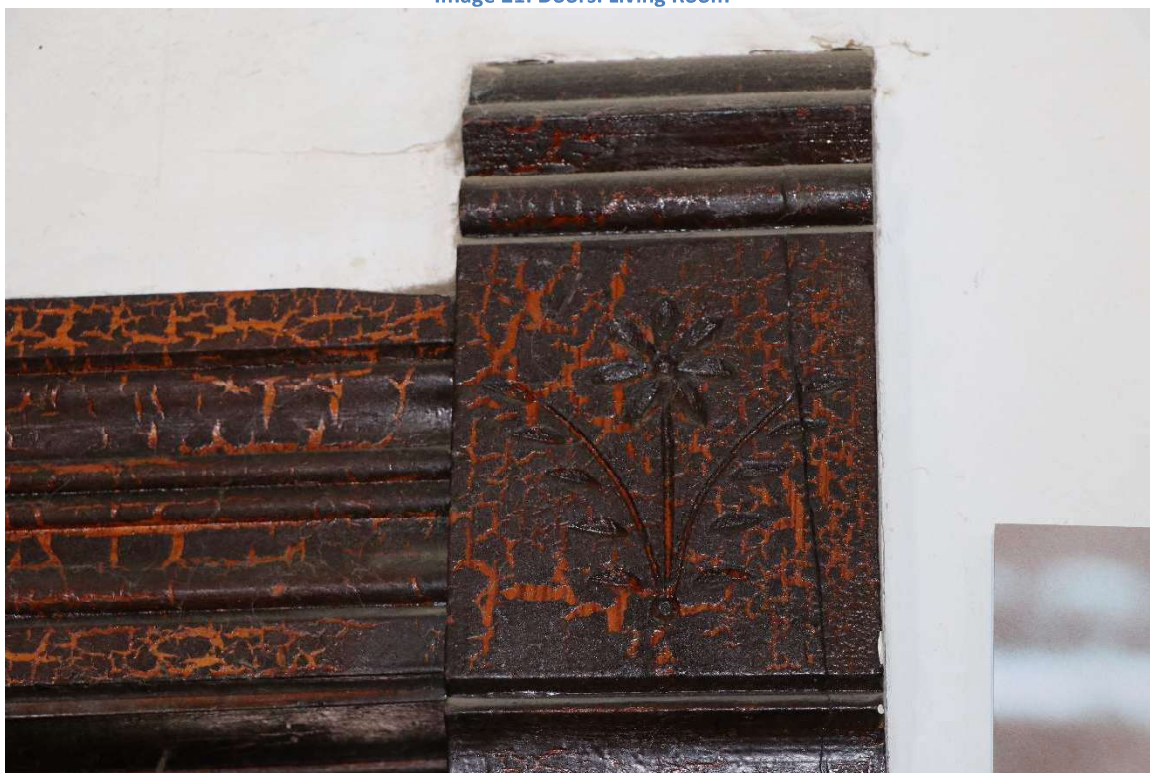
Image 22: Doors. Living room. Shellac deterioration detail

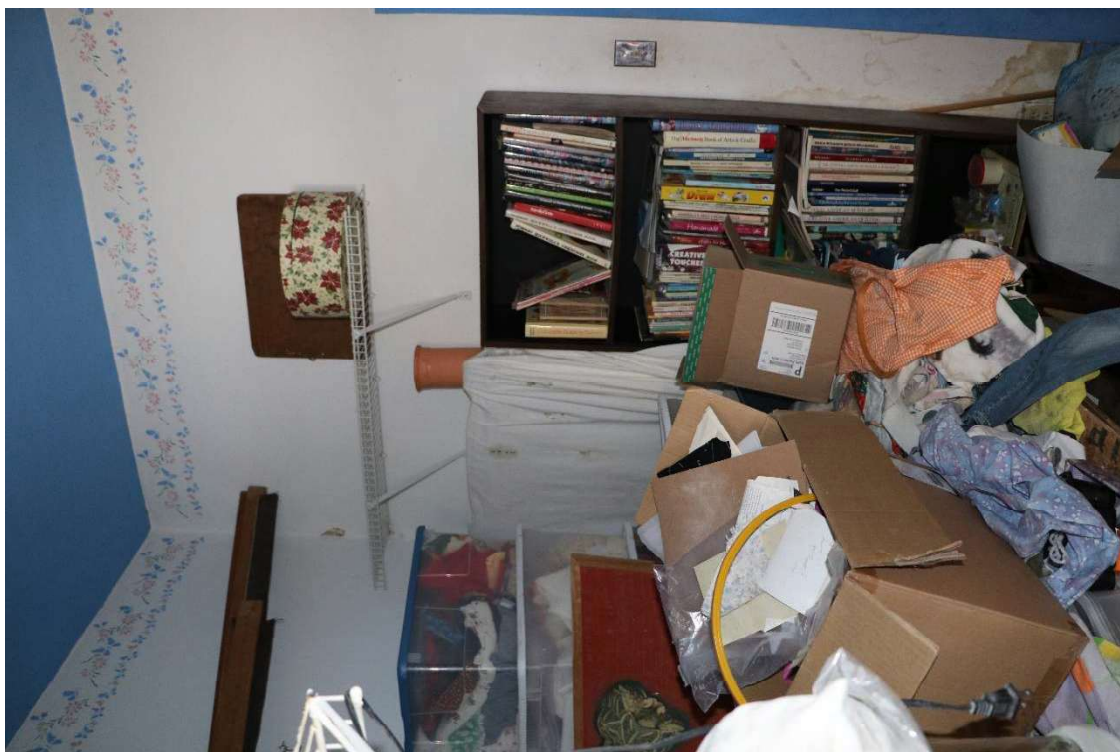
Image 28: Wall finishes. First floor. Typical conditions. Note the water stain by the door casing

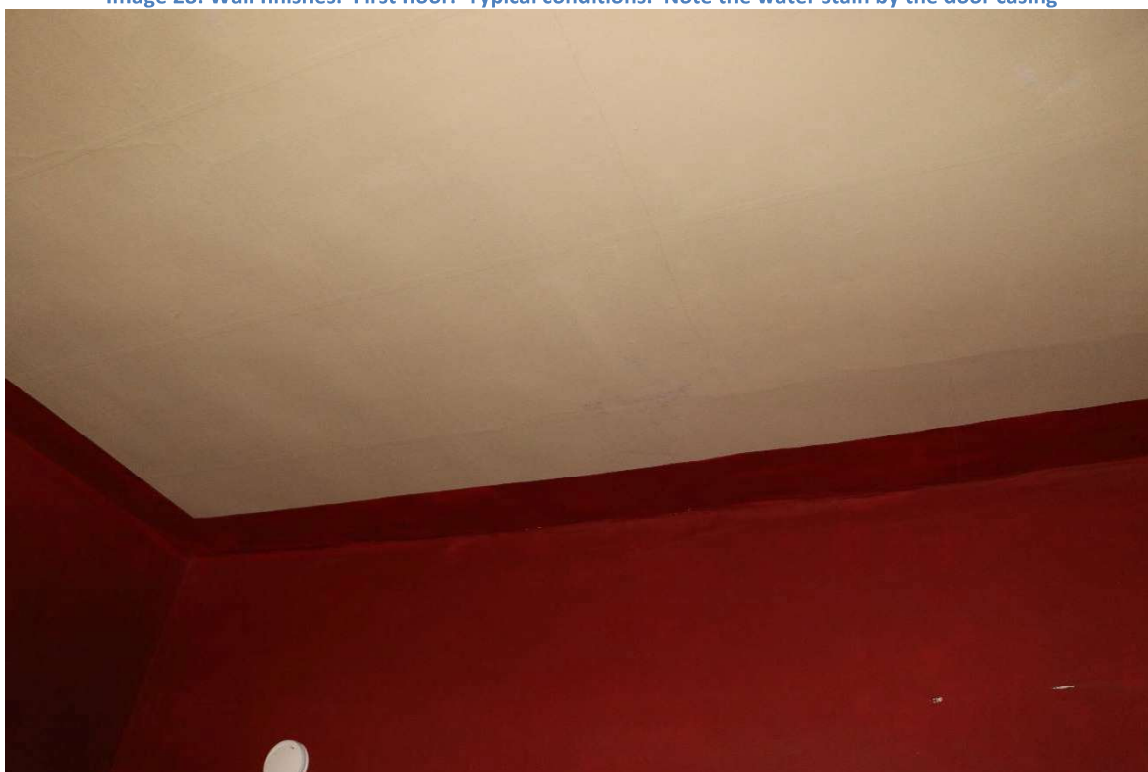
Image 29: Wall finishes. Den. Note the seams which can be seen on both the ceiling and walls. This could be due to over painting over wallpaper or over a fabric system designed to cover plaster cracks

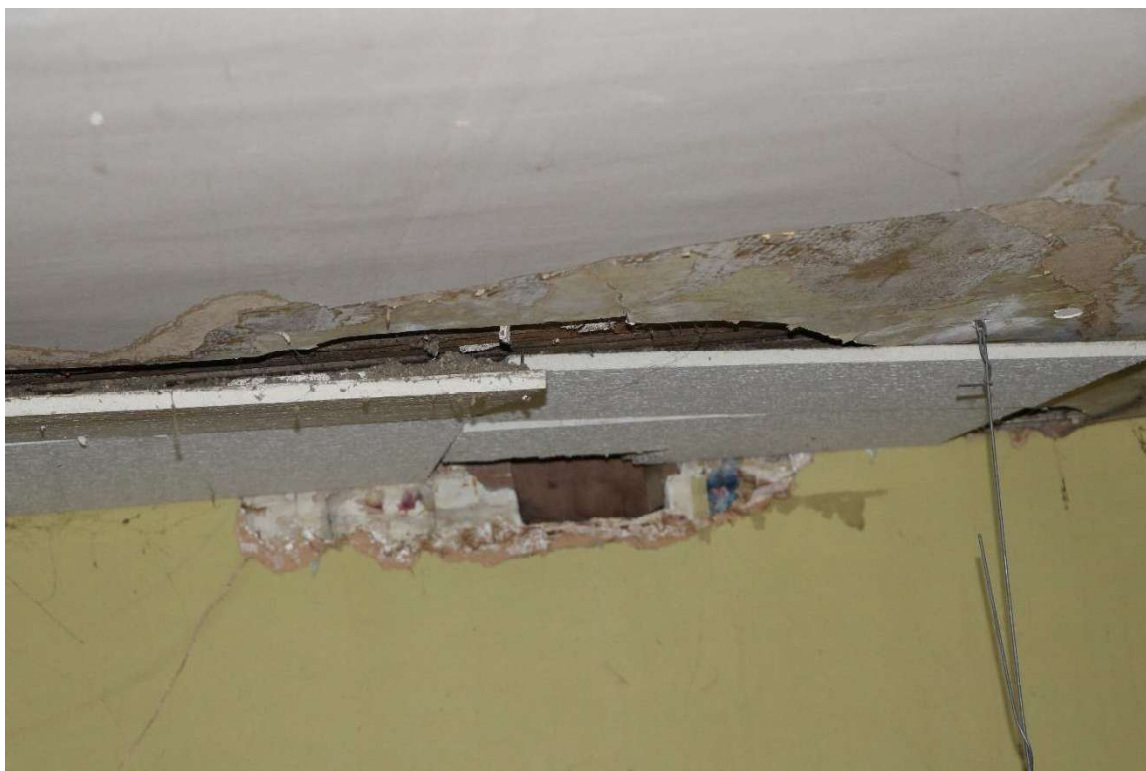
Image 34: Ceiling finishes. Ceiling over drop ceiling. Water damage

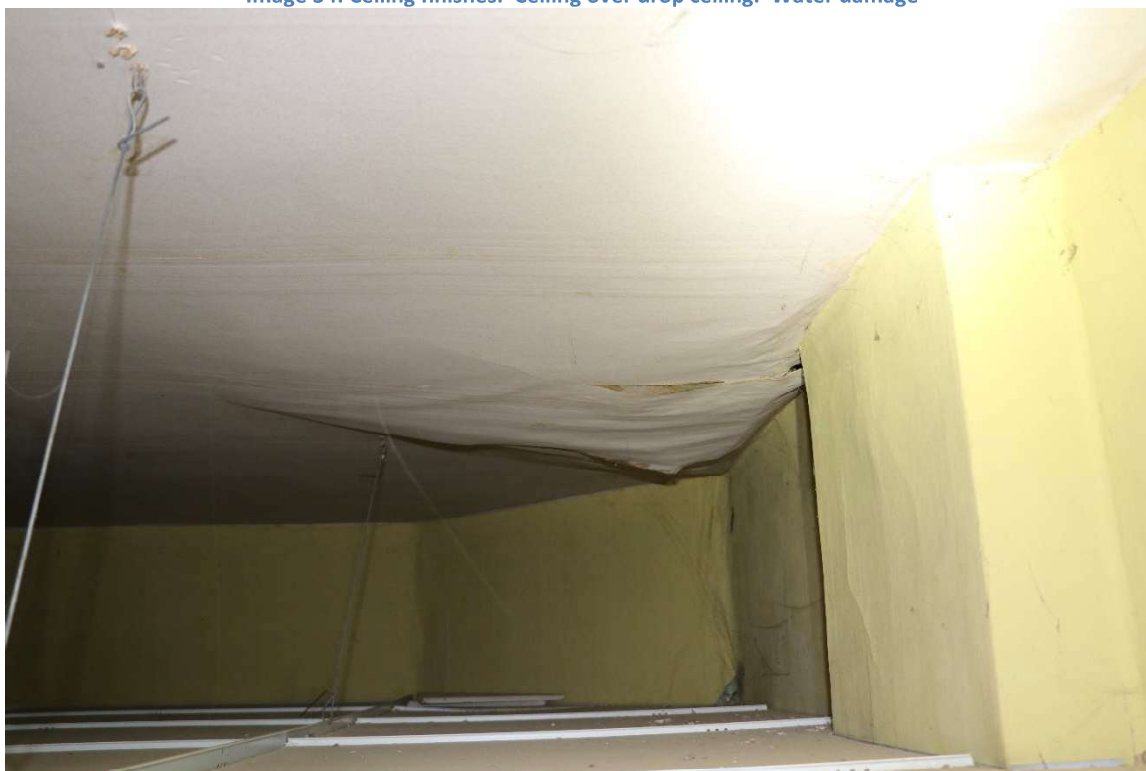
Image 35: Ceiling finishes. Ceiling over drop ceiling. Water damage

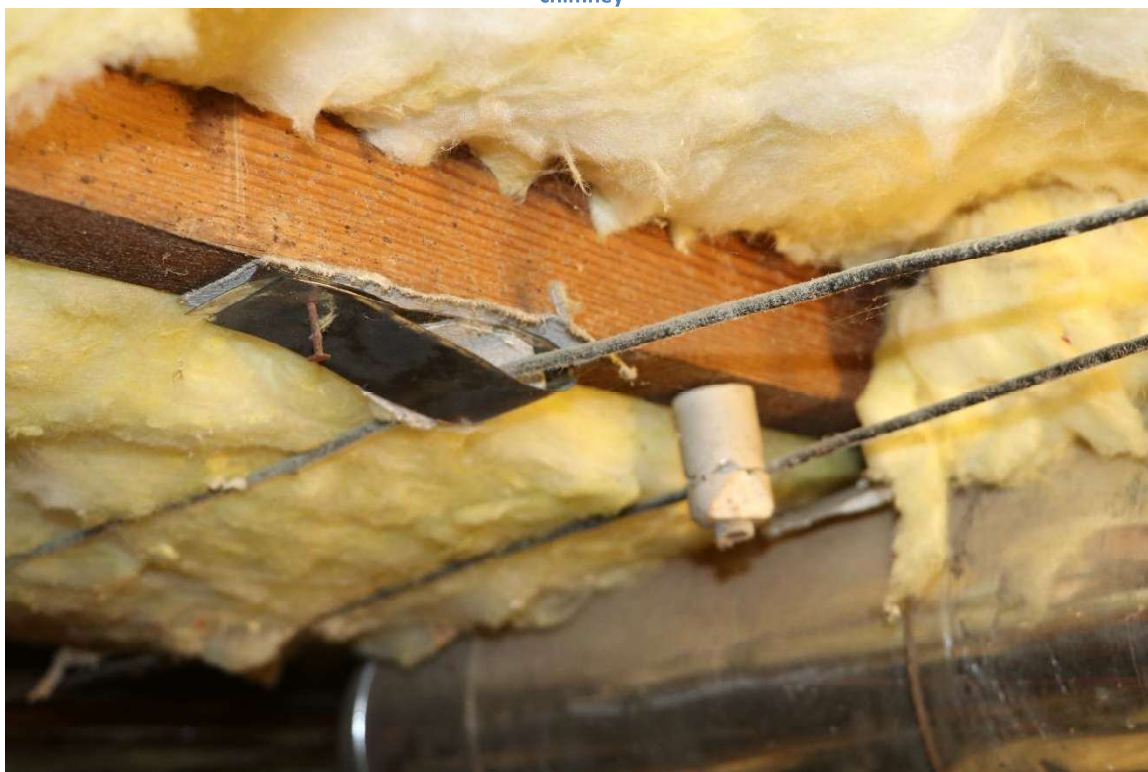
Image 43: Electrical Distribution. Basement. Knob and tube wiring with broken insulator

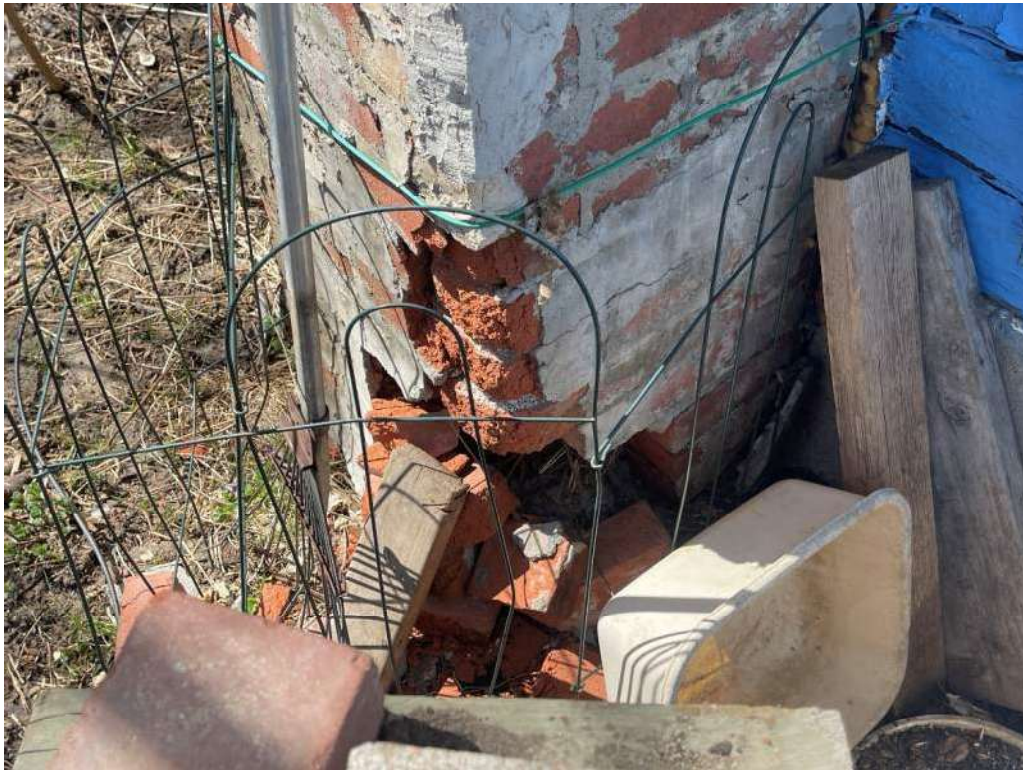
Figure 3: Missing bricks at base of chimney along east elevation

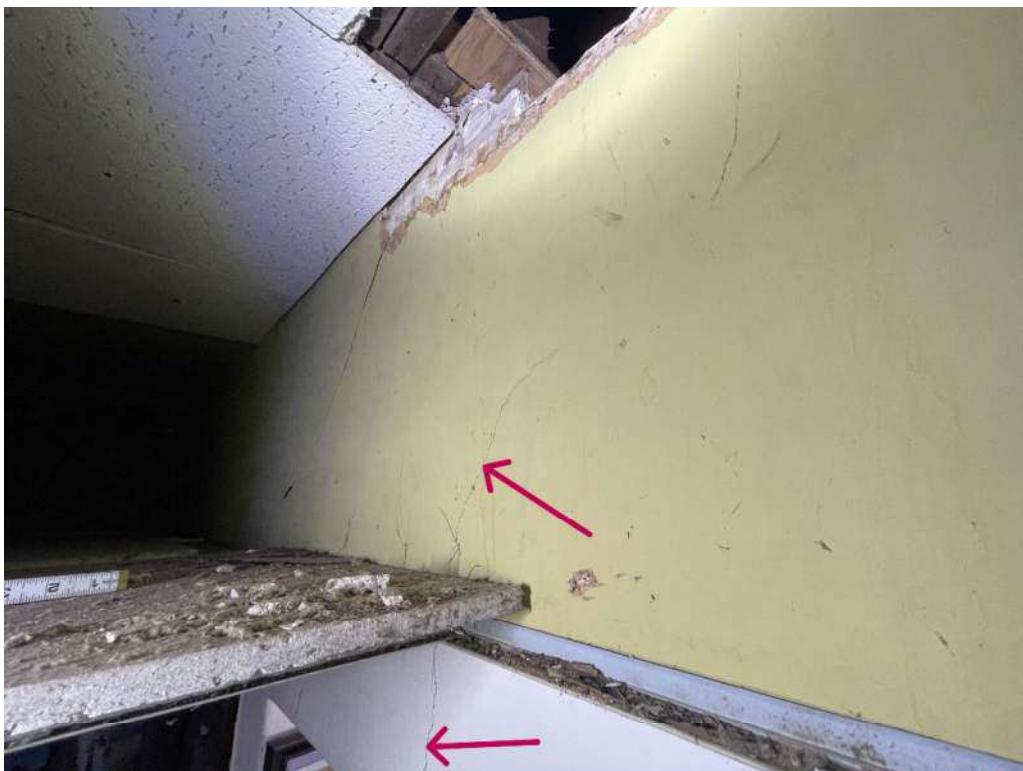
Figure 4: Crack at header between original house and addition

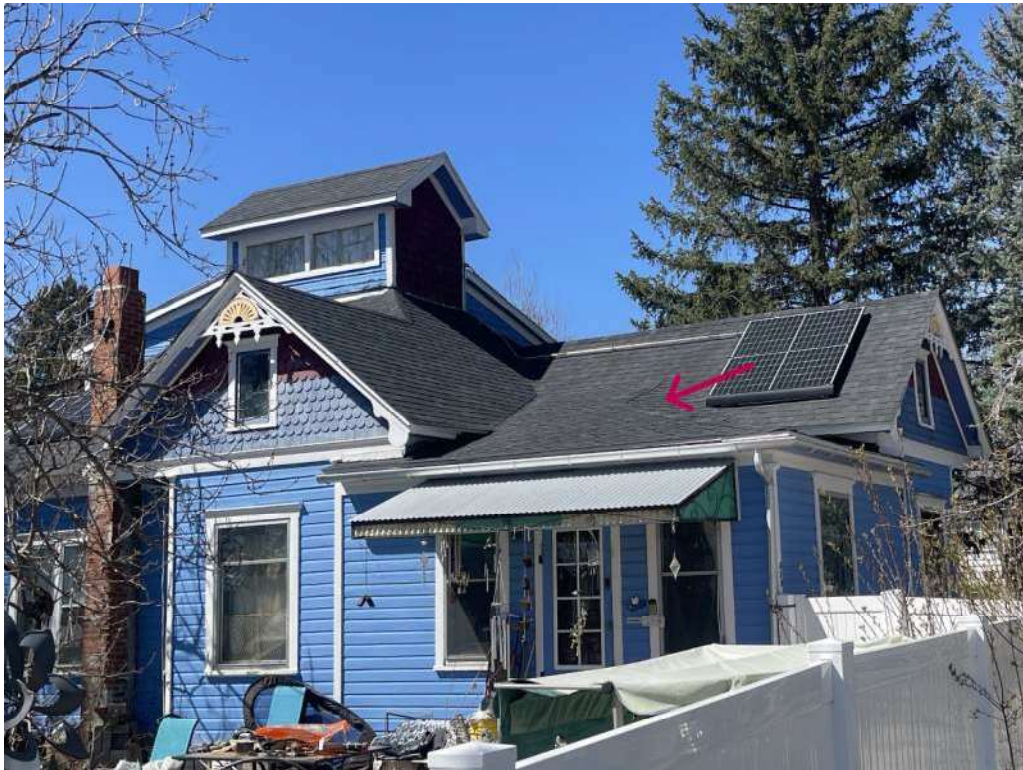
Figure 5: Northeast addition. Note over-framing at roof transition

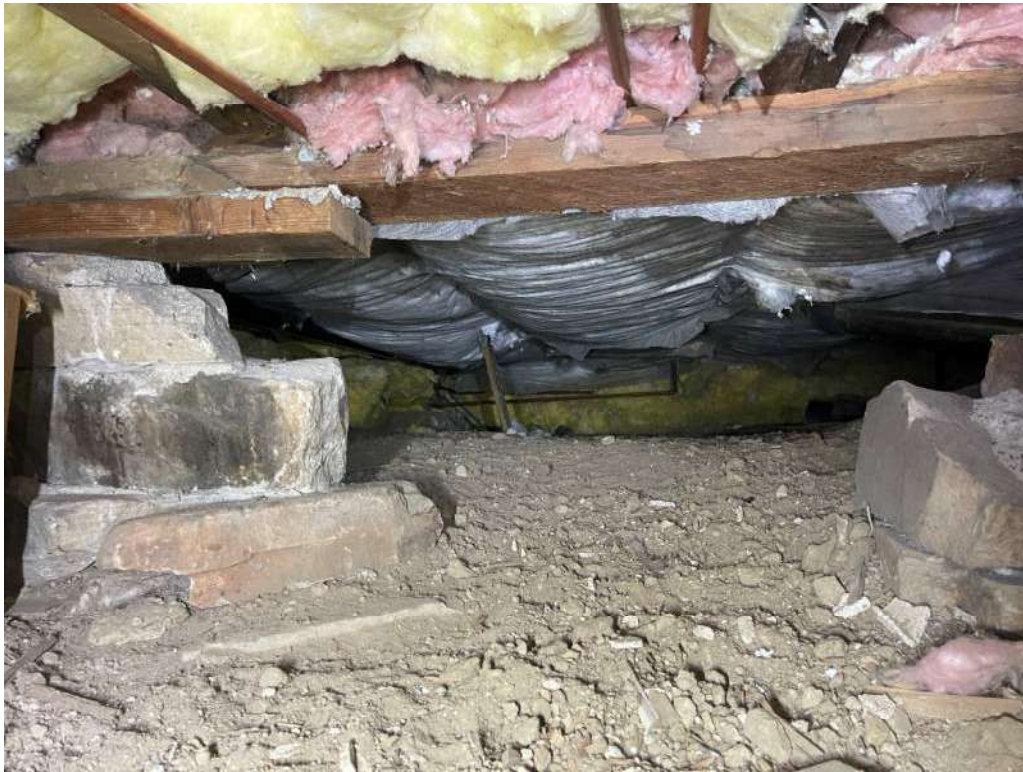
Figure 7: Crawlspace bearing line. Note one (2) 2x oriented flatwise between stone piers

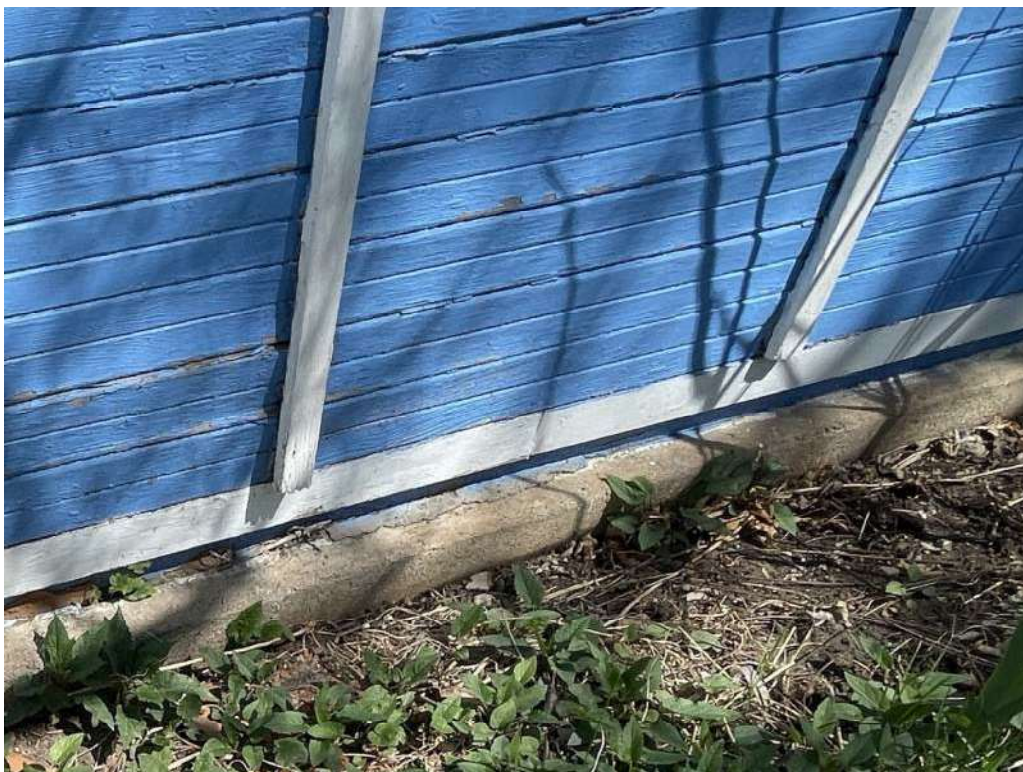
Figure 8: Parge coat over stone masonry foundation and grade proximate to wood framing

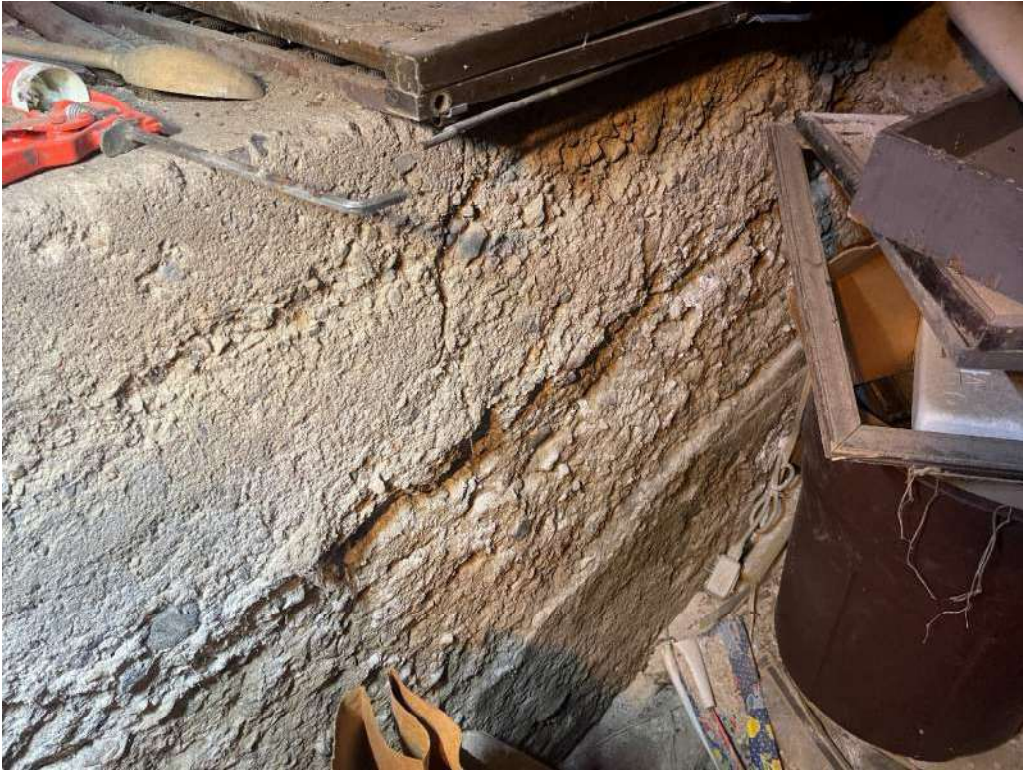
Figure 9: Inside face of concrete retaining wall. Note loss of cement paste and exposed aggregate due to moisture migration

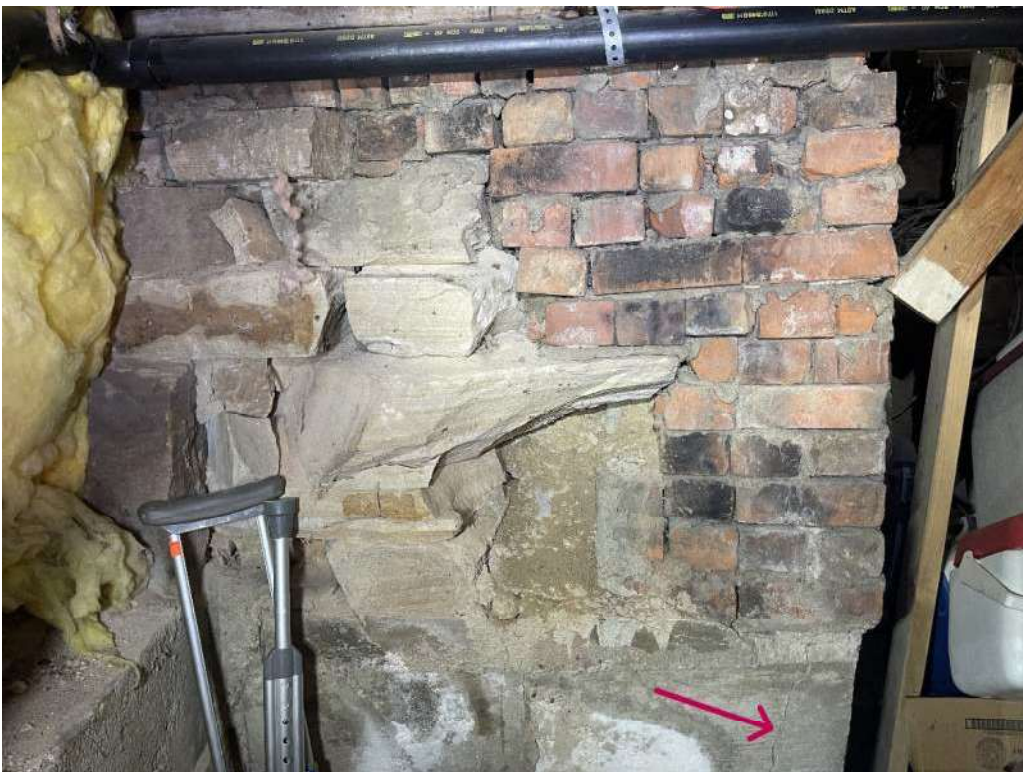
Figure 10: Area of foundation wall at stone to brick interface due for partial reconstruction
