**ITEM:** 1016 Main Street

**REQUEST:** A request for a demolition review to demolish the existing house and garage.

DAJ Design conducted an Historic Structural Assessment for the structure located at 1016 Main Avenue, Louisville, Colorado to determine its feasibility as a candidate for historic landmark designation as defined under the Historic Preservation program of the City of Louisville. The structure is a residential property. The City of Louisville Historic Preservation Commission found probable cause that the building may be eligible for landmarking under criteria in section 15.36.050 of the Louisville Municipal Code. Therefore, the Commission approved the Historic Structural Assessment to be paid for by the Louisville Preservation Fund grant.

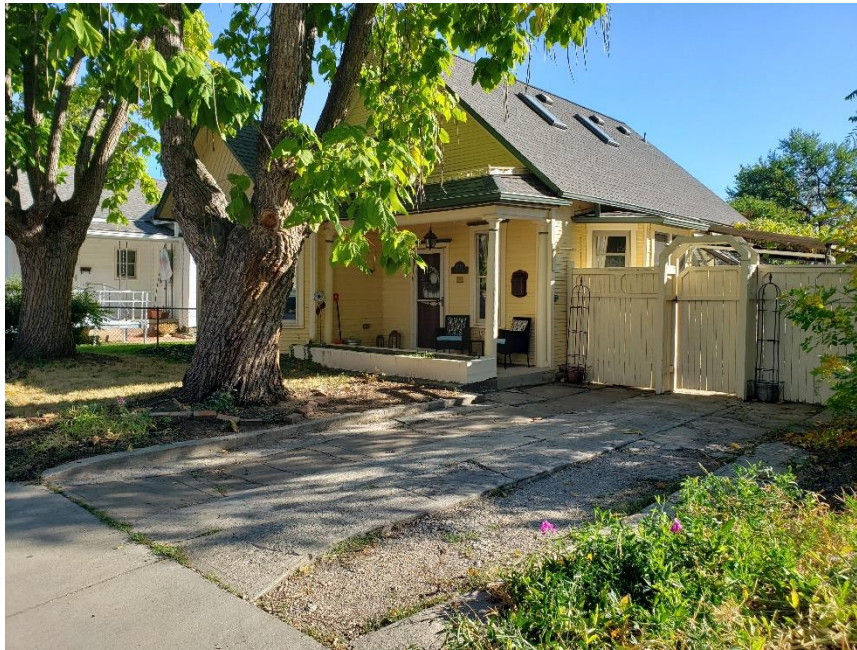
*Parking area in the southwest corner of the property.*

The uncovered concrete parking space in the southwest corner of the property is in poor condition. The concrete is well beyond the expected lifespan with numerous cracks. Additionally, it appears that some of the parking area may be on top of the coal room below and therefore not properly supported.

Similarly, the parking area on the west side of the house should be removed. On-site parking could be accommodated in this location with a new concrete slab or wheel tracks. However, no parking should occur above the coal room and the coal room should be further assessed prior to any above grade work.

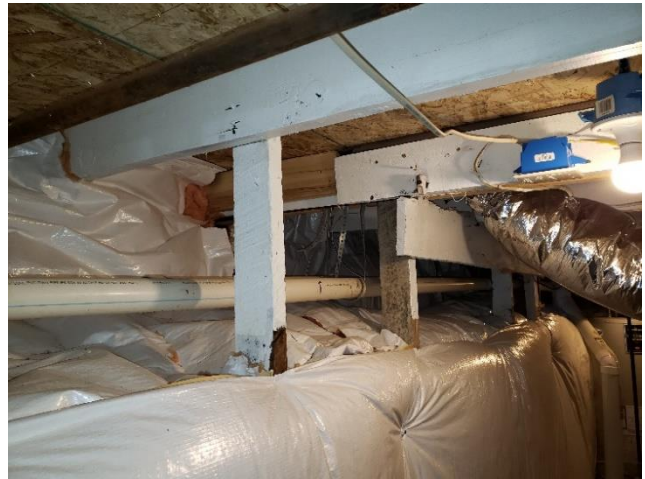
*Floor joist supports bearing on a retaining wall.*

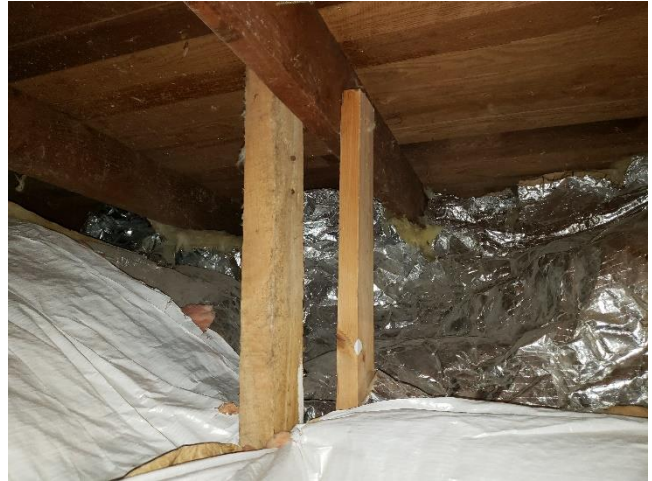
An evaluation of the second floor framing is not possible without further deconstructive investigation. It appears that the upper floor joists are 2x6, likely at 24-inches on-center spacing, and spliced on a central bearing wall. These are all assumptions and based on the assumptions, the upper floor joists do not meet the minimum IRC code requirements for today's standards.

*Original floor joists and floor sheathing.*

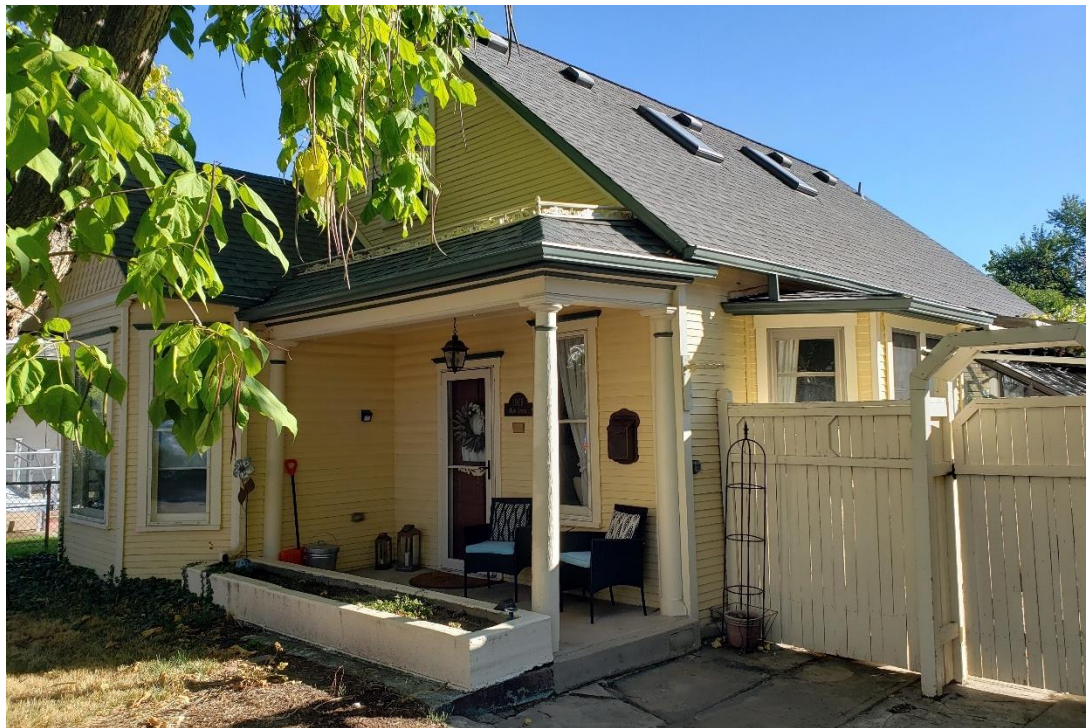
*Asphalt shingle roof with roof venting near the ridge.*

The asphalt composition shingle roof is in good condition. The areas of membrane roof appear to be in good condition but were not accessible during the site visit. The roof venting appears to be adequate for a small attic in the upper portion of the roof. However, this attic was not accessible and therefore assessment is limited.
