**ITEM:** 1155 Pine Street Landmark & Alteration Certificate Request

**REQUEST:** A request to landmark the building at 1155 Pine Street, and request for an alteration certificate.

DAJ Design conducted an Historic Structural Assessment for the structure located at 1155 Pine Street, Louisville, Colorado to determine its feasibility as a candidate for historic landmark designation as defined under the Historic Preservation program of the City of Louisville. The structure is a residential property. The City of Louisville Historic Preservation Commission found probable cause that the building may be eligible for landmarking under criteria in section 15.36.050 of the Louisville Municipal Code. Therefore, the Commission approved the Historic Structural Assessment to be paid for by the Louisville Preservation Fund grant.

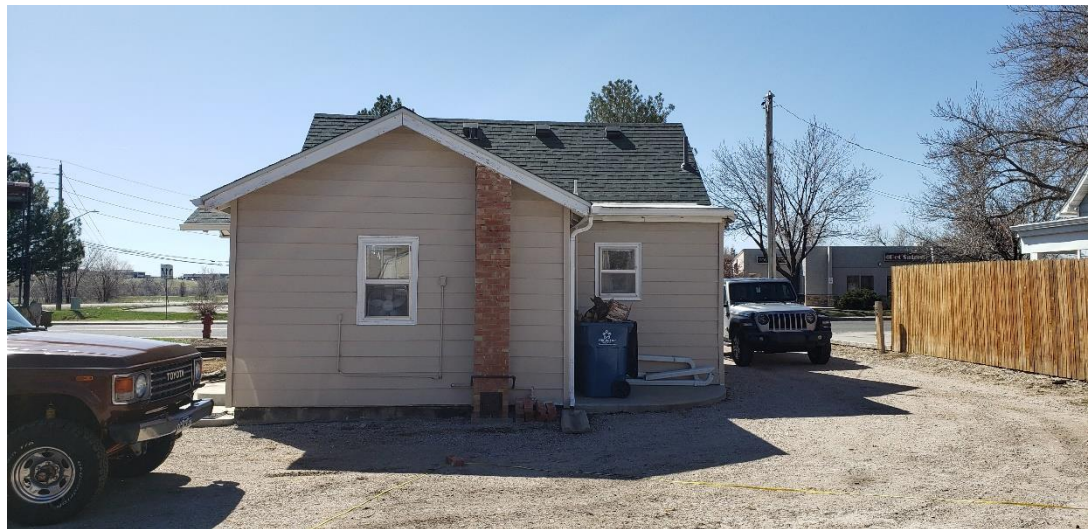
The gravel drive and parking area is in fair condition. The parking is not well defined and access to Pine Street is limited to one vehicle.

*A gravel parking area along the north of the house is accessed from Pine Street by a gravel drive along the west side of the house.*

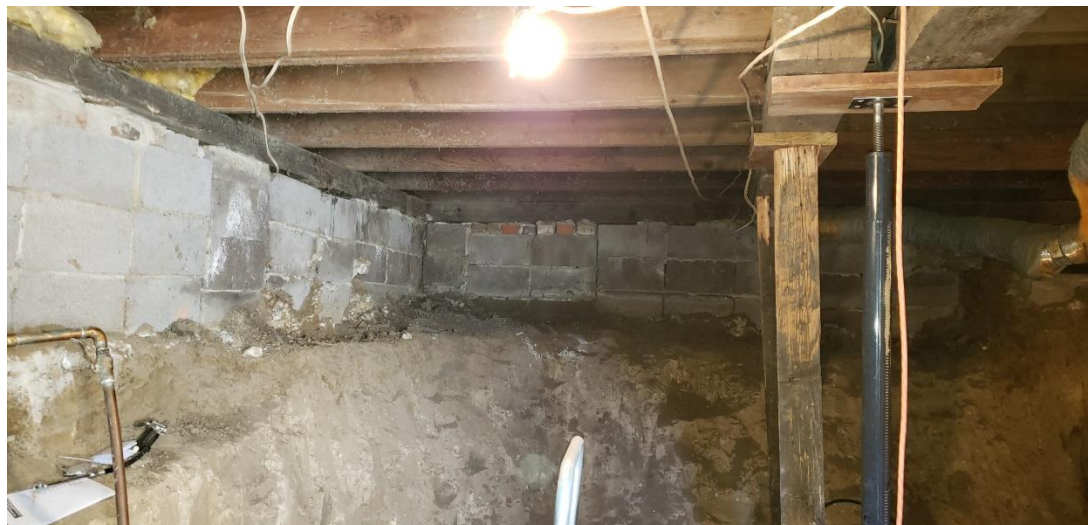
The concrete block perimeter foundation walls are in poor condition for several reasons. First, the crawl space was dug out without properly supporting the dirt excavation. The excavation was cut too close to the foundation walls, less than a one-foot distance in some areas, and the excavation is not supported with shoring. Additionally, the foundation walls do not appear to be supported by footings though the presence and size of footings is indeterminable. Furthermore, the foundation walls vary in their construction from various bond types to varying levels of grouting. It is unclear if the foundation walls are grouted solid and the presence of bricks in various locations further increases the variations in wall construction methods. Lastly, dirt has been removed from below some foundation wall elements and either wood or stone posts support the wall to the grade below. This looks to be temporary shoring.

*CMU foundation with various bonds, seams, grout, and heights. The excavation is unsupported.*

1. A retaining wall should be installed in the basement to retain the basement cut soil at all locations. Alternately, the building could also be lifted or moved to allow a new foundation to be installed to properly support the building. Coordinate all foundation repairs and further assessment with a licensed structural engineer.

2. The foundation walls showed various signs of damage that require further evaluation. No additional load should be added to the existing foundation system without a full analysis of the current foundation walls/footings. Immediate attention should be given to the locations where the existing foundation walls have been undermined and no longer have supporting soil. Coordinate all foundation repairs and further assessment with a licensed structural engineer.

3. Shoring should be added to support the floor at all locations where excavation has occurred below existing foundation walls or adjacent to the wall. The purpose of the shoring is to prevent settlement or collapse of the floor if damage were to occur to the foundation walls.

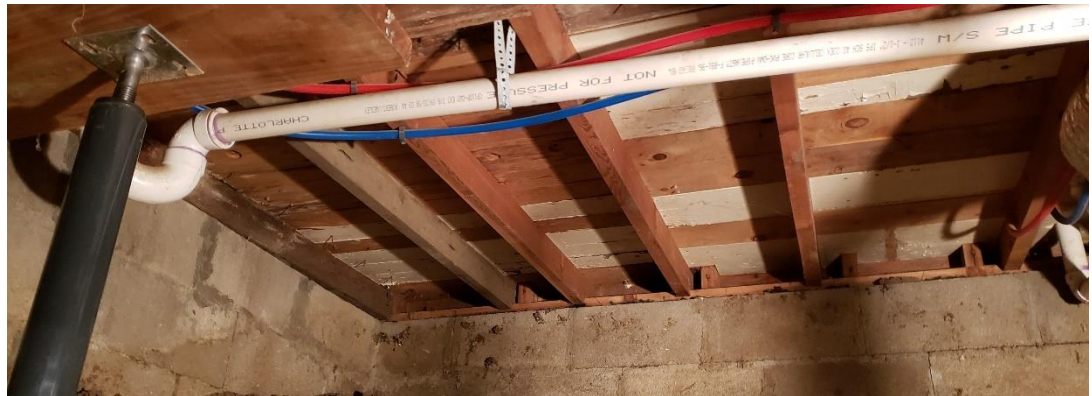
The floor sheathing appears to be in fair condition. The sheathing appears to be performing adequately, but there are several areas on the main floor that are bulging and may need additional exploration. The floor sheathing does meet minimum IRC code requirements for today's standards and appears to be performing adequately.

*Floor joists and sheathing of the northwest addition.*

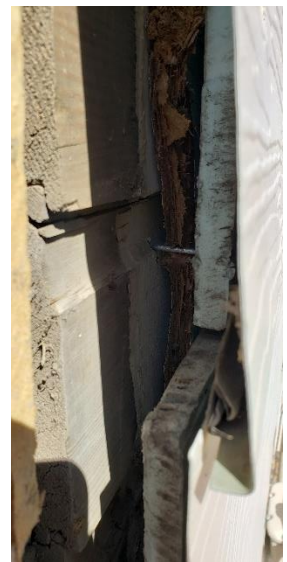
*Wood shiplap siding exposed in the southeast corner.*

1. Remove the steel siding, foam backer, and composite siding to expose the original wood siding.
2. Repair, refinish, or replace the original wood siding.

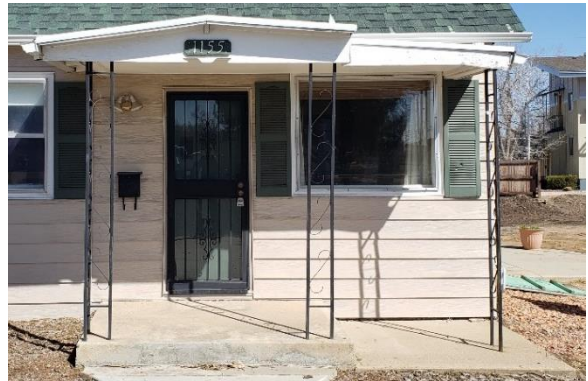
*Covered front porch.*

1. Remove the entire front porch roof and columns. The placement of the original front door covering should be visible with the exposure of the wood siding.
2. Consider moving the side awning to the original location if this is verified with the wood siding exposure. The side awning should be rehabilitated to match the original appearance by removing the trim and soffit. The structure of this awning should be assessed by a licensed structural engineer.

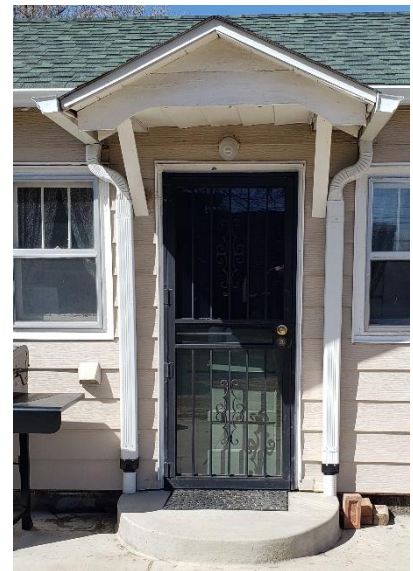
*Downspouts connected to buried pvc.*

1. Replace the missing downspouts on the covered front porch.
2. Determine the discharge location of the buried downspouts.
3. Ensure that all gutters, downspouts, and downspout extensions are maintained to discharge water away from the building foundation and are kept clear of debris.
4. The gutters and downspouts are not historic. Consider replacing the gutters with ½ round gutters and the downspouts with round downspouts. Though not historic, these styles will more appropriately match the historic nature of the house.

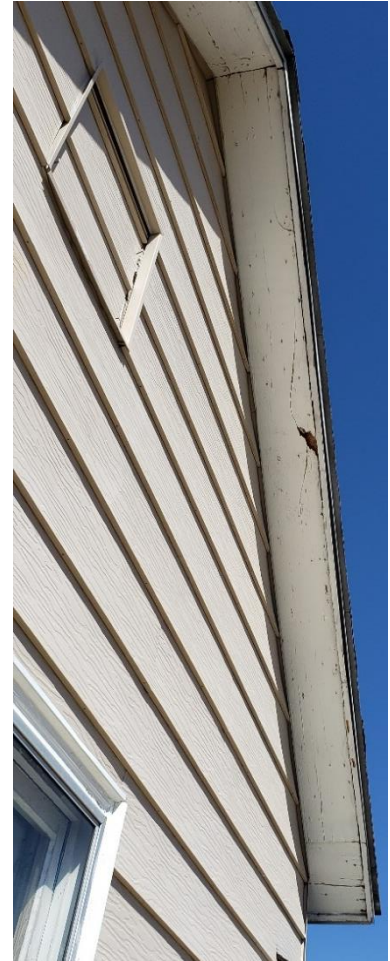
*Soffit and fascia on the original house.*

1. Remove the steel trim with the steel siding exposing the original window, door, and corner trim sizes below. Add new trim according to the determined sizes.
