# ***Historic Preservation Commission Agenda***

**ITEM:** 1155 Pine Street Landmark & Alteration Certificate Request

**REQUEST:** A request to landmark the building at 1155 Pine Street, and request for an alteration certificate.

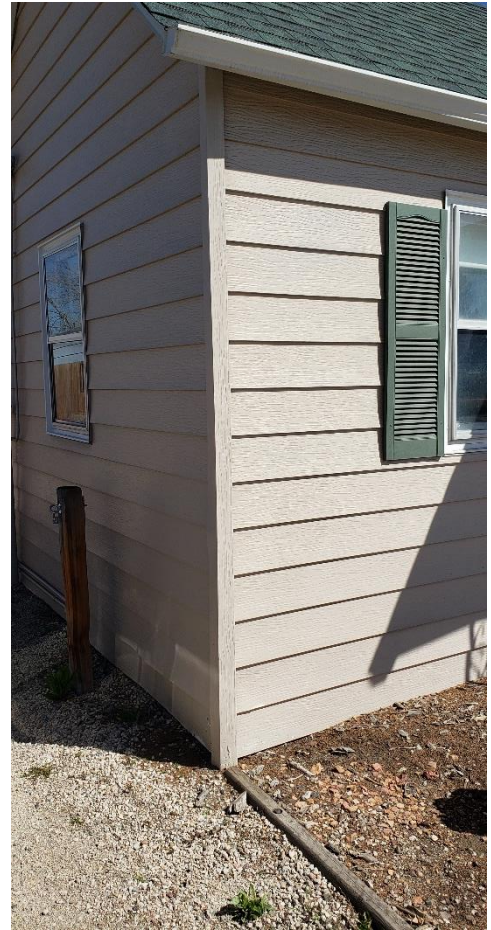
The overall site grading is in fair condition, but it does not meet the expected code requirements and geotechnical engineering requirements for grading away from a building's foundation. It is important that the grading around the house should be a minimum of 6 inches below the top of the foundation and slope away from the foundation for at least the first 5 feet. Due to the nature of the lot, it is difficult to meet these requirements without some amount of regrading or lifting the building. There are limited visible indications of poor or negative drainage, though not all areas of the home's foundation and sub-slab areas are visible for analysis without some level of deconstructive investigation.

*Southwest corner of the house where the siding meets grade.*

1. Continue to monitor the drainage around the perimeter of the house. The perimeter should be observed after snow and significant rain events to assess for any areas of pooling water.

2. The top of the foundation relative to the top of grade should be determined around the perimeter of the house. If the top of the foundation is determined to be at or below the existing grade, new grading should occur to bring the grade down below the top of the foundation, as prescribed by a licensed structural engineer.

3. The wood floor framing members including the sill plate, rim board, floor joists, and floor sheathing should be inspected for rot caused by poor drainage. If rot is found in any of these members, the affected flooring should be replaced as prescribed by a licensed structural engineer.

4. All areas where grade slopes towards the house, if any, should be regraded to direct water away from the house foundation.

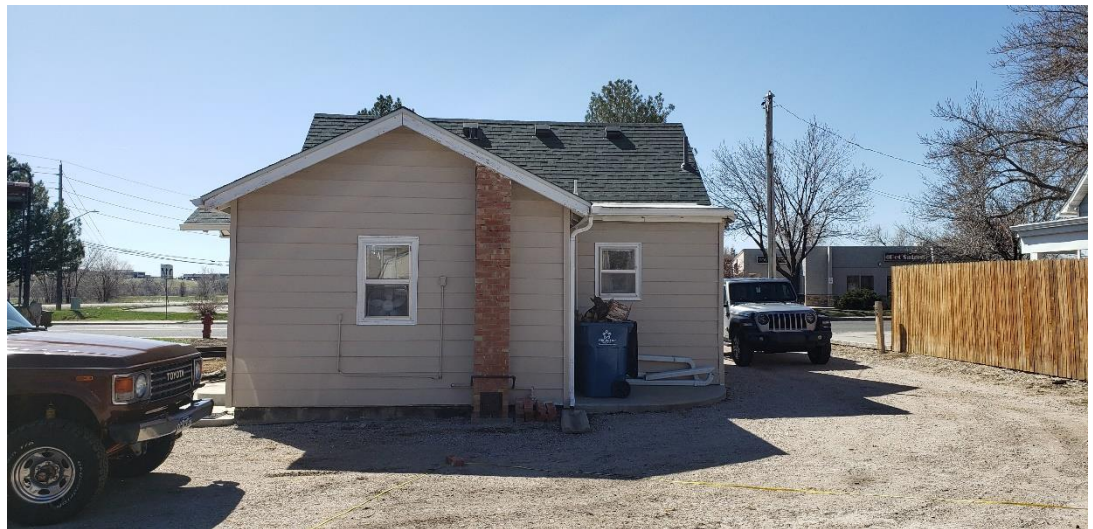
The gravel drive and parking area is in fair condition. The parking is not well defined and access to Pine Street is limited to one vehicle.

*A gravel parking area along the north of the house is accessed from Pine Street by a gravel drive along the west side of the house.*

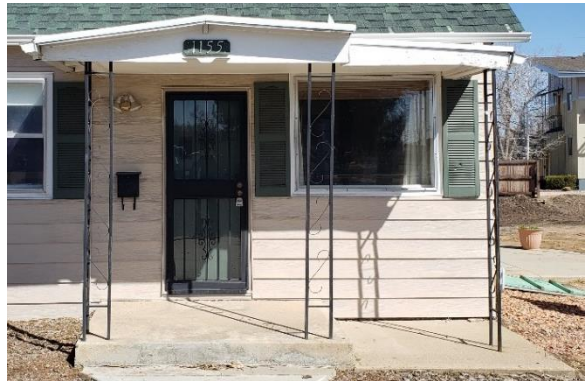
*Covered front porch.*

1. Remove the entire front porch roof and columns. The placement of the original front door covering should be visible with the exposure of the wood siding.
2. Consider moving the side awning to the original location if this is verified with the wood siding exposure. The side awning should be rehabilitated to match the original appearance by removing the trim and soffit. The structure of this awning should be assessed by a licensed structural engineer.
