# ***Historic Preservation Commission***

**ITEM:** 1040 LaFarge Avenue Demolition Review

**ADDRESS:** 1040 LaFarge Avenue  
**LEGAL DESCRIPTION:** Lots 13-14, Block 1, Barclay Place  
**DATE OF CONSTRUCTION:** ca. 1912

**REQUEST:** A request for a demolition review to demolish parts of the existing structure.

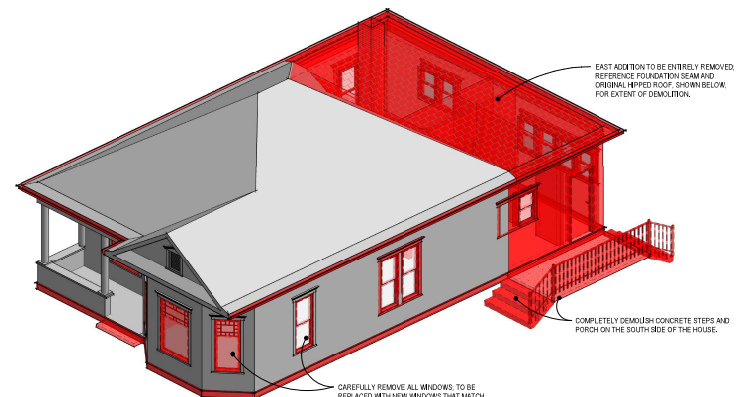
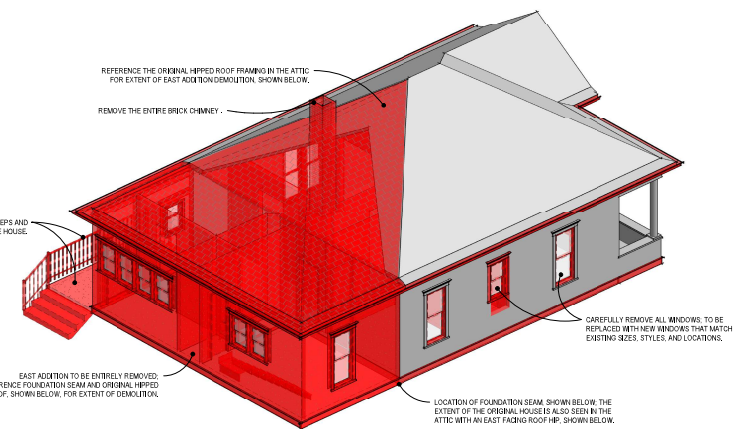
COLD JOINT SEAM IN THE CONCRETE FOUNDATION INDICATES THE EXTENT OF THE ORIGINAL HOUSE.

EAST ADDITION TO BE ENTIRELY REMOVED.  
REFERENCE FOUNDATION SEAM AND ORIGINAL HIPPED  
ROOF, SHOWN BELOW, FOR EXTENT OF DEMOLITION

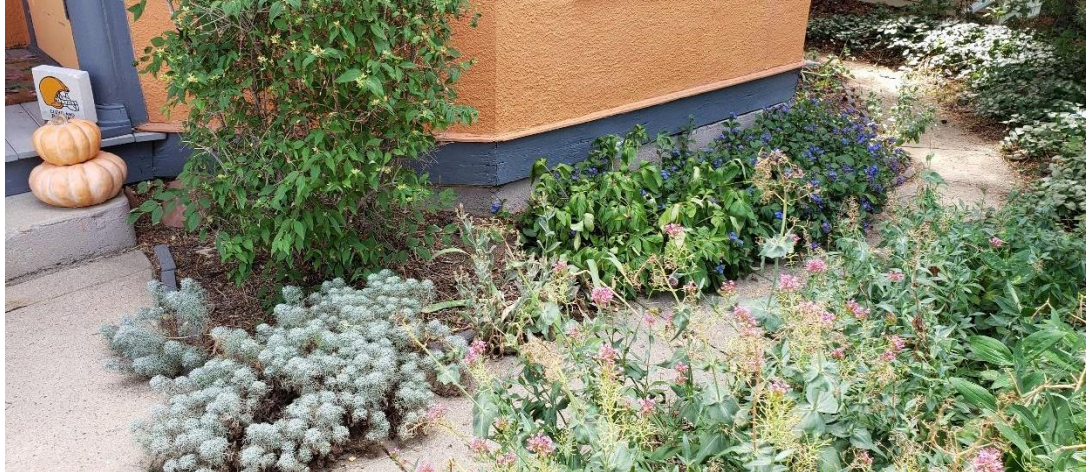
*Grade sits close to finish materials at the west side of the house with minimal slope away from the foundation.*

The overall site grading is in poor condition. It is important that the grading around the house should be a minimum of 6 inches below the top of the foundation and slope away from the foundation for at least the first 5 feet. Due to the nature of the lot, it is difficult to meet these requirements without a large amount of regrading or lifting the building and pouring a new foundation.

The effects of poor grading are difficult to determine in one site visit. However, no areas of water infiltration into the basement were observed or noted by the homeowner.

1. Continue to monitor the drainage around the perimeter of the house. The perimeter should be observed after snow and significant rain events to assess for all areas of pooling water.

2. The top of the foundation relative to the top of grade should be determined around the entire perimeter of the house. If the top of the foundation is determined to be at or below the existing grade, new grading should occur to bring the grade down below the top of the foundation, as prescribed by a licensed structural engineer.

3. Finished grade around the house perimeter should be re-graded to create positive drainage away from the house. The top of finished grade should be a minimum of 6 inches below the top of the foundation and slope away from the foundation for at least the first 5 feet. Coordinate slope with a licensed geotechnical engineer.

4. The house foundation could be replaced to bring the top of foundation at least six inches above finished grade. Coordinate with a licensed structural engineer and a licensed geotechnical engineer.

5. The wood floor framing members including the sill plate, rim board, floor joists, and floor sheathing should be inspected for rot caused by poor drainage. If rot is found in any of these members, the affected flooring should be replaced as prescribed by a licensed structural engineer.

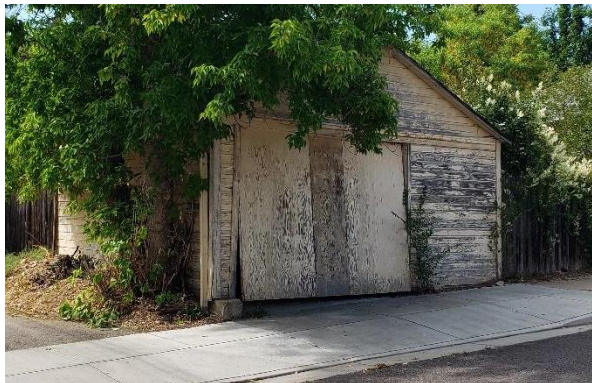
The entire garage is in poor condition. The framing does not meet current code by today's standards. The roofing is significantly deteriorated and there is sagging of the roof framing. The shiplap wood siding has not been maintained and such is worn beyond the expected lifespan. The person door is operable but does not create a good seal while the overhead door was not tested but appears to be minimally operable, if at all.

*Northeast view of the garage facing South Street and near the alley. The overhead door does not appear to be operable.*

The garage likely meets the age to qualify as a historic element of the site. However, the garage was not originally constructed in a manner to have a long life expectancy and has subsequently been poorly maintained. The size and location of the overhead garage door only provides for one on-site parking space, though it appears that the overhead door is no longer operable, and the condition of the roof poses a safety concern. For these reasons, we recommend removing the garage at this time.

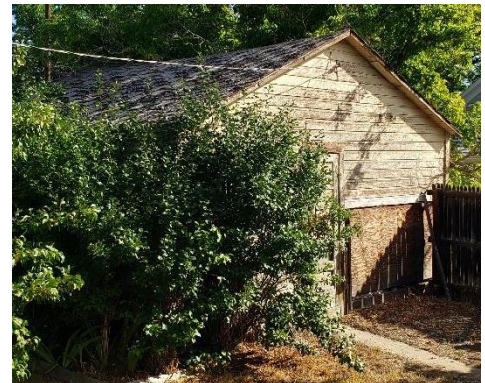
*Southwest view of the garage. The roof is sagging and deteriorated.*

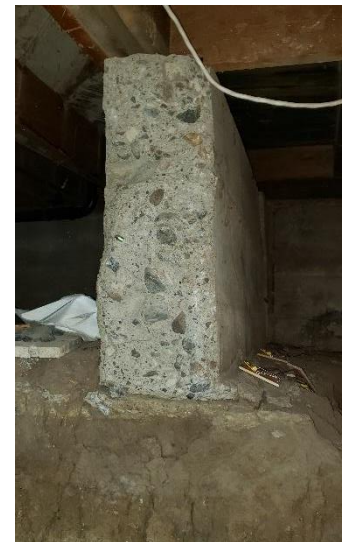
*The original east foundation wall was cut to dig out the basement.*

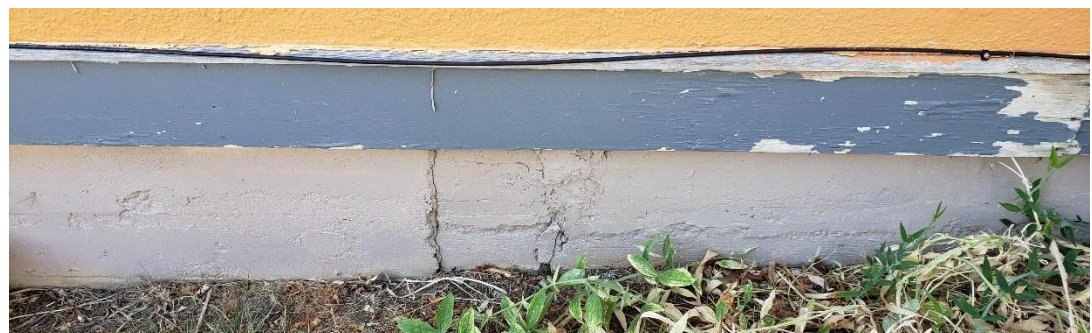
*The original foundation on the right and the east addition on the left. A vertical cold joint distinguishes the two.*

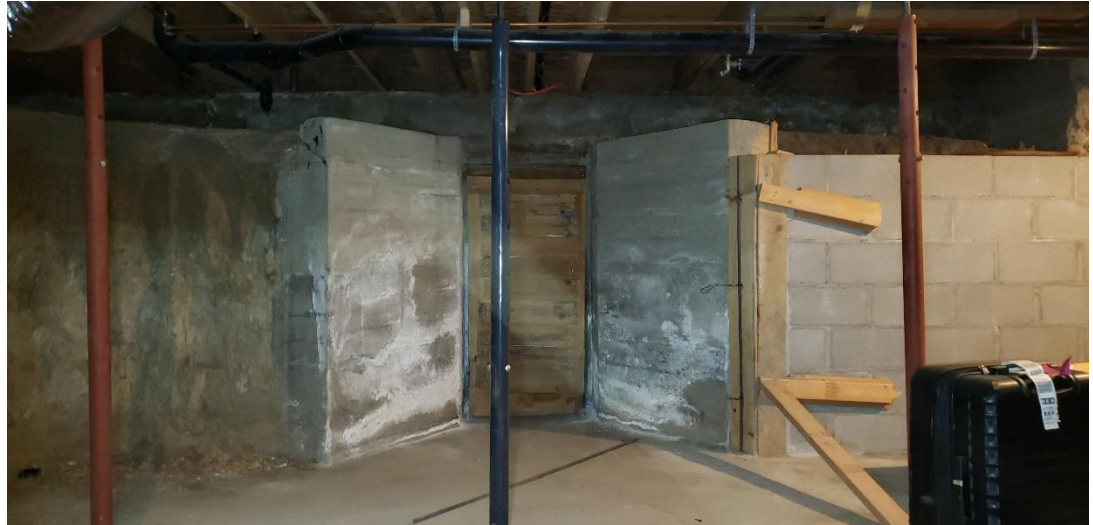
*Entrance to the coal room. Unsupported grade on the left and a CMU wall intended for retaining on the right.*

The CMU walls separating basement from crawlspace areas are also in poor condition. These walls do not appear to be supported by proper footings and are not grouted solid. Furthermore, the walls do not retain the cut soil, which appears to be the intended purpose, as there is a gap between the soil and the CMU wall face. The CMU walls appear to bear directly on the concrete slab floor. The concrete slab floor is in fair condition, but the slab thickness could not be determined. The concrete slab supports the CMU walls as well as several columns as discussed below. The concrete slab floor may not be of adequate thickness or properly reinforced at the point load and wall load locations, possibly compromising the floor and any loads that it supports.

4. The CMU walls in the basement should be grouted solid and the gap between the CMU walls and the soil cut filled so that the walls act as proper retaining for the cut soil. Coordinate all repairs with a licensed structural engineer and a licensed geotechnical engineer. In addition, all soil cuts should be properly retained and supported.

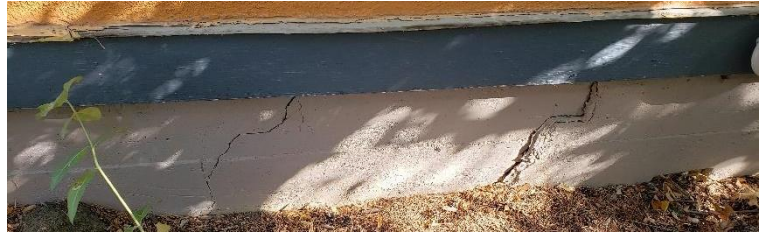
The entire concrete foundation is in poor condition with some areas that are severely compromised. The foundation at the west side of the building was minimally exposed for analysis but it is likely in poor condition as well as it was constructed at the same time as the visible areas further east. There are several cracks in the foundation that are visible on the exterior and interior. The south foundation wall is of particular concern where the foundation wall appears to tip outward, it is cracked and is not properly designed to support lateral earth pressure and gravity loading from above. In this area the basement excavation is right at the edge of the foundation wall without any type of retaining. There appears to have been concrete that was poured under the original crawlspace depth foundation and it appears to have been poured against dirt or that possibly the concrete formwork failed during concrete installation. Water infiltration appears to happen at this location and the foundation wall is undermined by the grade cut and not supported. The cracking throughout is likely caused by the foundation settling and it is unclear what size footing was used, if any.

*Foundation wall cracks on south side exterior.*

1. The basement and crawlspace foundation walls showed various signs of damage that require further evaluation. No additional load should be added to the existing foundation system without a full analysis of the current foundation walls/footings. A full analysis, review and repair should also be completed for the continued safe occupancy of the building.

3. The foundation wall along the south side of the basement should be replaced where it is at basement depth (the crawlspace areas along the south side do not necessarily need replacing). Coordinate a design and replacement methodology with a licensed structural engineer. Proper connection between the full height basement wall and the adjacent crawl space walls is needed to prevent any further movement.

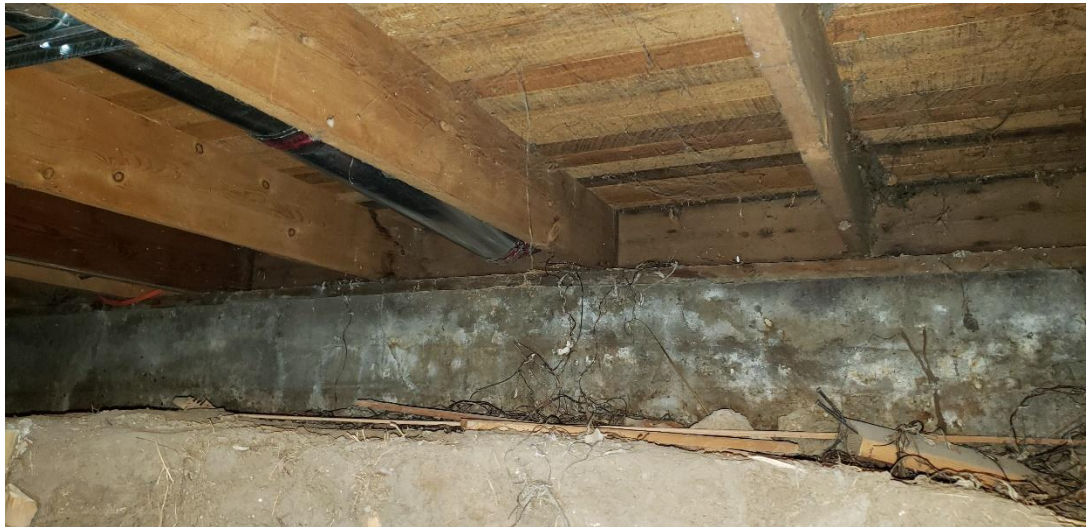
*Original floor joists & sheathing. Water damage is apparent on the rim and sill plate.*

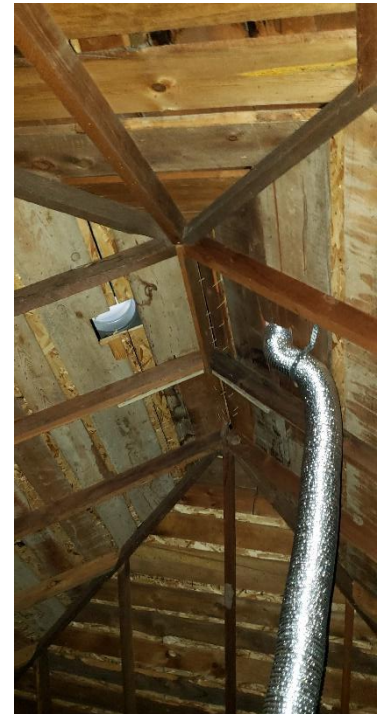
*Broken ridge beam of original roof.*

9. It is not recommended to add additional roofing materials such as an additional layer of shingles, or solar panels without the additional structural support mentioned above.

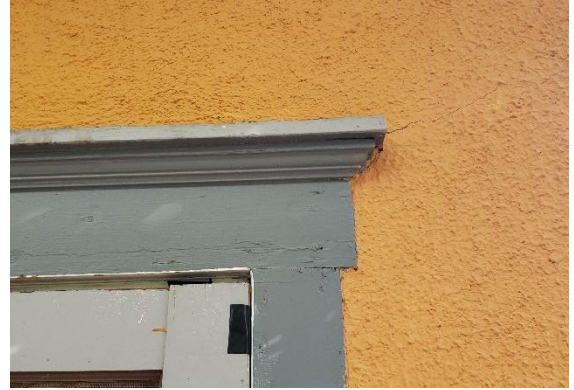
*Cracked stucco is seen at several windows and doors. The door trim is nearly flush with the stucco, indicating an additional siding layer beneath the stucco.*

Alternatively, the stucco siding meets the historic requirements and could be retained and repaired as needed. An additional layer of finish coat stucco could be applied to preserve the historic stucco appearance.

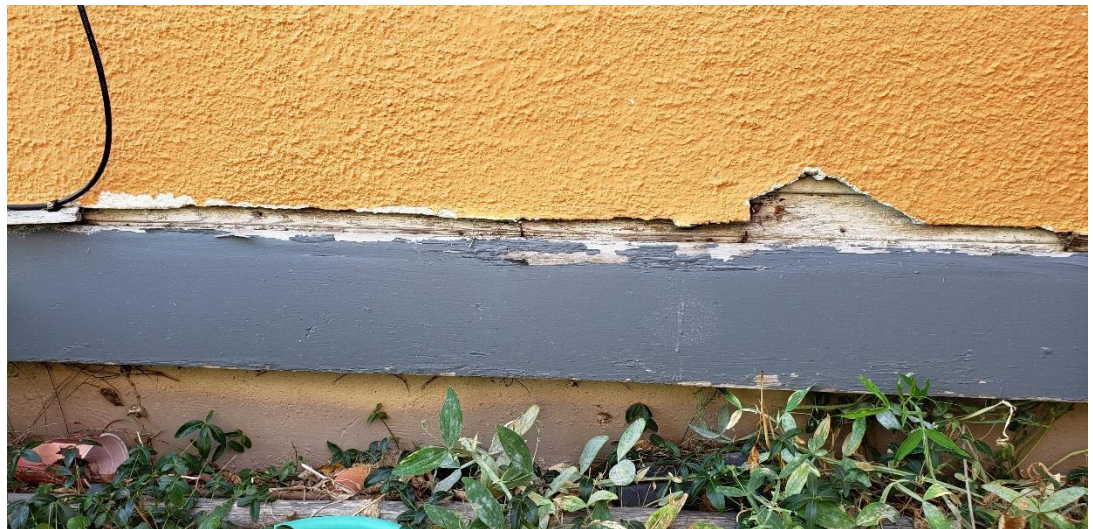
*The stucco is damaged at the wall base. There appears to be wood clapboard siding beneath the stucco.*

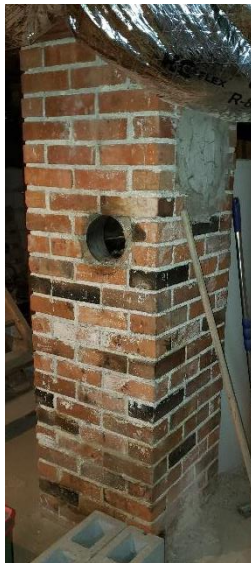
*Chimney in the basement.*

The chimney's masonry should be tuck-pointed to stabilize its condition.

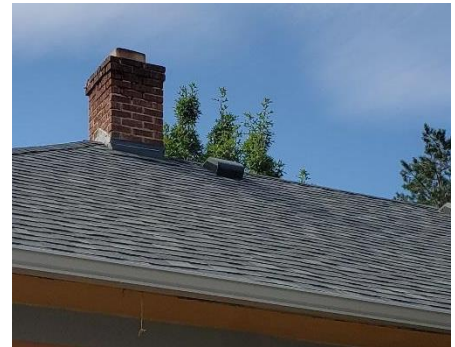
The metal flashing at the chimney is in fair condition. The flashing appears to be older but not original and was likely not replaced during the most recent re-roof as removal and replacement could damage the chimney.

*Metal flashing at the chimney-roof interface.*
