**ITEM:** 1040 LaFarge Avenue Demolition Review

**REQUEST:** A request for a demolition review to demolish parts of the existing structure.

DAJ Design conducted an Historic Structural Assessment for the structure located at 1040 LaFarge Avenue, Louisville, Colorado to determine its feasibility as a candidate for historic landmark designation as defined under the Historic Preservation program of the City of Louisville. The structure is a residential property. The City of Louisville Historic Preservation Commission found probable cause that the building may be eligible for landmarking under criteria in section 15.36.050 of the Louisville Municipal Code. Therefore, the Commission approved the Historic Structural Assessment to be paid for by the Louisville Preservation Fund grant.

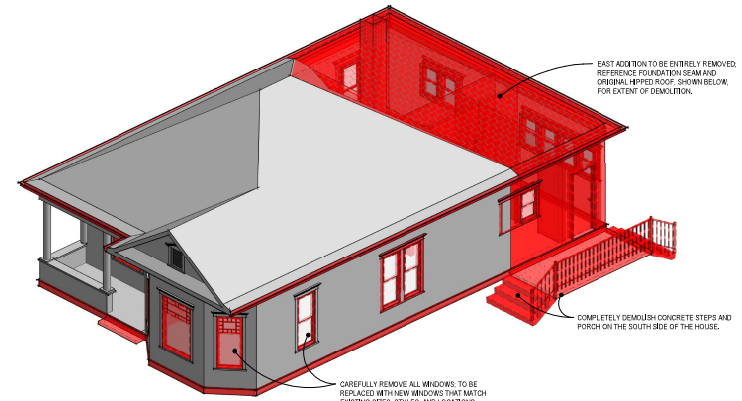
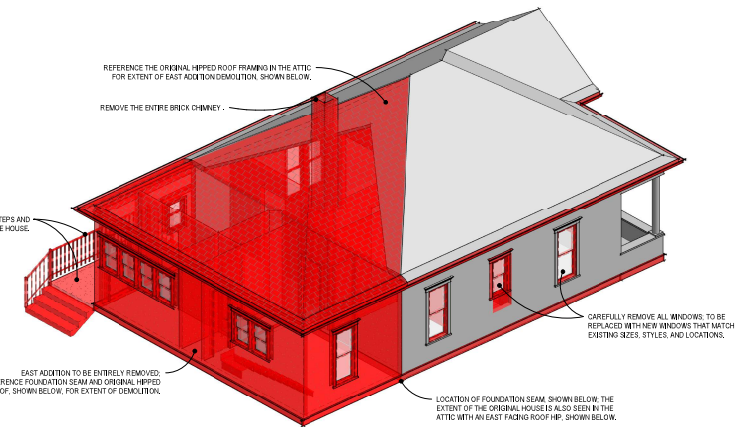
COLD JOINT SEAM IN THE CONCRETE FOUNDATION INDICATES THE EXTENT OF THE ORIGINAL HOUSE.

EAST ADDITION TO BE ENTIRELY REMOVED.  
REFERENCE FOUNDATION SEAM AND ORIGINAL HIPPED  
ROOF, SHOWN BELOW, FOR EXTENT OF DEMOLITION

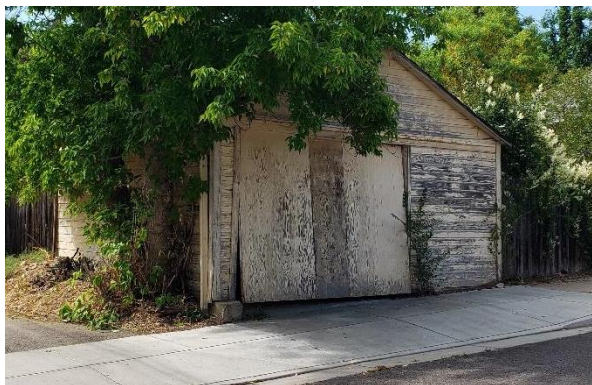
The entire garage is in poor condition. The framing does not meet current code by today's standards. The roofing is significantly deteriorated and there is sagging of the roof framing. The shiplap wood siding has not been maintained and such is worn beyond the expected lifespan. The person door is operable but does not create a good seal while the overhead door was not tested but appears to be minimally operable, if at all.

*Northeast view of the garage facing South Street and near the alley. The overhead door does not appear to be operable.*

The garage likely meets the age to qualify as a historic element of the site. However, the garage was not originally constructed in a manner to have a long life expectancy and has subsequently been poorly maintained. The size and location of the overhead garage door only provides for one on-site parking space, though it appears that the overhead door is no longer operable, and the condition of the roof poses a safety concern. For these reasons, we recommend removing the garage at this time.

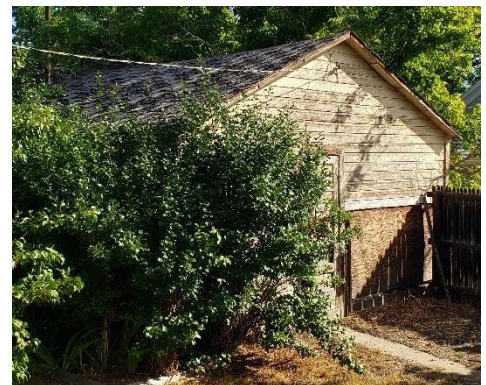
*Southwest view of the garage. The roof is sagging and deteriorated.*

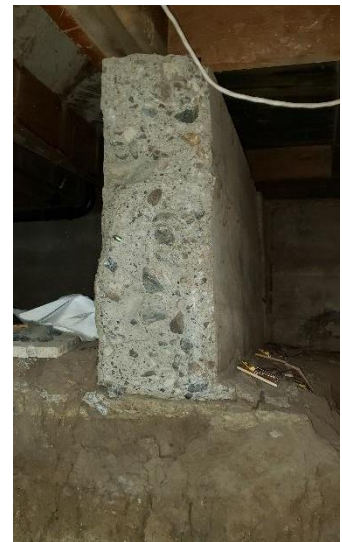
*The original east foundation wall was cut to dig out the basement.*

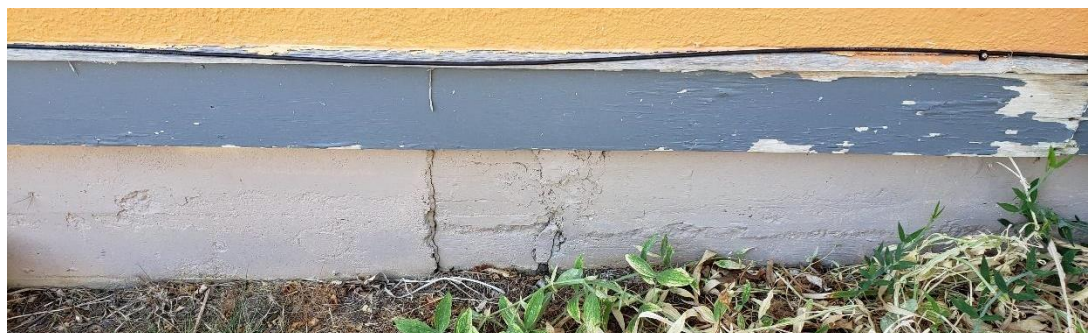
*The original foundation on the right and the east addition on the left. A vertical cold joint distinguishes the two.*

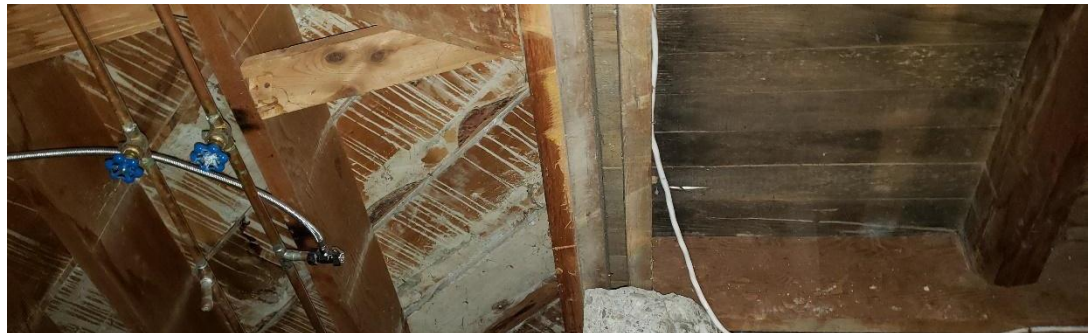
*Diagonal skip sheathing of east addition on the left with original house sheathing on the right.*

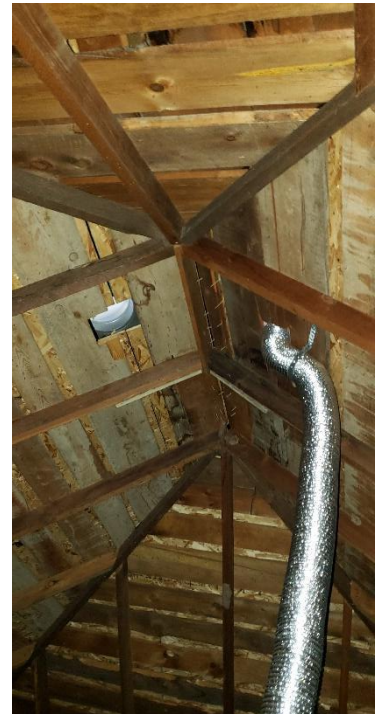
*Broken ridge beam of original roof.*

9. It is not recommended to add additional roofing materials such as an additional layer of shingles, or solar panels without the additional structural support mentioned above.

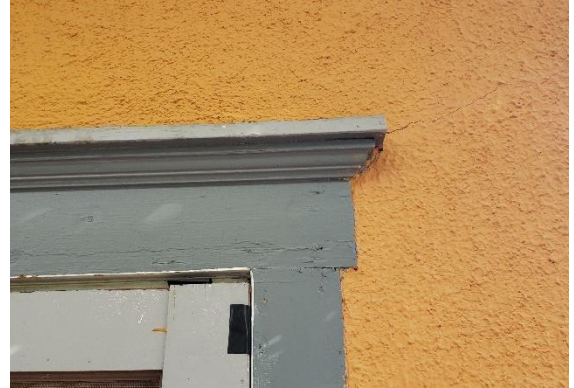
*Cracked stucco is seen at several windows and doors. The door trim is nearly flush with the stucco, indicating an additional siding layer beneath the stucco.*

Alternatively, the stucco siding meets the historic requirements and could be retained and repaired as needed. An additional layer of finish coat stucco could be applied to preserve the historic stucco appearance.

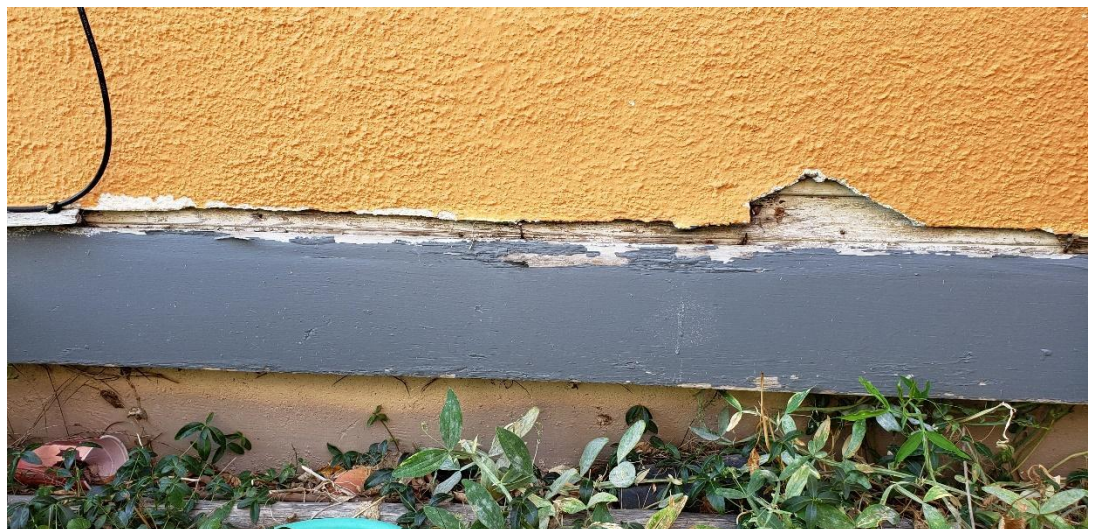
*The stucco is damaged at the wall base. There appears to be wood clapboard siding beneath the stucco.*

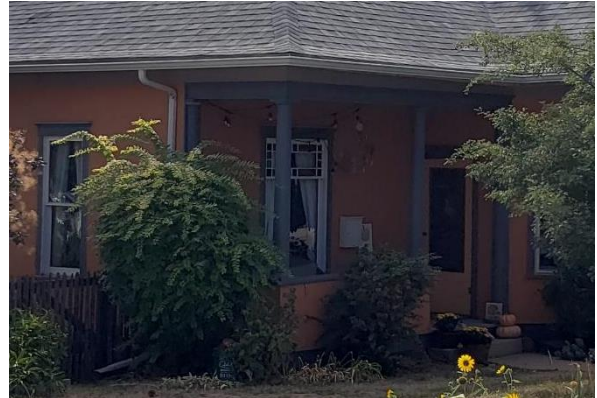
Overall, the covered front porch is in fair condition. Many of the finish materials are in a similar condition to those described throughout this report. With the exception of some of the roof framing, the remainder of the front porch framing was not exposed for review. The porch beam sizes could not be determined due to finish materials. The support of the columns at the base could not be determined due to the knee-wall finish. Neither could the construction of the knee-wall nor the deck framing be observed. For these reasons, the condition of many of the structural elements of the front porch could not be determined.

*Covered front porch in the northwest corner of the house.*

1. Further deconstructive investigation is necessary to properly analyze the covered front porch. The beams, columns, knee-wall construction, support, and attachments need to be verified and analyzed by a licensed structural engineer. The porch floor may be constructed of wood framing sitting on concrete or dirt and therefore has the potential to contain rot. The condition of these elements needs to be verified with deconstructive investigation.
2. The concrete stoop on the south side of the house should be removed and replaced with a similar element. The stoop is not historic and is likely trapping water along wood elements of the house and possibly applying added forces against the concrete foundation. Any repairs or replacement should be coordinated with a licensed architect, a licensed structural engineer, and licensed geotechnical engineer.
