**ITEM:** 1155 Pine Street Landmark, Alteration Certificate, Grant, and Probable Cause Request

**REQUEST:** A request to landmark 1155 Pine Street, a request for an Alteration Certificate, Preservation & Restoration and New Construction Grant requests, and a Probable Cause request.

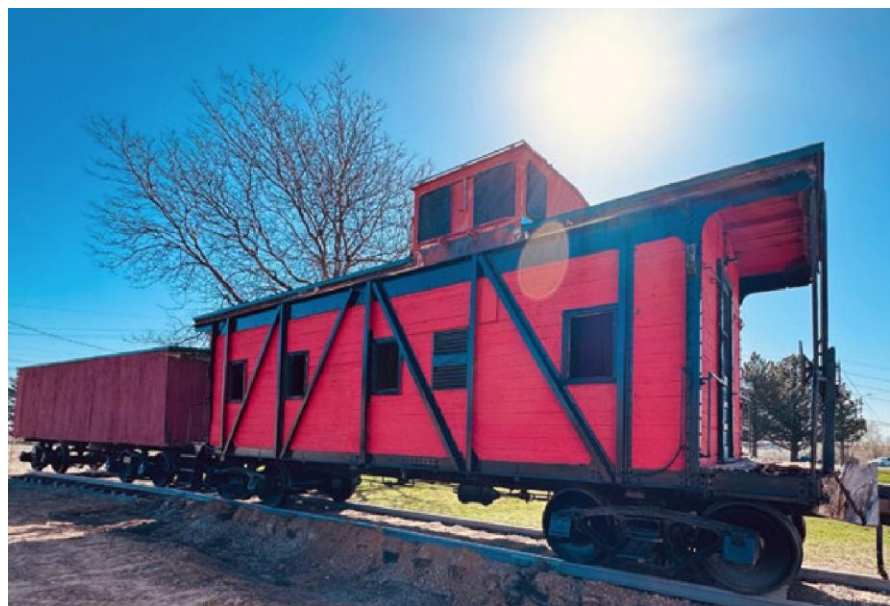
The structure has been gutted inside and is currently a single-level open bay, with tongue-in-groove wood walls and flooring clad to steel framing. It maintains a rectangular form with an all-steel cupola on top, five window openings on each long side, and one door on each end. The Caboose retains its original Bettendorf trucks and most of its exterior hardware, though only two of its original four steps remain.

*Current photo of the Caboose.*

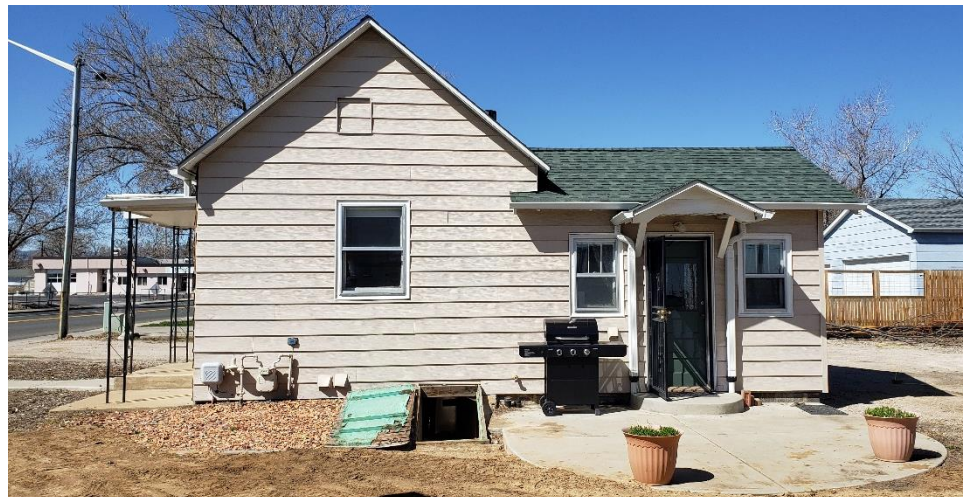
*West side of the house showing an uncovered concrete porch, dirt, gravel, and mulch surrounding the house.*

Landscaping east of the house and north of the caboose and boxcar should be completed to limit soil movement.

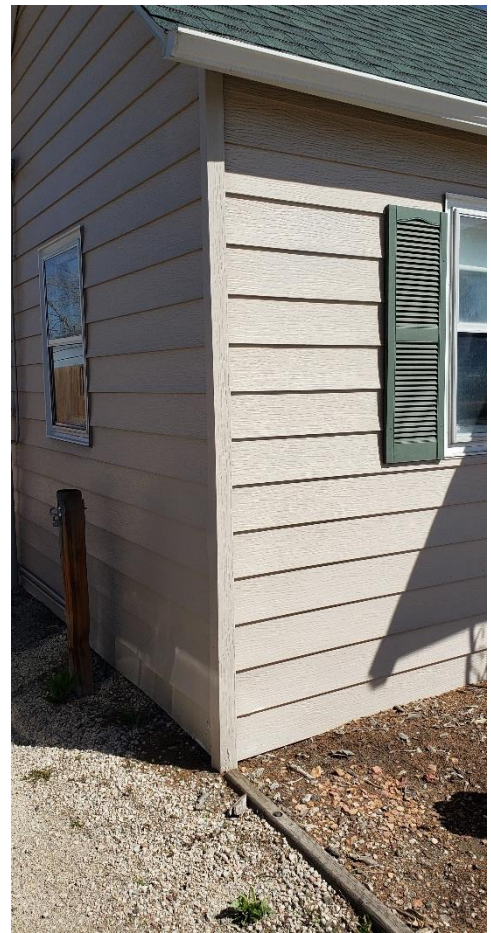
*Southwest corner of the house where the siding meets grade.*

4. All areas where grade slopes towards the house, if any, should be regraded to direct water away from the house foundation.

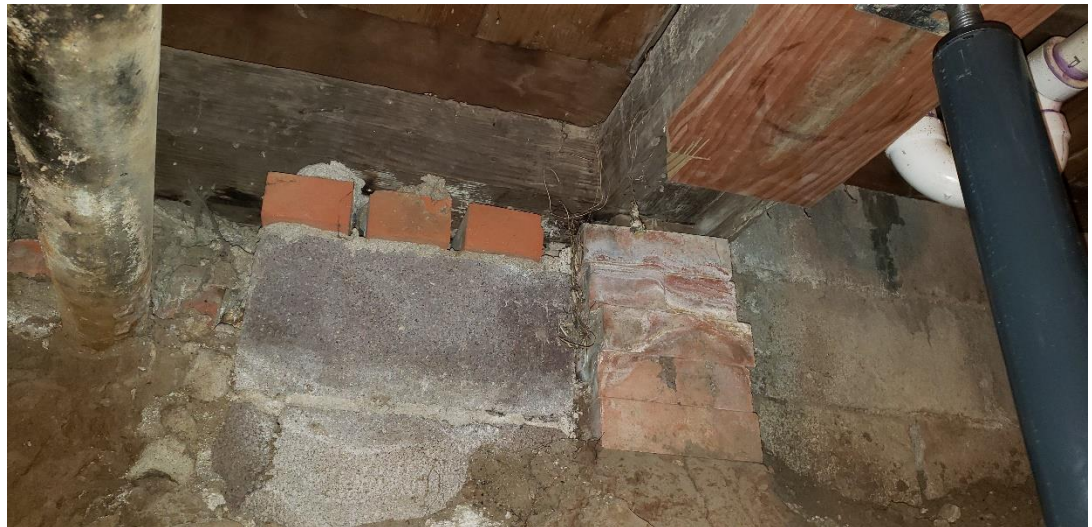
It could not be determined what type of footings support the foundation walls, if any. The floor in the crawlspace is exposed dirt with concrete slabs poured only for the furnace and water heater.

*Some brick is used in various location of the foundation wall.*

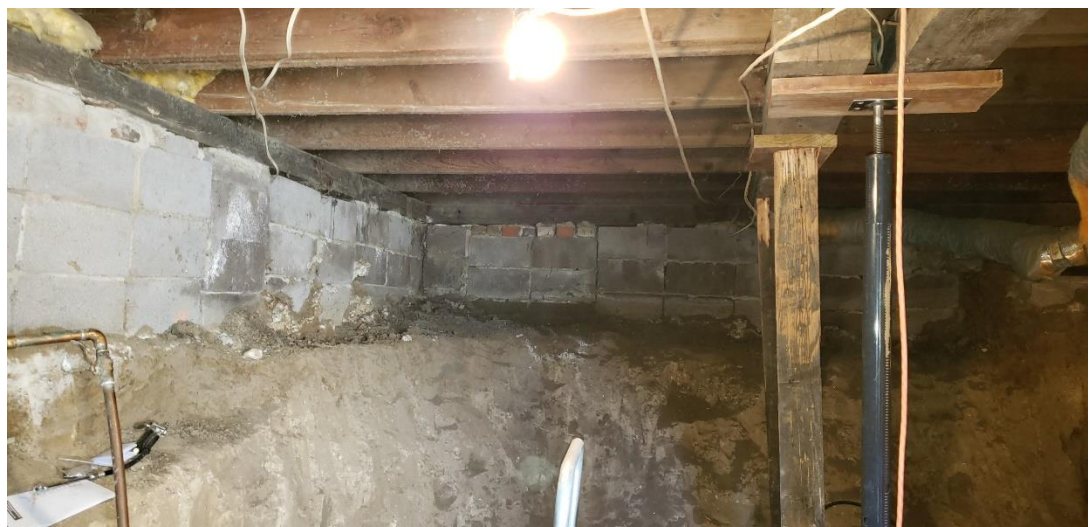
*CMU foundation with various bonds, seams, grout, and heights. The excavation is unsupported.*

6. New footings are likely needed to support the point and distributed loads from the roof and floor framing as specified in the recommendations above. New foundation support below new beam and posts supporting the floor and roof framing should be coordinated with a licensed structural engineer.

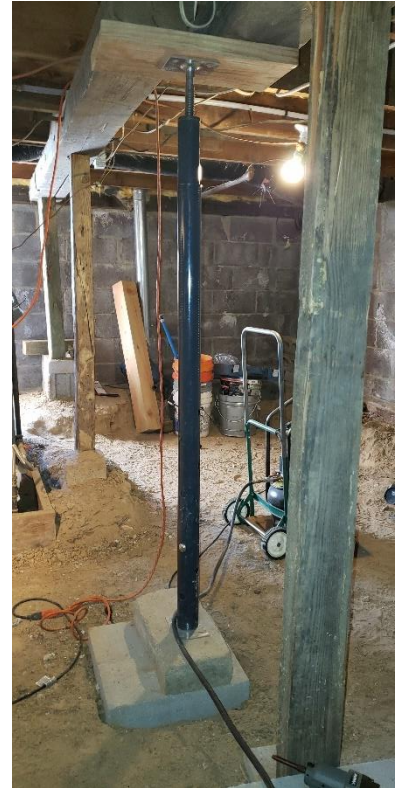
*Beam & columns supporting the floor joists.*

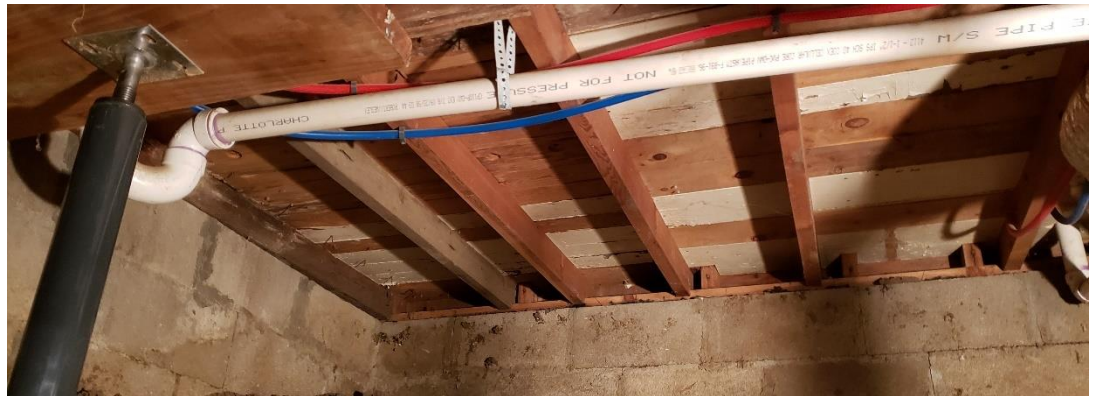
The floor sheathing appears to be in fair condition. The sheathing appears to be performing adequately, but there are several areas on the main floor that are bulging and may need additional exploration. The floor sheathing does meet minimum IRC code requirements for today's standards and appears to be performing adequately.

*Floor joists and sheathing of the northwest addition.*

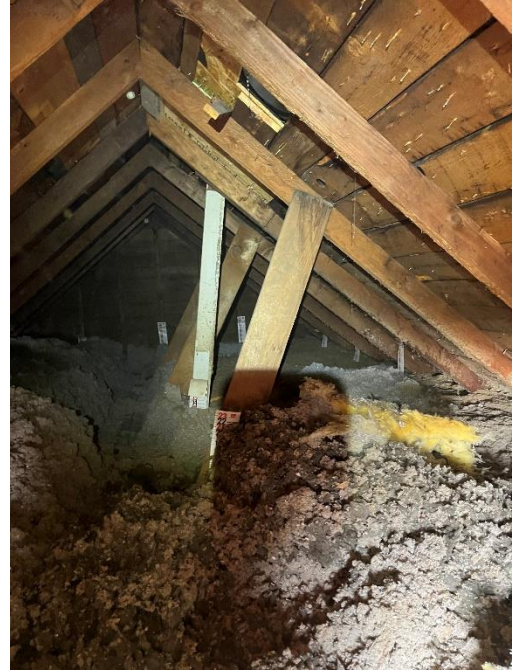
*Roof framing members of original gable roof.*

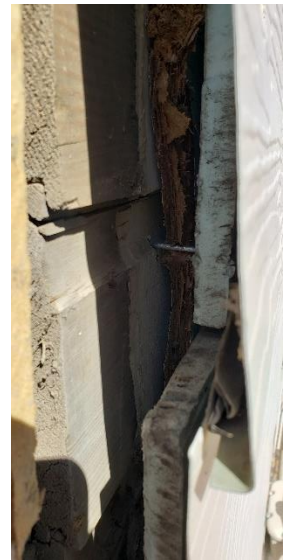
*Wood shiplap siding exposed in the southeast corner.*

1. Remove the steel siding, foam backer, and composite siding to expose the original wood siding.
2. Repair, refinish, or replace the original wood siding.

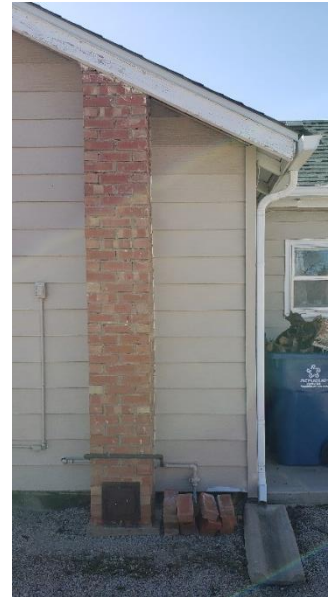
*Chimney on the north facing exterior wall.*

Consider adding a new false chimney centered on the original house gable. The location of this chimney can be determined by patchwork in the roof sheathing as seen in the attic.

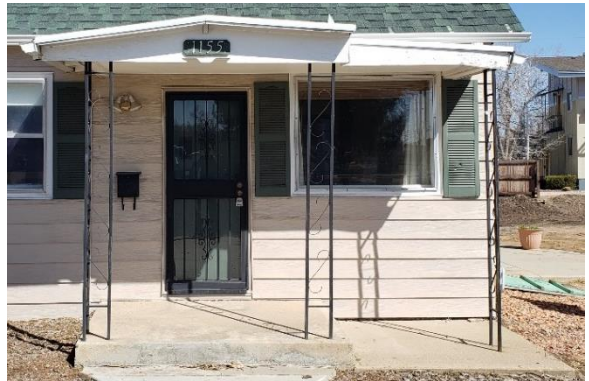
*Covered front porch.*

1. Remove the entire front porch roof and columns. The placement of the original front door covering should be visible with the exposure of the wood siding.
2. Consider moving the side awning to the original location if this is verified with the wood siding exposure. The side awning should be rehabilitated to match the original appearance by removing the trim and soffit. The structure of this awning should be assessed by a licensed structural engineer.

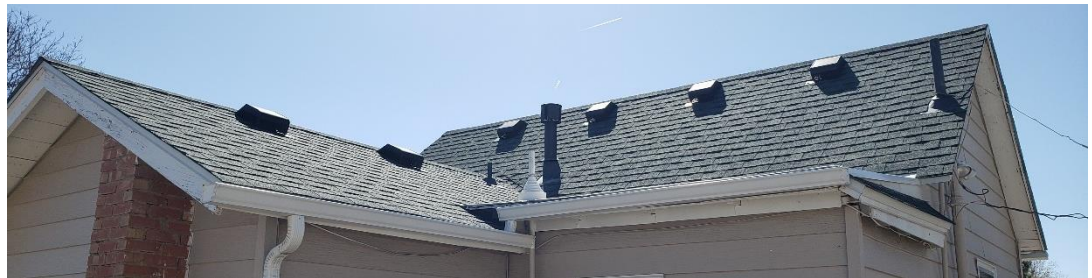
*Asphalt composition shingle roof and ridge vents.*

Consider replacing the roof with a fire-treated wood sawn shingle (cedar) to match the original roof.

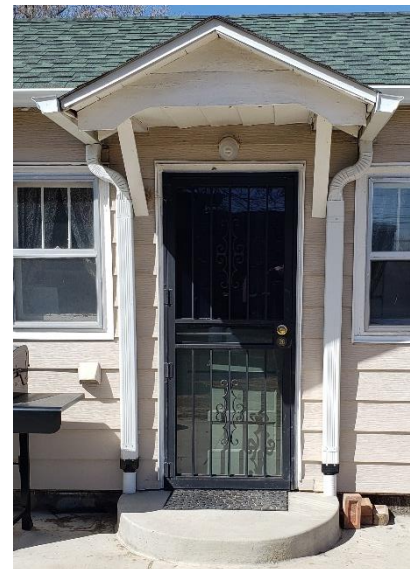
*Downspouts connected to buried pvc.*

1. Replace the missing downspouts on the covered front porch.
2. Determine the discharge location of the buried downspouts.
3. Ensure that all gutters, downspouts, and downspout extensions are maintained to discharge water away from the building foundation and are kept clear of debris.
4. The gutters and downspouts are not historic. Consider replacing the gutters with ½ round gutters and the downspouts with round downspouts. Though not historic, these styles will more appropriately match the historic nature of the house.

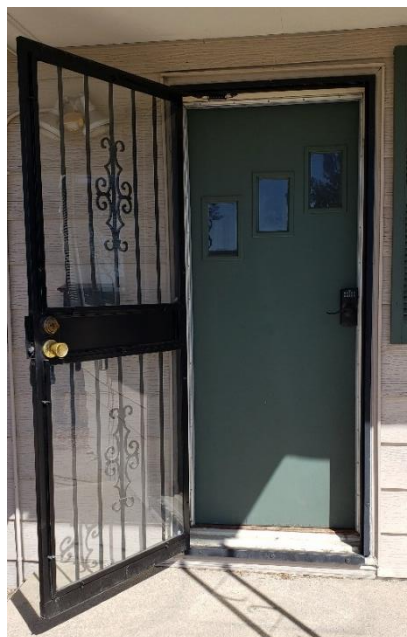
*Front door and storm door.*

1. Remove the aluminum storm doors from both doors. These doors are in well covered areas that do not need storm doors for weather protection. If screen doors are desired, a minimally framed screen door could be added.
2. Remove the front entry wood door. Replace this door with a new wood door that matches the 1948 Boulder County Assessor's card image.

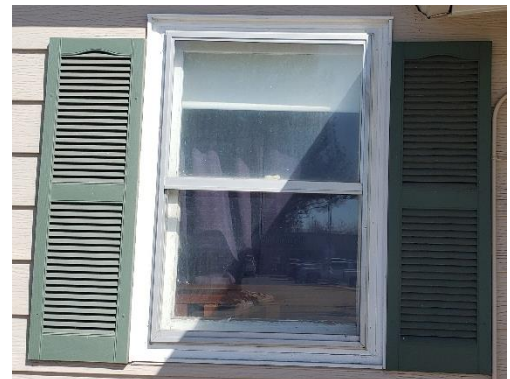
Window operability was not tested, though some windows were open during the site visit. It appears that some, if not most of the windows are operable, even if only partially so. According to building records, the aluminum storm windows may have been added in 1978 as part of the urban renewal plan for the house.

*South facing single-hung wood window and vinyl shutters.*

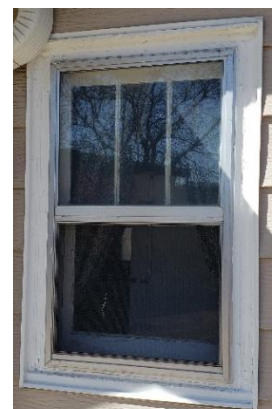
*Typical single-hung wood window on north addition.*

1. Remove the aluminum storm windows from all windows. Consider replacing with new wood storm windows of minimal visual impact. These windows should be removable, with an option for bug screens installed in their place during the warmer months.
2. Determine the original window opening sizes and locations when the framing or original siding is revealed with the removal of the steel and composite siding.
3. Windows should be replaced with new window units that match the appearance of those in the historic photo from 1948. Typical tall and narrow, single-hung windows can be found on several houses in the Louisville area built at a similar time.

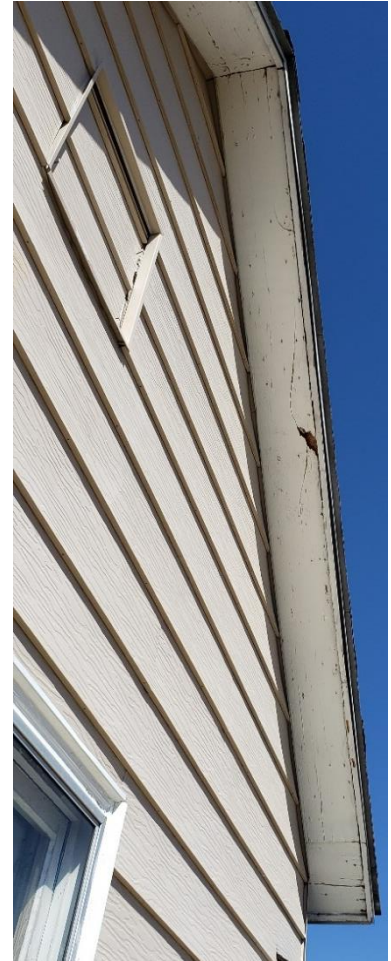
*Soffit and fascia on the original house.*

1. Remove the steel trim with the steel siding exposing the original window, door, and corner trim sizes below. Add new trim according to the determined sizes.

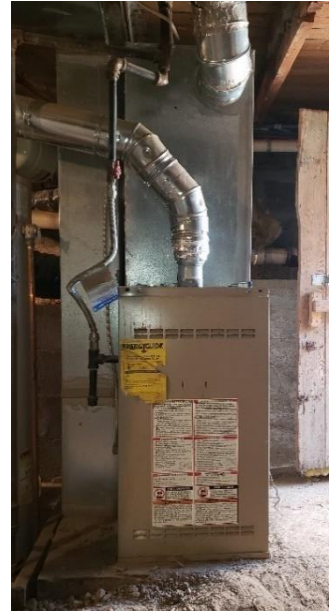
*Gas furnace located in the crawlspace.*

1. The furnace should be replaced with a high-efficiency unit with a sealed combustion intake/exhaust system. Once replaced, the existing supply and return lines should be evaluated for any leaks.
2. Consider adding an air-condition unit that supplies the entire house as the house is likely poorly insulated.

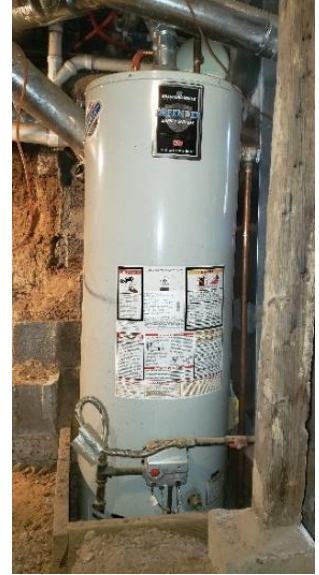
*Gas water heater located in the crawlspace.*

Consider replacing the water heater with a high-efficiency unit with a sealed combustion intake/exhaust system.

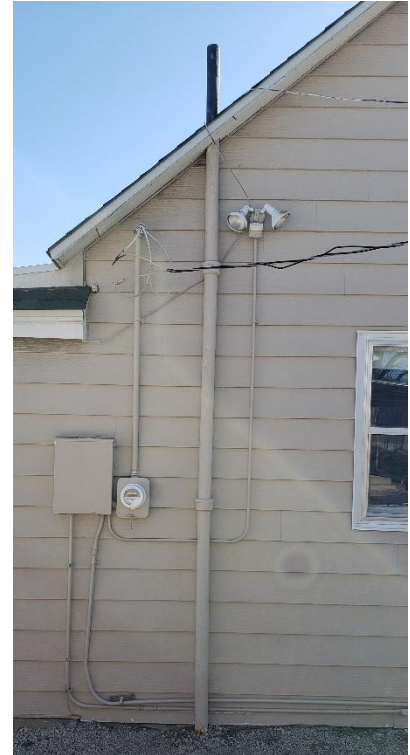
*Overhead electrical service, panel, and meter.*

1. The electrical service panel should be replaced by a licensed electrical engineer with a new 200-amp panel compliant with current codes.
2. The overhead electrical service should be replaced by a licensed electrical engineer with a new underground electrical line compliant with current codes.

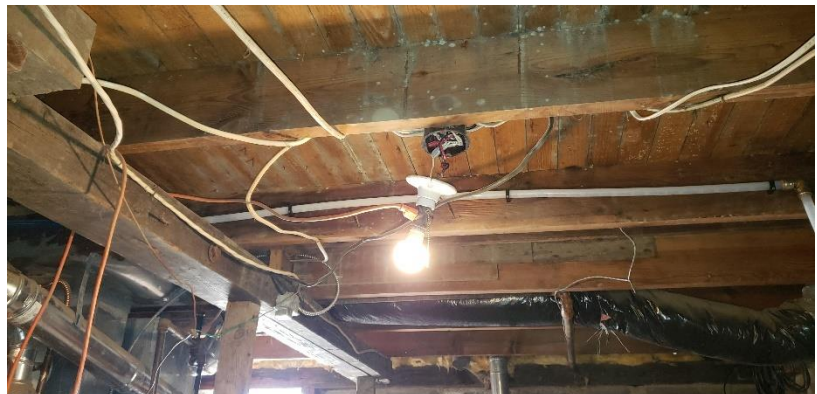
*Romex wiring is seen throughout the crawlspace.*

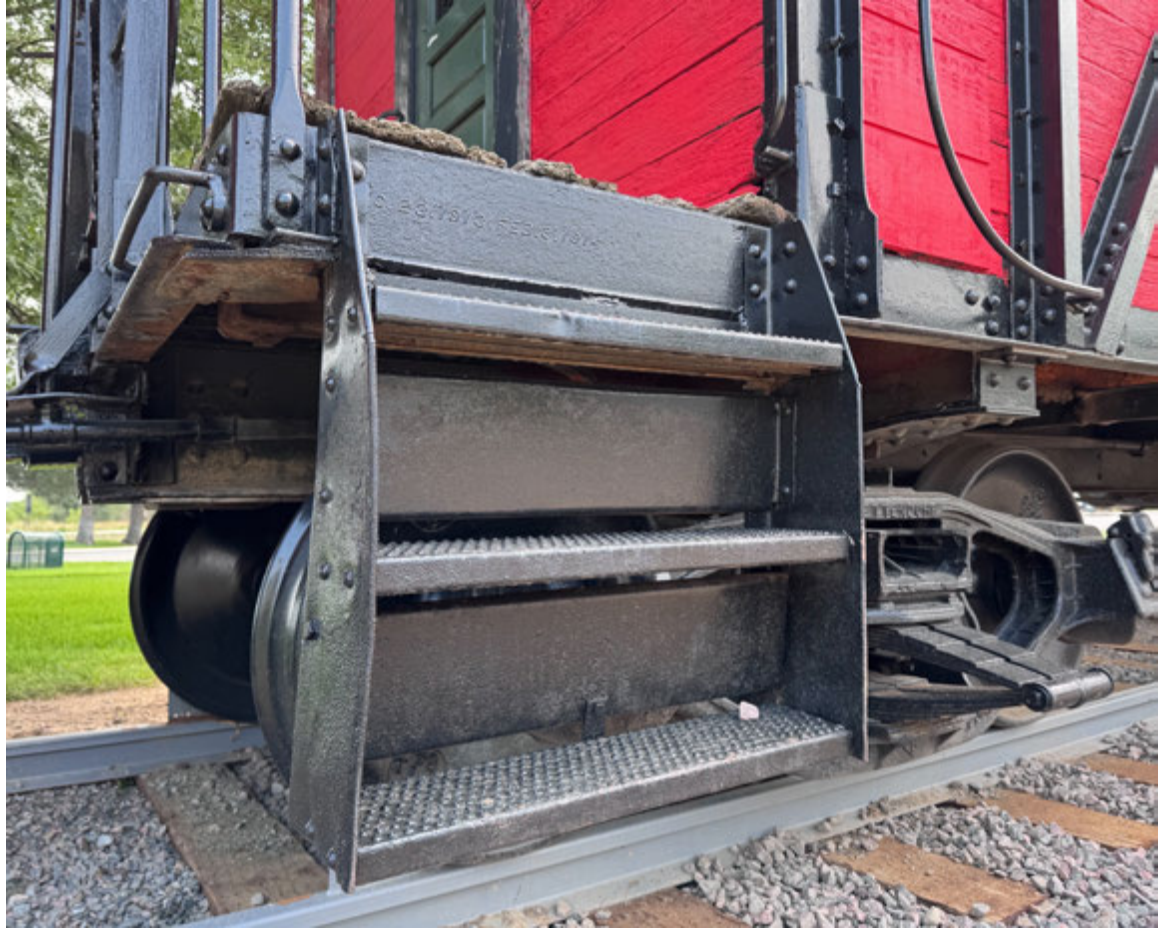
*(The one remaining step ladder on The Louisville Caboose)*

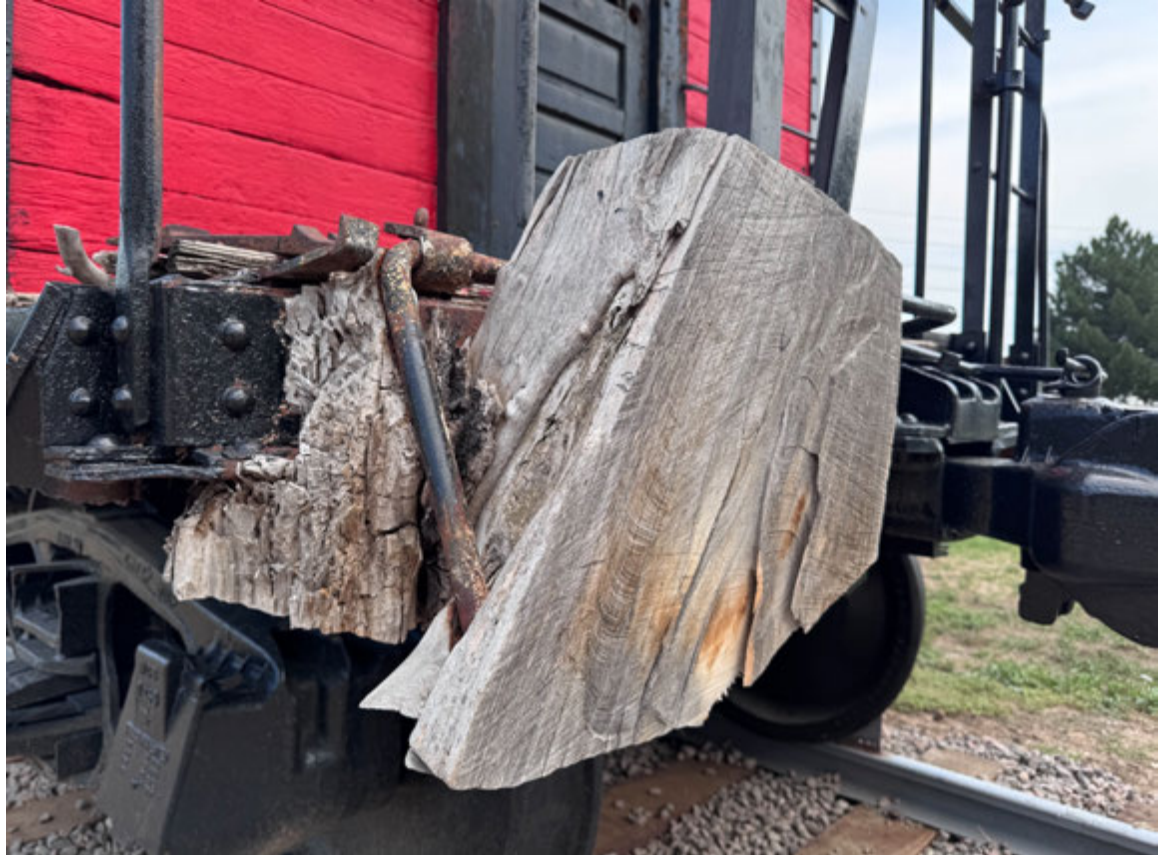
*(Platform on South side of The Louisville Caboose showing the remnants of the trunk of a tree that had grown around the corner of the caboose while it was at Main St. & South Boulder Rd. location)*
