**ITEM:** 1016 Main Street Landmark Request

**REQUEST:** A request to Landmark 1016 Main Street

DAJ Design conducted an Historic Structural Assessment for the structure located at 1016 Main Avenue, Louisville, Colorado to determine its feasibility as a candidate for historic landmark designation as defined under the Historic Preservation program of the City of Louisville. The structure is a residential property. The City of Louisville Historic Preservation Commission found probable cause that the building may be eligible for landmarking under criteria in section 15.36.050 of the Louisville Municipal Code. Therefore, the Commission approved the Historic Structural Assessment to be paid for by the Louisville Preservation Fund grant.

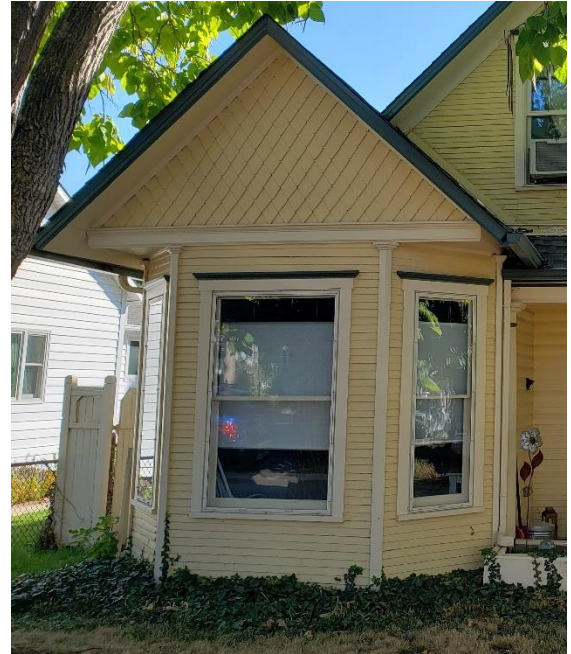
Overall, the landscape features are in fair condition. The trees and large plants appear to be healthy and well maintained. The vines appear to have been trimmed away from the house roof but there are some around the northwest part of the house that are grown around the foundation and partially up the face of the house. There are some larger shrubs throughout the property that are overgrown but do not pose a risk to any of the structures. Furthermore, some of the hardscape walking surfaces throughout the site may pose tripping hazards as they are not level throughout but again, they do not pose any danger to the buildings.

*Ground covers growing on the house and the foundation.*

1. Work with a licensed arborist to maintain the mature trees and shrubs. Ensure that growth does not interfere with the house roof, siding, or foundation.
2. Keep overgrowth trimmed away from the house and overhead electrical lines and remove any overhead branches. The ground covers should be trimmed away from the house foundation and should not be allowed to grow up the house walls.
3. Consider replacing the hardscape walking surfaces throughout the rear and side yards with new surfaces that are level.

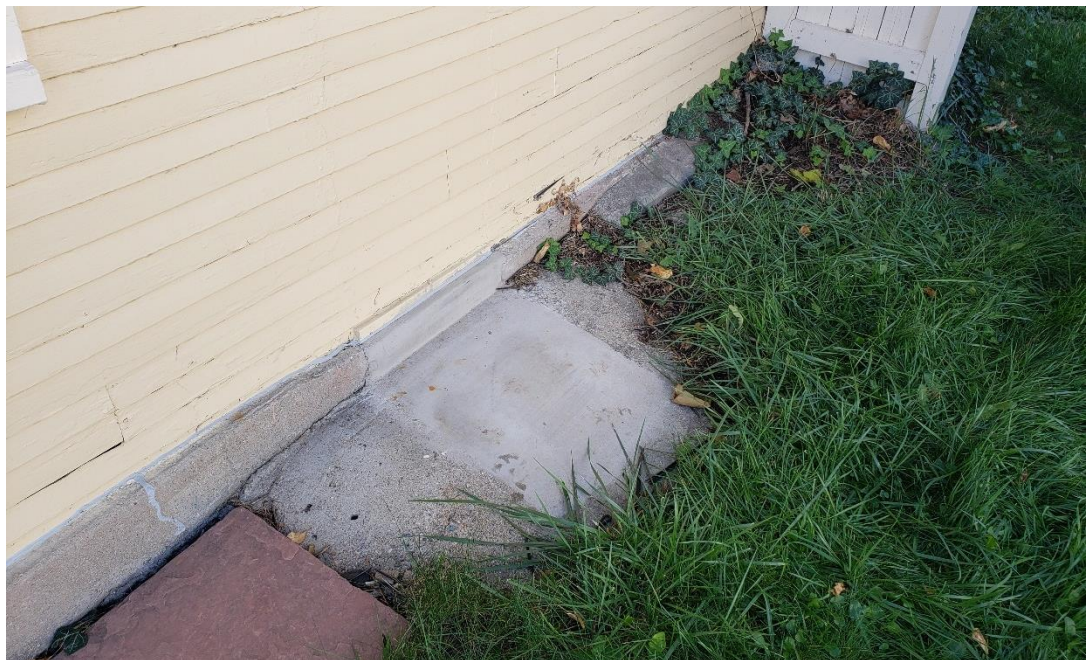
The overall site grading is in poor condition. It is important that the grading around the house should be a minimum of 6 inches below the top of the foundation and slope away from the foundation for at least the first 5 feet. Due to the nature of the lot, it is difficult to meet these requirements without a large amount of regrading, especially on the west side of the property. Regrading would also be difficult along the north and south sides of the house as there is little room to direct water away from the house and not onto the neighboring property. Bringing the top of the foundation up to allow for regrading is an option that would also be consistent with the historic aspect of the house relative to finished grade.

*There is a slight downward grade slope to the east. The top of the foundation is minimally above grade at most locations. Also seen is the concrete foundation of an exterior chimney that was removed.*

1. Continue to monitor the drainage around the perimeter of the house. The perimeter should be observed after snow and significant rain events to assess for all areas of pooling water.

2. The top of the foundation relative to the top of grade should be determined around the entire perimeter of the house, especially at the west side of the house. If the top of the foundation is determined to be at or below the existing grade, new grading should occur to bring the grade down below the top of the foundation, as prescribed by a licensed structural engineer.

3. Finished grade around the house perimeter should be re-graded to create positive drainage away from the house. The top of finished grade should be a minimum of 6 inches below the top of the foundation and slope away from the foundation for at least the first 5 feet. Coordinate the slope with a licensed geotechnical engineer. This option may be difficult at the north, west, and south sides of the house as significant grading is necessary and there is little room to create new grading due to the proximity of the property lines.

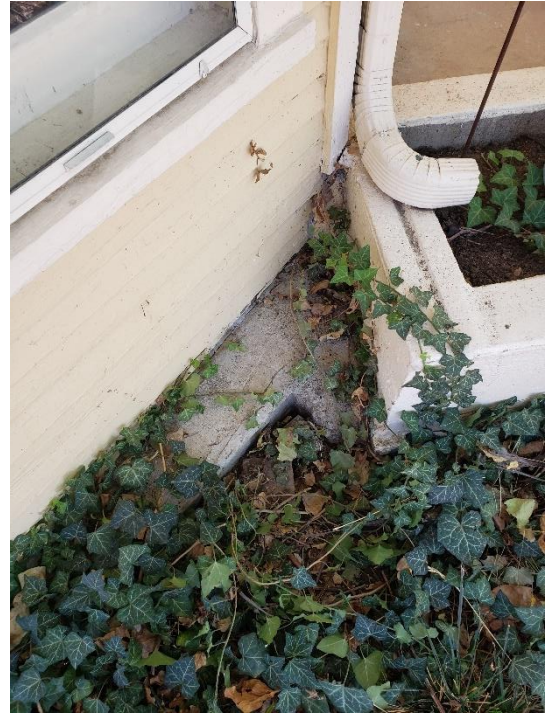
*The top of grade sits at or near the top of the foundation on the west side of the house.*

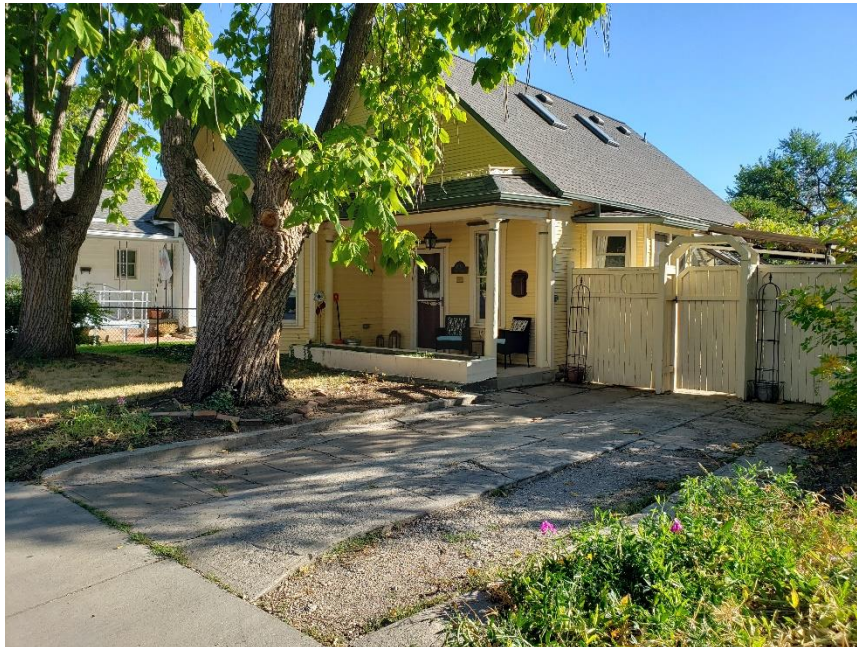
*Parking area in the southwest corner of the property.*

The uncovered concrete parking space in the southwest corner of the property is in poor condition. The concrete is well beyond the expected lifespan with numerous cracks. Additionally, it appears that some of the parking area may be on top of the coal room below and therefore not properly supported.

Similarly, the parking area on the west side of the house should be removed. On-site parking could be accommodated in this location with a new concrete slab or wheel tracks. However, no parking should occur above the coal room and the coal room should be further assessed prior to any above grade work.

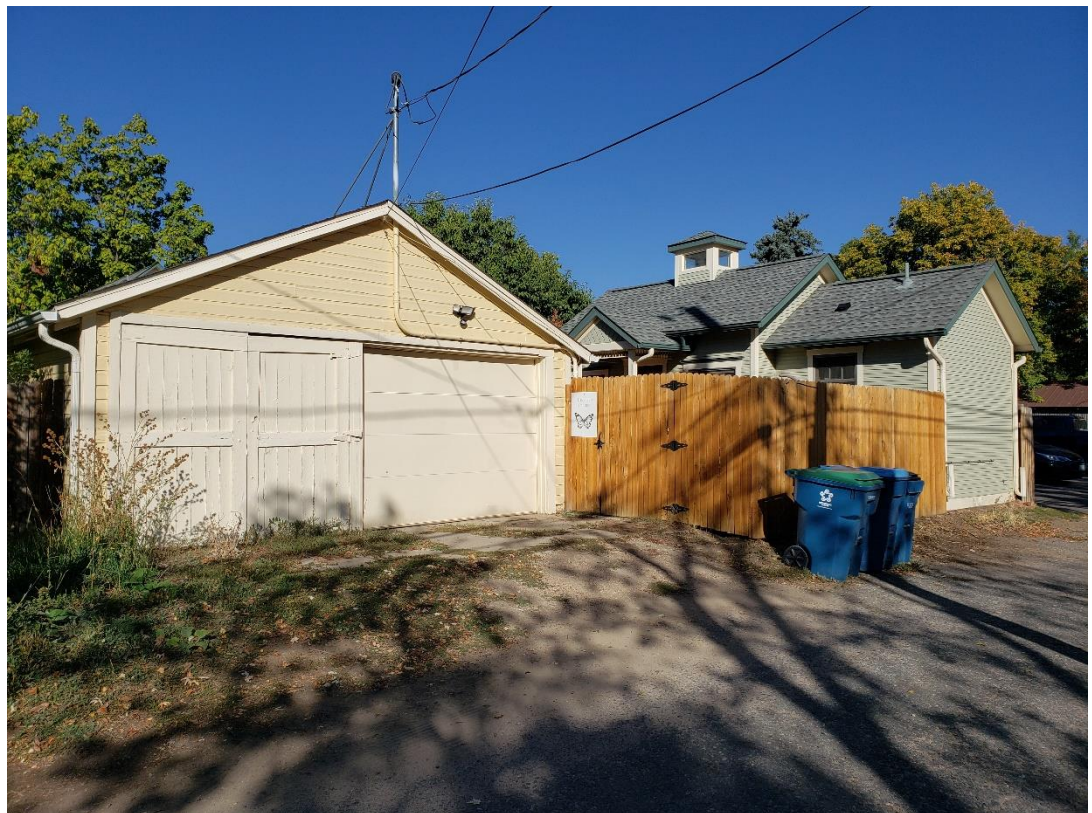
The entire garage is in poor condition. The framing does not meet the current code by today's standards. The roof appears to be sagging and unsupported and the walls are set into the concrete foundation with unsupported gable end walls above the top plate. The concrete foundation and concrete slab are in poor condition with numerous cracks, and it is unclear how deep the foundation is or how it is supported. Additionally, the person door and overhead door appear to work but the two swing doors facing the alley do not appear to be operable or create proper seals.

*Garage and studio viewed from the alley.*

The garage likely meets the age to qualify as a historic element of the site. However, the garage was not originally constructed in a manner to have a long-life expectancy and has subsequently been minimally maintained. The size and location of the overhead garage door only provides one on-site parking space, and the condition of the roof poses a safety concern. For these reasons, we recommend removing the garage or extensive structural repair to the existing framing should occur to meet current code standards.

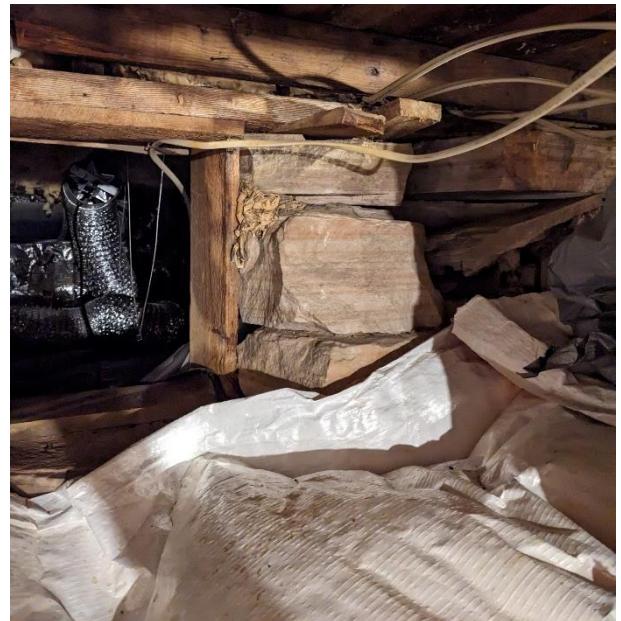
*The original stone foundation is only exposed in some areas inside the basement but is mostly covered with insulation.*

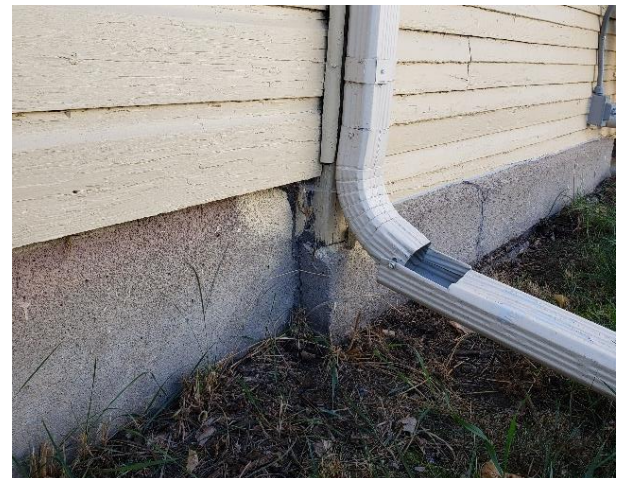
*A jog in the foundation shows the concrete face over the original stone foundation (right) relative the concrete foundation of the east addition (left).*

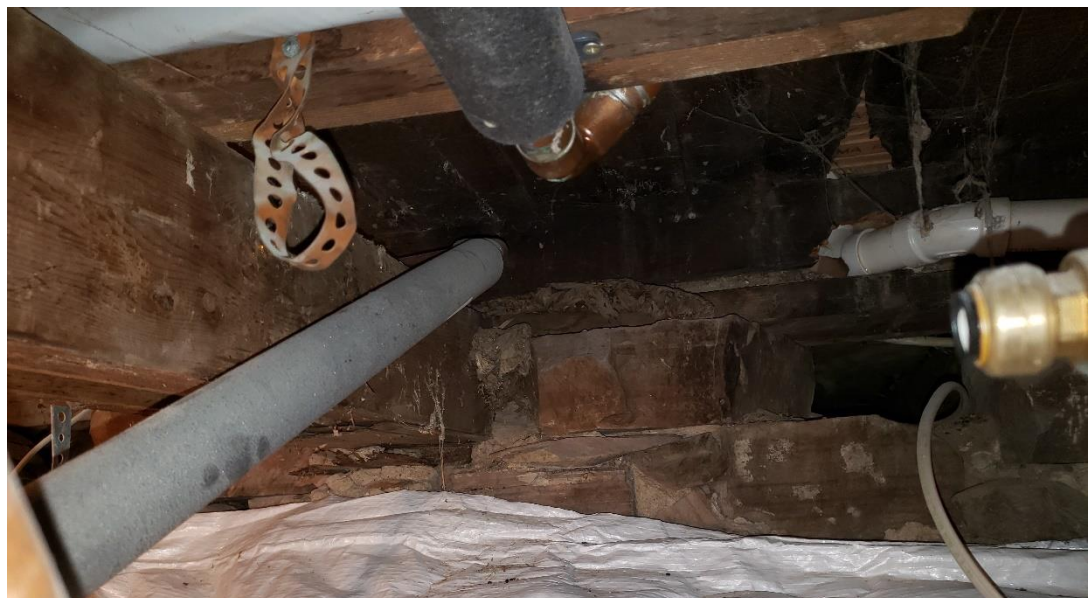
Overall, the various foundation elements appear to be in fair to poor condition, but our assessment is limited. The foundation walls extend below grade and the presence of any footings cannot be determined without destructive investigation; it is likely that a footing does not exist. It is also likely that the original foundation does not extend to a minimum frost depth of three feet below grade. There is a layer of concrete on the exterior face of the original stone foundation that is in fair condition, but this obscures visibility of the stone foundation to determine its condition. The concrete layer on top of the stone foundation does not provide adequate waterproofing of the foundation and appears to run minimally below grade. Some of the crawlspace areas at the east and west ends of the house have limited access and limited visibility to be able to determine the condition at all locations. Finally, there is a layer of vinyl drape insulation that obscures most of the foundation walls on the interior face. Where observed, the stone foundation requires tuck-pointing and it is presumed that this is true of the entire stone foundation.

*The foundation is minimally exposed as it is covered by insulation. The original foundation appears to be stone.*

1. The basement and crawlspace foundation walls showed various signs of damage that require further evaluation. No additional load should be added to the existing foundation system without a full analysis of the current foundation walls/footings. Additional strengthening of existing crawlspace walls may be needed as determined by a licensed structural engineer to meet current code specifications.

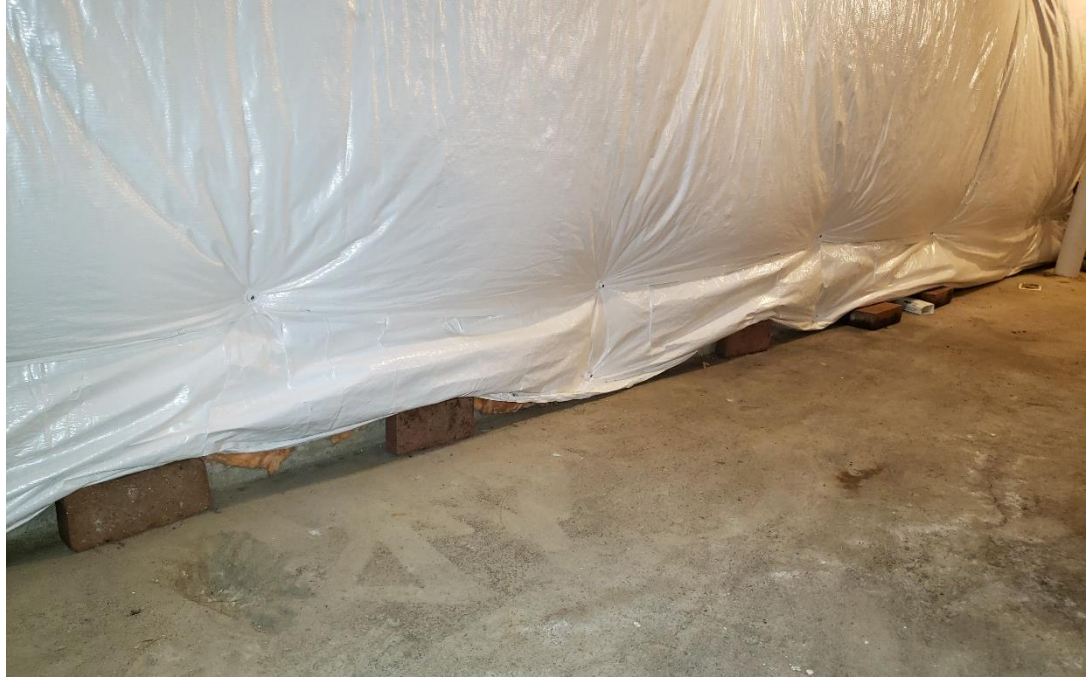
*The concrete retaining walls are minimally exposed as they are covered by insulation.*

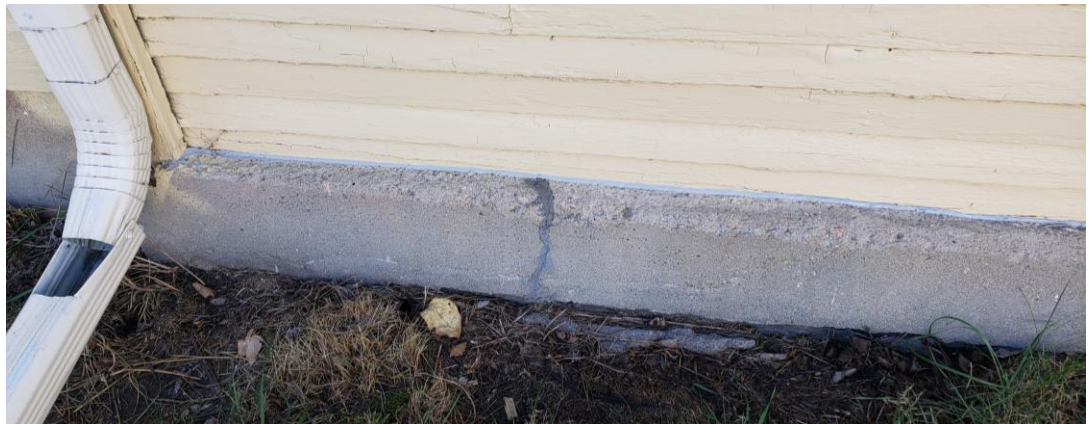
*The concrete face over the stone foundation is cracked and does not extend below grade in most areas.*

3. The concrete on the exterior face of the stone foundation showed various signs of cracking. Further investigation is required to determine if the cracking is related to foundation movement in the stone foundation or if the cracking is caused by improper application of the concrete face.

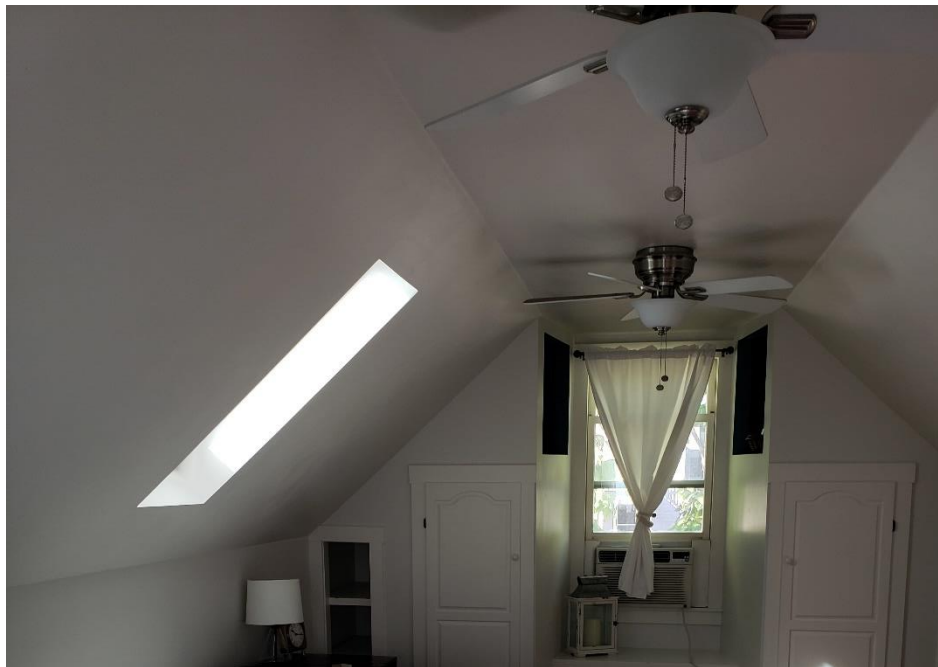
*The roof pitch, flat roof, and skylight depth indicate what the roof structure might be.*

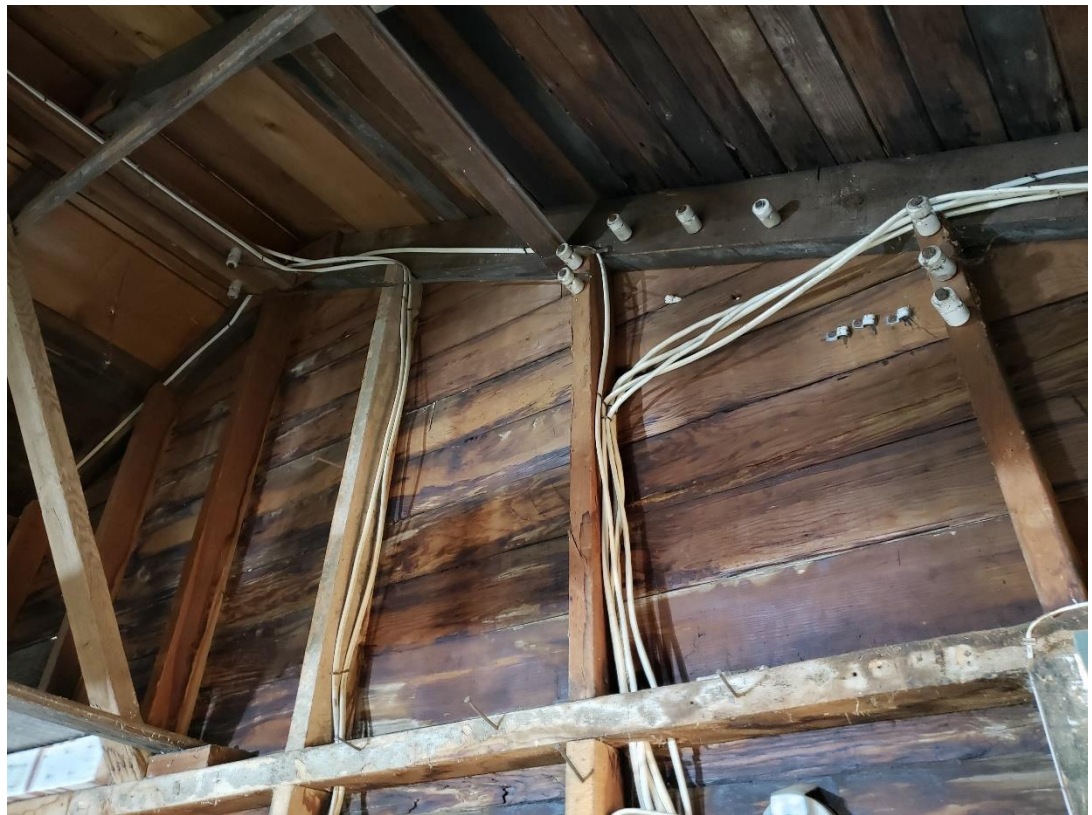
*Romex wiring next to abandoned knob-and-tube wiring in the garage.*
