**ITEM:** 728 Grant Avenue Landmark, Alteration Certificate, & Grant Request

**REQUEST:** A request to Landmark 728 Grant Avenue, and requests for an Alteration Certificate and Preservation and Restoration Grant

**728 GRANT AVENUE**  
**HISTORIC STRUCTURE ASSESSMENT**  
LOUISVILLE, CO

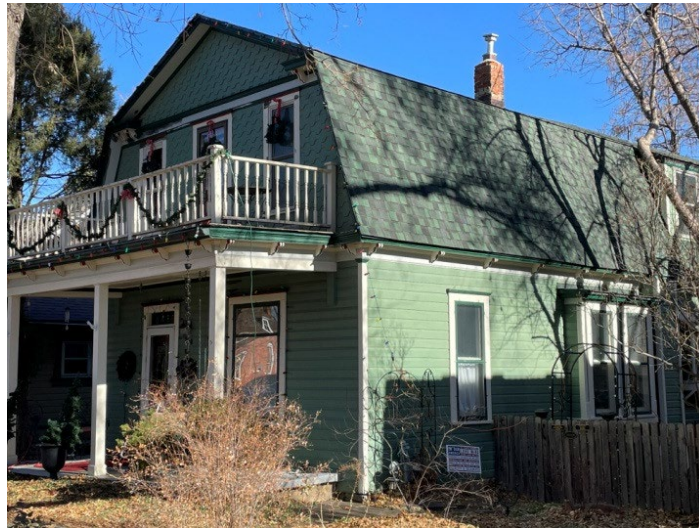
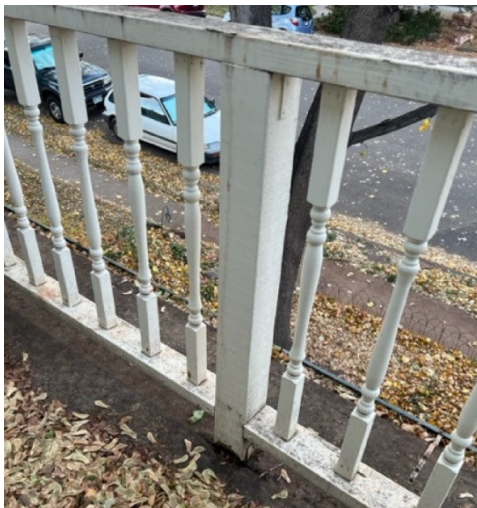
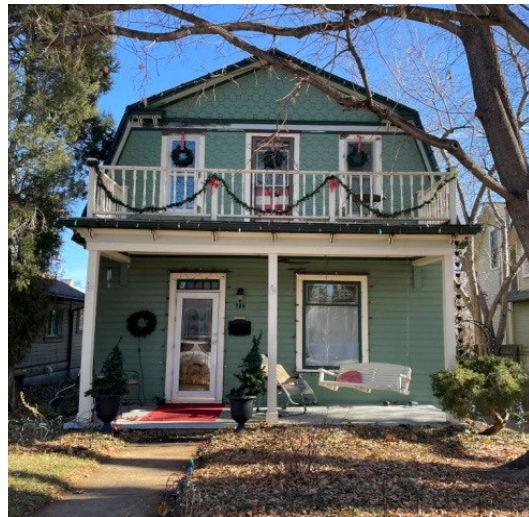
*The 2nd floor deck on the front of the house appeared to show plywood sub-floor with a water-proof membrane on top. The wood framed rail appeared to be made of modern mill-work parts and dimensional lumber....For the west facing covered deck, we suggest the removing and replacing of the subroof, roof waterproofing, deck walking surface, deck wood fascia, gutters, most or all of the railing pickets, and fasteners. Upon removal of the subroofing, a more complete evaluation of the condition of the joists and structural members may be determined...*

Photos of 728 Grant Ave from Historic Structure Assessment, 2023 showing condition.

| Criteria and Standards | Met? | Evaluation |
|---|---|---|
| 6. <i>The condition of existing improvements and whether they are a hazard to public health and safety.</i> | <b>Yes</b> | The existing conditions of the porch are very hazardous and is currently not structurally sound. |

- Demolish the entire front porch structure including concrete base;
- Rebuild balcony to match existing style, including new railing, decking and second floor structure;
- Remove and replace existing posts and covered porch;
- Install flashing to prevent moisture from front of house;
- Paint to match existing porch/balcony;
- Replace rotted trim around windows/front of house;
- Replace upper storm door to protect historic door; and
- Carpentry as required to properly seal upper door frame.

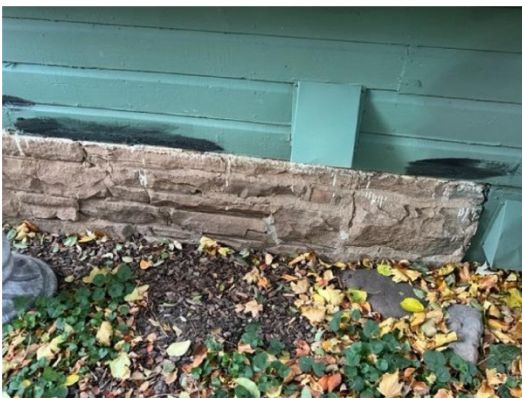
Figure 2: Exterior foundation with timber

The overall condition of the visible perimeter rubble stone foundation is good. Some cracks are visible and should be expected in construction of this type and age. The interior footings visible in the crawlspace are in poor condition due to the un-shored soil adjacent to their location, and inadequate sizing. This soil is sloughing away and may undermine these footings. Along the south and east sides of the cellar space is an older timber wall and a newer wall that appears to be pressure treated plywood and wood studs. These walls hold back the soil with the stone foundation wall just to the south or east of that. The bottom of this newer wood wall is sitting directly on grade and does not appear to be able to resist the lateral pressure of the sloughing soil. The grade around the house within 5 feet of the building is generally flat and sloping toward the front porch at the front of the house. It was conveyed by Ann Weise that before spray-foam was applied, daylight could be seen through multiple places in the stone foundation.

Ascent recommends a new foundation adjacent to the excavated cellar area be constructed of reinforced concrete and the area behind it backfilled to prevent the soil from sloughing off any further. The interior crawl-space framing and supports will be more readily accessible during this process and possible accessible for further evaluation and repair. New cast-in-place footings are recommended to be installed in concert with the framing recommendations below. Repair and repointing of the existing masonry will not reduce the possibility of future movement due to frost heave and expansive soils. Maintaining drainage away from the house is paramount to the foundation success. Some grading issues cause some water to pool against the house. This should be repaired to slope away from the house and gutter downspouts maintained to discharge away from the foundation. Additional tuckpointing of the stonework is also recommended.

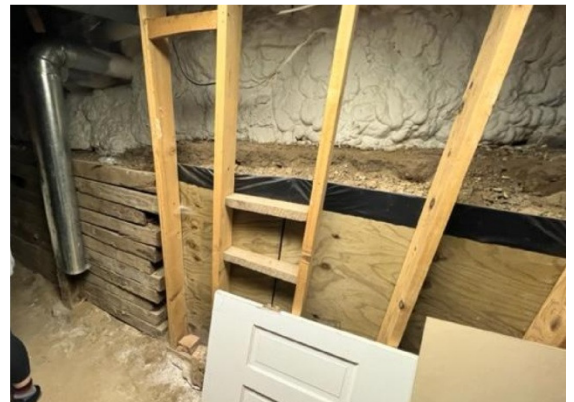
Figure 3: Interior of perimeter Foundation and wood cellar walls

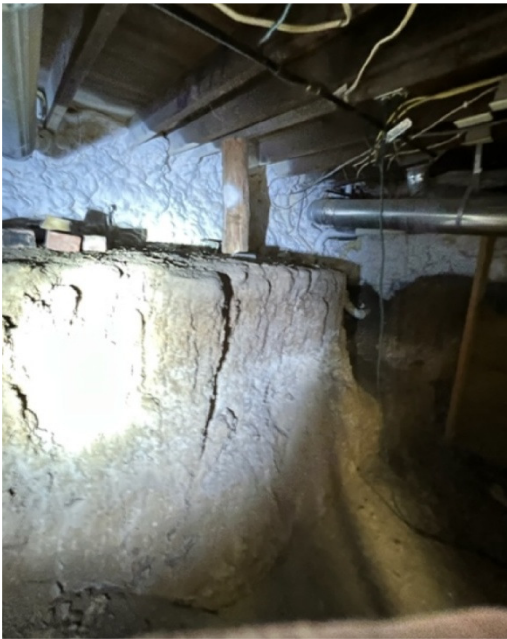
Figure 7: Precarious Beam Support

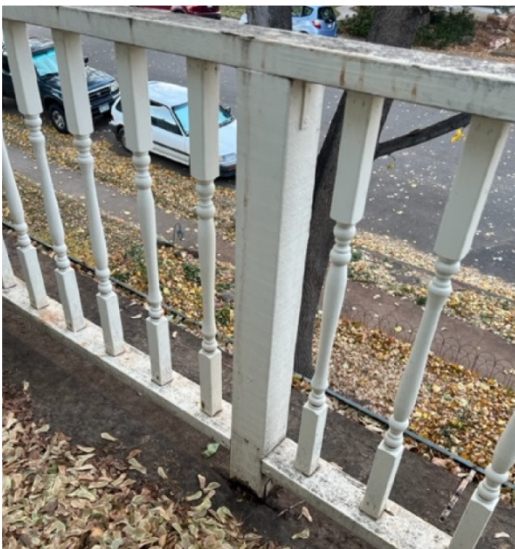
The primary floor framing that was visible consists of 2x6 nominal wood floor joists spaced at 16" centers generally spanning in the north/south direction with post and beam bearing lines at roughly 6 to 7 feet on center running perpendicular to the floor joists. The finished wood flooring is attached directly to the floor joists. There appears to be no sub-floor. The 2<sup>nd</sup> floor framing was not visible. The 2<sup>nd</sup> floor deck on the front of the house appeared to show plywood sub-floor with a water-proof membrane on top. The wood framed rail appeared to be made of modern mill-work parts and dimensional lumber.

Figure 4: 2<sup>nd</sup> Floor Deck Rail

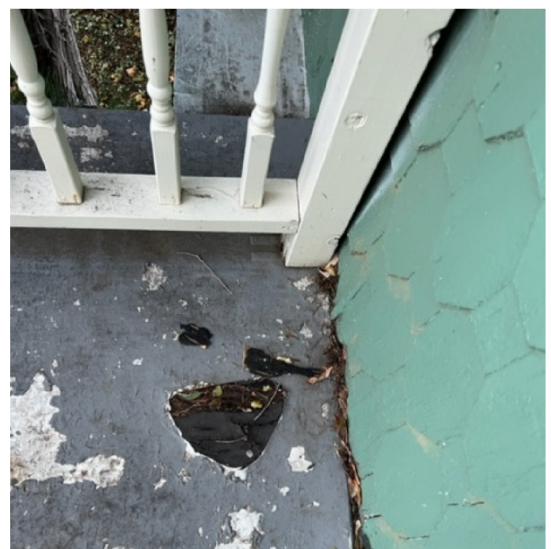
Figure 5: Deck Surface

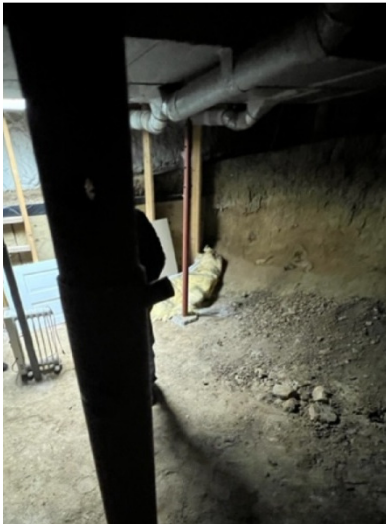
There appears to have been multiple improvements of the existing floor post and beam bearing lines within the basement at some point over the life of the building. The newer steel posts are not installed properly with the adjustable extension extended too far and in one case a steel adjustment pin not properly installed. The beams under the floor framing are not properly sized and this, combined with the footings, result in an un-even floor above. A floor system of this type would not be used under current codes. There are some areas in the home where floor movement can be felt and this translates into the 2<sup>nd</sup> floor as well. Some joists have been notched for plumbing or electrical lines. The 2<sup>nd</sup> floor deck framing and rails are in poor condition. Rot is evident at the base of certain rail posts and it appears that water can infiltrate the deck surface. The deck joists were not visible, but further rot in these areas is likely.

Figure 9: Improperly installed steel pin (Foreground)  
Over-extended post cap (Background)

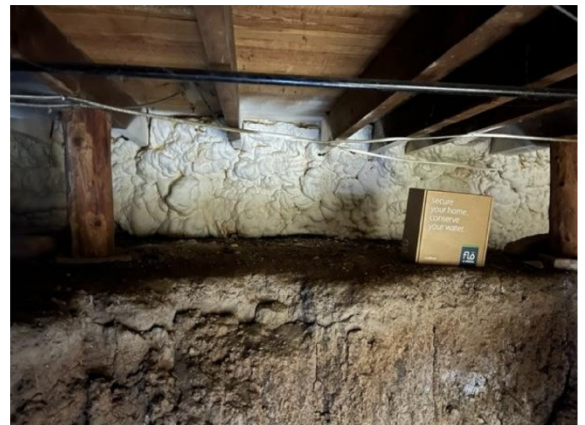
Figure 10: Logs under individual joists

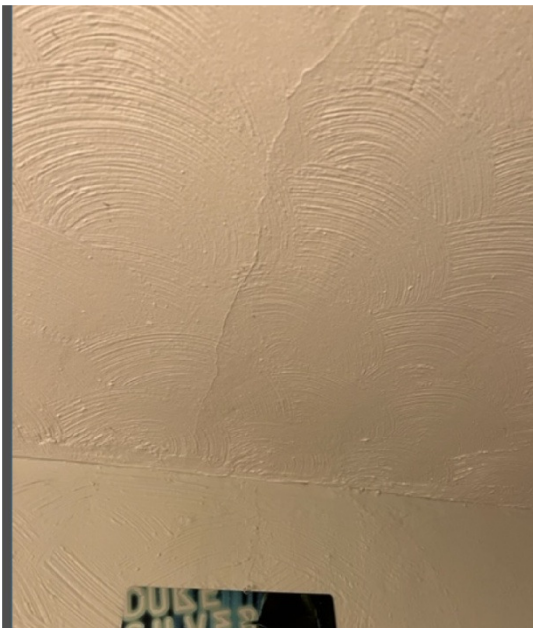
In the portions of the roof that were visible and accessible, no damage or excessive deflections were observed. Although there were some cracks in the plaster below, this is typical of a structure of this vintage. Future loading events such as snow loads and wind loads may result in some movement over the life of the structure. The ceiling finish appeared to be in good shape and no signs of excessive deflection were observed.

Figure 11: Painted over Ceiling Crack

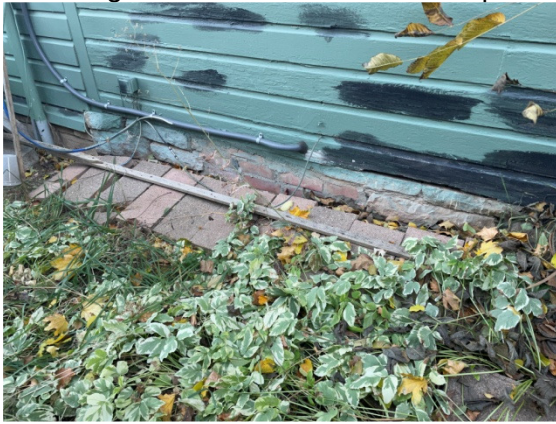
Image 1-3.3.2

While the building looks as if the painting has been done in the last five years, there are signs of peeling. Some wood siding and trim exhibit signs of rotting and damage (Image 1&2 3.3.2).

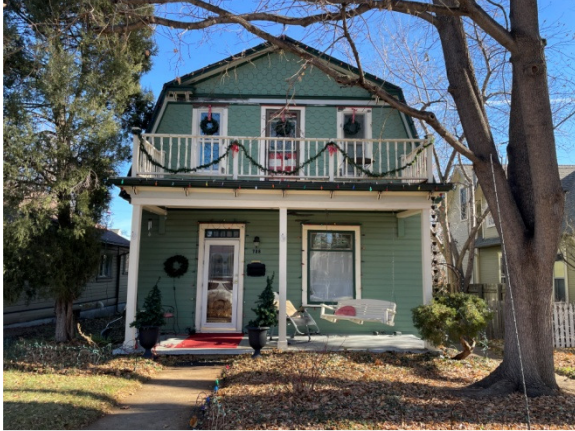
Image 1 – west deck - 3.3.4

Refer to 3.2.4 for structural repairs. For the west facing covered deck, we suggest the removing and replacing of the subroof, roof waterproofing, deck walking surface, deck wood fascia, gutters, most or all of the railing pickets, and fasteners. Upon removal of the subroofing, a more complete evaluation of the condition of the joists and structural members may be determined. The east deck and balcony above are of new construction and in good condition.
