## PRELIMINARY EVALUATION

## GEOLOGIC HAZARDS AND SLOPE STABILITY

COYOTE RUN OPEN SPACE LANDSLIDE  
BEHIND 583-597 W. SAGEBRUSH CT  
LOUISVILLE, CO

PROJECT NO. 0180-D15

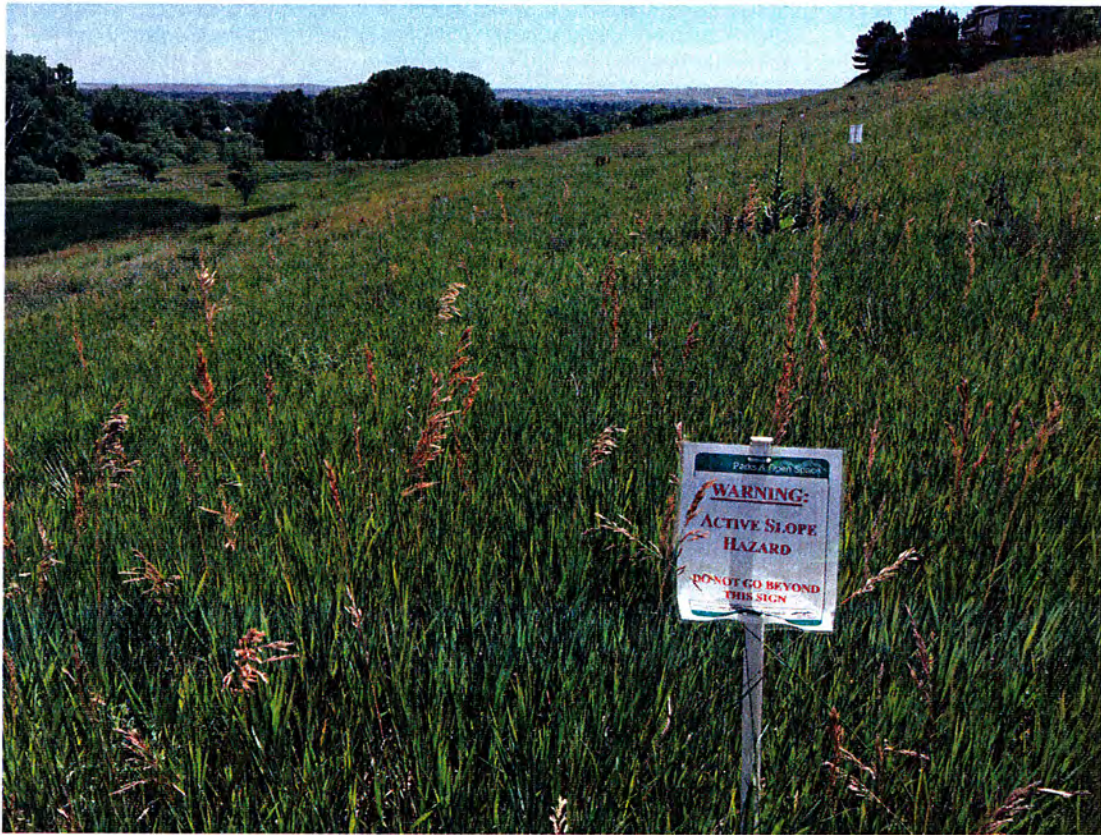
Site topography with evidence of landslide

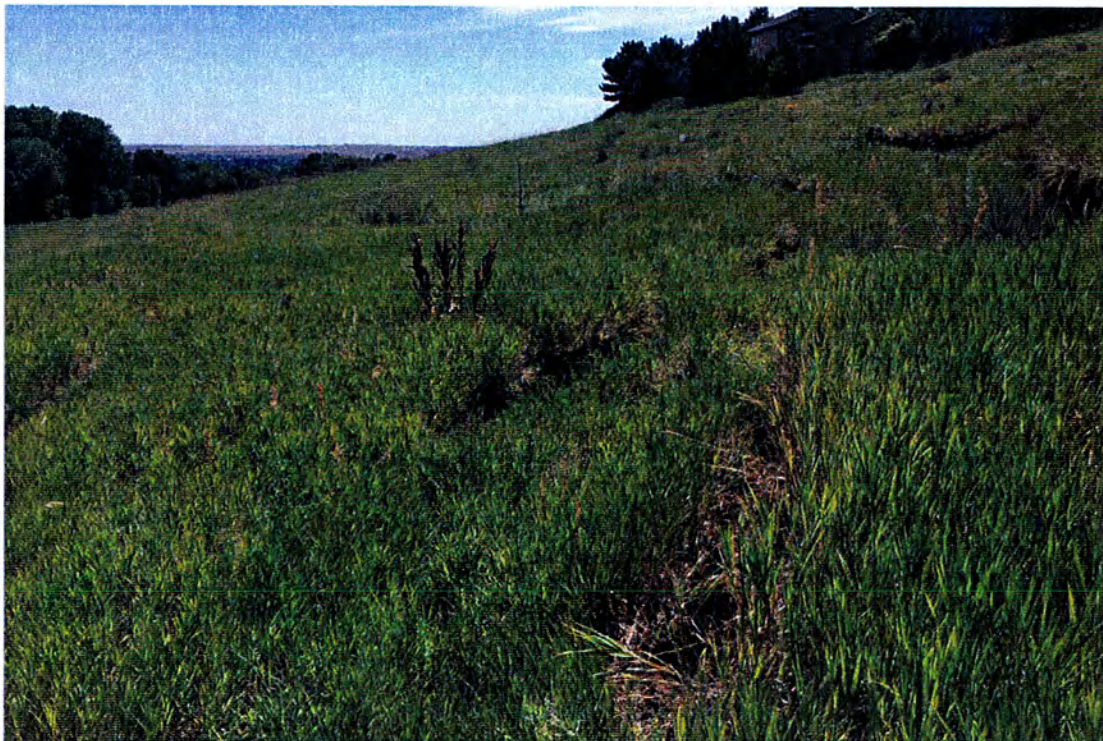
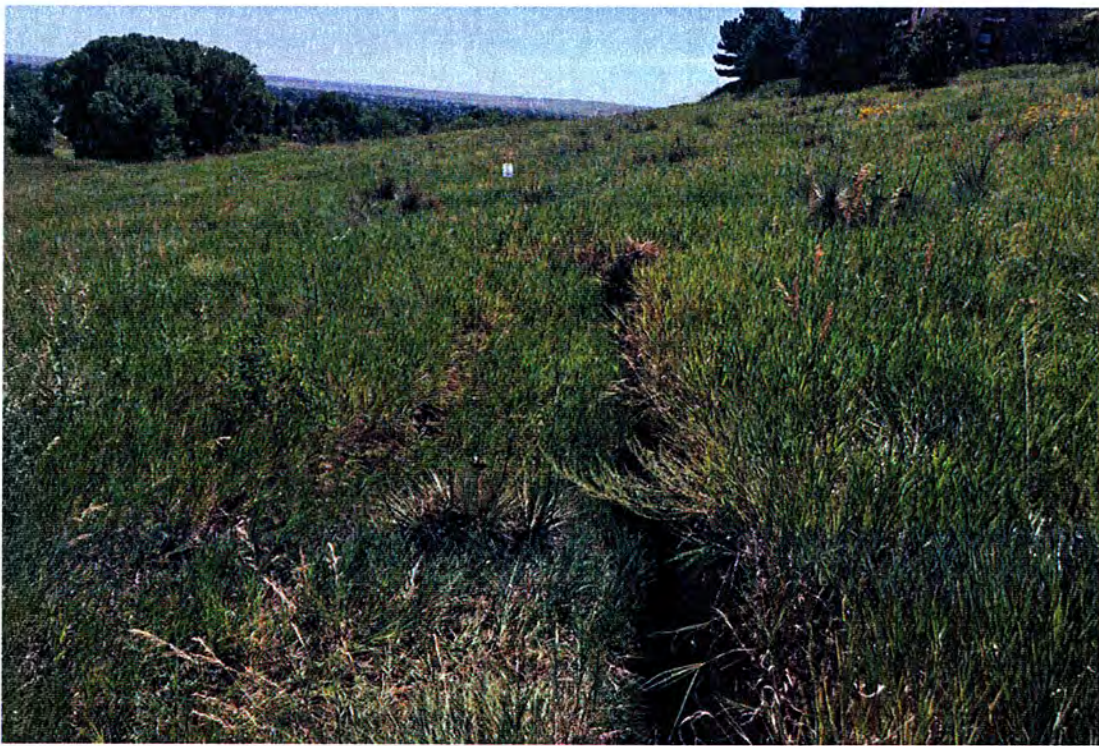
Tension cracks

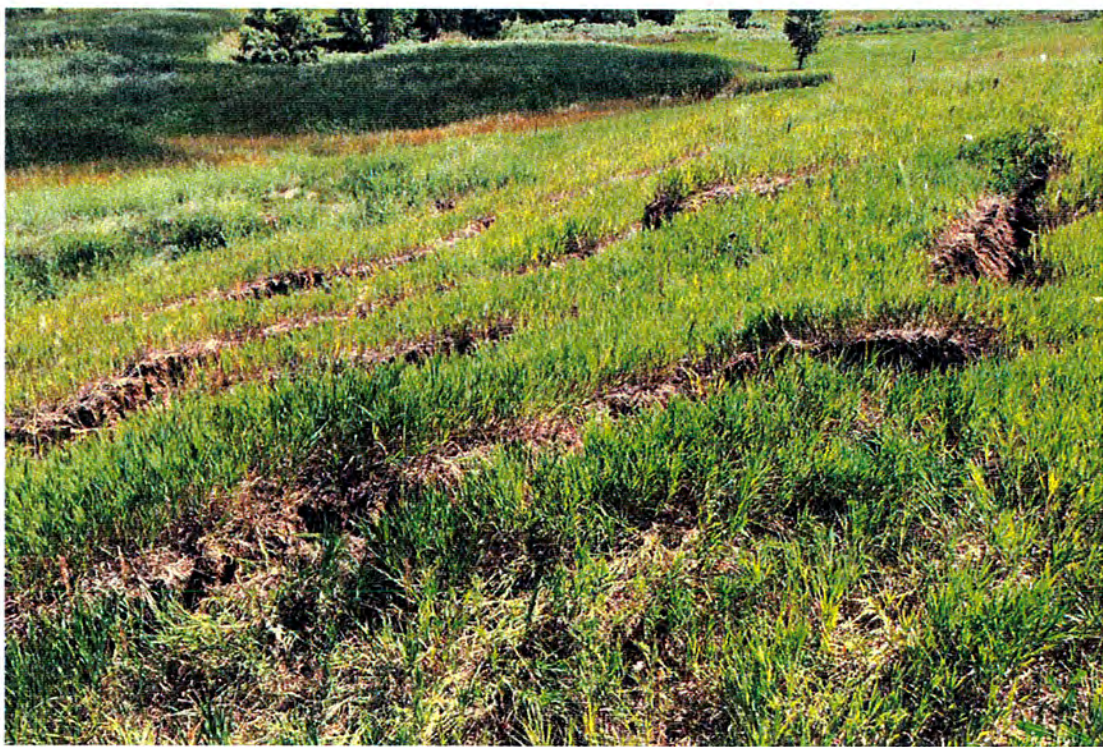
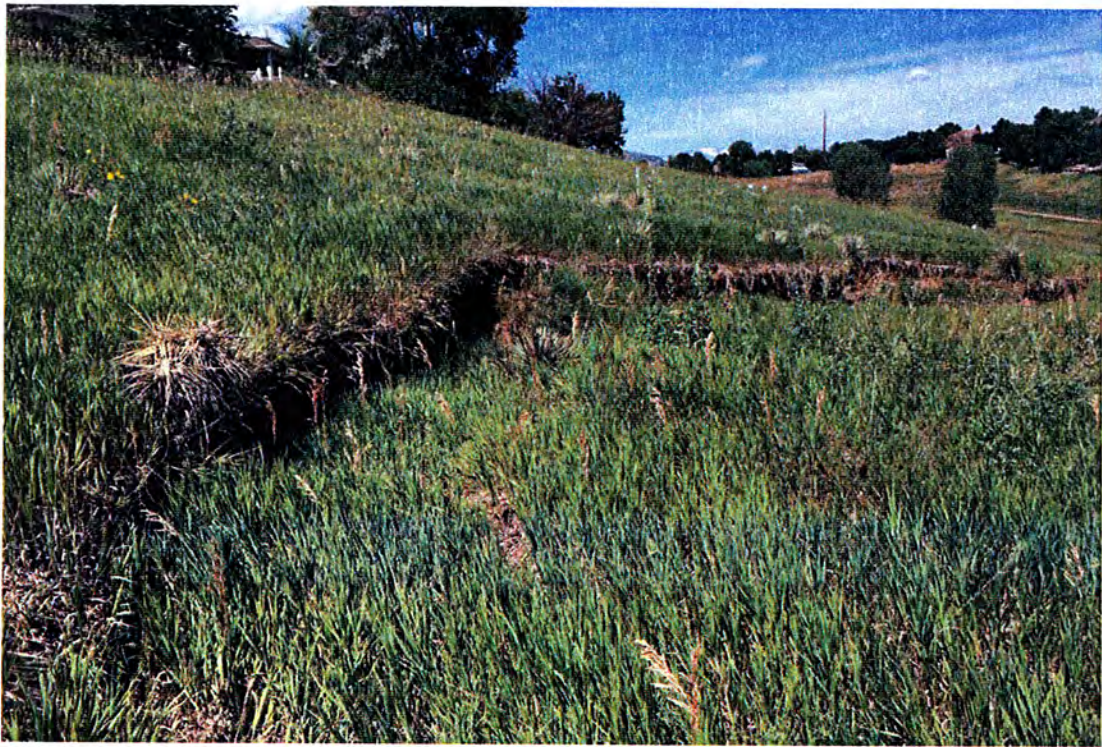
Headscarp

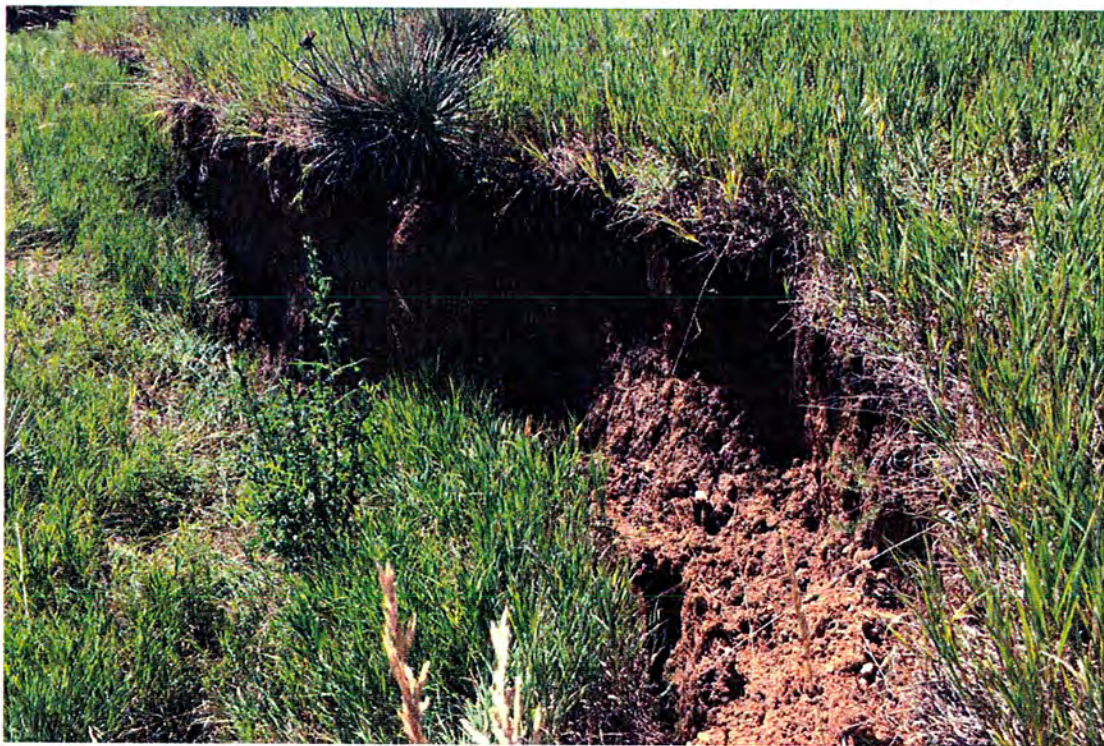
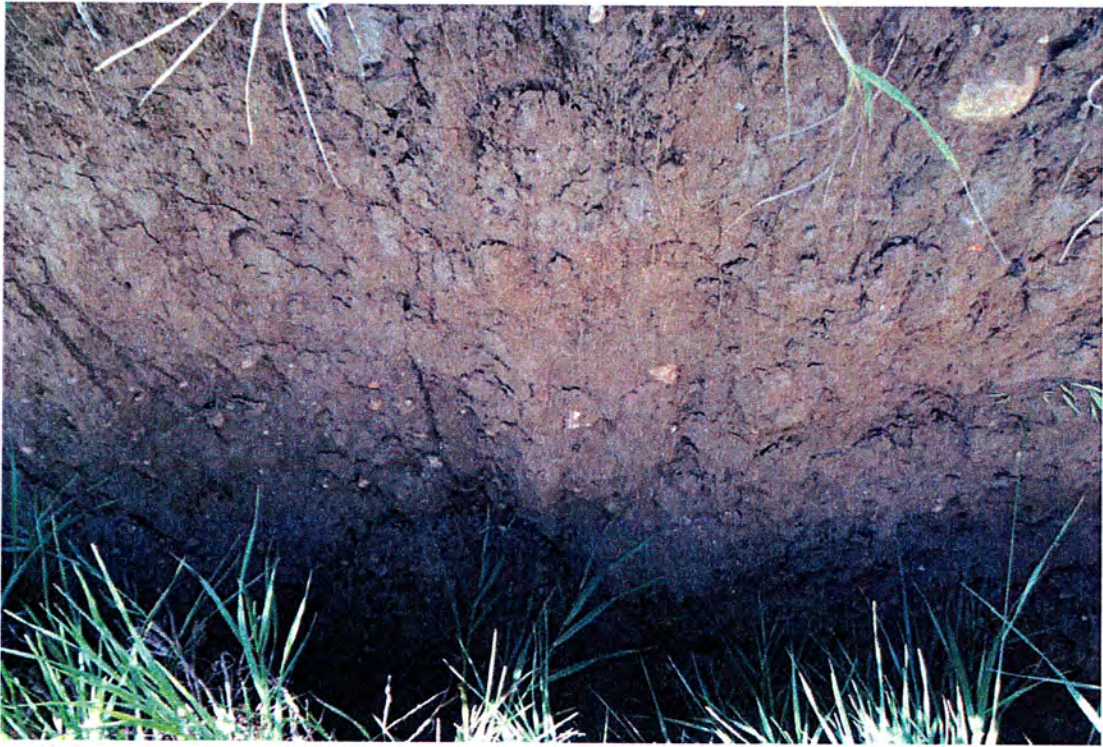
Headscarp closeup

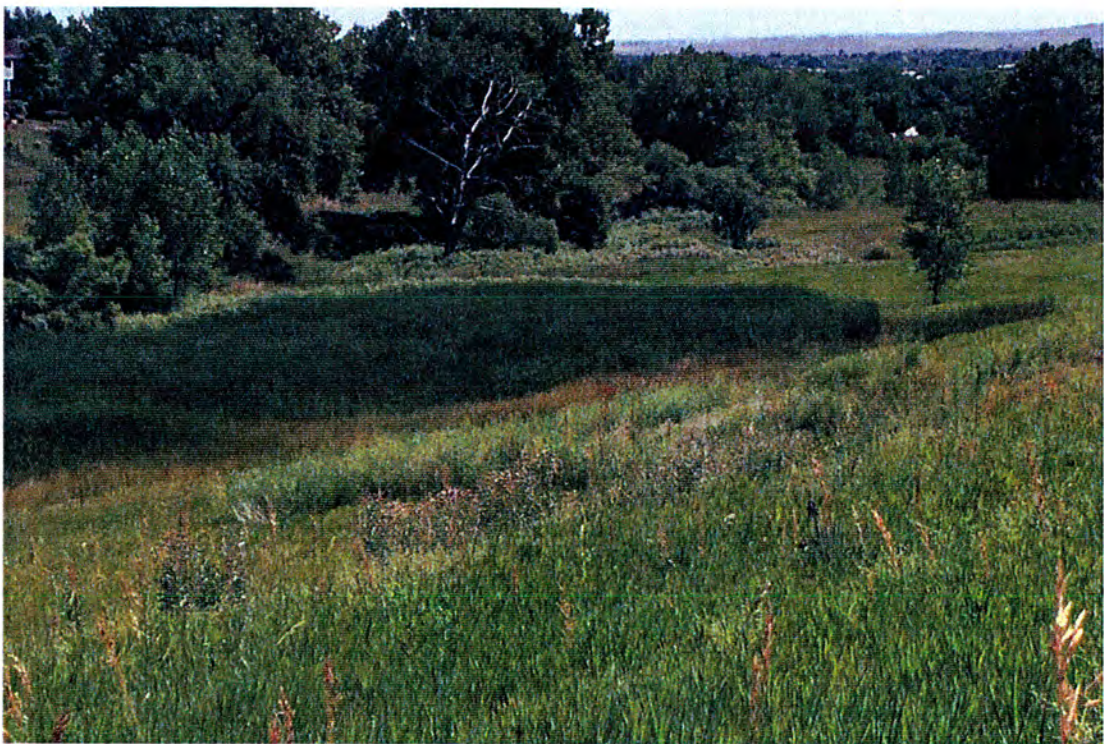
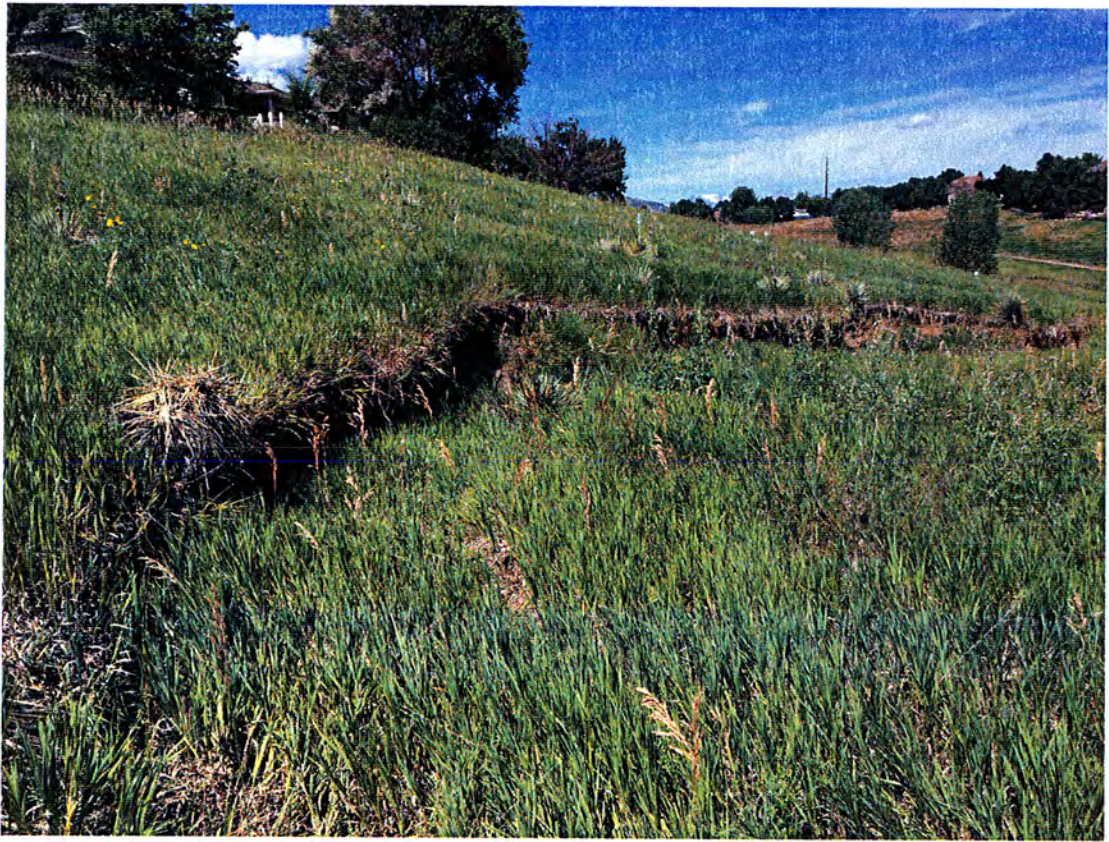
Our curbside reconnaissance of the houses situated at 597, 593, 587, and 583 W. Sagebrush Ct did not reveal the presence of slide related damage such as tension cracks, severe foundation settlement, twisted

Houses immediately uphill from the slide with adequate setback

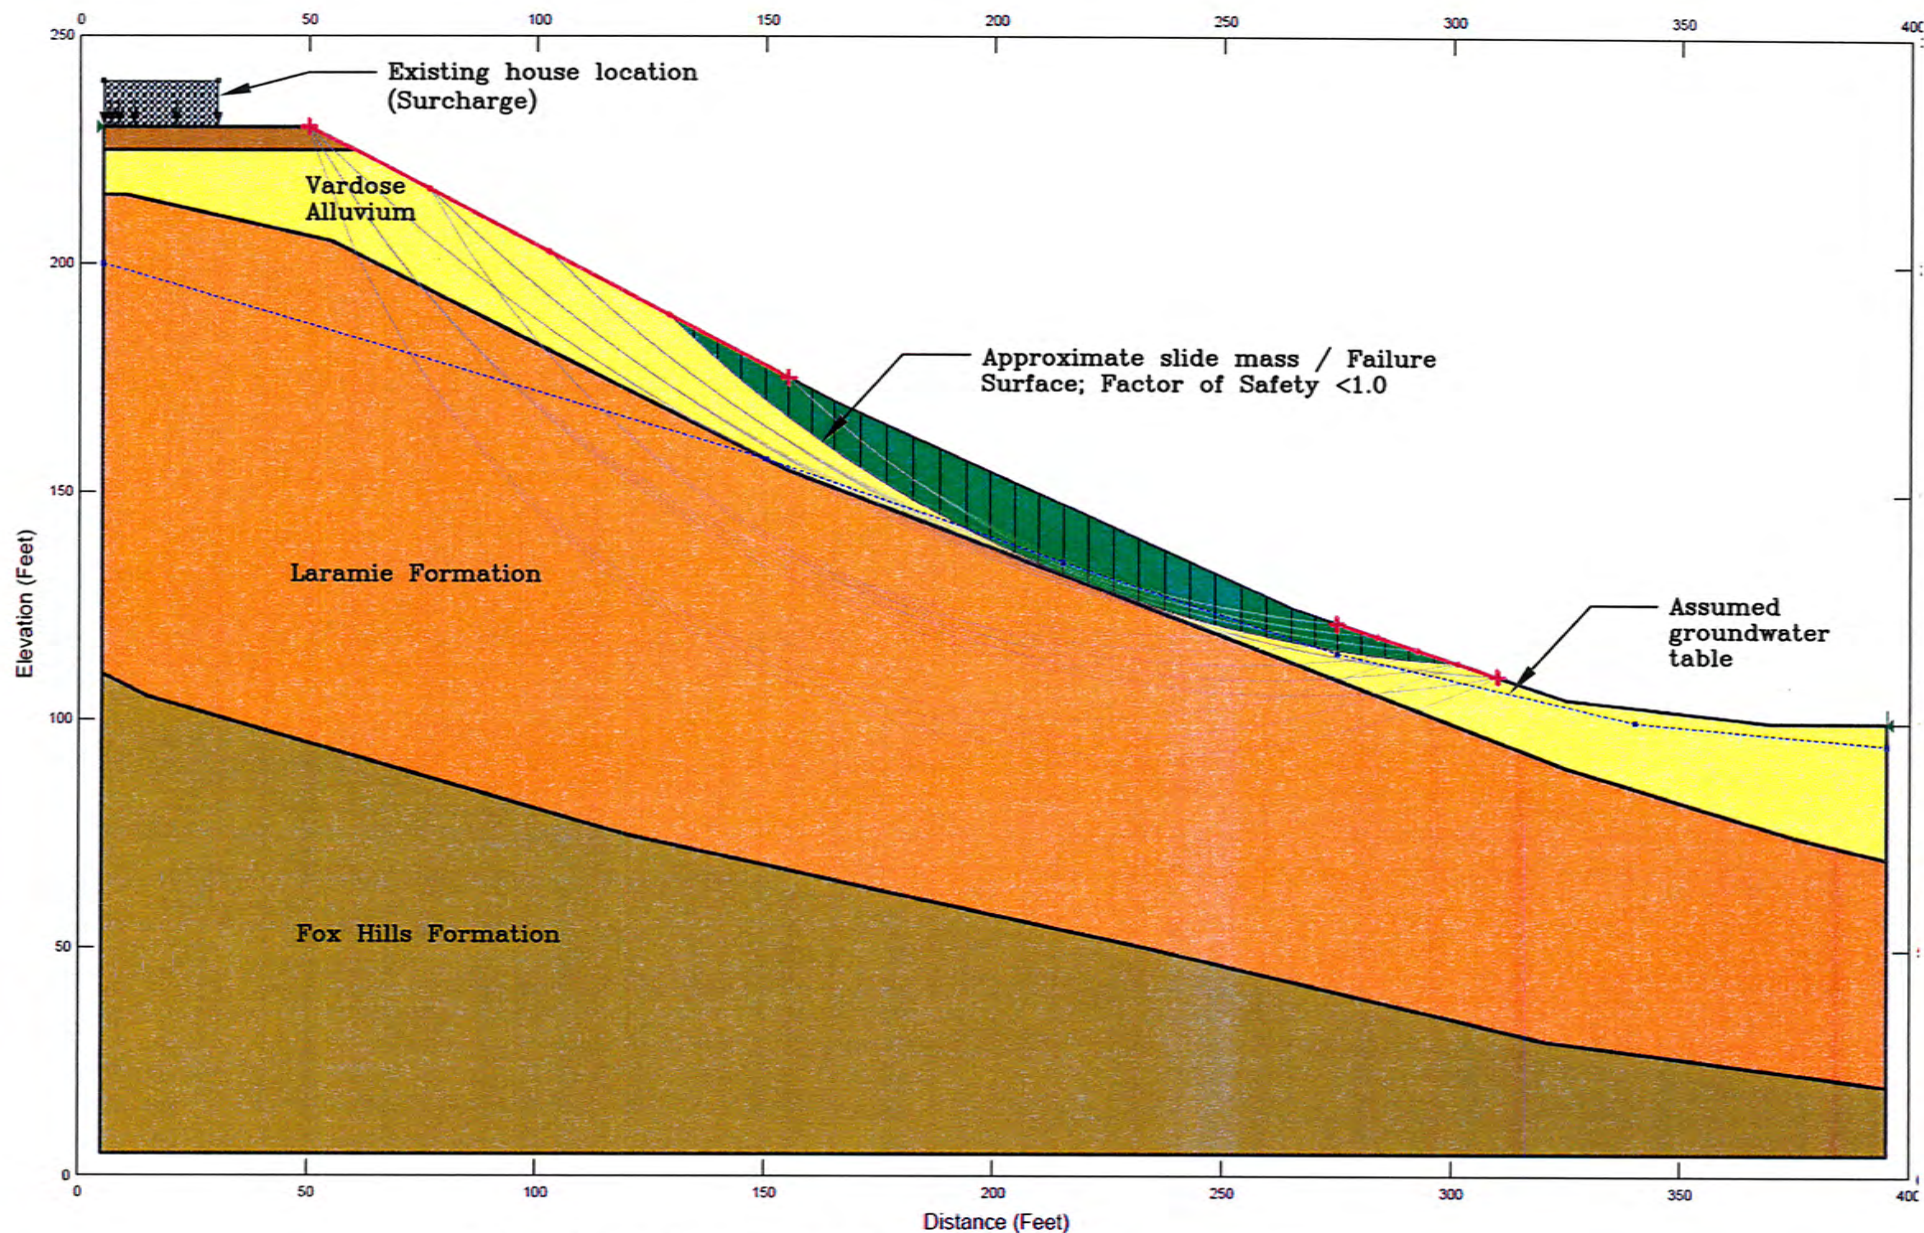
## PRELIMINARY SLOPE STABILITY ANALYSES

- As illustrate in Figure 11 by faint gray lines representing various possible slope failure scenarios, there is a possibility for the presence of deeper slide planes or the potential for future slides, however at this time, majority of the possible slide scenarios do not adversely impact the stability of the existing residential structures located immediately uphill from the slide area (583-597 W. Sagebrush Ct). In other words, for these structures, there is an adequate safety setback currently present from the slide area. Notwithstanding, due to the limited scope of work, this preliminary conclusion can be confirmed only be performing Stage II Investigation which may include soil borings, laboratory testing for soil strength parameters, proper determination of groundwater table, inclinometer installation and monitoring, and detailed slope stability analyses.

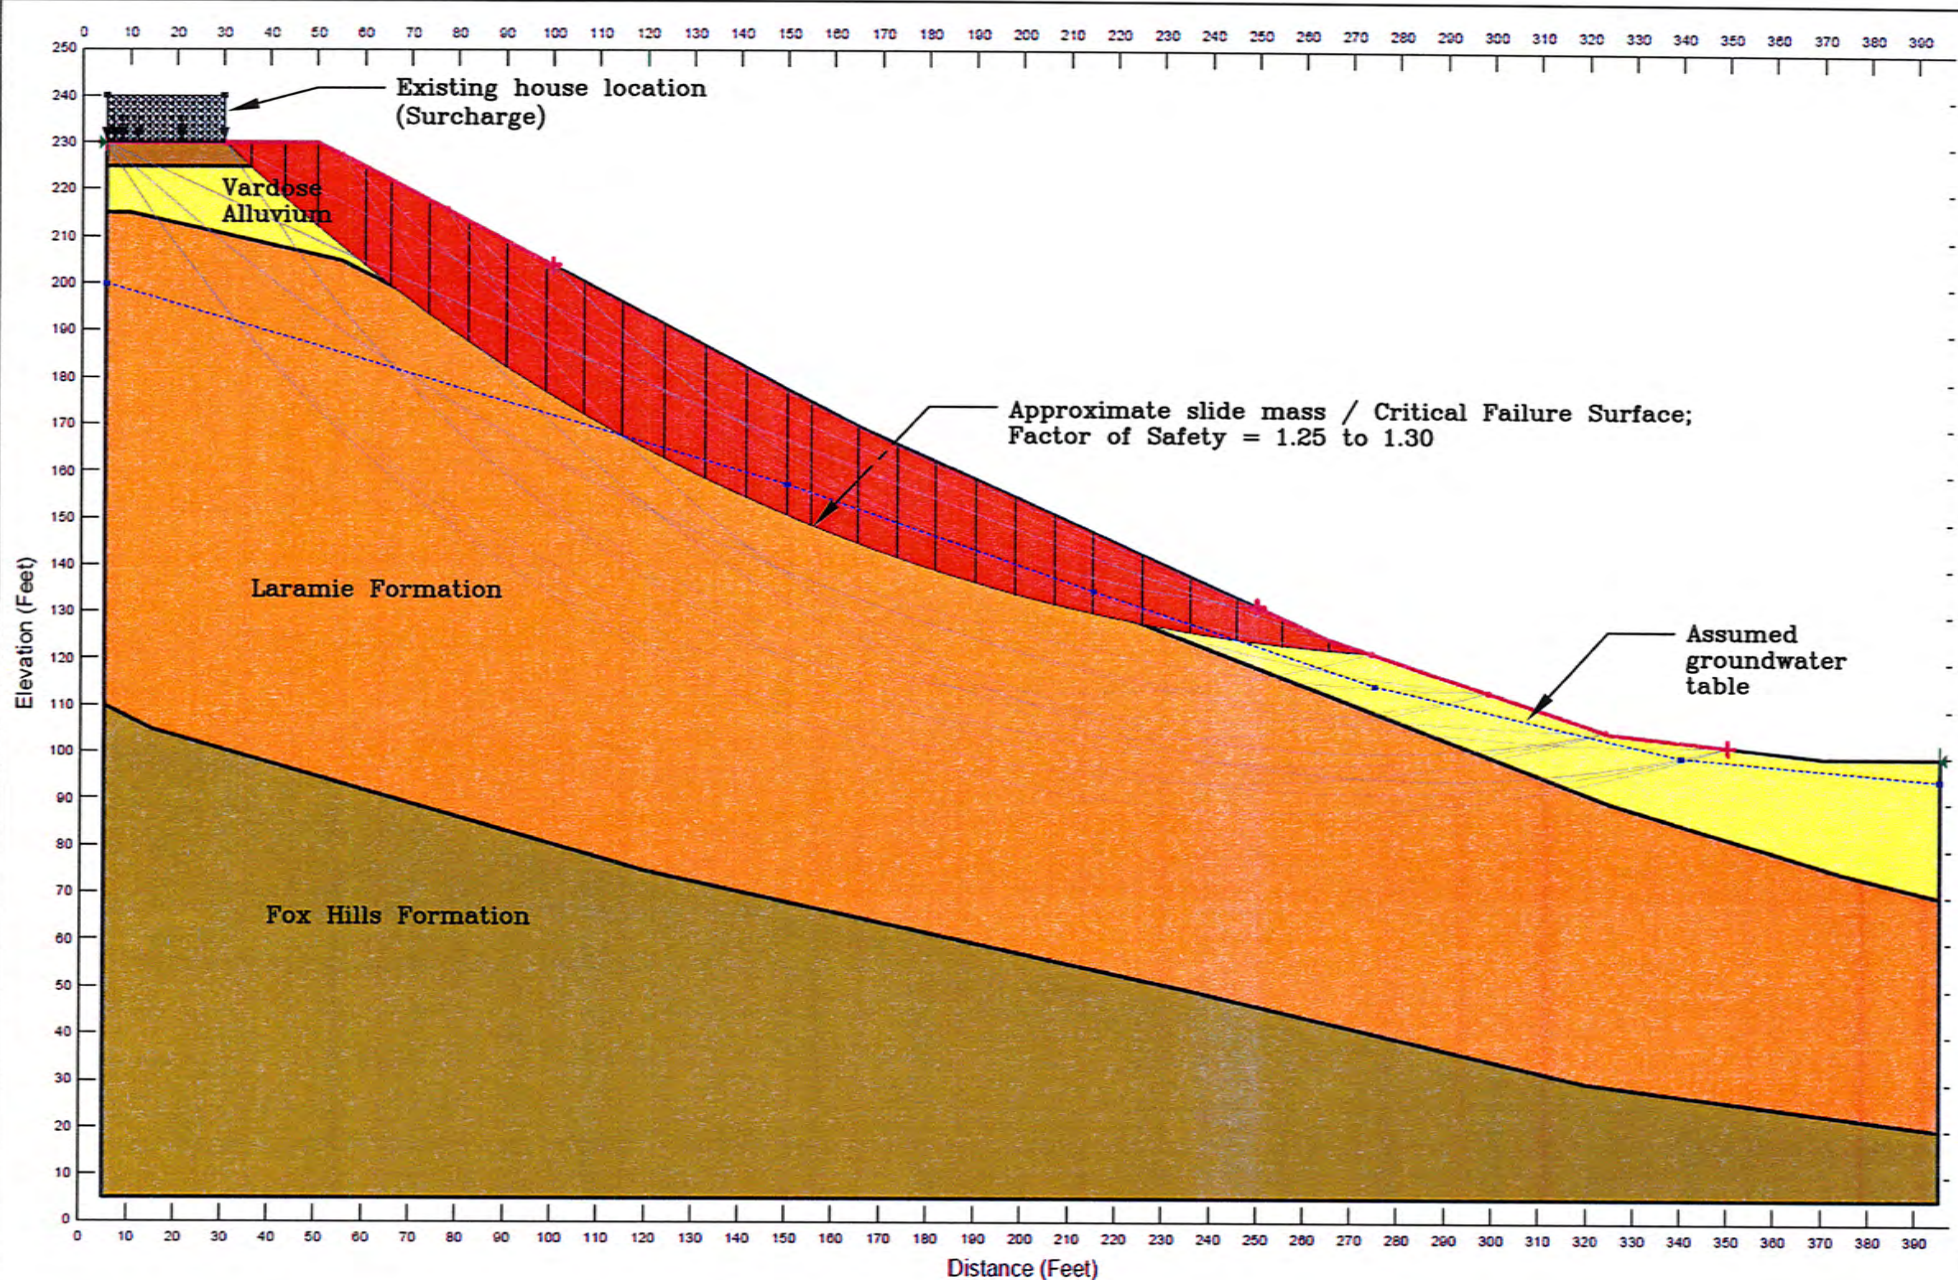
## PRELIMINARY ANALYSES

- The existing slide may lead to further slope instability in the uphill areas and may cause future slides over the period of several years. However, as illustrated in Figure 12, the slide scenario that is most likely to adversely impact the existing structures along W. Sagebrush Ct has the safety factor in the range of 1.25-1.30. In other words, future sliding in the uphill slope areas is less likely to reach the existing houses, assuming there is no unusual event such as the abandoned mine collapse, loess subsidence, or the 500-year storm event. It should be noted that, due to the limited scope of work, this preliminary conclusion can be confirmed only by performing Stage II Investigation which may include soil borings, laboratory testing for soil strength parameters, proper determination of groundwater table, inclinometer installation and monitoring, and detailed slope stability analyses.
