**SUBJECT:** RESOLUTION NO. 9, SERIES 2026 – A RESOLUTION DESIGNATING THE RESIDENCE LOCATED AT 728 GRANT AVENUE A HISTORIC LANDMARK TO BE NAMED THE KOEPLER HOUSE AND APPROVING A PRESERVATION AND RESTORATION GRANT

**728 GRANT AVENUE**  
**HISTORIC STRUCTURE ASSESSMENT**  
LOUISVILLE, CO

Date: July 14, 2023

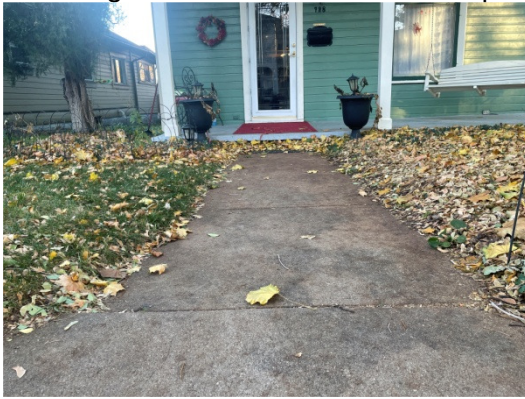
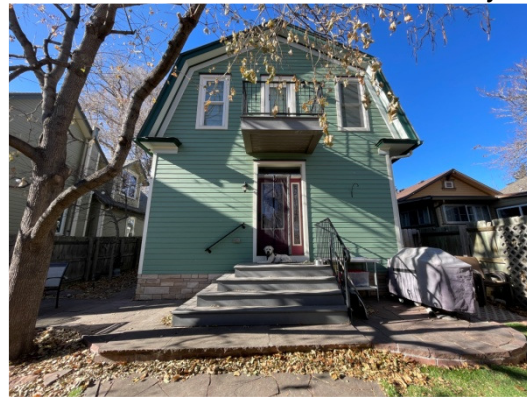
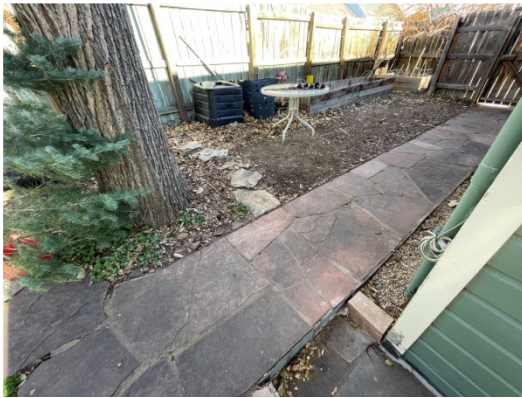
At the front or west side of the lot, there is a deciduous trees at the southwest corner and an evergreen at the northwest corner of the house. The grade at the west side of the property slopes toward the porch and can accumulate water against the porch slab during heavy rainfall. (Image 1-3.1.1). The west side of the house is mainly turf with some small shrubs and ground cover. The north side of the house is mainly leafy groundcover. The south side of the house has a walkway that wraps to the east of the house. This side of the house has a few trees and leafy ground cover. The east side of the house has a stone deck from the back door and a stone patio with seating and access to the two car garage that faces the alley and a walkway at the north side of the garage that leads to alley access. (Image 2-3.1.1) This area at the east side of the lot has several garden boxes and leafy ground cover with small patches of turf. (Image 3-3.1.1)

The tree at the northwest corner of the lot is within four feet of the porch and has some branches very close to the second floor balcony. This tree could be pruned back as part of general maintenance. Extensions should be provided at downspouts to direct water five feet away from the foundation. It is advised that the front yard and the walk that leads to the front door be regraded higher to provide slope away from the foundation and direct water to the north and/or south side of the house.

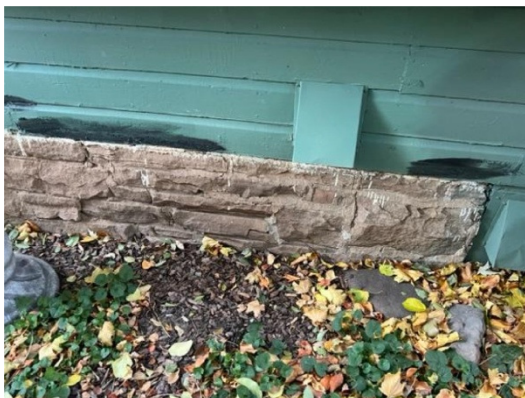
Figure 2: Exterior foundation with timber

The overall condition of the visible perimeter rubble stone foundation is good. Some cracks are visible and should be expected in construction of this type and age. The interior footings visible in the crawlspace are in poor condition due to the un-shored soil adjacent to their location, and inadequate sizing. This soil is sloughing away and may undermine these footings. Along the south and east sides of the cellar space is an older timber wall and a newer wall that appears to be pressure treated plywood and wood studs. These walls hold back the soil with the stone foundation wall just to the south or east of that. The bottom of this newer wood wall is sitting directly on grade and does not appear to be able to resist the lateral pressure of the sloughing soil. The grade around the house within 5 feet of the building is generally flat and sloping toward the front porch at the front of the house. It was conveyed by Ann Weise that before spray-foam was applied, daylight could be seen through multiple places in the stone foundation.

Ascent recommends a new foundation adjacent to the excavated cellar area be constructed of reinforced concrete and the area behind it backfilled to prevent the soil from sloughing off any further. The interior crawl-space framing and supports will be more readily accessible during this process and possible accessible for further evaluation and repair. New cast-in-place footings are recommended to be installed in concert with the framing recommendations below. Repair and repointing of the existing masonry will not reduce the possibility of future movement due to frost heave and expansive soils. Maintaining drainage away from the house is paramount to the foundation success. Some grading issues cause some water to pool against the house. This should be repaired to slope away from the house and gutter downspouts maintained to discharge away from the foundation. Additional tuckpointing of the stonework is also recommended.

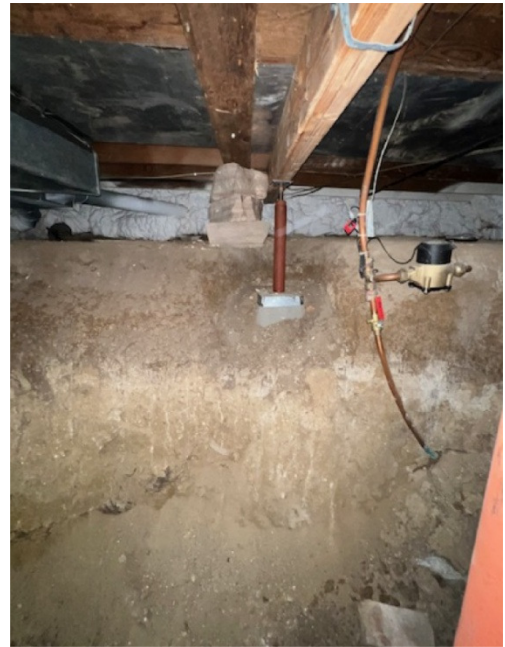
Figure 8: Supports near sloughing soil

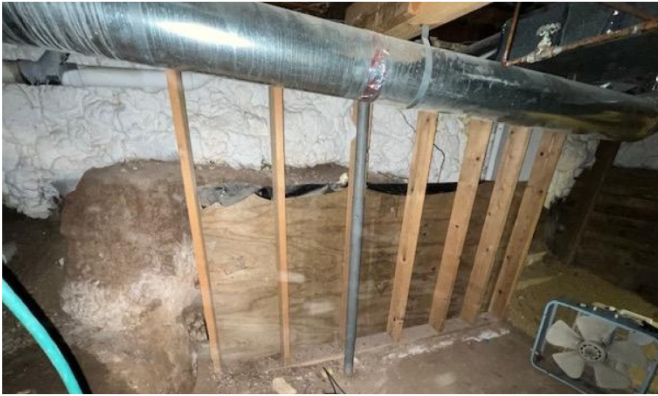
Figure 12: Wood retaining wall

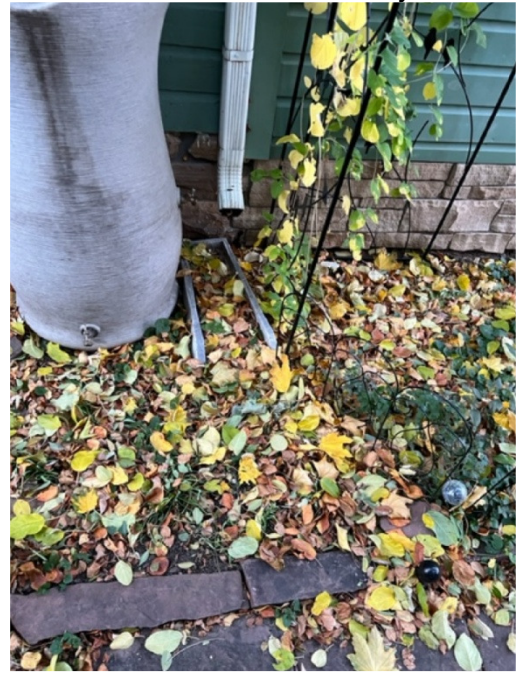
Figure 13: Gutter downspout

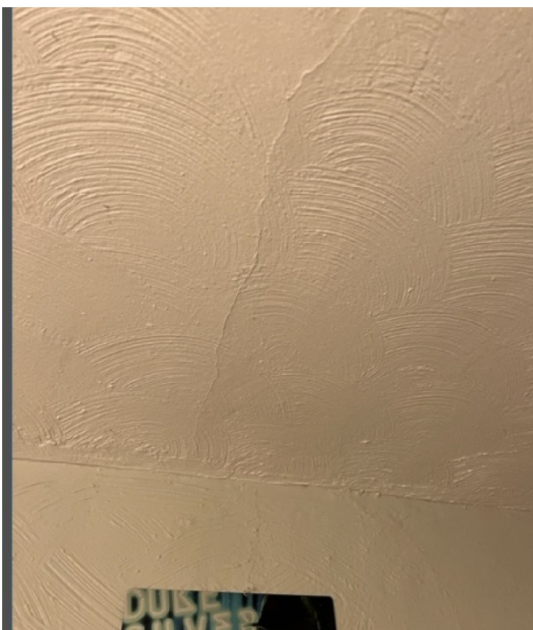
In the portions of the roof that were visible and accessible, no damage or excessive deflections were observed. Although there were some cracks in the plaster below, this is typical of a structure of this vintage. Future loading events such as snow loads and wind loads may result in some movement over the life of the structure. The ceiling finish appeared to be in good shape and no signs of excessive deflection were observed.

Figure 11: Painted over Ceiling Crack

There are no recommendations at this time.

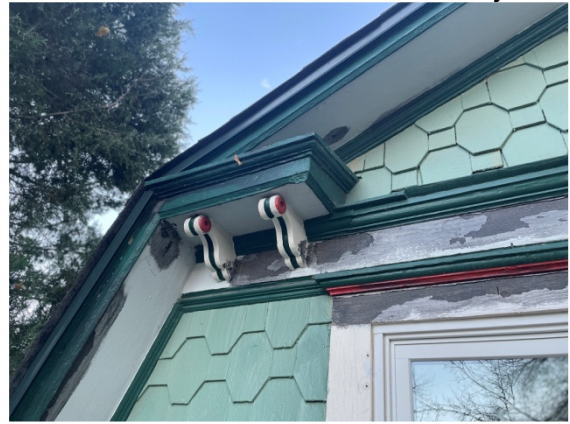
While the building looks as if the painting has been done in the last five years, there are signs of peeling. Some wood siding and trim exhibit signs of rotting and damage (Image 1&2 3.3.2).
