# ***Historic Preservation Commission Agenda***

**ITEM:** 1101 Main Street Probable Cause Determination

**REQUEST:** A request to find probable cause for a landmark designation to allow for funding of a historic structure assessment for 1101 Main Street.

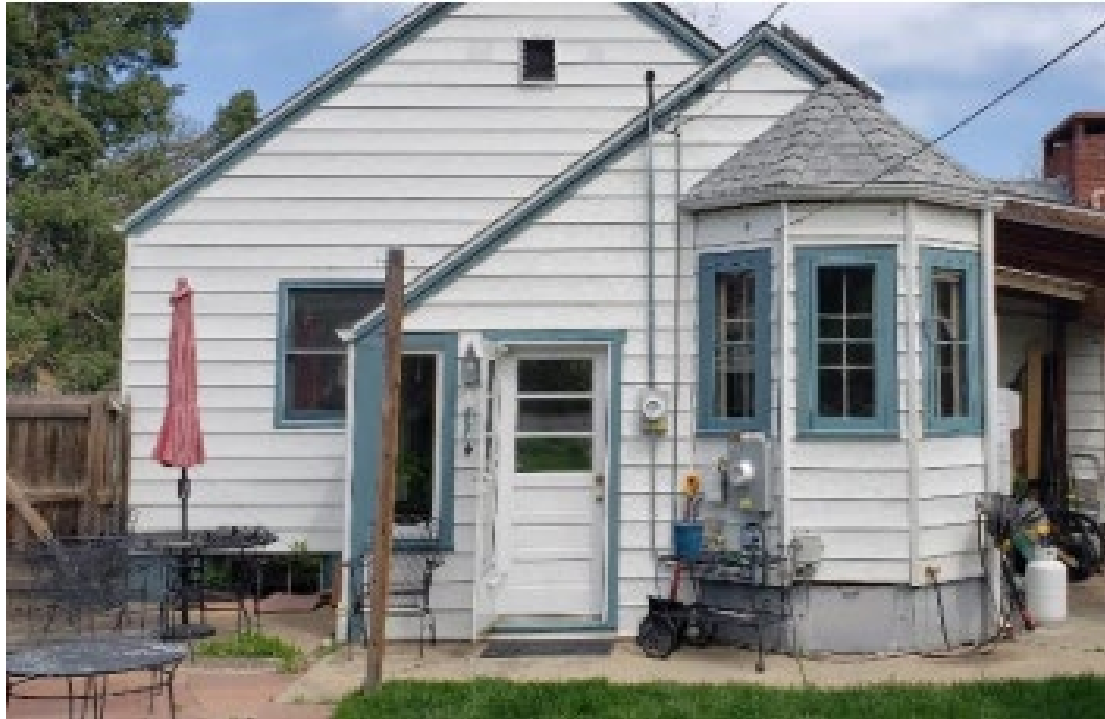
Recent photo highlighting concrete apron from Historic Structure Assessment, 2024

- Construct a new studio shed/ office space
- Remove detached woodshed in rear yard
- Partial enclosure of rear porch
- Replace 420 square feet of cracked non-sloping concrete apron adjacent to the house on the west side in the backyard and replace with proper sloping and a window well

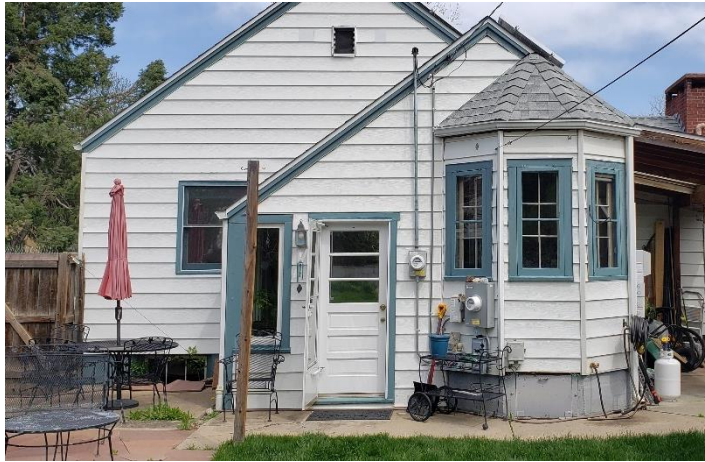
*The foundation is exposed in most areas except for at the rear entry.*

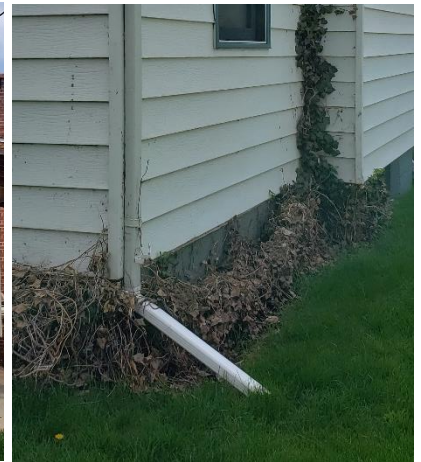
Overall, the site is relatively flat with slight grade changes apparent in some areas. Grade generally slopes away from the house though minimally in most areas. There do not appear to be any areas of negative drainage towards the house, though this assessment was limited as there were no recent rain or snow events. The siding sits well above grade, at a foot or more, in most areas around the entire house perimeter. However, the portion of the house at the rear that was originally a porch and later enclosed does not have exposed foundation due to the concrete patio. The siding runs down to the top of the concrete path in this area.

*Grading and growth at the northeast corner.*

- Finished grade around the house perimeter should be re-graded to create positive drainage away from the house.
- Rim joist insulation should be added to achieve an R-value as close as possible to current code standards.
- Determine the original window opening sizes and locations when the framing or original siding is revealed with the removal of the aluminum and composite siding.
- Windows should be replaced with new window units that match the appearance of those in the historic photo from 1948. Typical 3-over-1, or 4-over-1 single-hung windows can be found on several houses in the Louisville area built at a similar time.

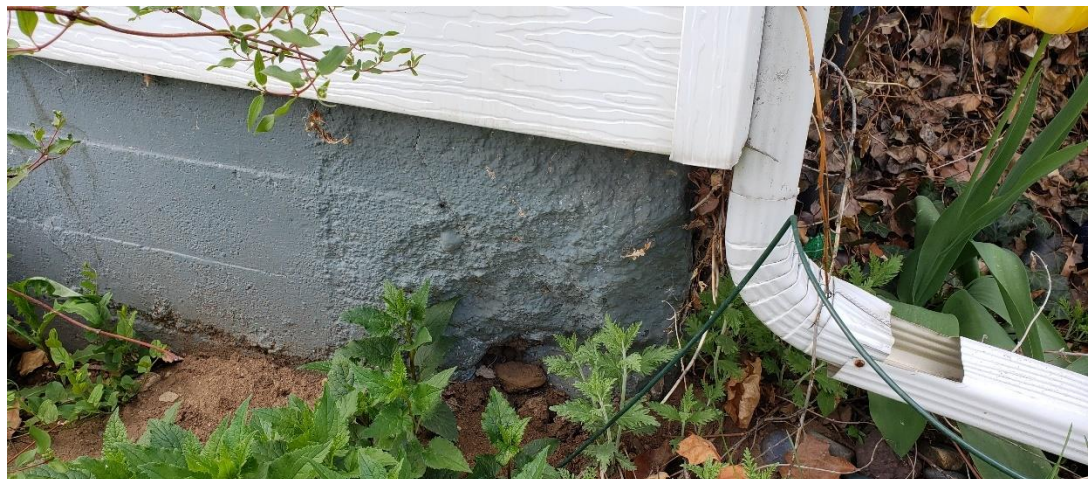
*Foundation deterioration at the northeast corner. The added downspout extension appears to have remedied the issue.*

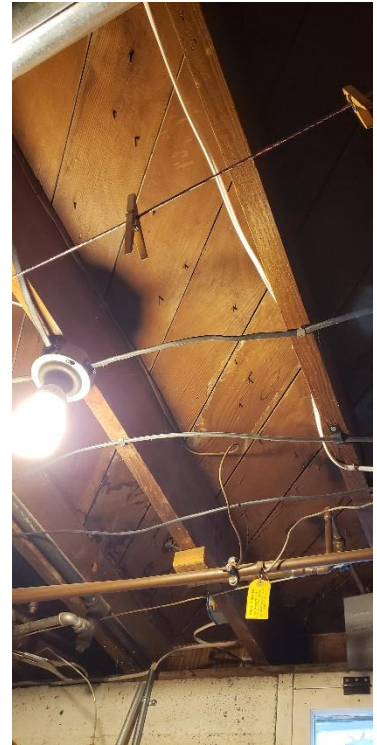
*Floor framing bears on a 2x sill plate with an uninsulated rim joist.*

4. If the main floor deflection is inadequate, consult a licensed structural engineer for additional support design options.
5. Rim joist insulation should be added to achieve an R-value as close as possible to current code standards. Verify that the crawlspace is a conditioned area otherwise insulation should be added to achieve an R-value as close as possible to current code standards.

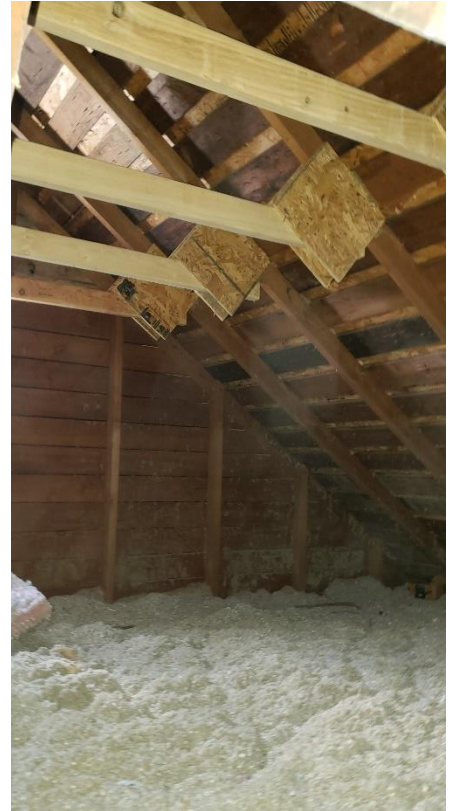
*Original roof framing with newer collar ties.*

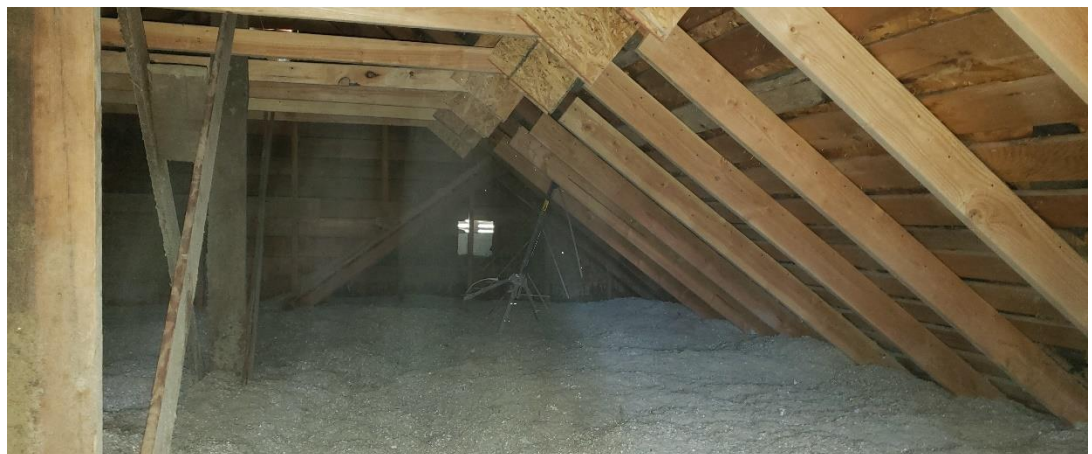
Where observed, the insulation in the attic is blown-in cellulose insulation with a depth of approximately one foot. This insulation appears to cover the entire house roof above conditioned space. It is unclear when the roof insulation was added, though it is not original.

*Roof bracing of the ridge beam and rafters, attic insulation throughout.*

5. Purlins and braces could be added to the existing roof structure down to a load bearing wall or new beam in the ceiling system to support the roof to today's standards. This should be evaluated and designed by a structural engineer.

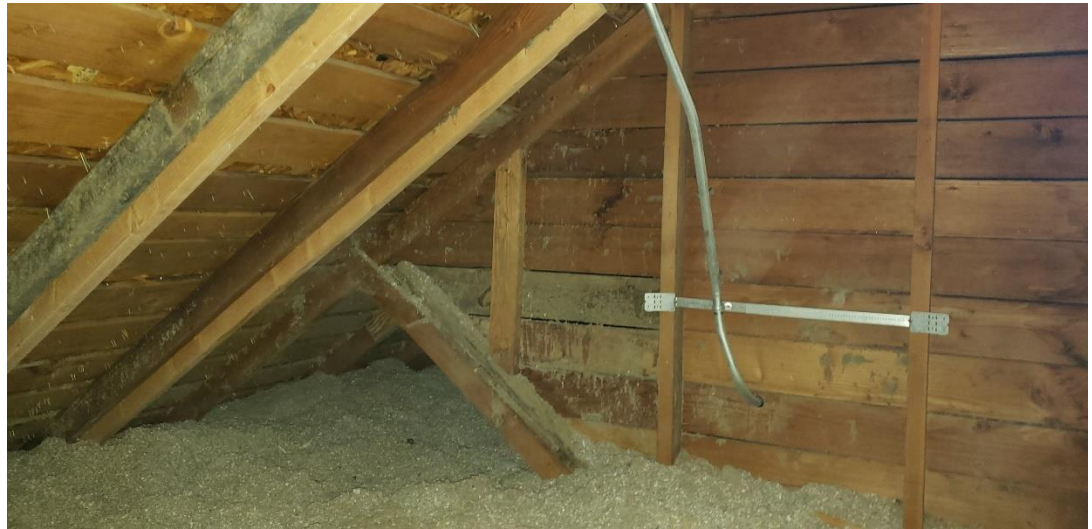
The main level wall framing was not exposed for review. The wall framing is likely a 2x4 stud wall with studs on regular spacing (site measurements support this assumed wall thickness). The original wood siding appears to be attached directly to the wall framing, as seen in the attic. The wall insulation type could not be determined, if any exists. It is likely that there is minimal to no insulation in the original house walls.

*West gable showing gable end wall studs and original wood siding attached directly to the wall studs.*

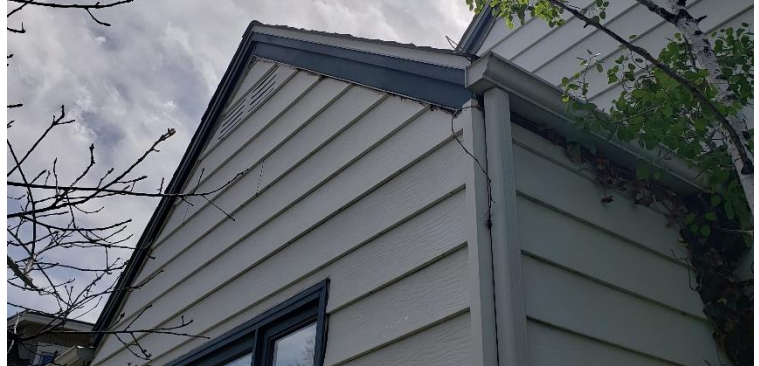
The entirety of the house is clad in painted steel siding. The steel siding wraps the original house as well as the south addition and the siding runs from the top of the foundation to the gable ends. Beneath the steel siding there is a layer of rigid foam, likely applied at the time of the steel siding, followed by a layer of asbestos siding. The asbestos siding is visible in the 1948 image.

*Steel siding wraps the entire house.*

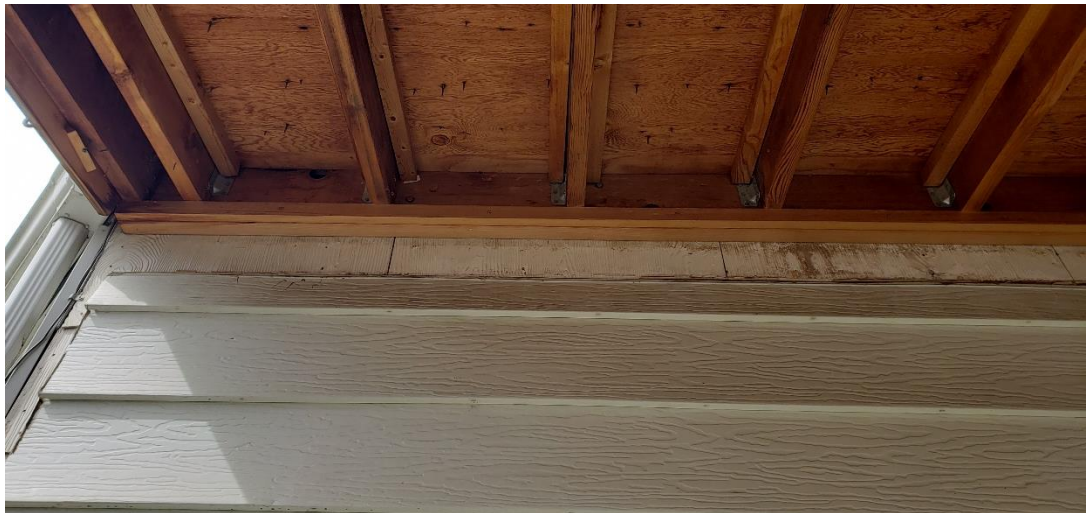
Beneath the asbestos siding there is a layer of wood shiplap siding with, most likely, a Dutch cove profile. The wood siding is visible in the attic. The wood siding is likely original and appears to be attached directly to the wall framing. It is unclear if the wood siding exists at the south addition or only on the original portion of the house.

*Asbestos siding is visible below the new patio roof.*

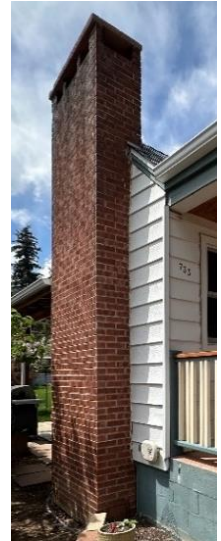
*South addition chimney.*

1. Consider adding a new false chimney on top of the main house gable. The location of this chimney may be determined by patchwork in the roof sheathing as seen in the attic or by the location of the chimney remnants in the basement.
2. The current chimney is not original to the house, nor is the south addition that it is attached to. However, the south addition is minor in comparison to the overall house form and is an extension of the original south facing gable. For this reason, consider removing the existing brick chimney as it does not match the historic nature of the house.

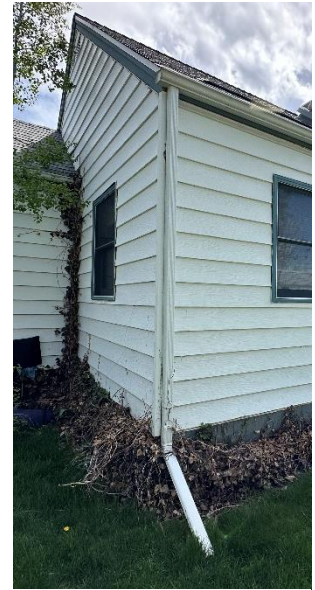
*Typical gutter detail*

1. Ensure that all gutters, downspouts, and downspout extensions are maintained to discharge water away from the building foundation and are kept clear of debris.
2. The gutters and downspouts are not historic. Consider replacing the gutters with ½ round gutters and the downspouts with round downspouts. Though not historic, these styles will more appropriately match the historic nature of the house.

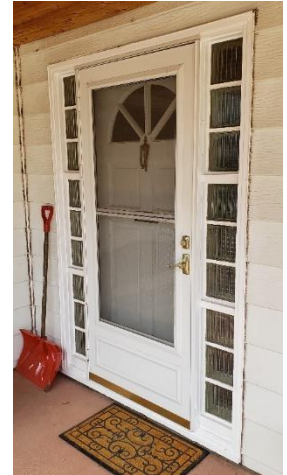
*Front door, storm door and sidelights.*

Remove the aluminum storm doors from the front door. This door is in a well-covered area that does not need storm doors for weather protection. If screen doors are desired, a minimally framed screen door could be added.

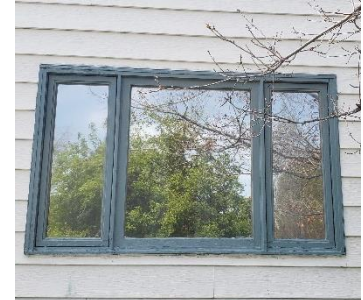
Most of the windows are in fair to poor condition. Operation was not tested but appears to be minimal. The vinyl and wood windows are beyond the expected lifespan of such windows and do not perform well thermally in Louisville's climate. However, the wood windows appear to have been somewhat protected since the addition of the storm windows. The modern wood windows also appear to be in fair condition. There was some flaking paint, but no signs of rot. The tripartite window appears to be showing some deterioration as it is exposed to direct sunlight.

*Tripartite east facing window.*

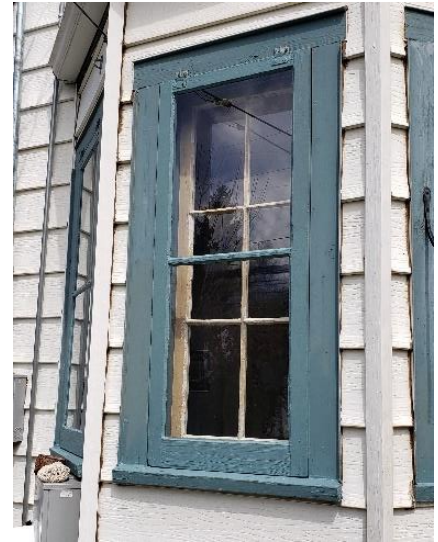
*Bay window and storm window.*

1. Determine the original window opening sizes and locations when the framing or original siding is revealed with the removal of the aluminum and composite siding.
2. Windows should be replaced with new window units that match the appearance of those in the historic photo from 1948. Typical 3-over-1, or 4-over-1 single-hung windows can be found on several houses in the Louisville area built at a similar time.

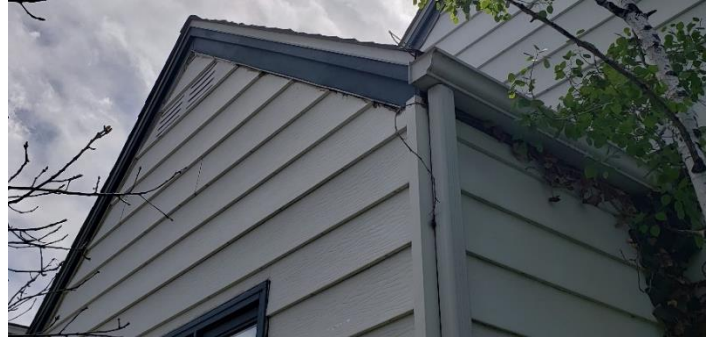
1x painted wood fascia is used at the original house which is partially covered by the drip edge of the roof. The south addition has an identical or similar fascia. All fascia components appear to be original or replaced to match the original. There are no roof eaves on the house and therefore there are no soffits, except for the covered front porch soffit as described above. Although the lack of eaves is atypical for the 1930's, examples do exist in Louisville and there are no eaves visible in the 1948 photograph.

*Front gable showing painted wood fascia that is partially covered by the metal drip edge and gutters.*

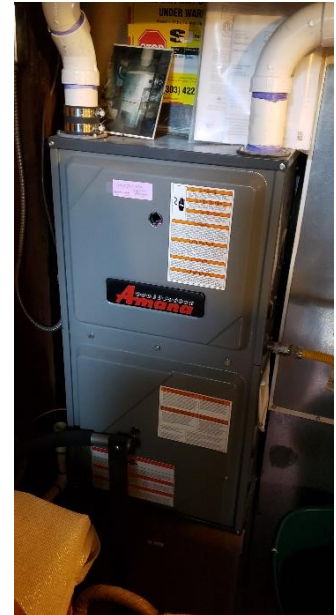
*Gas furnace located in the basement.*

Consider adding an air-condition unit that supplies the entire house as the house is likely poorly insulated.

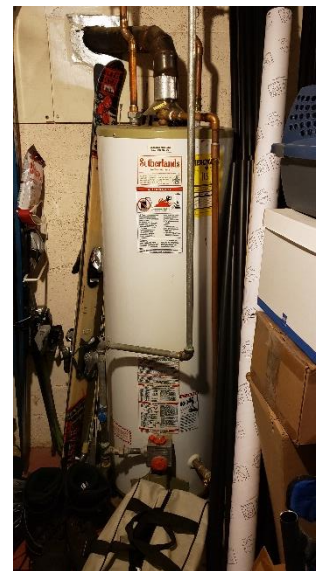
*Gas water heater located in the crawlspace.*

Consider replacing the water heater with a high-efficiency unit with a sealed combustion intake/exhaust system.

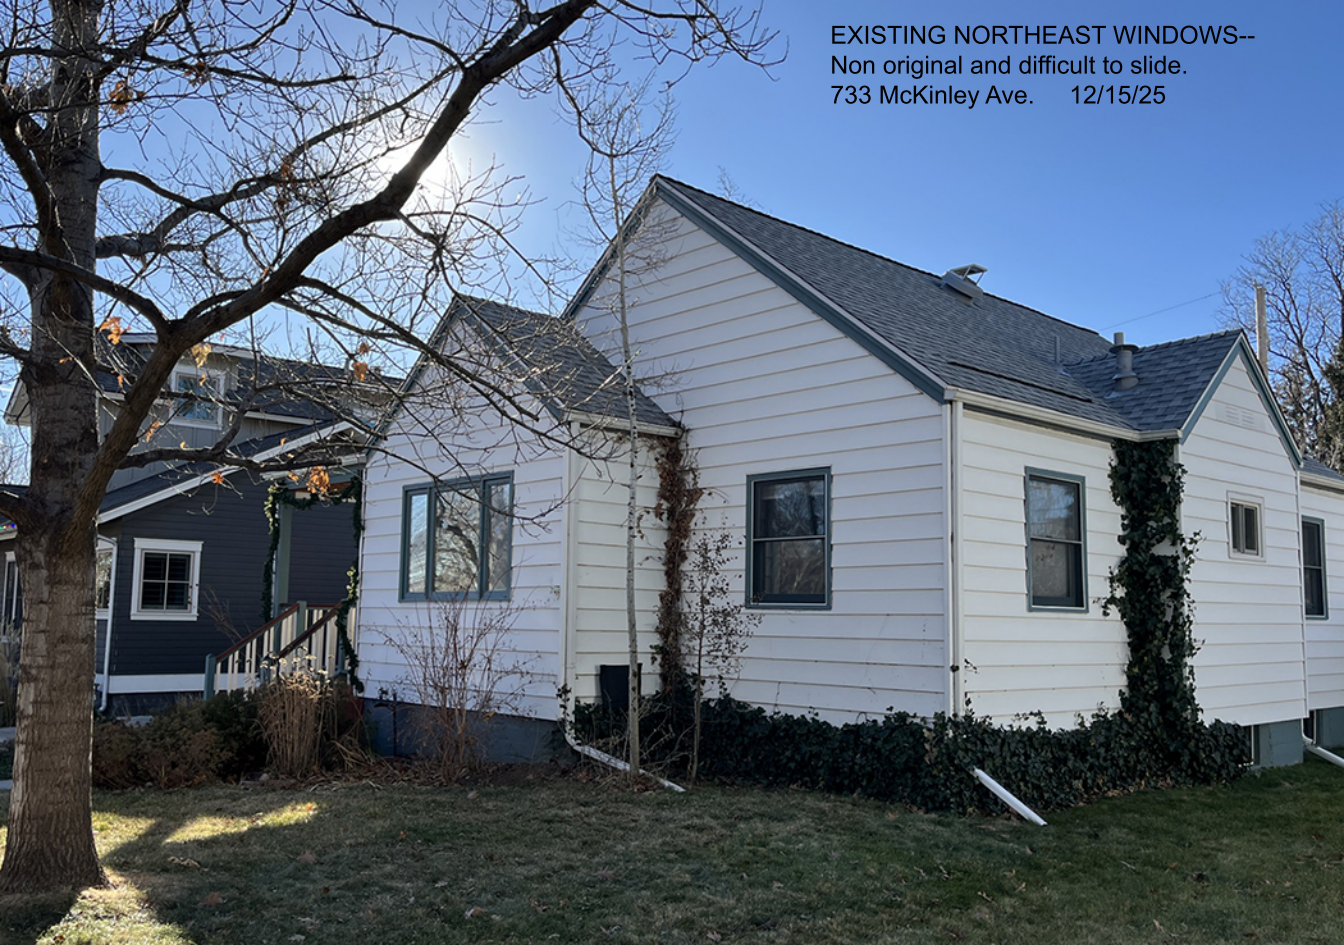
EXISTING NORTHEAST WINDOWS--  
Non original and difficult to slide.  
733 McKinley Ave. 12/15/25

TWO NORTHEAST WINDOWS TO BE  
REPLACED WITH MULLION WINDOWS  
733 McKinley Ave. 1/27/26
