**SUBJECT: 917 REX STREET LANDMARK AND GRANT REQUEST**

- i. **RESOLUTION NO. 42, SERIES 2024– A RESOLUTION APPROVING THE LANDMARK DESIGNATION FOR 917 REX STREET, THE WAREMBOURG HOUSE**
- ii. **RESOLUTION NO. 43, SERIES 2024 – A RESOLUTION APPROVING A GRANT REQUEST FOR THE PROPERTY AT 917 REX STREET**

**DATE: SEPTEMBER 17, 2024**

917 REX STREET, LOUISVILLE, COLORADO

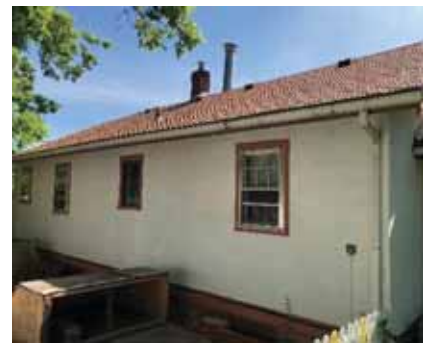
The overall site grading is in poor condition, as signs of damage caused by poor or negative drainage were observed and reported in the basement. Ideally, the grading around the house should be a minimum of 6 inches below the top of the foundation and slope away from the foundation for at least the first 5 feet. Due to the nature of the lot, it is unrealistic that these requirements may be achieved.

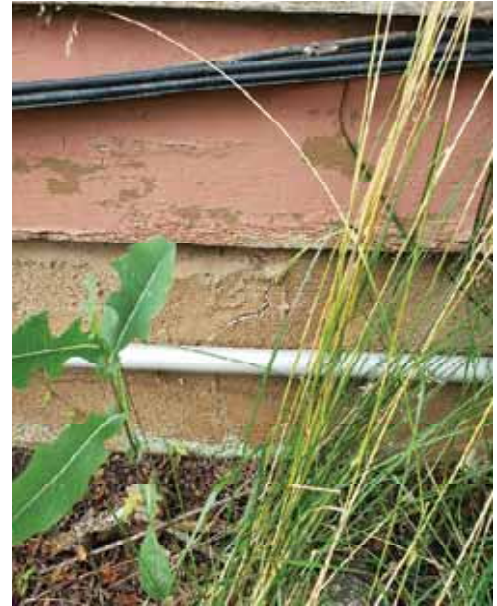
*Foundation cracking viewed from the exterior.*

The poured concrete perimeter foundation walls at the house are in fair to poor condition. Not all of the foundation walls could be fully analyzed as finish materials have been applied. A majority of the foundation was not showing cracks and there were minimal drywall cracks inside the home, indicative of a fair performing foundation system. However, concrete cracking was observed in a few areas around the exterior of the home. In addition, water infiltration has been observed on the west foundation wall. The access was limited at this location, and we were unable to determine if the water infiltration was due to improper exterior grading at this location or due to any cracks in the foundation wall at this location.

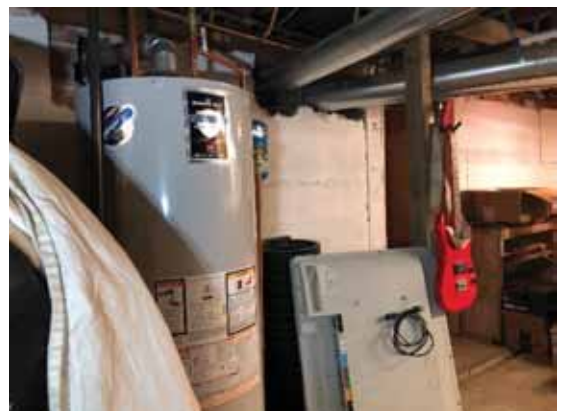
*Central foundation wall with openings for ductwork.*

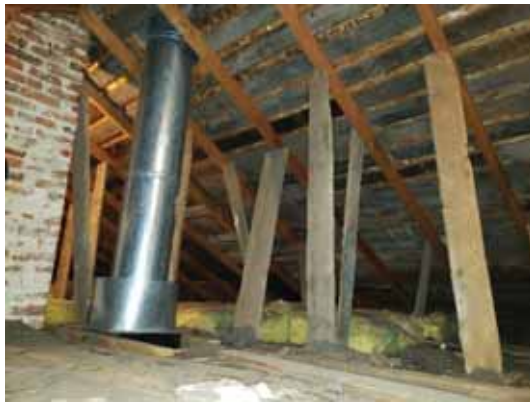
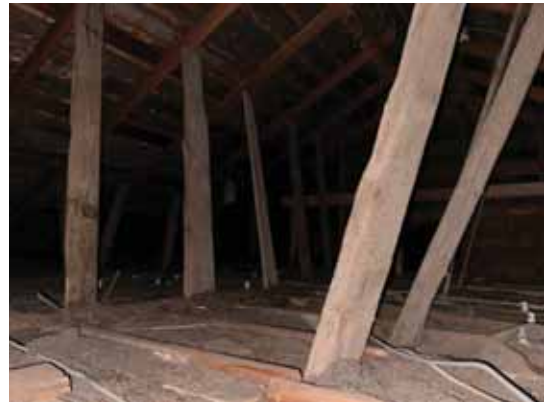
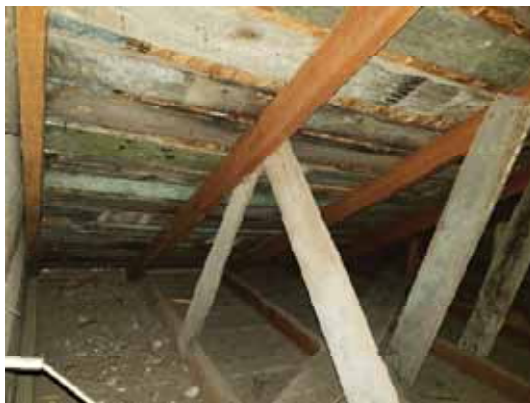
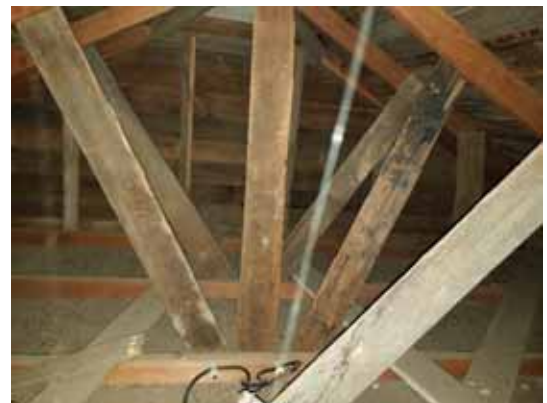
The connection of the porch roof framing on the east side of the house could not be verified due to installation of finish material.

The roof and ceiling structure are not to current code standards. The roof and ceiling system has shown higher than allowable deflection and if not revised will likely perform in a similar manner. Some of the following items should be considered to further solidify roof structure performance.

7. Additional rafters may need to be added to the porch roof on the east side of the building to meet the minimum IRC code requirements. This must be coordinated with a licensed structural engineer.

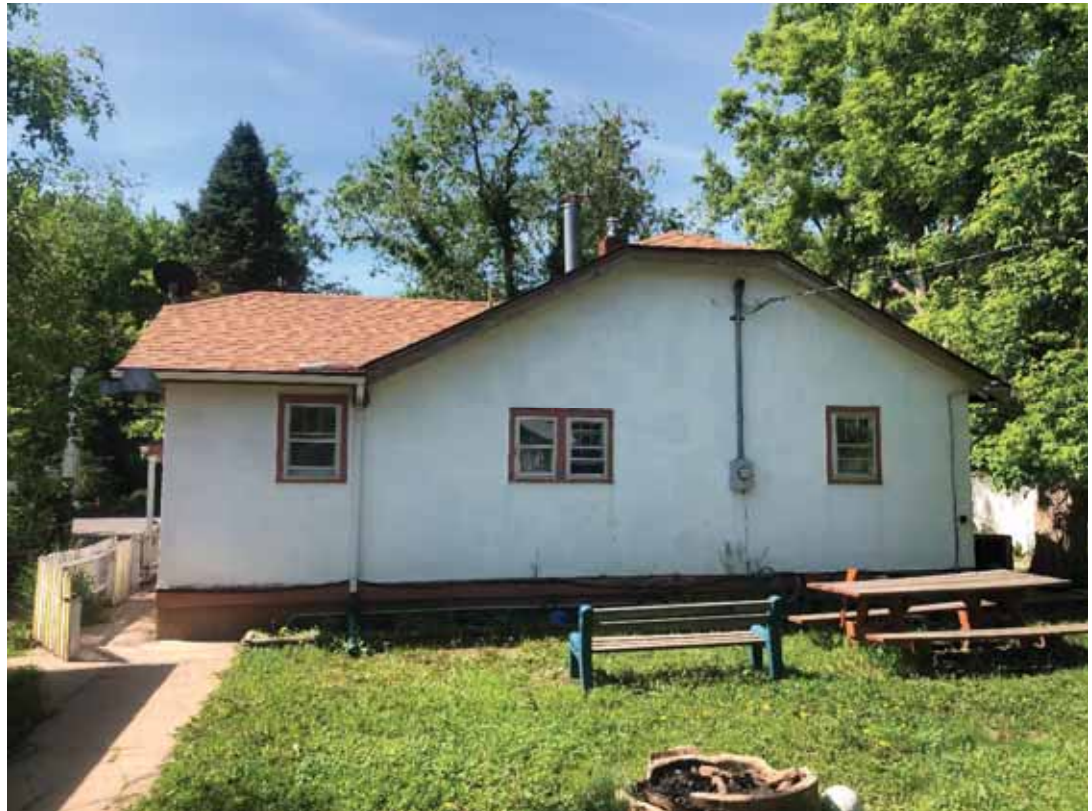
The electrical service was not tested during the site visit but appears to be in working condition. The locations of the electrical panels present difficulties in servicing and they are not properly protected.

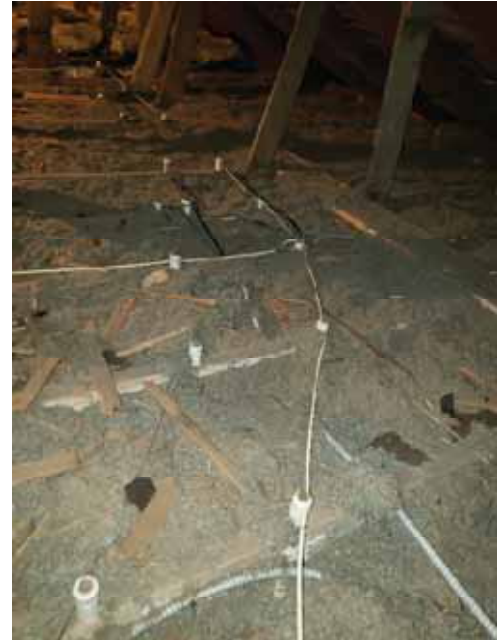
*Extensive knob and tube wiring in the attic.*

The knob and tube wiring should be tested by a licensed electrical engineer. If it is determined that the knob and tube wiring is still being used, consider replacing with new wiring that meets current code standards. If the knob and tube wiring is still in use, it presents a possible fire hazard. If the knob and tube wiring has been abandoned, no action is necessary.
