**ITEM:** 509 LaFarge Avenue Landmark, Alteration Certificate, & Grant Request

**REQUEST:** A request to Landmark 509 LaFarge Avenue and a request for an Alteration Certificate, Preservation and Restoration Grant, and New Construction Grant for the property.

**509 LaFarge Avenue  
Louisville, CO  
Historic Structure Assessment**

7 January 2016

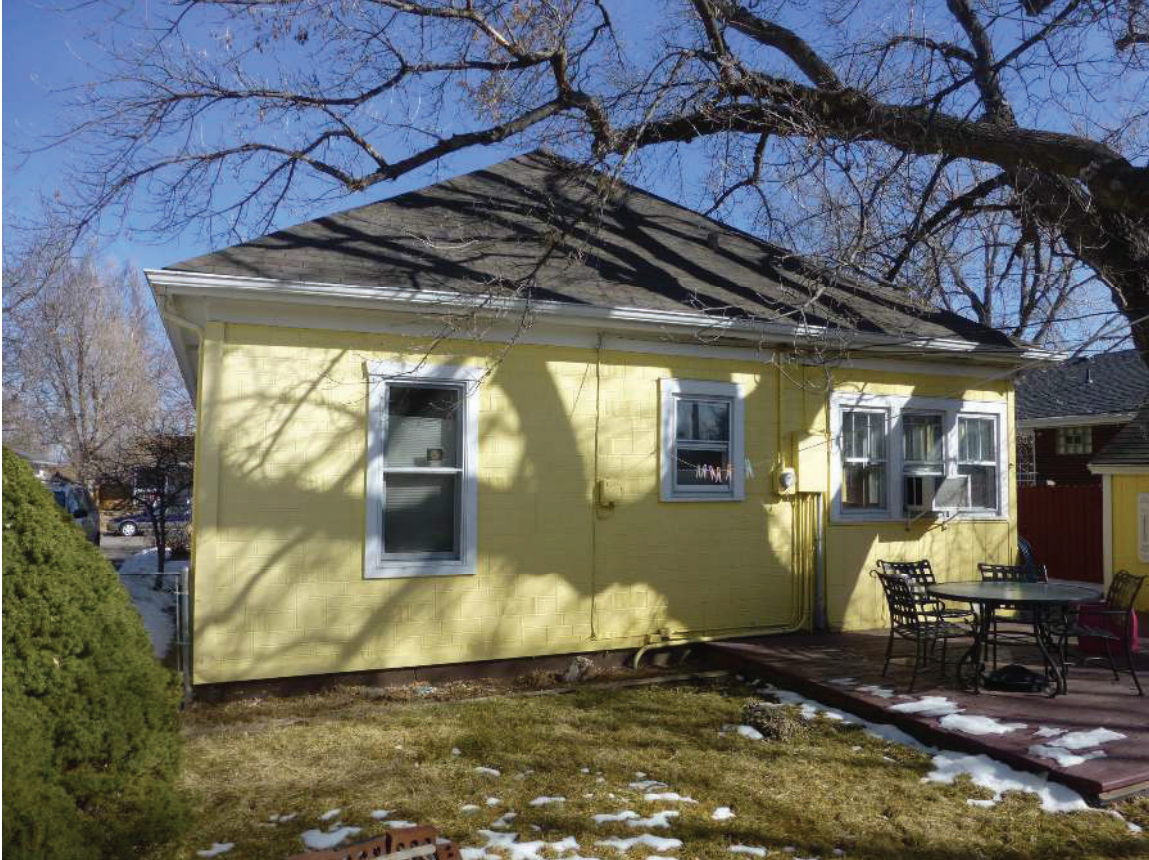
Improve drainage around structure

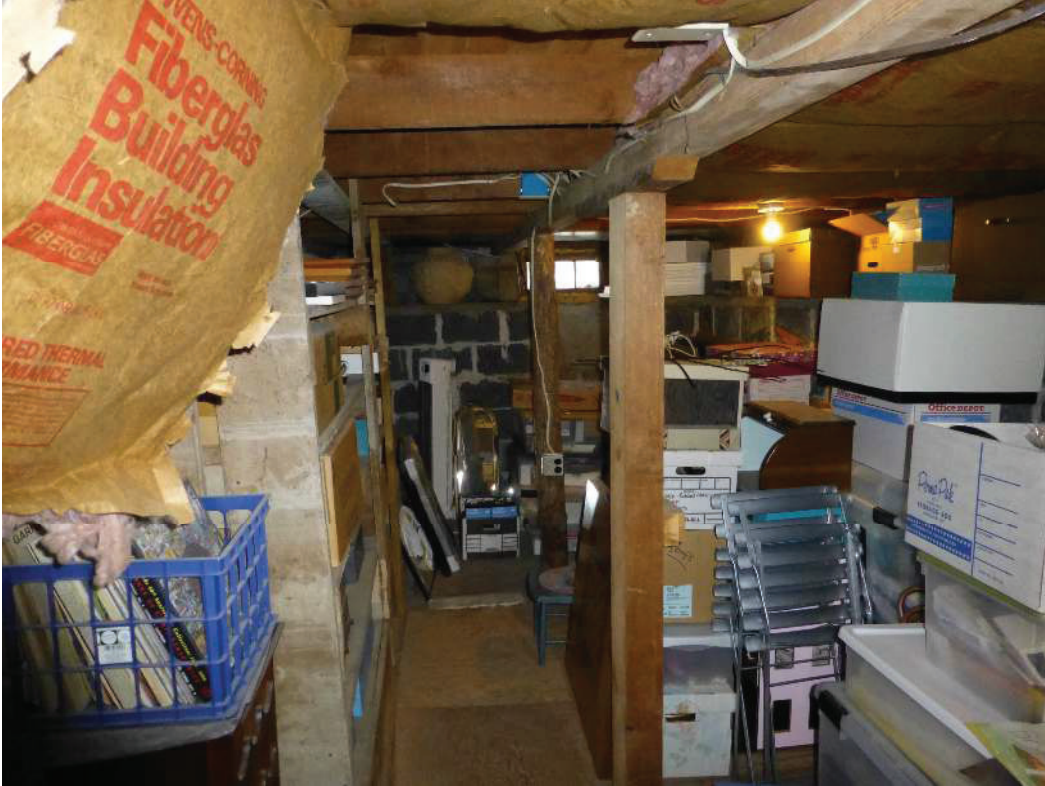
Replace beams supporting first floor structure

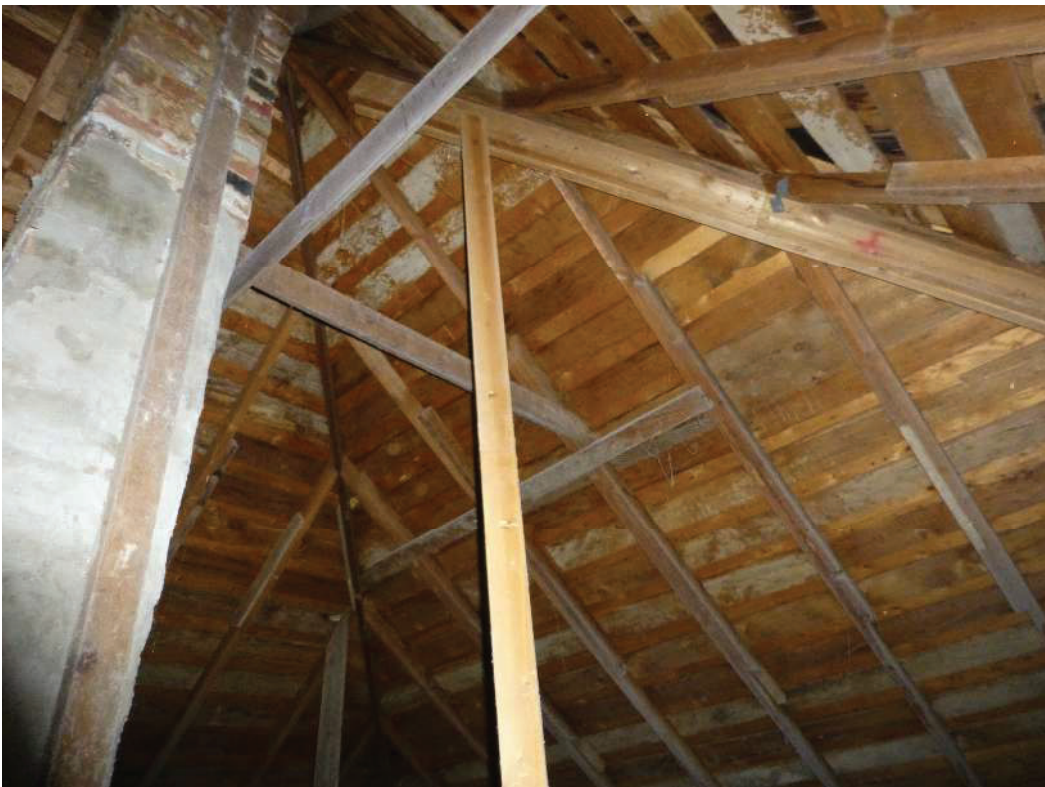
Reinforce roof rafters

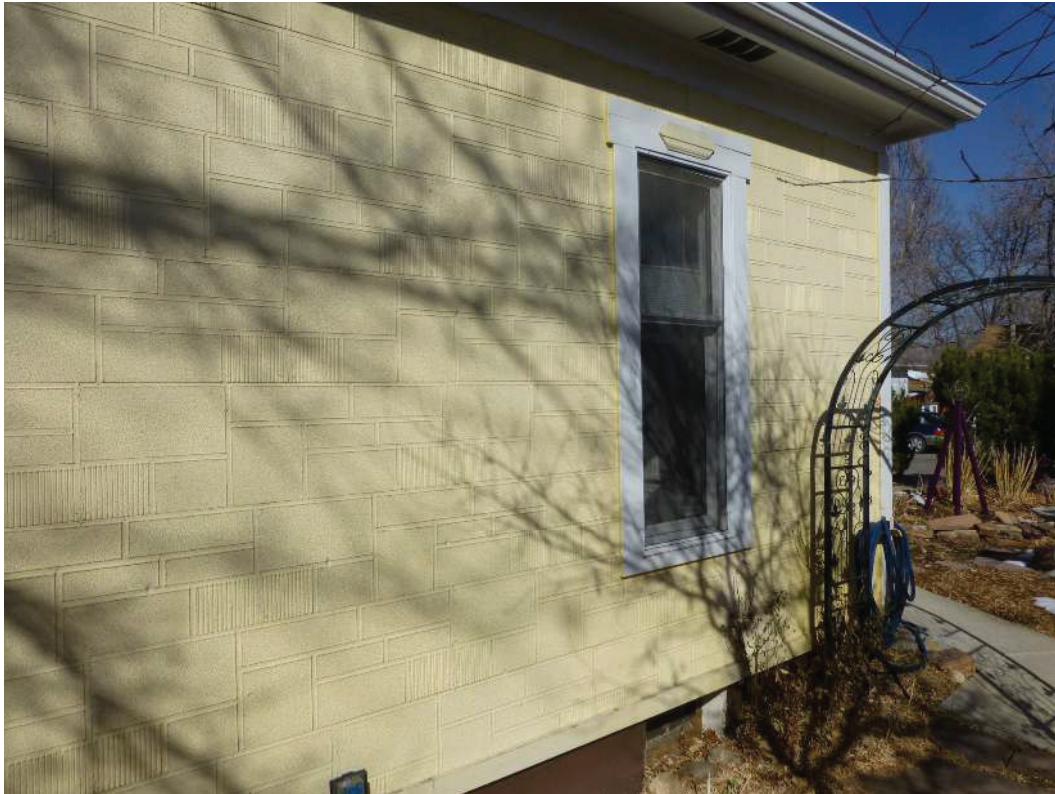
Asphalt siding (painted)

- Remove asphalt siding, T-111 & fiber board lap siding.
- Repair or install new lap siding matching the structure's original siding. Include painting.
- Insulate all exterior walls

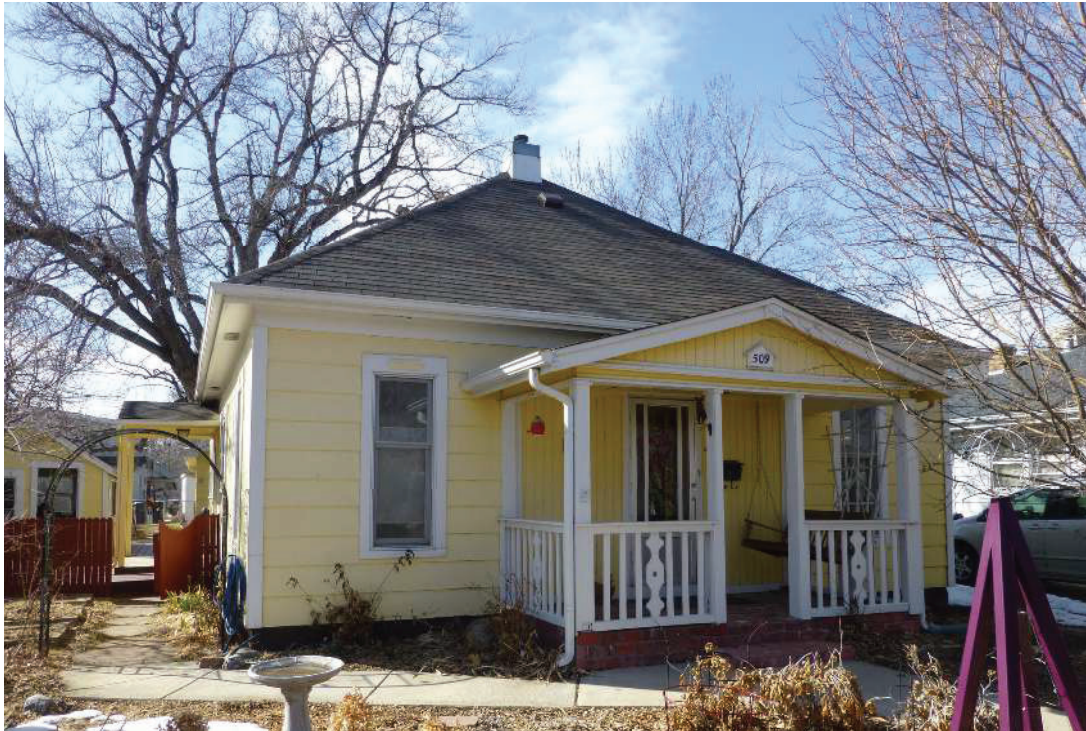
Fiber board siding and T-111 siding

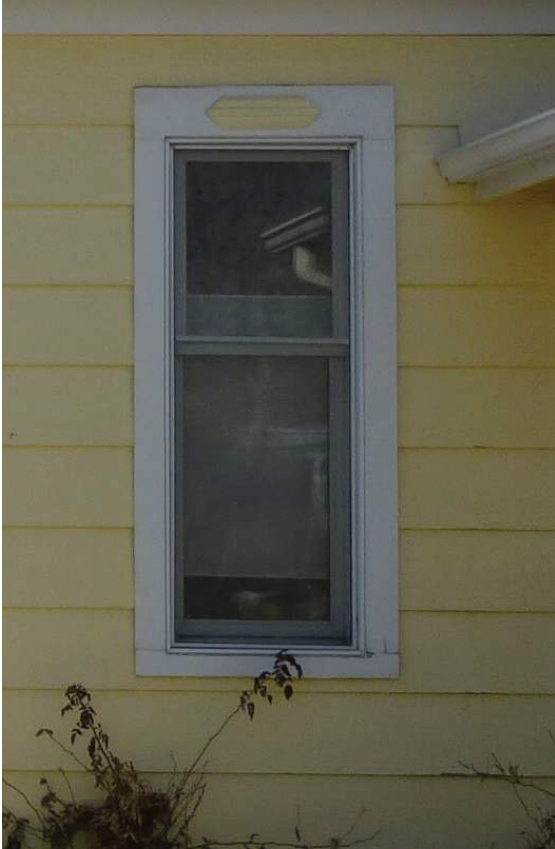
Aluminum-clad replacement windows

- Replace 1990's era clad windows with wood windows
- Maintain existing entry & rear door. Provide new storm doors

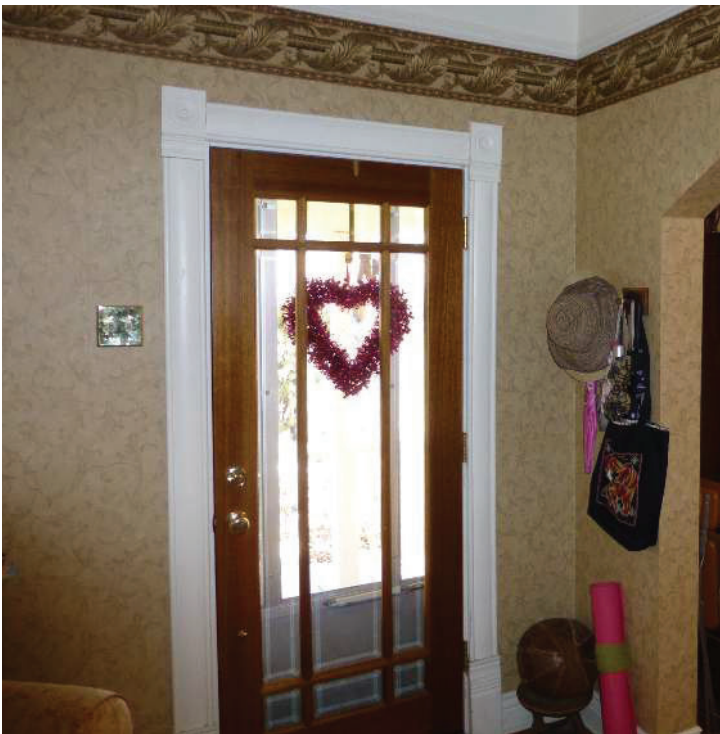
Entry door to remain- provide new storm door

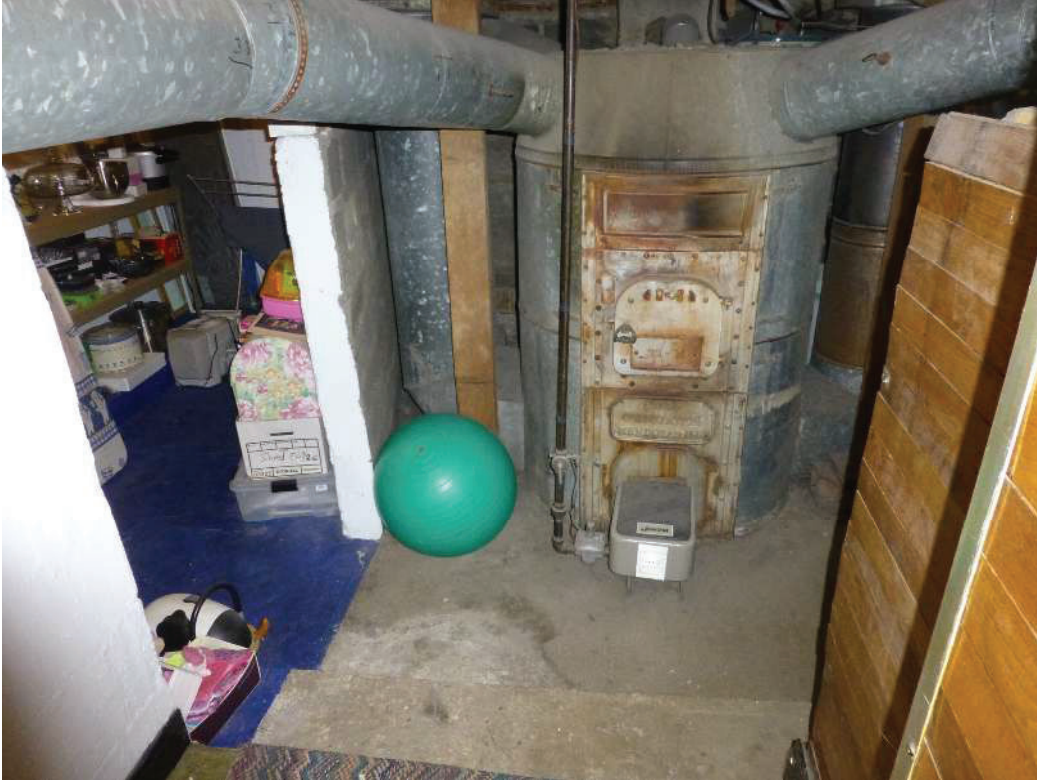
Converted coal furnace

- Remove and replace converted coal furnace.

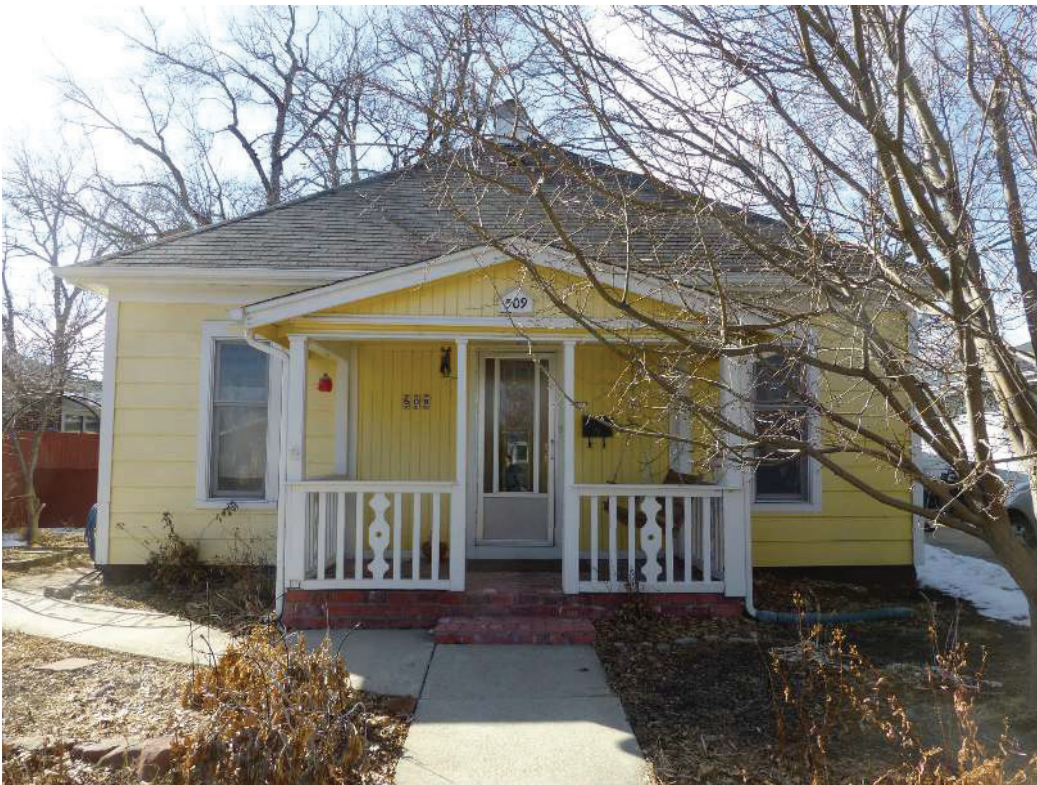
Entry porch

- Entry Porch- restore wood columns, ceiling, and railings
