# ***Historic Preservation Commission***

**ITEM:** 1016 Main Street

**REQUEST:** A request for a demolition review to demolish the existing house and garage.

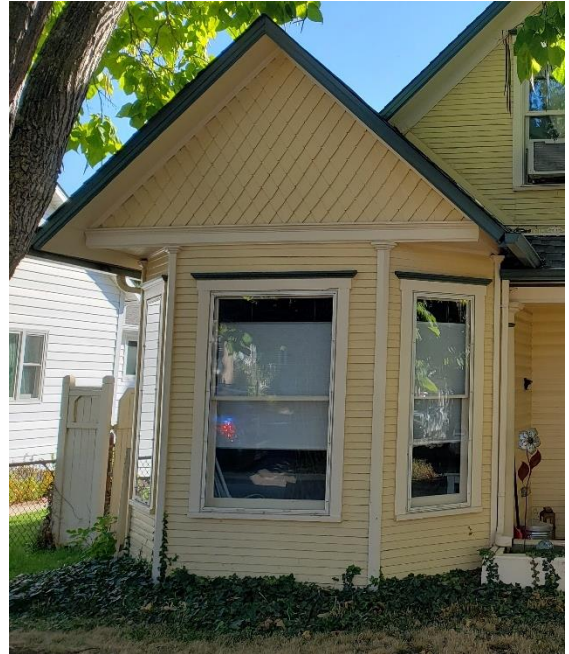
*Ground covers growing on the house and the foundation.*

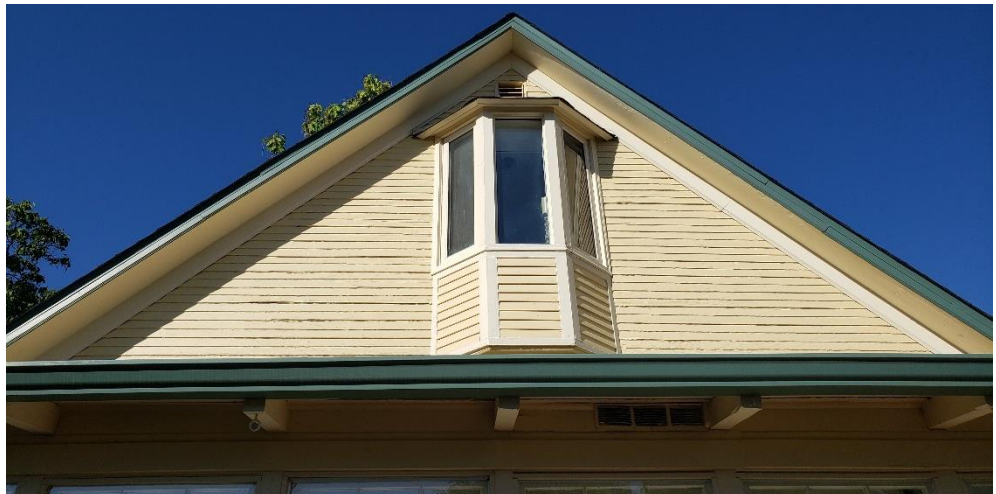
*The original roof is a steep gable & the east addition roof is a low pitch with exposed rafter tails.*

7. It is not recommended to add additional roofing materials such as an additional layer of shingles, or solar panels without the additional structural support mentioned above.

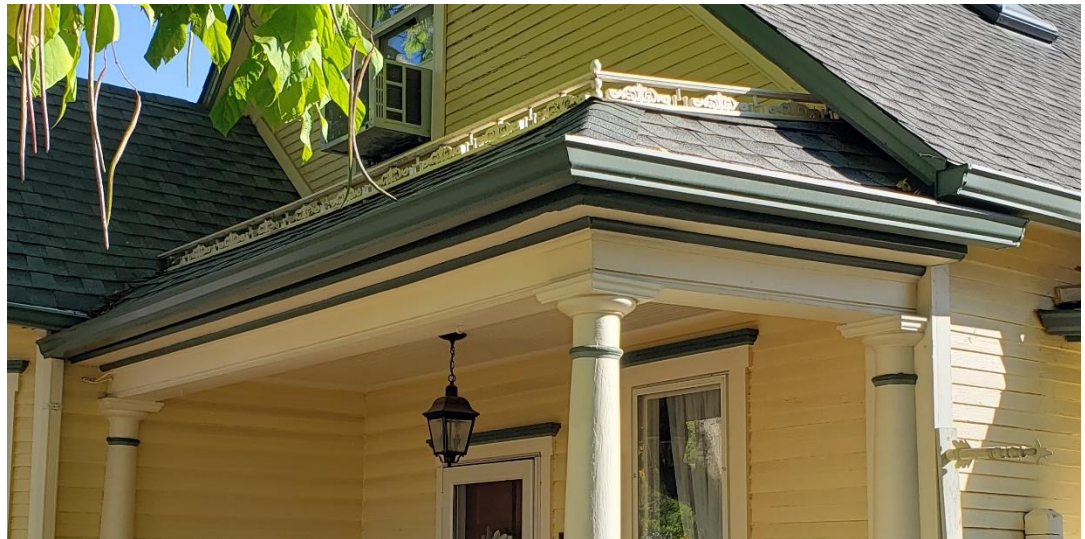
*Decorative painted wood railing and column capitals at the front porch roof.*

Repair, restore, or replace all of the painted wood ornamentation as necessary.
