**SUBJECT:** RESOLUTION NO. 97, SERIES 2025 – A RESOLUTION  
DESIGNATING THE RESIDENCE LOCATED AT 1016 MAIN  
STREET A HISTORIC LANDMARK

DAJ Design conducted an Historic Structural Assessment for the structure located at 1016 Main Avenue, Louisville, Colorado to determine its feasibility as a candidate for historic landmark designation as defined under the Historic Preservation program of the City of Louisville. The structure is a residential property. The City of Louisville Historic Preservation Commission found probable cause that the building may be eligible for landmarking under criteria in section 15.36.050 of the Louisville Municipal Code. Therefore, the Commission approved the Historic Structural Assessment to be paid for by the Louisville Preservation Fund grant.

The primary purpose of this HSA is to evaluate the property's current condition and to identify preservation priorities for the best use of rehabilitation funds. DAJ Design inspected 1016 Main visually to identify areas of necessary maintenance and repair. It is possible that complications exist that were not visible and therefore it is recommended that the property owner includes contingency funding in any repai

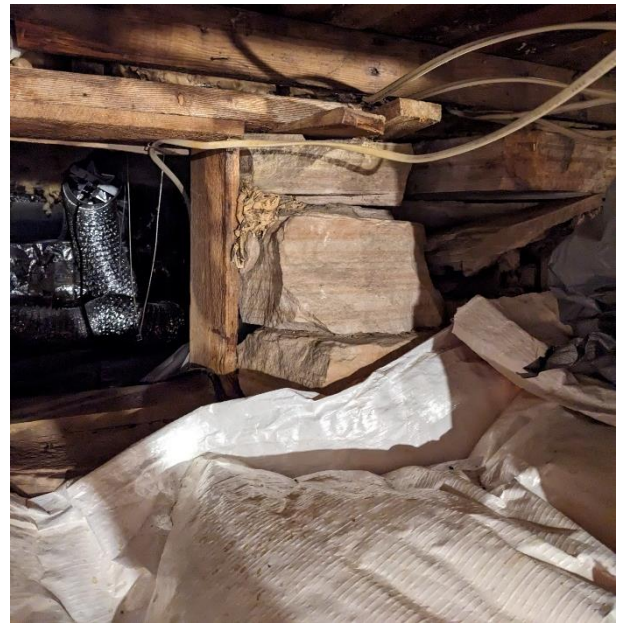
*The original stone foundation is only exposed in some areas inside the basement but is mostly covered with insulation.*

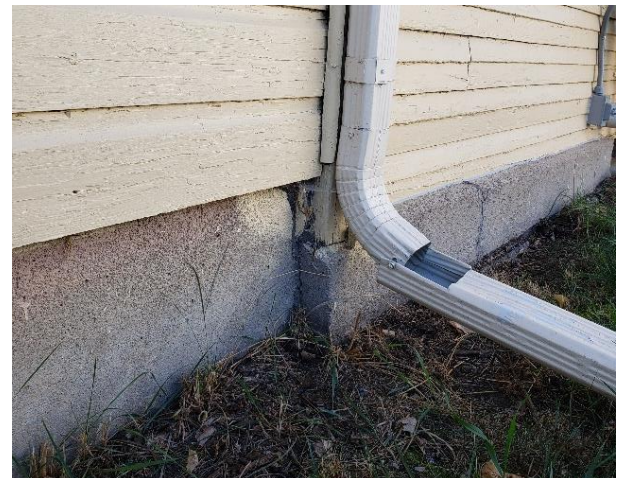
*A jog in the foundation shows the concrete face over the original stone foundation (right) relative the concrete foundation of the east addition (left).*

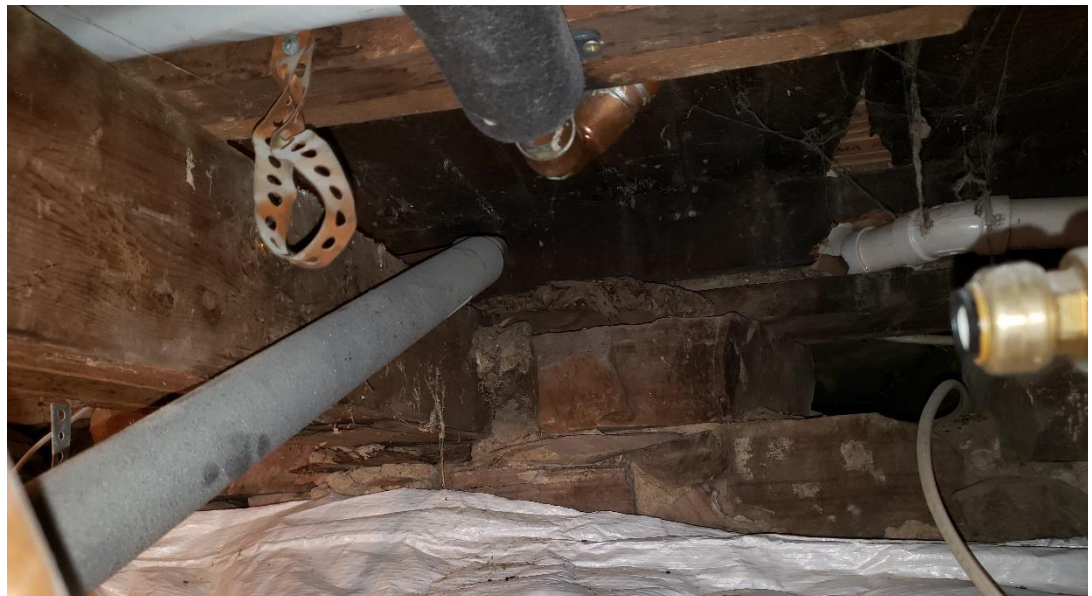
Overall, the various foundation elements appear to be in fair to poor condition, but our assessment is limited. The foundation walls extend below grade and the presence of any footings cannot be determined without destructive investigation; it is likely that a footing does not exist. It is also likely that the original foundation does not extend to a minimum frost depth of three feet below grade. There is a layer of concrete on the exterior face of the original stone foundation that is in fair condition, but this obscures visibility of the stone foundation to determine its condition. The concrete layer on top of the stone foundation does not provide adequate waterproofing of the foundation and appears to run minimally below grade. Some of the crawlspace areas at the east and west ends of the house have limited access and limited visibility to be able to determine the condition at all locations. Finally, there is a layer of vinyl drape insulation that obscures most of the foundation walls on the interior face. Where observed, the stone foundation requires tuck-pointing and it is presumed that this is true of the entire stone foundation.

*The foundation is minimally exposed as it is covered by insulation. The original foundation appears to be stone.*

1. The basement and crawlspace foundation walls showed various signs of damage that require further evaluation. No additional load should be added to the existing foundation system without a full analysis of the current foundation walls/footings. Additional strengthening of existing crawlspace walls may be needed as determined by a licensed structural engineer to meet current code specifications.

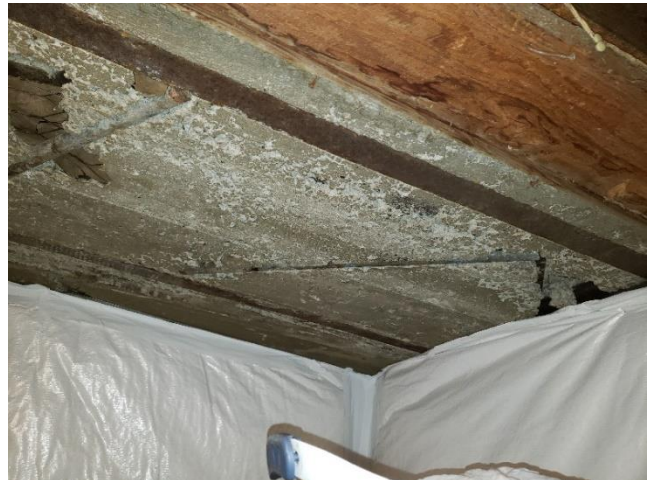
*Concrete ceiling in what was previously a coal room.*

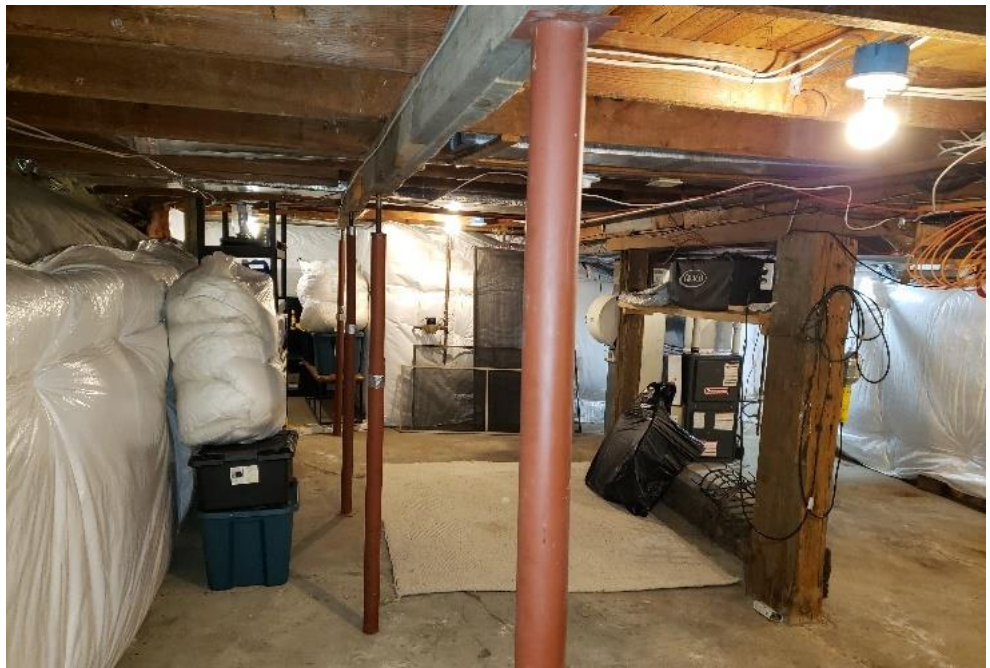
*Two beam lines supporting the main floor joists with columns bearing on a concrete slab floor.*

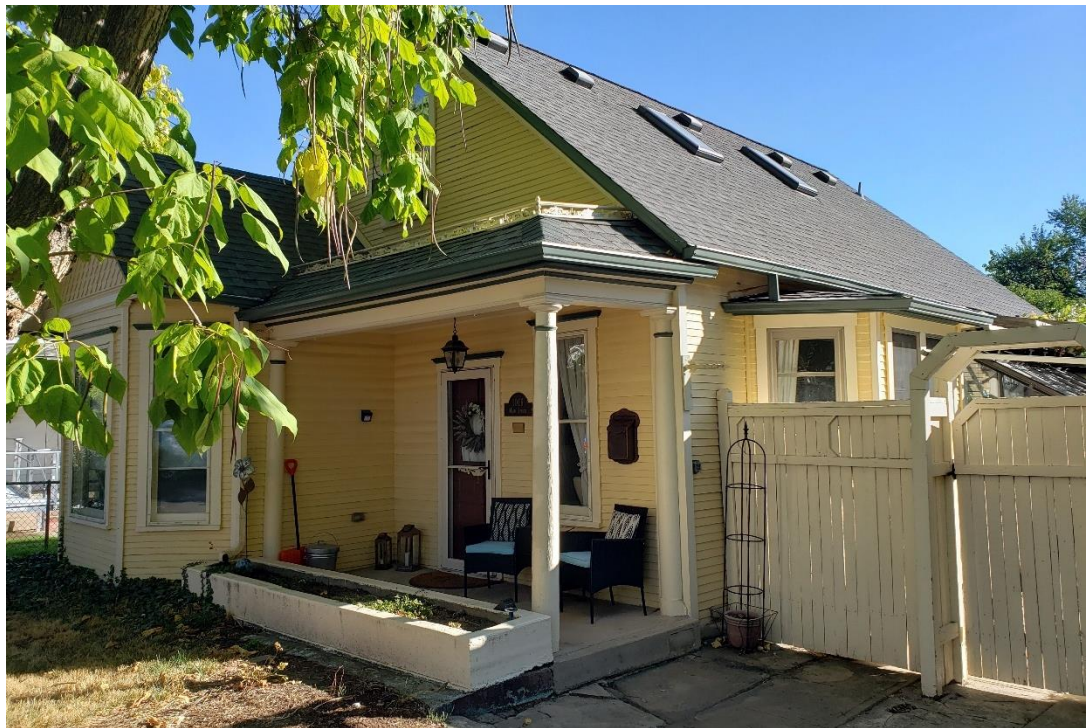
*Asphalt shingle roof with roof venting near the ridge.*

The asphalt composition shingle roof is in good condition. The areas of membrane roof appear to be in good condition but were not accessible during the site visit. The roof venting appears to be adequate for a small attic in the upper portion of the roof. However, this attic was not accessible and therefore assessment is limited.

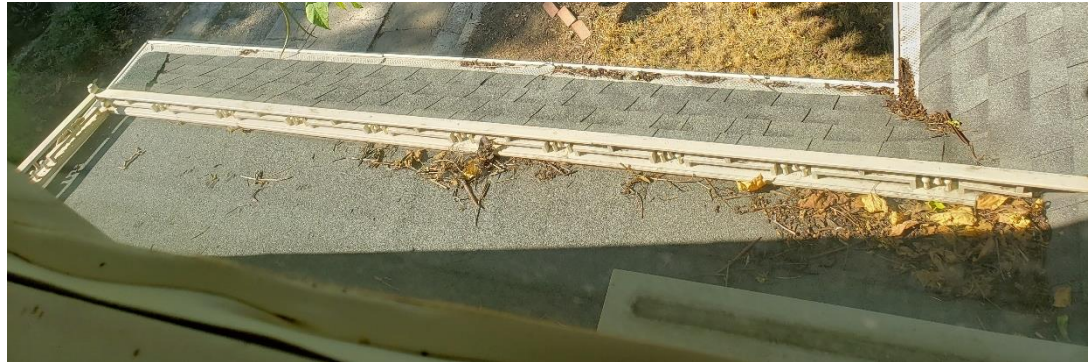
*Membrane roof at the covered front porch that is also found on the east addition.*

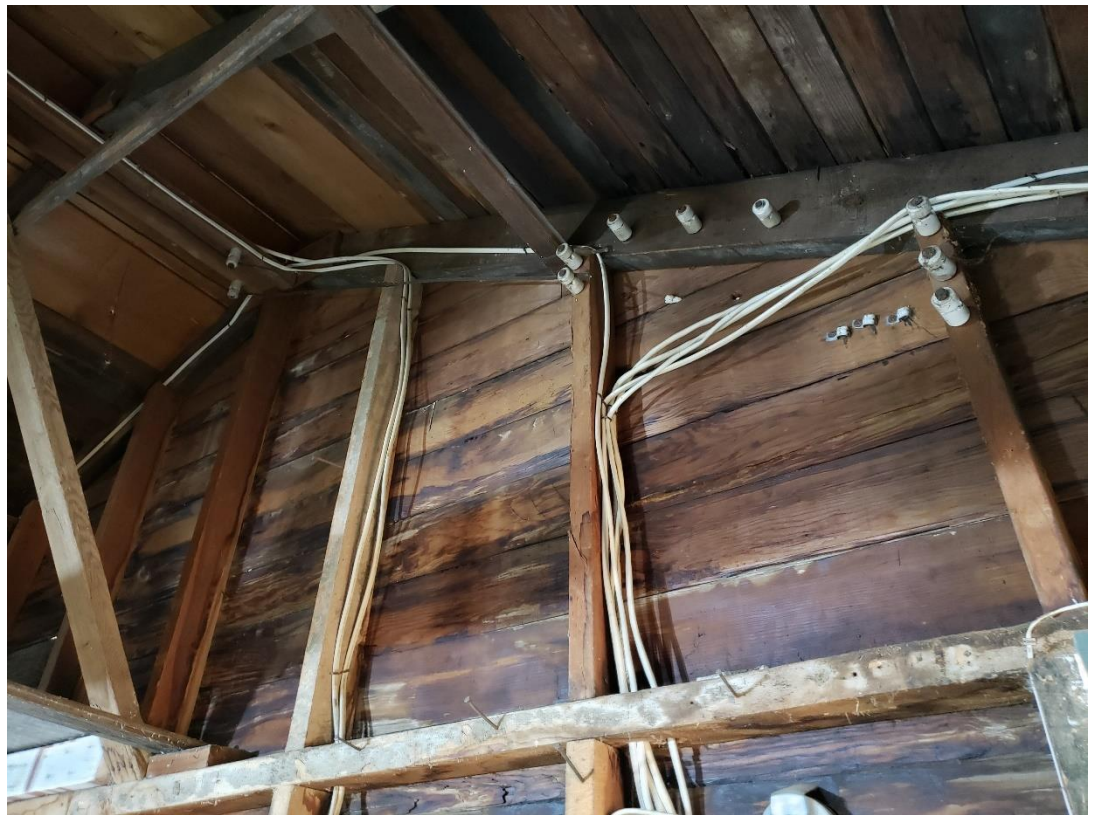
*Romex wiring next to abandoned knob-and-tube wiring in the garage.*
