## COLORADO CULTURAL RESOURCE SURVEY

### Architectural Inventory Form

1. Resource number: **5BL929**
2. Temporary number: **N/A**
3. County: **Boulder**
4. City: **Louisville**
5. Historic building name: **Romano House**
6. Current building name: **Leach House**
7. Building address: **536 Main Street**
8. Owner name: **Marian R. Leach**  
Owner address: **536 Main Street**  
**Louisville, CO 80027**

48. Report title: **"Old Town" Louisville Historical Building Survey**

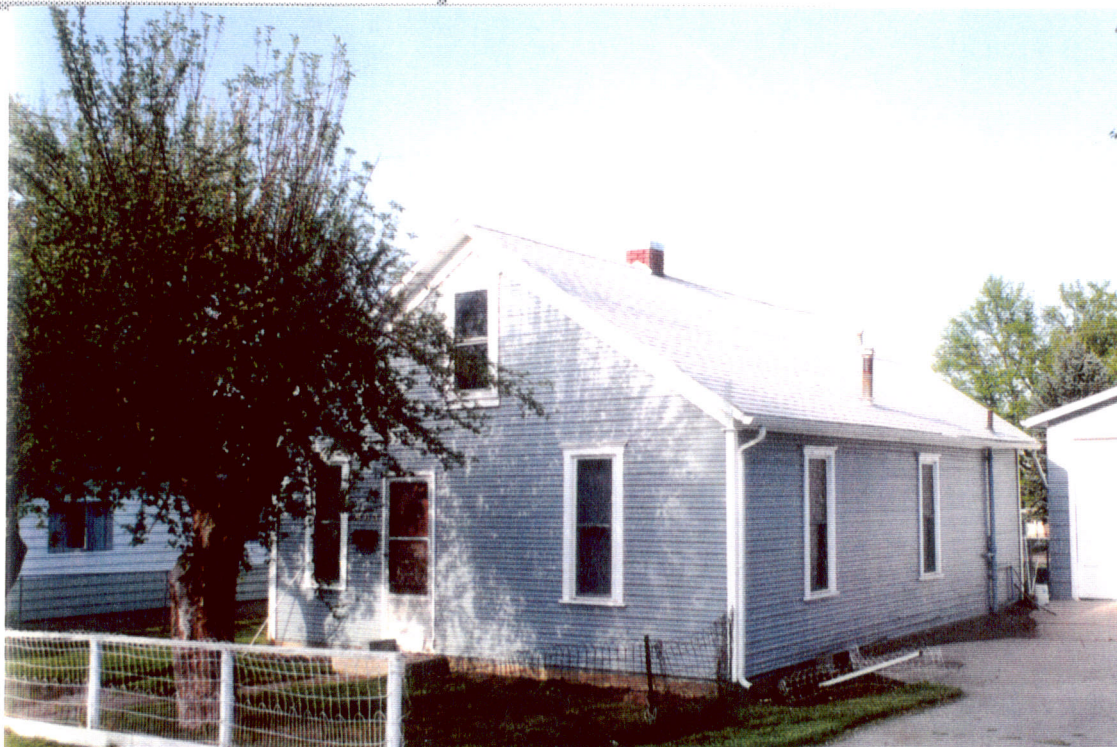
**Other Style**  
**(Wood Frame Front**  
**Gabled Dwelling)**
