## COLORADO CULTURAL RESOURCE SURVEY

### Architectural Inventory Form

#### II. GEOGRAPHIC INFORMATION

#### Official Eligibility Determination

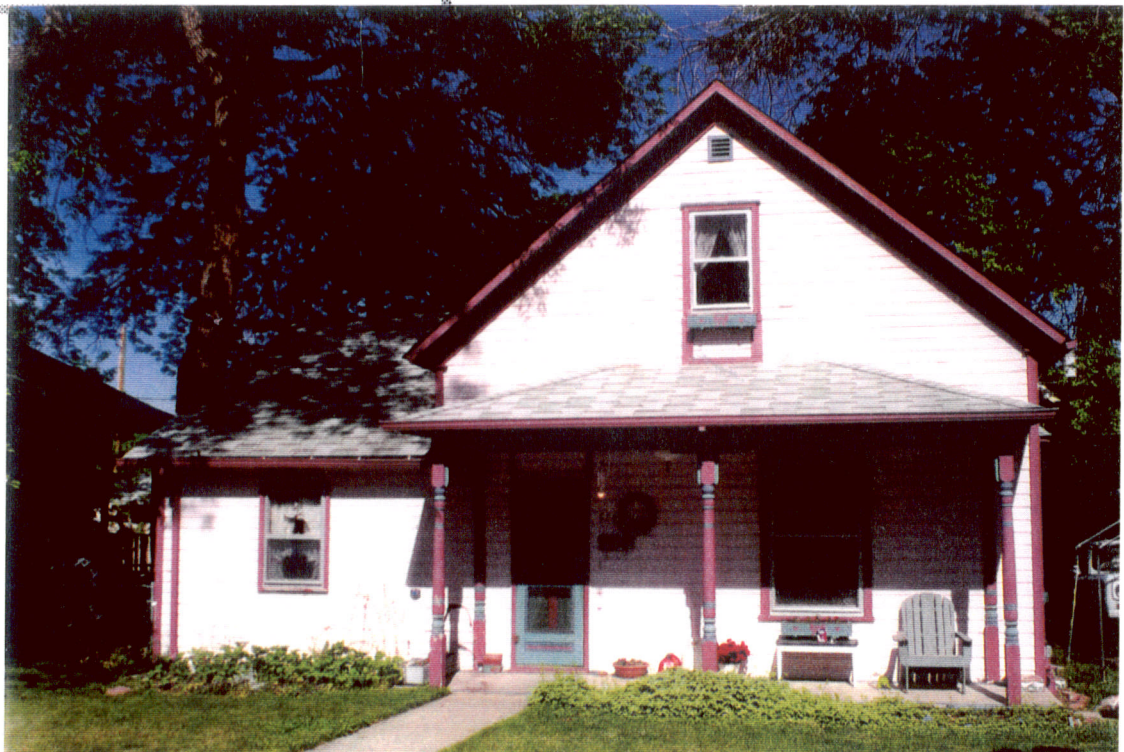
Built at the turn of the twentieth century, this residence is a 1½-story wood-frame dwelling, supported by a low sandstone foundation, covered with concrete pargeting. The building's exterior walls are painted beige horizontal weatherboard, with painted buff red 1" by 4" corner boards. The roof is a moderately-pitched front gable, with an intersecting gabled to the north elevation. (This portion may be an early addition.) The roof is covered with grey asphalt shingles and has boxed eaves. A red brick chimney is located just below the ridge on the north facing roof slope. Windows are primarily 1/1 double-hung sash, with painted white wood frames, and painted buff red wood surrounds. Double hung windows on the north elevation, and on the facade (west elevation) are also decorated with flower boxes beneath the sills. Other windows of note include a canted hipped-roof bay on the south elevation, and two 8-light casement windows in an enclosed shed-roofed rear porch, at the east end of the south elevation. A painted brown and green wood-paneled door, with six upper sash lights, and with a painted green wood screen door, opens onto a concrete porch which extends along the south end of the facade. Painted buff red and green turned columns support a low-pitched hipped porch roof. The house's secondary entrance is located on the east elevation. Two non-historic 1x1 horizontal sliding glass bypass doors, open onto a large non-historic redwood deck, covered by a shed roof.
