## COLORADO CULTURAL RESOURCE SURVEY

### Architectural Inventory Form

1. Resource number: **5BL8014**
2. Temporary number: **N/A**
3. County: **Boulder**
4. City: **Louisville**
5. Historic building name: **Wolfer House**
6. Current building name: **Louisville Chamber of Commerce**
7. Building address: **901 Main Street**
8. Owner name: **Vanatta Limited Partnership LLLP**  
Owner address: **1492 Alpine Avenue**  
**Boulder, CO 80304**

48. Report title: **"Old Town" Louisville Historical Building Survey**

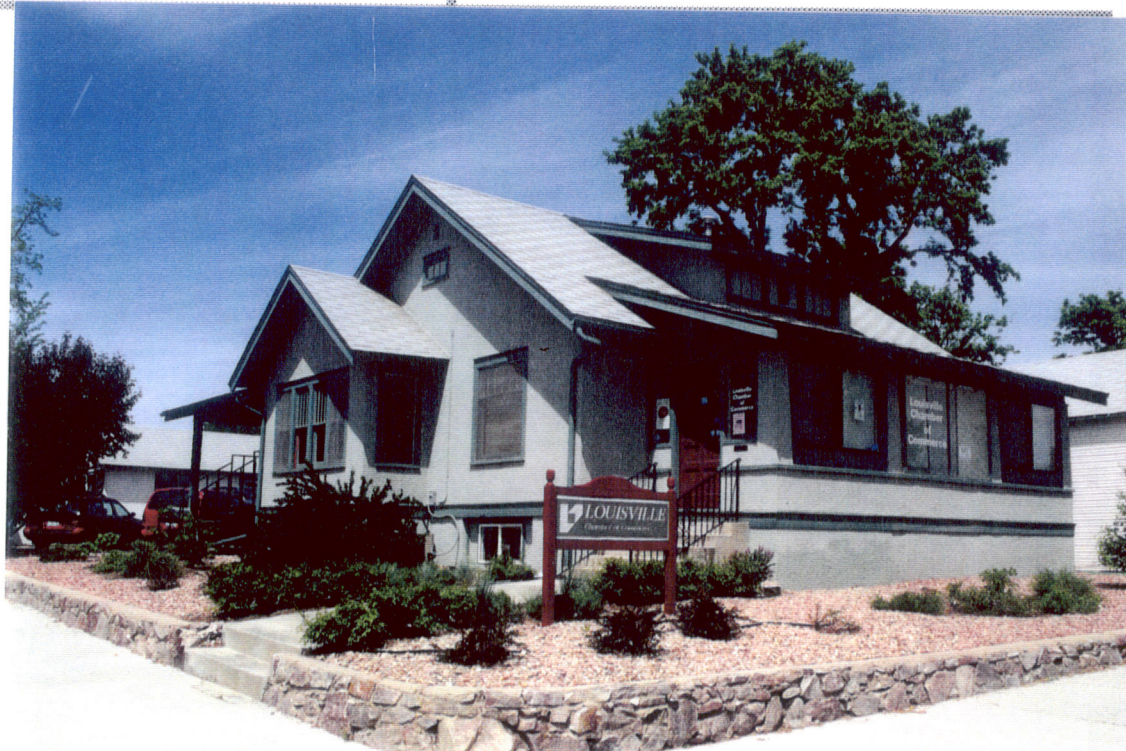
14. Building plan (footprint, shape):  
**Rectangular Plan**
15. Dimensions in feet: **2112 square feet**
16. Number of stories: **1½**
17. Primary external wall material  
**Stucco**
18. Roof configuration (enter one):  
**Gabled Roof / Cross Gabled Roof**
19. Primary external roof material (enter one):  
**Asphalt Roof**
20. Special features (enter all that apply):  
**Porch**  
**Dormer**

**Late 19th and Early Twentieth  
Century American Movements  
/ Craftsman**

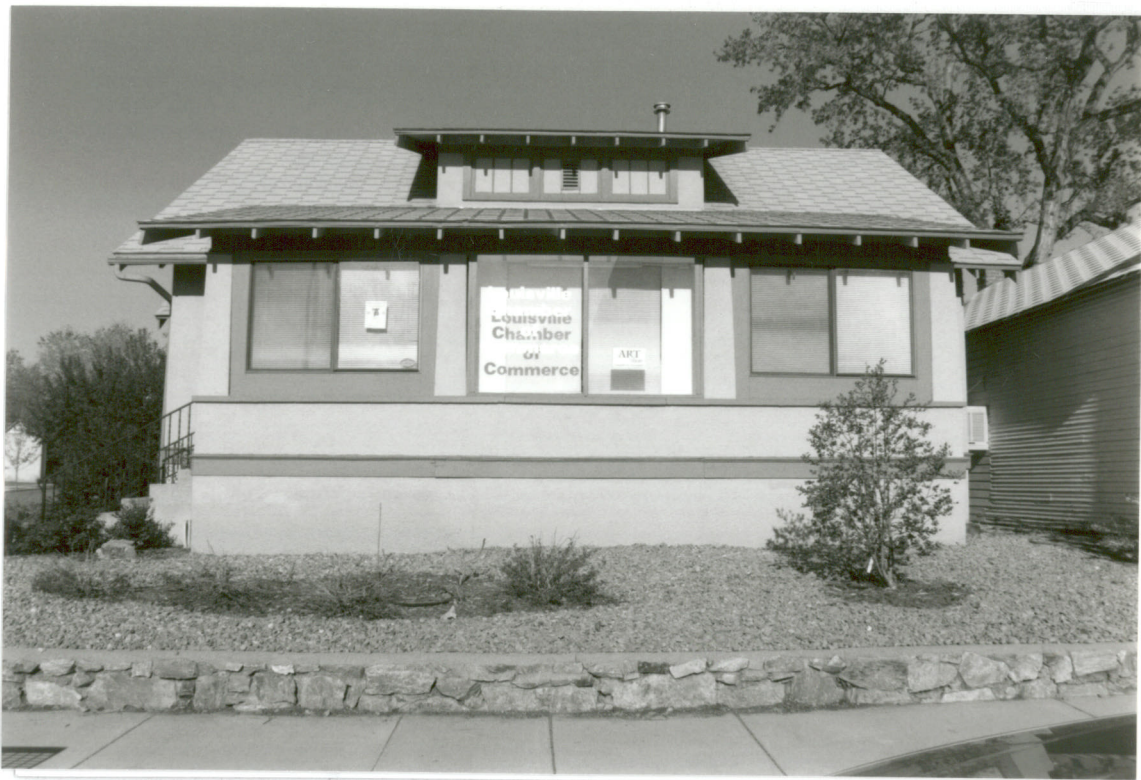
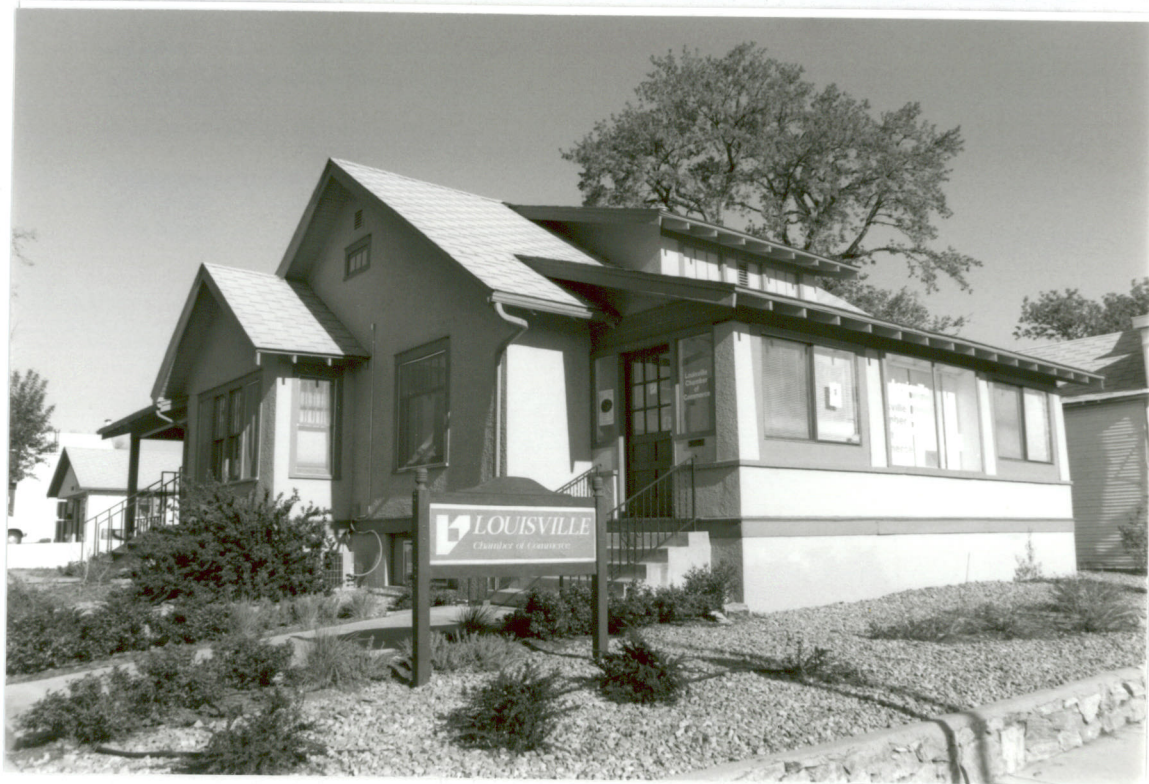
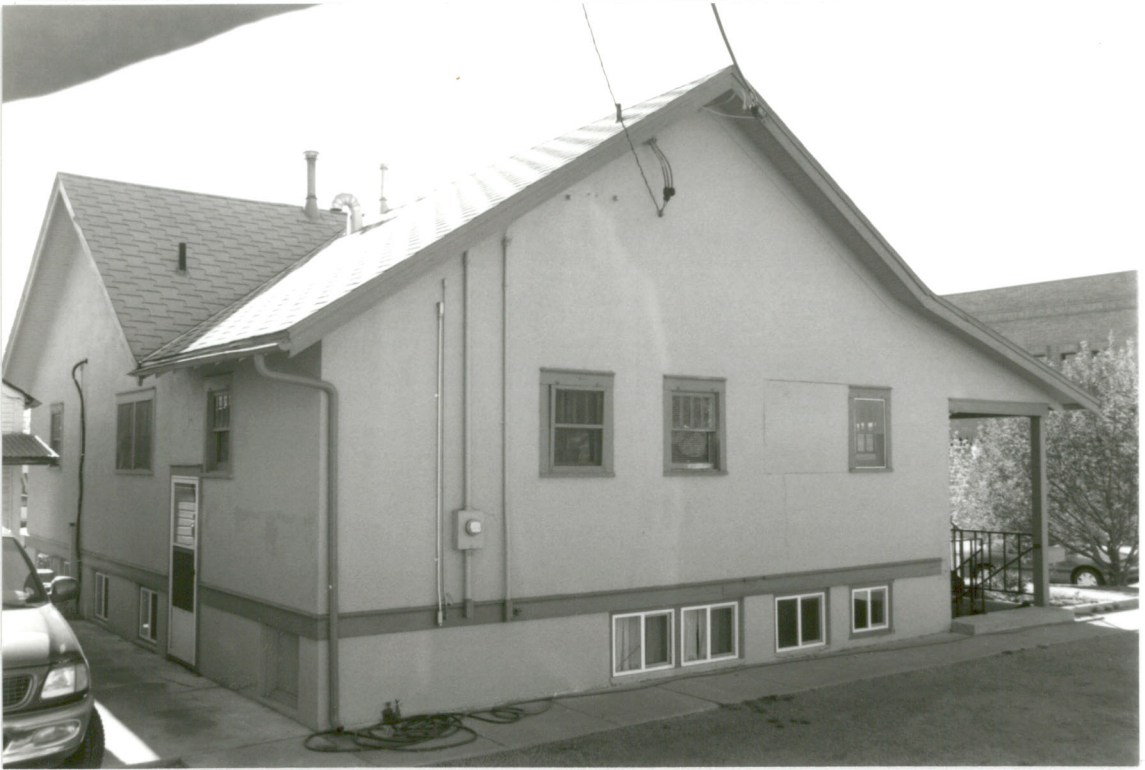
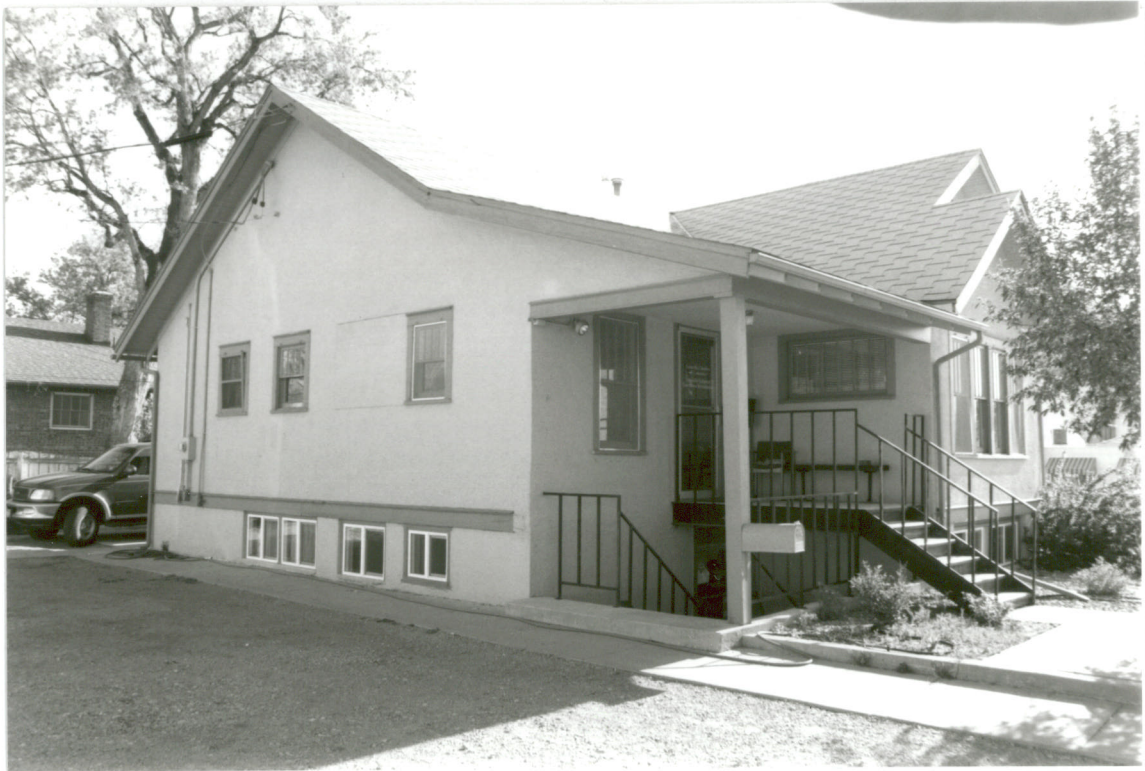
901 Main Street, Louisville, Colorado

Exhibiting elements of the Craftsman style of architecture, this building is supported by a concrete foundation, covered with painted blue green color stucco. There is at least a partial basement, with non-original 1x1 horizontal sliding windows. The building's walls are also painted blue green color stucco, over masonry or wood frame construction. The intersecting gables roof is clad with green asphalt shingles, and the rafter ends are exposed. A shed-roofed dormer, on the east elevation, has three 3-light windows. Windows are primarily 4/1 and 6/1 double-hung sash (ribbon style), with painted wood frames and surrounds. A large, rectangular bay window, covered by a gable roof, is located on the south elevation. An enclosed shed-roofed front porch extends nearly the full length of the facade. The porch is illuminated by a large 2-light fixed-pane center window, flanked by smaller 2-light windows. A painted buff red entry door provides access to the front porch at the far east end of the south elevation. A painted solid wood door, with an aluminum storm door, opens onto a concrete sidewalk, located on the building's north elevation. A flight of six steel steps, flanked by a black wrought iron, leads to a glass-in-steel-frame door, located on the south elevation. Below this door, another flight of steps descends to a basement-level door.
