## **REQUEST FOR PROPOSALS FOR HISTORIC STRUCTURE RELOCATION AND REHABILITATION**

# HISTORIC STRUCTURAL ASSESSMENT OF: 801 & 809 Lee Ave., Louisville, Colorado

**Inspection Date:**  
4 May 2017

**Prepared By:**  
F&D International LLC  
1930 Central Ave., Unit B  
Boulder, CO 80301  
303.652.3200  
[www.fdi-one.com](http://www.fdi-one.com)

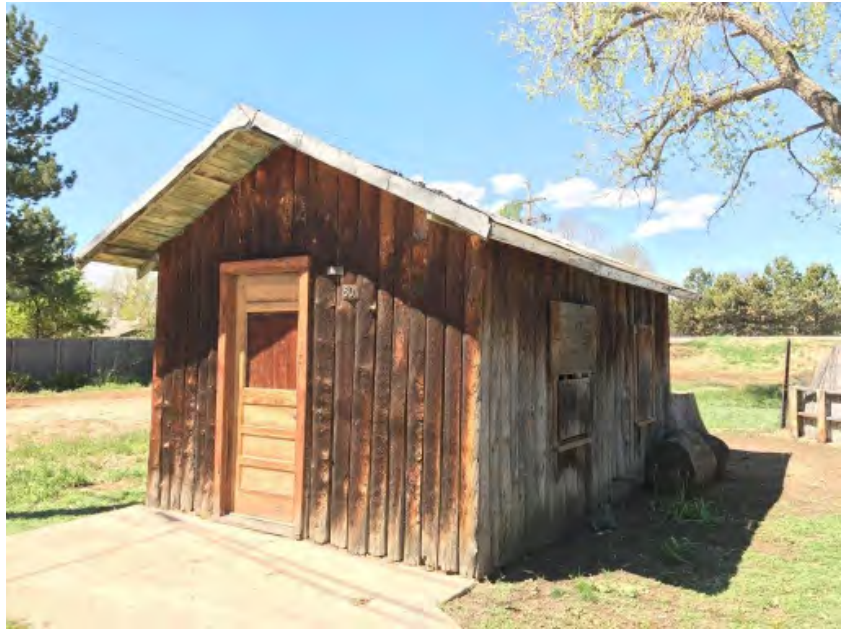
**Picture 5** – East and north elevation of Cabin 801. The siding is a pine log siding that has been debarked and sawn to a thickness of approximately 1 ½" inches. It is nailed to a horizontally planked wood sheathing. The siding is in good condition, some signs of deterioration though. It is believed the cabin sits upon a concrete pad type foundation.

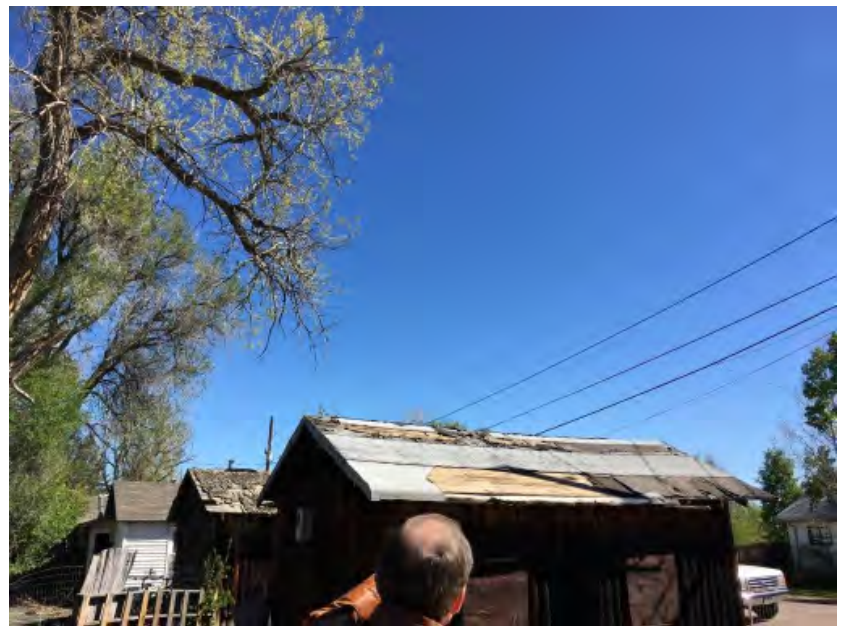
**Picture 6** – Cabin 801, The roof is a 1 vertical to 2 horizontal gabled roof. The covering is 90 lb granular rolled roofing material in very poor condition.

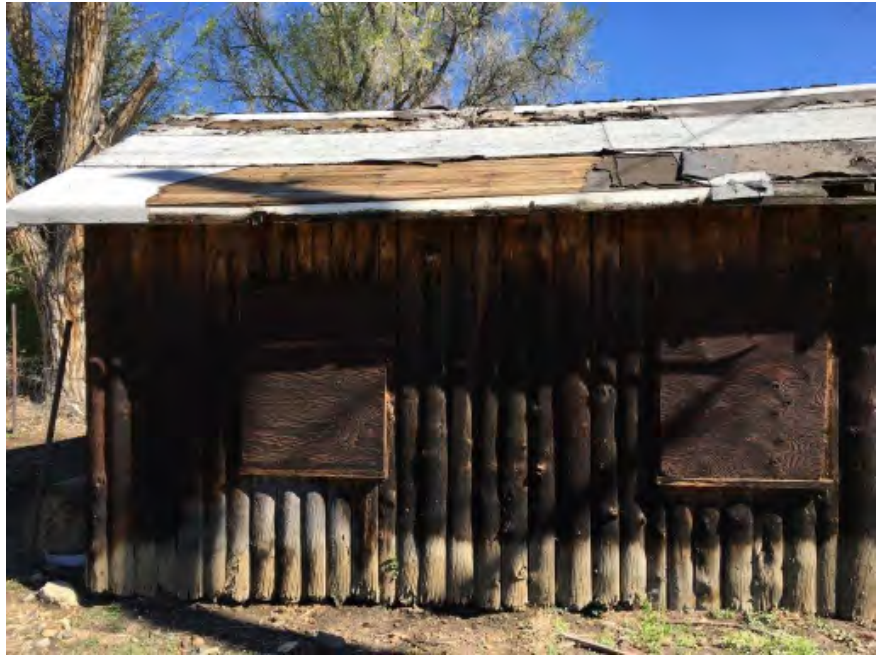
**Picture 7** – Cabin 801, south facing roof, as noted the roof covering is in very poor condition. If the cabin is to be preserved, it will require immediate attention to a new roof covering.

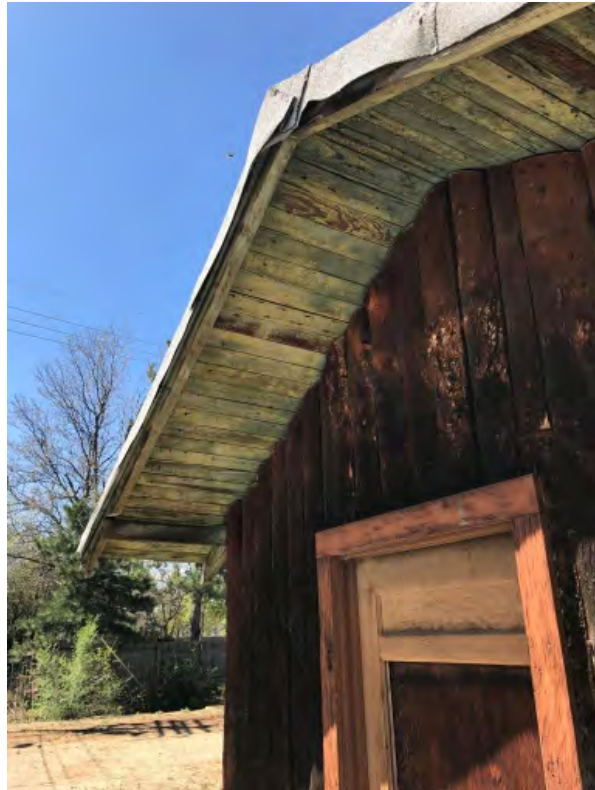
**Picture 8** – Cabin 801, the roof is stick framed with rough sawn 2x4 on 24 inch centers and sheathed with a 1x4 wood planks, rabbet joinery. From what could be seen from the sheathing and rafters, it appeared in sound structural condition.

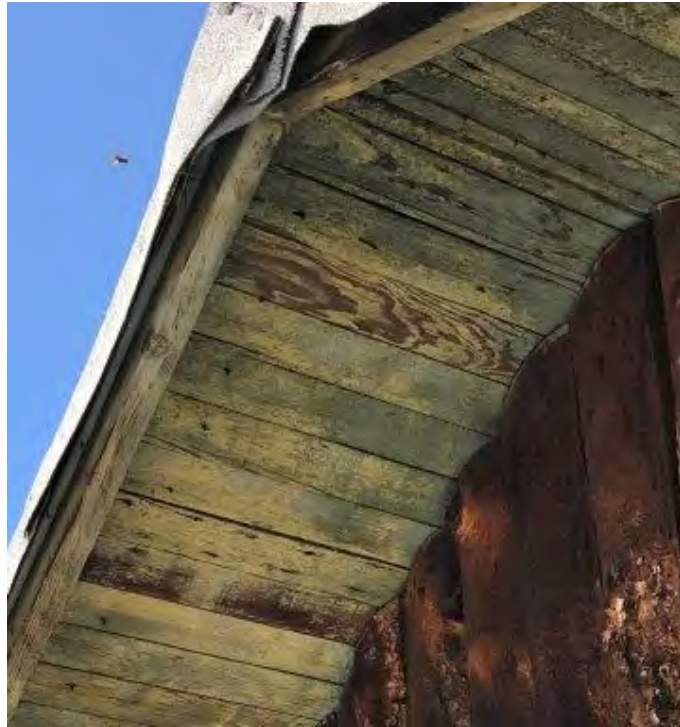
**Picture 9** – Closer view of Cabin 801 roof sheathing and end rafters.

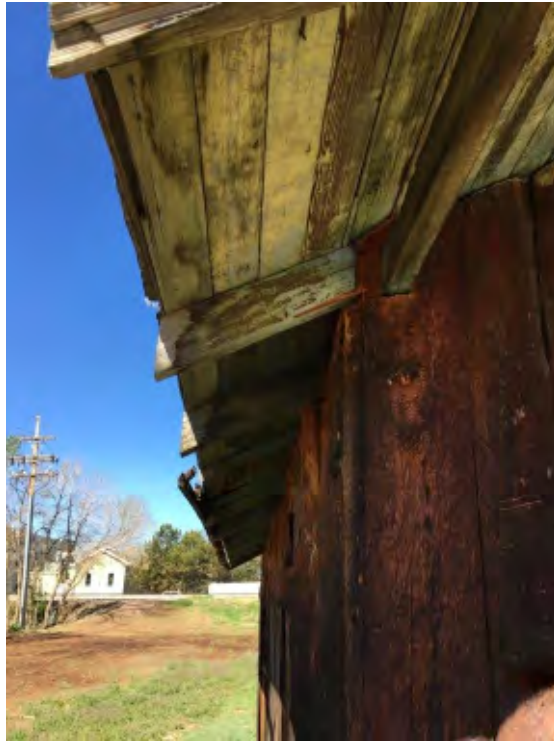
**Picture 11** – Cabin 809 roof system is stick framed rough-sawn rafters on 24 inch centers and a roof pitch of 1 unit vertically to 2 units horizontally. The roof deck is sheathed with 1x6 wood planks, rabbeted together. The roof structure appears in sound condition.

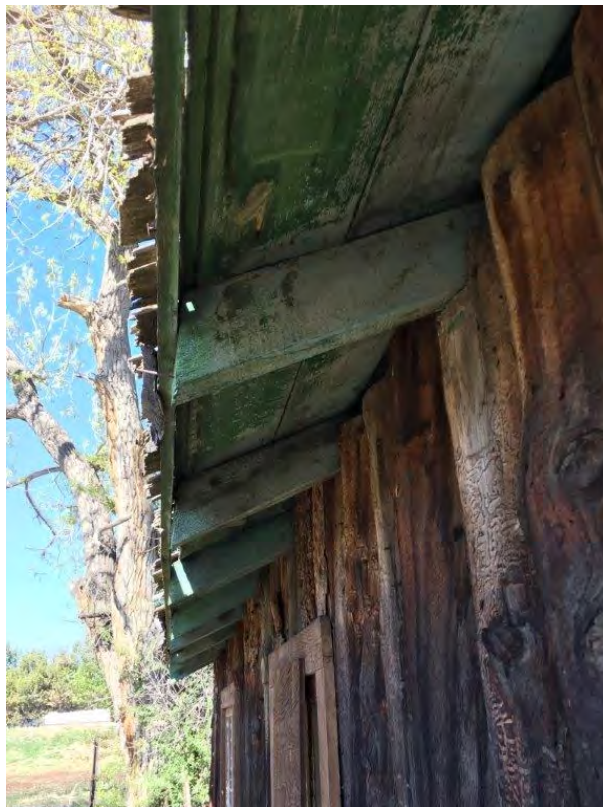
**Picture 14** – The rafters on both Cabin 801 and 809 are plumb cut and trimmed with a fascia board. The fascia board on both cabins is in various states of decay and needs replacement as well as the fascia boards on the end gables as well.

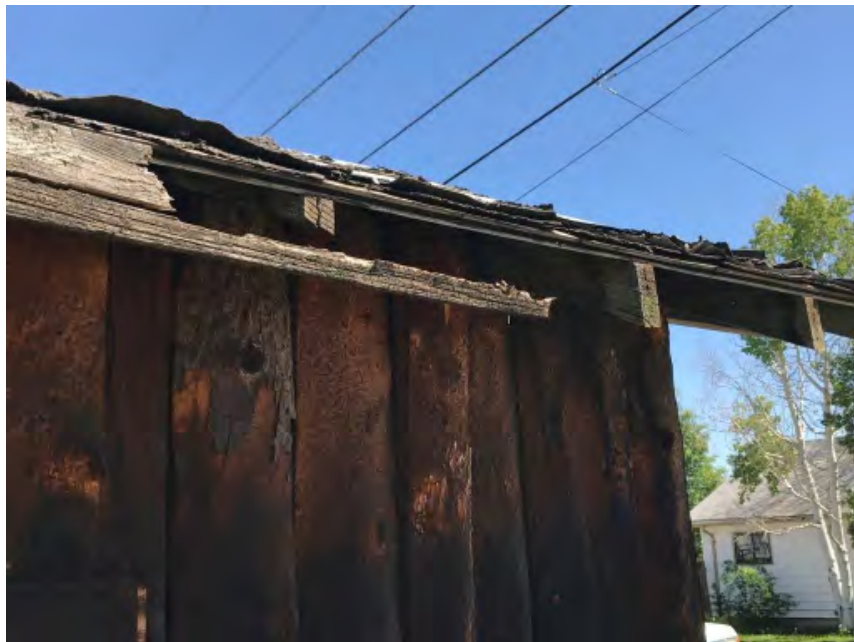
**Picture 16** – Trim fascia boards on Cabin 801, note condition of trim fascia board is in decayed poor condition. If cabins are to be preserved, all roof trim boards will need to be replaced, along with new roof covering.

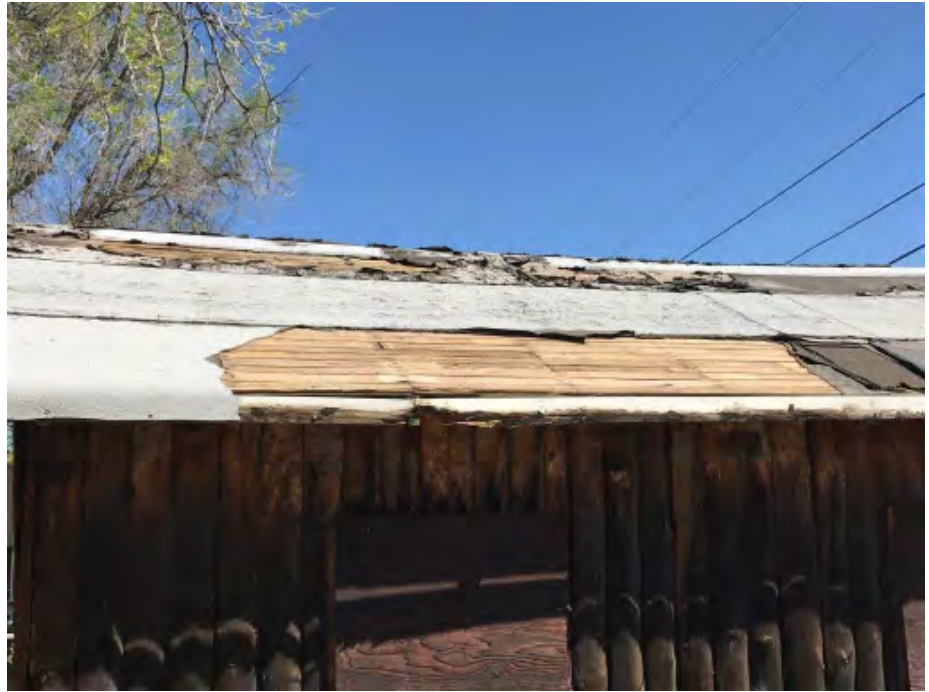
**Picture 17** – Roof covering on Cabin 801, in very poor condition, urgently needs to be replaced.

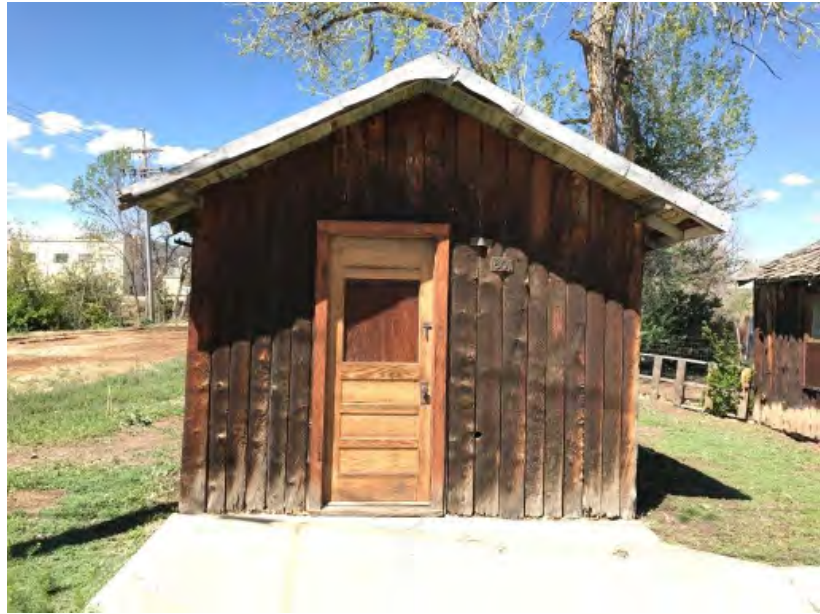
**Picture 19** – View of east elevation. Cabin is sided in pine plain sawn pine logs. It is believed the siding is original. Overall the siding is in good condition. Currently the cabin is being used as a storage facility.

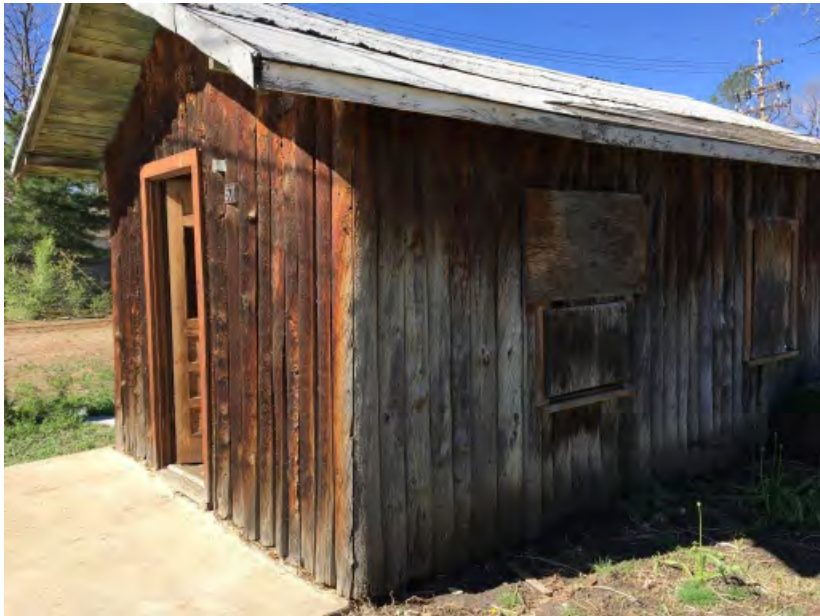
**Picture 20** – View of cabin, siding is in generally sound condition, needs to be re-sealed. Siding is nailed to the underlying wood plank sheathing.

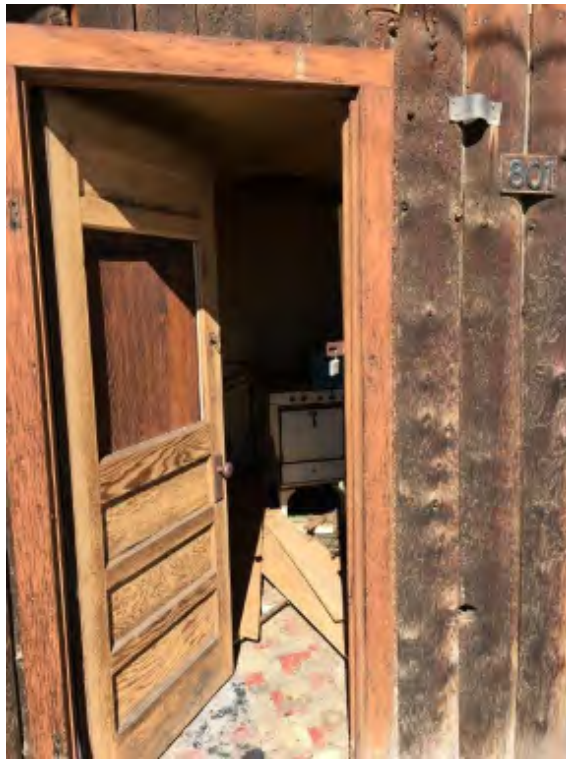
**Picture 21** – Entrance door, door is in poor condition. Door could be restored. Door jamb is relatively plumb and level, in good condition.

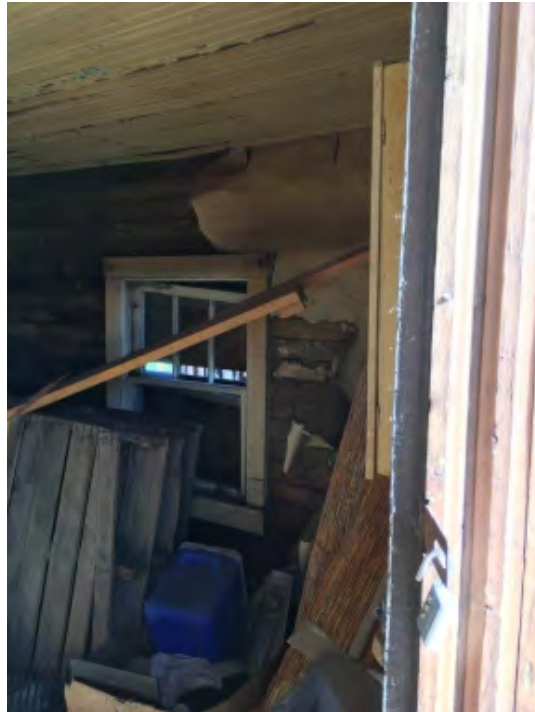
**Picture 22** – Interior view of east room, refer to page 4 in report for a sketch floor plan. Exterior wall is sheathed with 1x4 horizontal planks, rabbeted. Exterior wall is assumed to be rough-sawn 2x4's on 24 inch centers, sheathed on both sides.

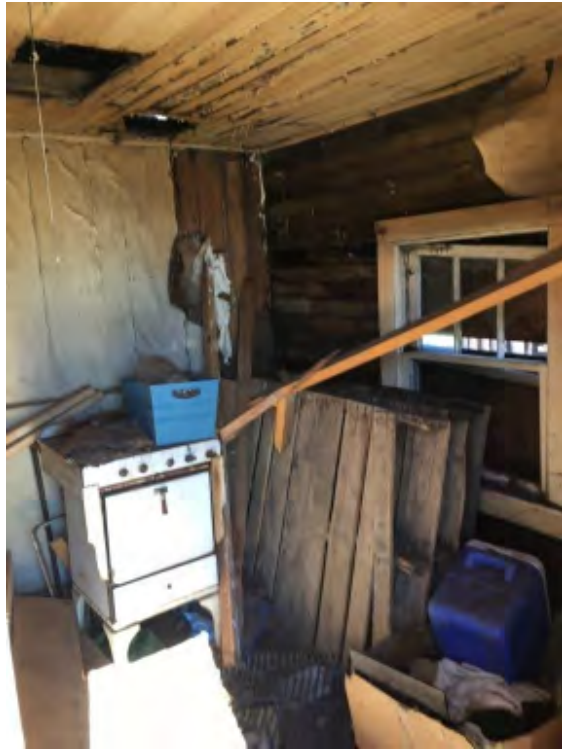
**Picture 23** – View of front room. Gas stone in the corner, located to the back of the front room to the north side. Note ceiling is beaded board, nailed to rough-sawn 2x4 ceiling joists.

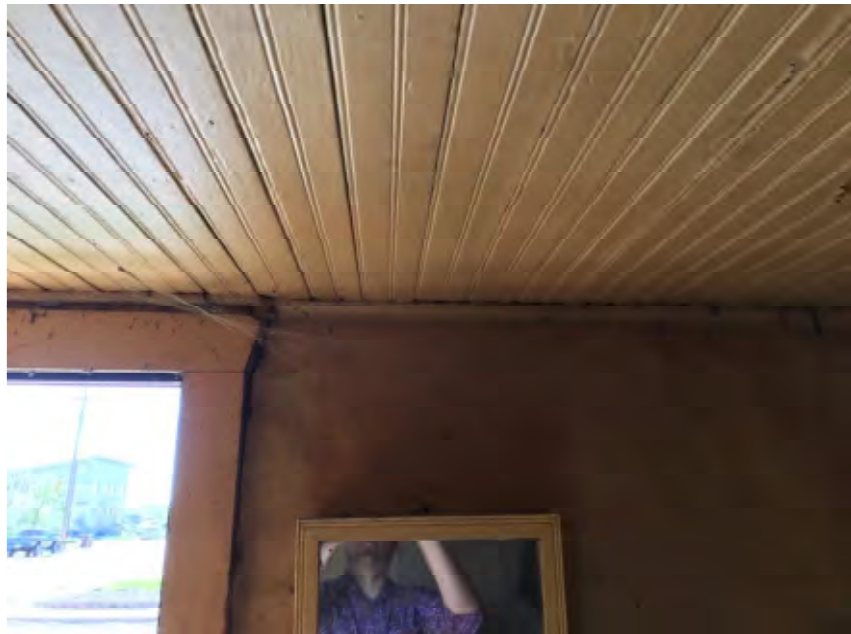
**Picture 26** – Ceiling treatment. T&G beaded board. Also note the casing around the entry door, 1x4 pine casing.

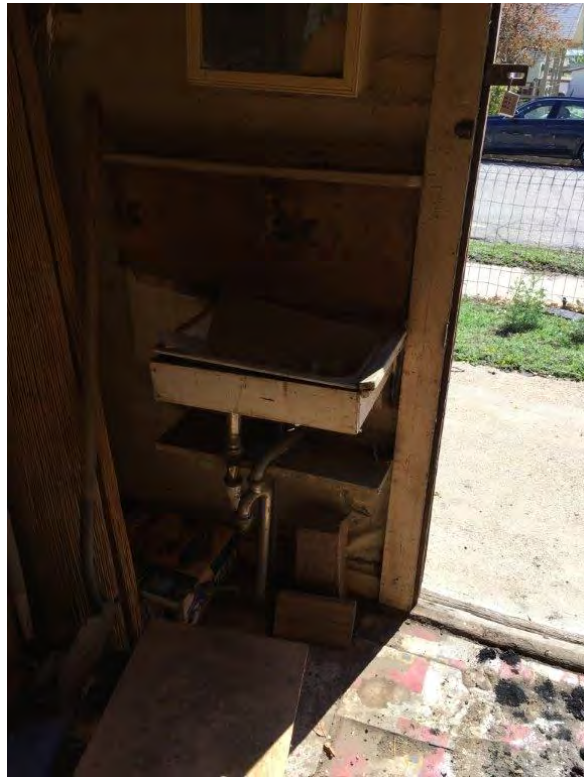
**Picture 27** – Immediately to the north of the front door is a sink. Sink was not operational.

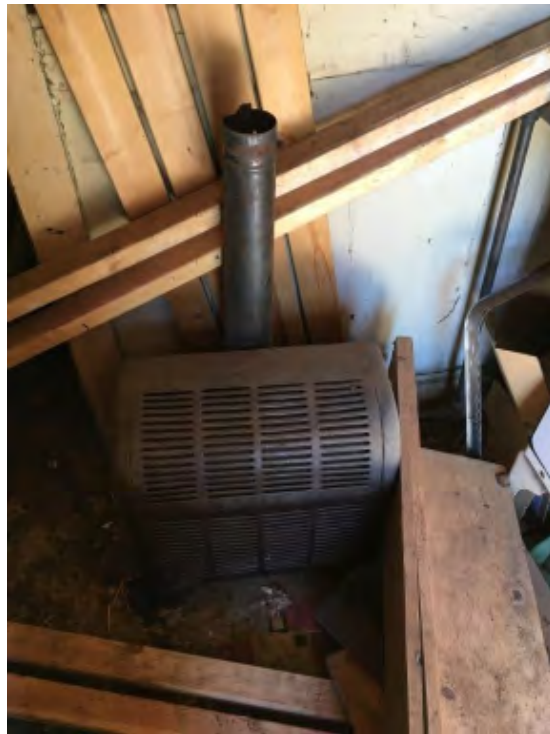
**Picture 28** – Cabin also appears to have had a gas fired heater. The manufacturing date of the heater was not discovered. It is opined that the gas heater and stove were added to the cabin sometime after the cabin was constructed.

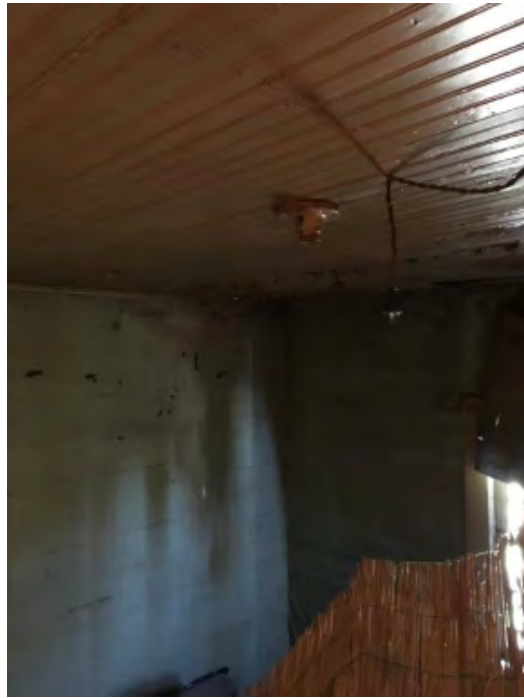
**Picture 29** – The cabin was electrified. The service entered on the west side (back of the cabin). The wiring method was knob & tube and surface mounted conductors with porcelain devices. Each room has a ceiling mounted light and at least one receptacle. Note also the interior finish of the back room as well.

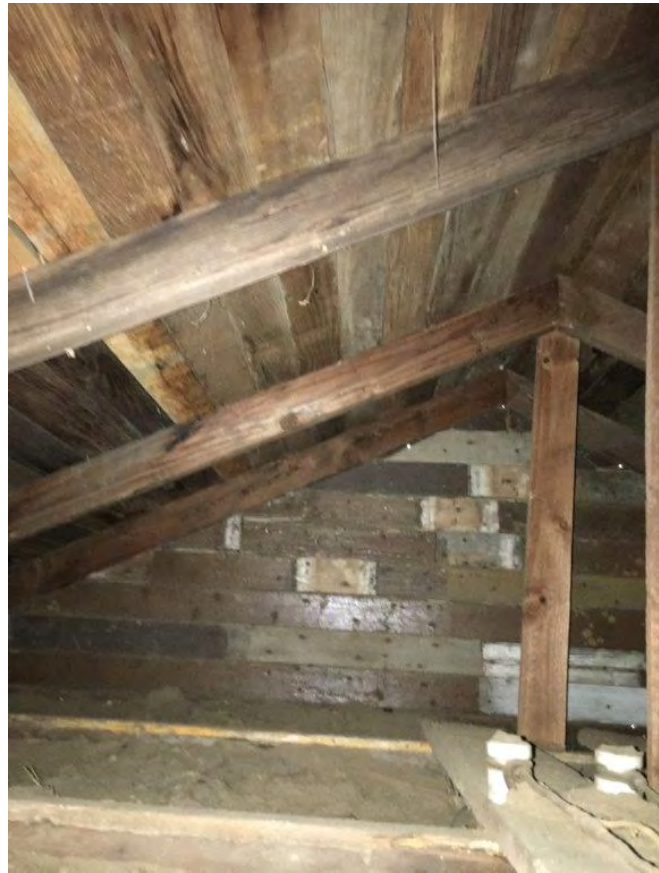
**Picture 31** – View of the roof structure. As noted, rafters are rough-sawn 2x4, 24 inches on center sheathed with 1x4 rabbeted planks. The structure appears sound and in relatively good condition.

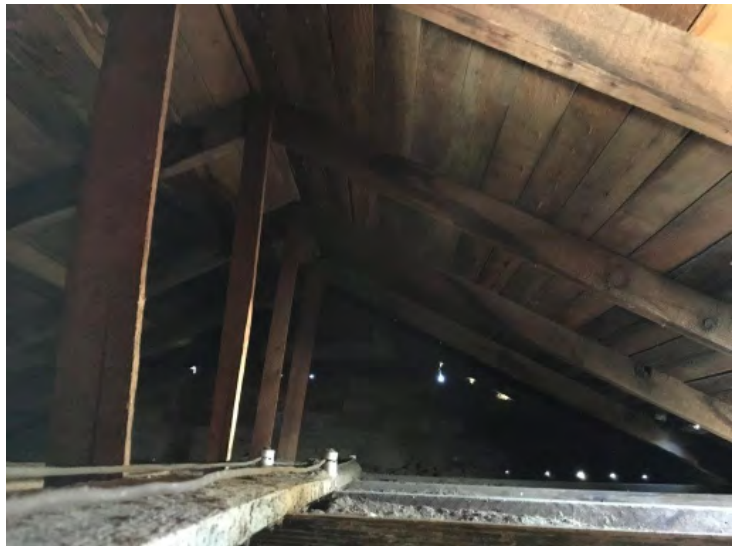
**Picture 32** – Another view of the roof structure. Note also the electric conditions, using knob insulators. It is conjectured, due to the surface running on conductors that the cabin was originally not electrified and the electrification came sometime after the cabin was constructed.

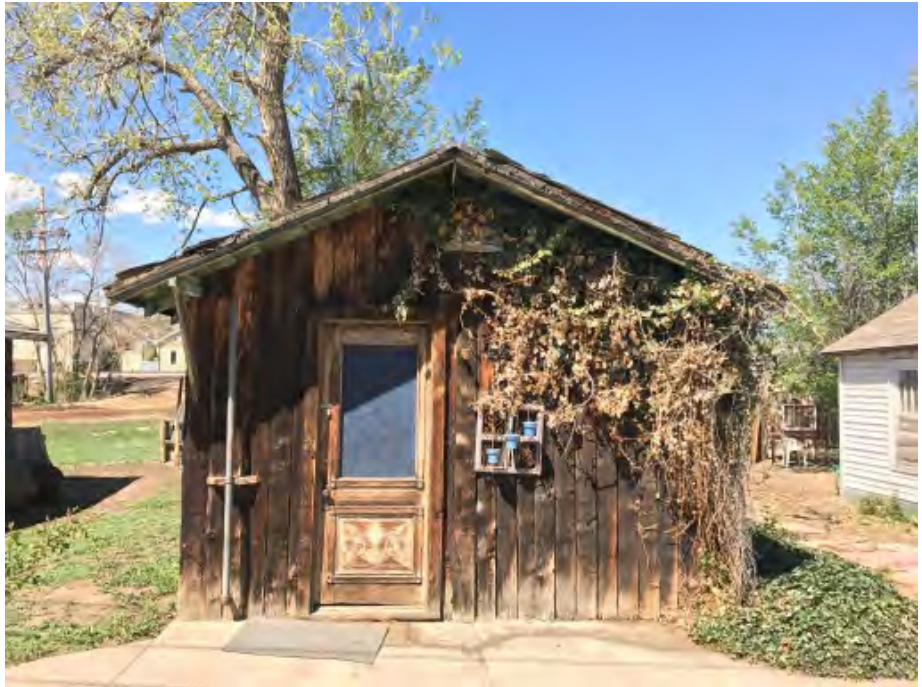
**Picture 33** – East elevation of Cabin 809. Cabin 809 is the larger of the two cabins. Construction methods and material are very similar as Cabin 801. The front entry door appears to be original to the structure and would recommend the door be restored. The vertical pipe to the left of the door is the vent pipe for the sink.

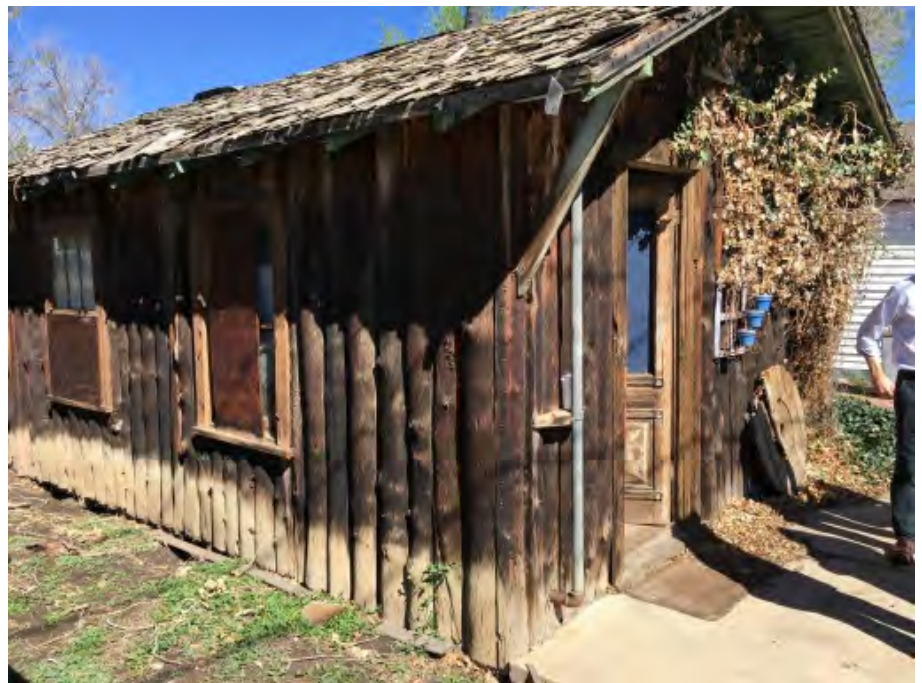
**Picture 34** – View of the east and south elevations. Windows are double hung unit units, in various stages of decay.

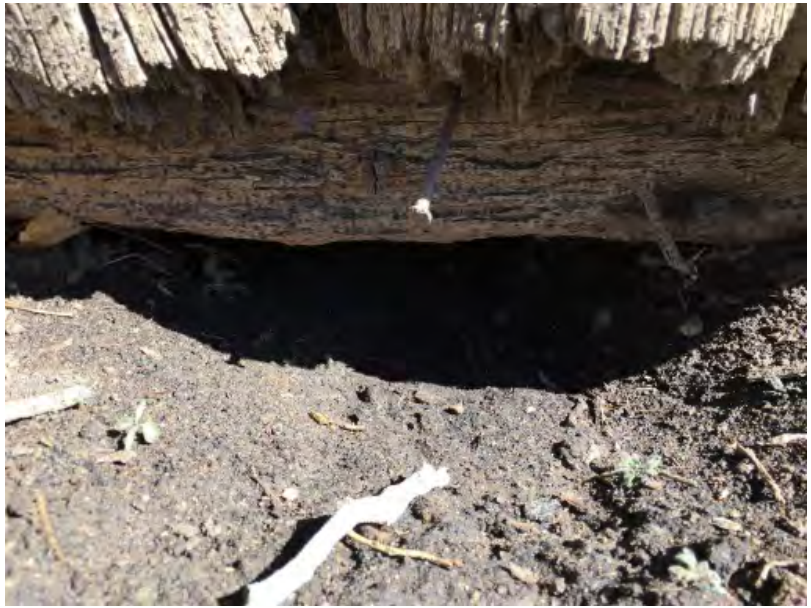
**Picture 36** – The floor structure system is indeterminable. It is assumed to be sitting on wood girders with rough-sawn floor joists, which is typical for the era and similar to the exterior wall framing. The lower sections of the siding are showing decay.

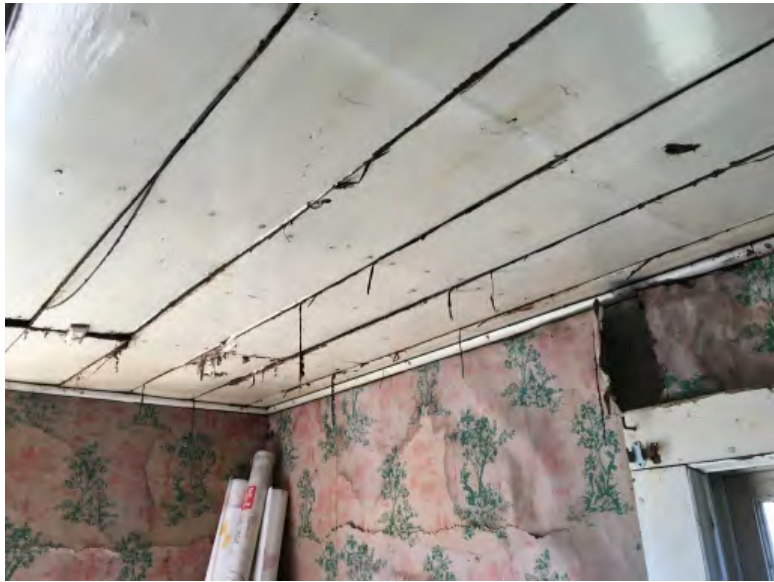
**Picture 37** – The interior has painted ceiling and trim and wallpaper covered walls. The ceiling is finished with 1x6 pine planks, nailed to ceiling joists. It appears the ceiling may be insulated to some degree as evidence of the tar paper that is hanging through the cracks in the pine planking.

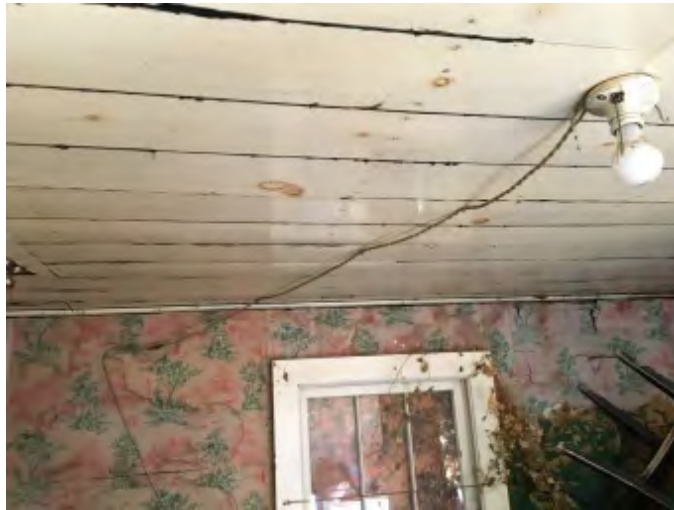
**Picture 39** – It is conjectured sometime after the cabin was constructed and occupied, it was electrified, probably sometime in the 1950's the cabin received electric power. Each room, of the two-room cabin had a ceiling mounted porcelain lamp holder and at least one receptacle. Wiring is knob and tube and surface wiring.

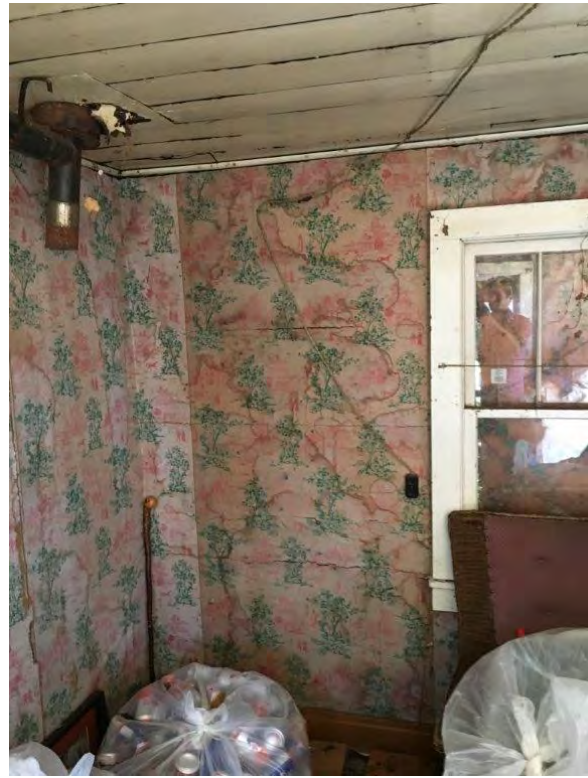
**Picture 41** – To the left of the window is a surface mounted electrical receptacle. The cabin was also fitted with what was assumed a gas fired heater and stove similar to Cabin 801 to the south.

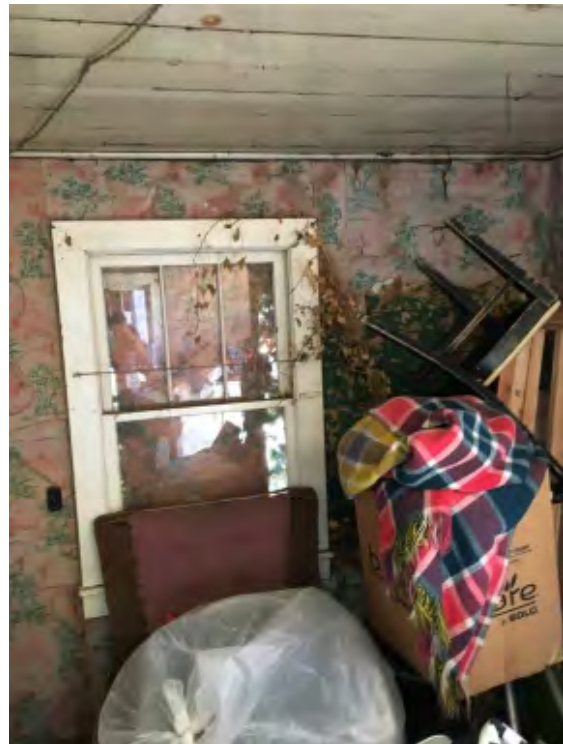
**Picture 42** – Window is cased out and is a double hung window. Upper sash is three divided lights and the lower sash is full lite. Such a window style was common for the era found in homes all across Boulder County.
