**SUBJECT:** RESOLUTION NO. 55, SERIES 2025 – A RESOLUTION  
APPROVING A PURCHASE CONTRACT TO BUY AND SELL REAL  
ESTATE AT 1016 MAIN STREET AND AUTHORIZING THE USE OF  
HISTORIC PRESERVATION FUNDS FOR THE PURCHASE PRICE

**DATE:** AUGUST 5, 2025

**PREPARED BY:** ROB ZUCCARO, COMMUNITY DEVELOPMENT DIRECTOR

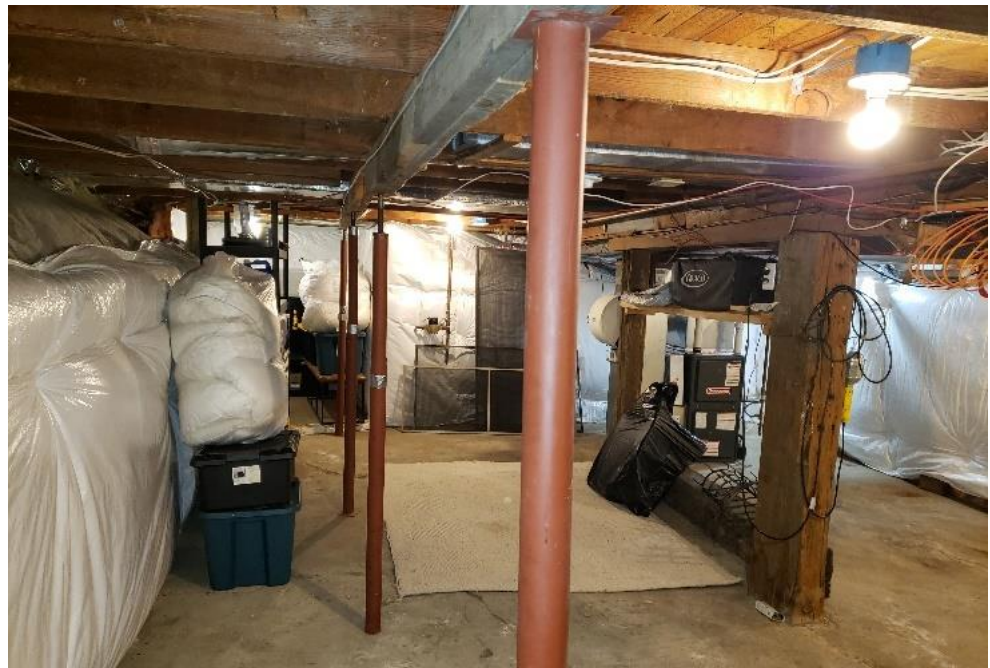
*Two beam lines supporting the main floor joists with columns bearing on a concrete slab floor.*

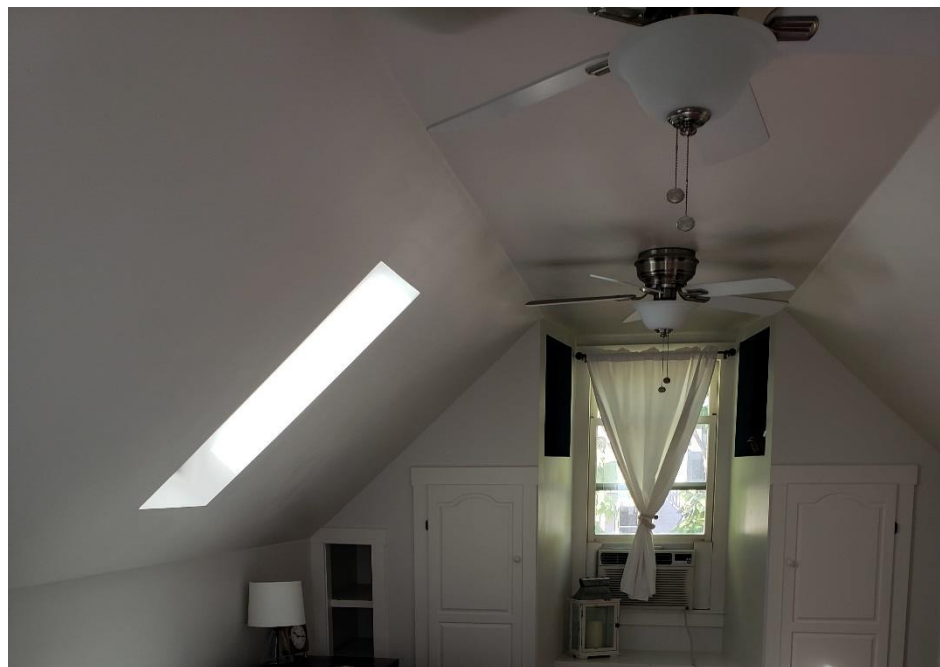
The east addition has a low-pitch shed roof. This roof appears to be constructed with 4x6 rafters, as the rafter tails are exposed, and the rafters are at 24-inch on-center spacing. The rafters appear to be supported by a beam and columns within the wall structure.

*The roof pitch, flat roof, and skylight depth indicate what the roof structure might be.*

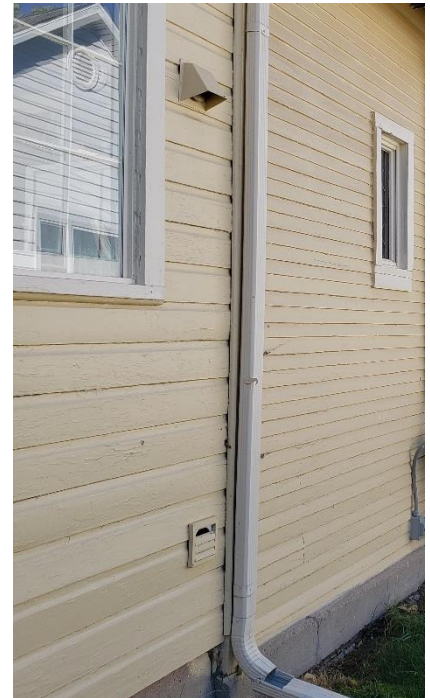
The original house is clad in painted wood clapboard siding that runs from the top of the foundation to the bottom of the roof eaves. The same clapboard siding is also present on the main roof gable ends on the east and west sides. However, the smaller gable end above the west bay has decorative painted wood shingle siding with a diamond face. The clapboard siding and the shingle siding appear to be original as both are seen in an early 1900's photograph of the house. The east addition siding is painted wood shiplap siding with a Dutch cove profile. This type of siding is commonly found throughout Louisville and is likely original to when this part of the house was enclosed.

*Clapboard siding (right) on the original house and shiplap (left) on the addition.*
