# ***Historic Preservation Commission Agenda***

**ITEM:** 720 Grant Street Probable Cause Determination

**REQUEST:** A request to find probable cause for a landmark designation to allow for funding of a historic structure assessment for 720 Grant Street.

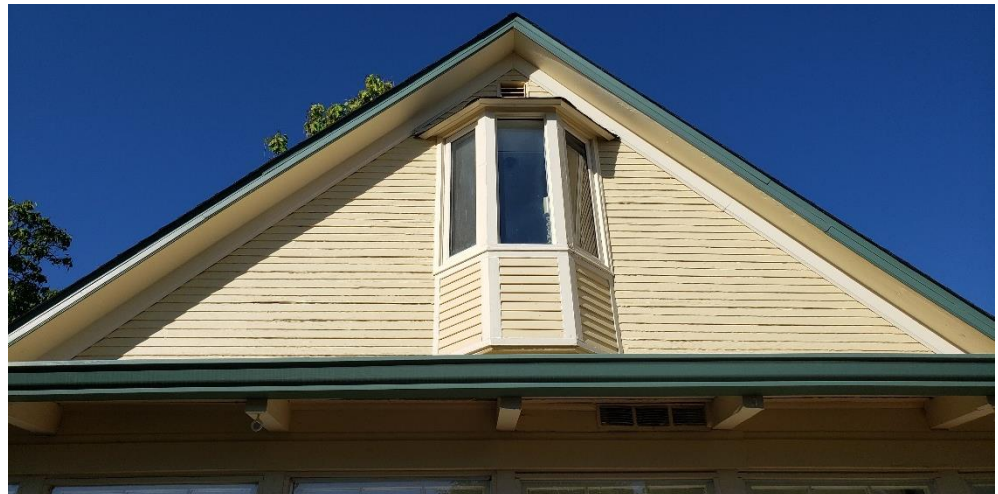
*The original roof is a steep gable & the east addition roof is a low pitch with exposed rafter tails.*
