# ***Historic Preservation Commission Agenda***

**ITEM:** 908 Garfield Avenue Probable Cause Determination

**728 GRANT AVENUE**  
**HISTORIC STRUCTURE ASSESSMENT**  
LOUISVILLE, CO

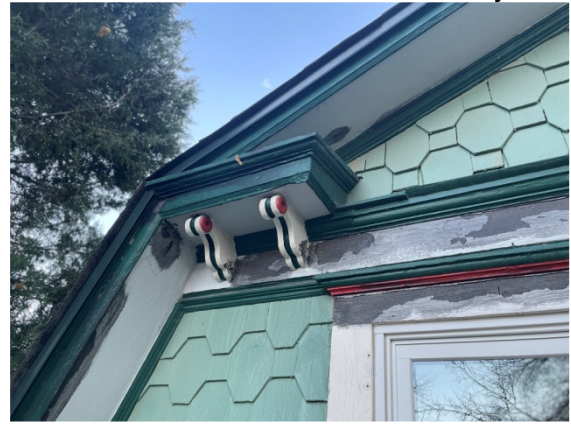
While the building looks as if the painting has been done in the last five years, there are signs of peeling. Some wood siding and trim exhibit signs of rotting and damage (Image 1&2 3.3.2).

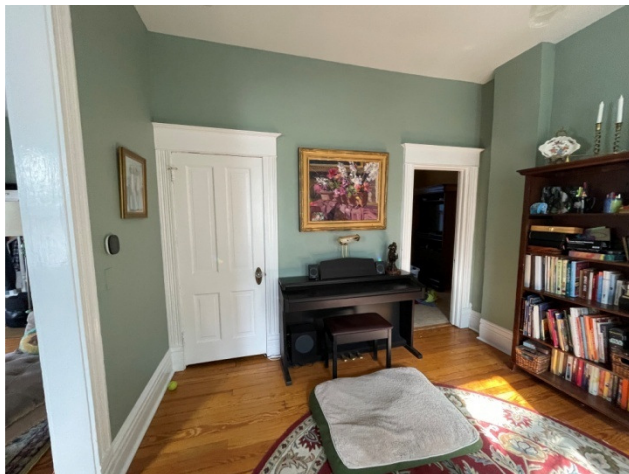
Image 1 – parlor walls – 3.6.1

The condition of the walls throughout is in good shape. No extensive cracking or water is visible. Although some wear and tear can be seen at interior wood trim at the base, at doors, and at openings, the trim is in good shape throughout.

There are no recommendations to the interior wall finish or trim at this time.

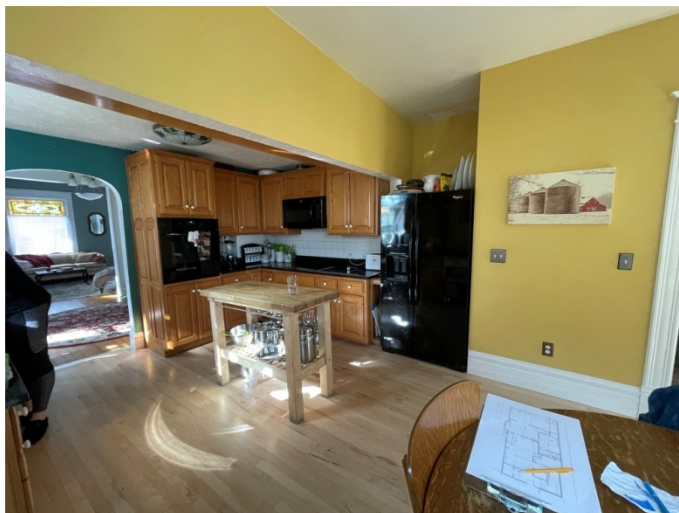
Image 1 – 3.6.4

The wood flooring in the original portion of the house is in good shape and shows no obvious signs of deterioration. The wood flooring in the kitchen does not appear to be level and tends to sag toward the west. This is not uncommon among older houses. The wood flooring in the kitchen is new and the owner indicated that the flooring was attempted to be leveled during the last renovation to moderate success. (Image 1 – 3.6.4)

No recommendations at this time except routine cleaning and maintenance.
