# Coal Creek

GOLF COURSE

## Golf Course Improvement Plan

December 19, 2011

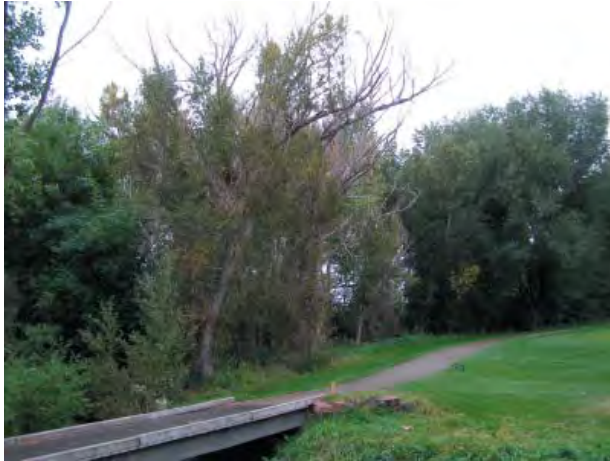
Dead trees on hole 6.

Our recommendation would be to implement a tree removal and replacement program whereby poorly positioned, short-lived or structurally compromised trees would be selectively removed to improve safety, reduce maintenance, improve playability and allow for the establishment of more-desirable, longer-lived trees. Trees which are good for golf courses include Oak, Hickory, Catalpa, Sugar Maple, Red Maple, American Elm (disease resistant), American Linden, Ginko, Hackberry and Pine. Care must be taken to allow for adequate space at maturity. Trees which drop fruit, have thorns or have shallow root systems are generally poor choices for golf courses. These may include, Spruce, Silver Maple, Norway Maple, Cottonwood, Poplar, Walnut, Locust, Ash, Apple, Russian Olive and Willow.

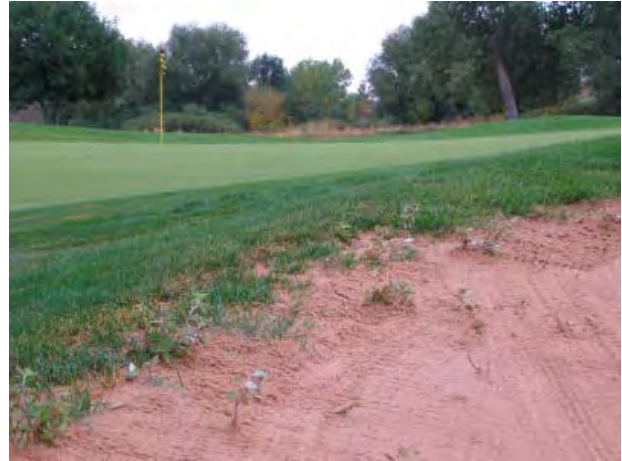
Roots & suckers in bunker at hole 4 green.

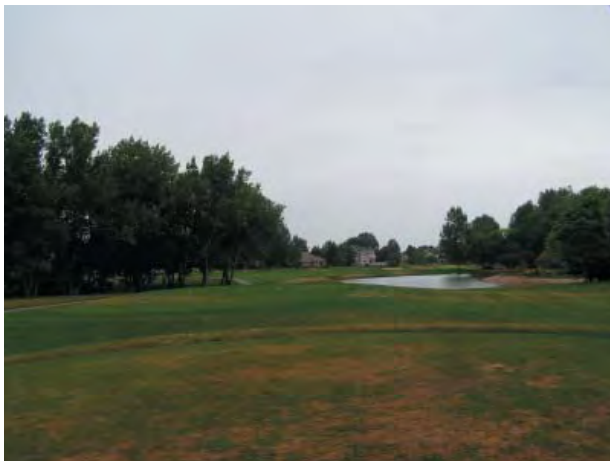
From a playability standpoint, many of the ditches have become so choked with trees that they obscure the golfer's view of the golf course. On holes No. 2, 4, 10 and 14 the trees have created a safety issue by obscuring the landing area and unnecessarily forcing golfers to hit the ball towards neighboring homes. In addition, trees which overhang

Trees left push ball towards houses right on hole 2.

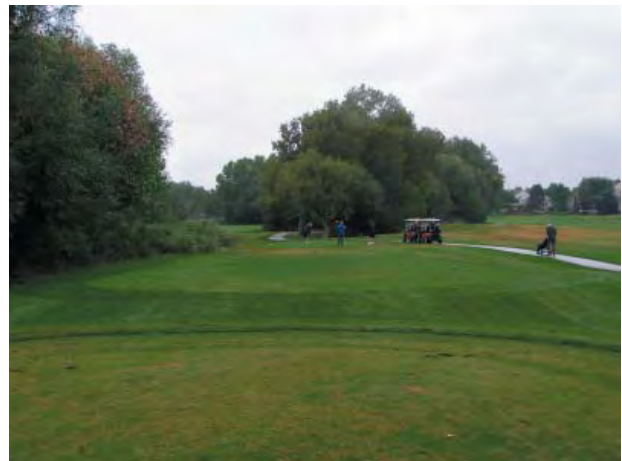
Restricted view to fairway on hole 6 tees.

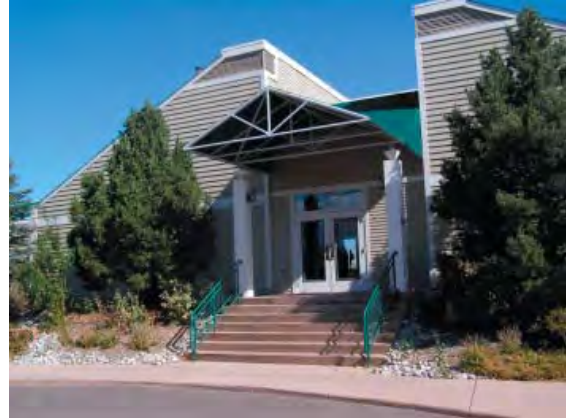
*Clubhouse main entrance is overgrown & dated.*

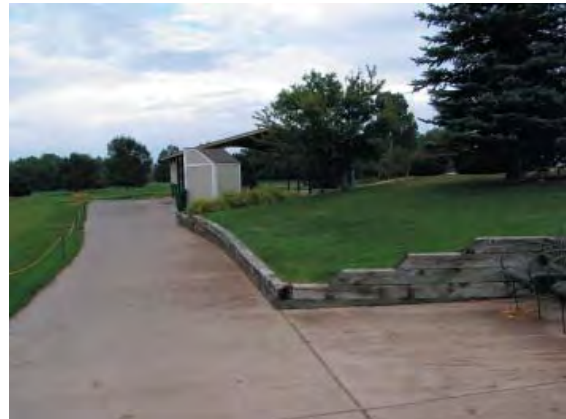
*Timber retaining walls are dated & require maintenance.*

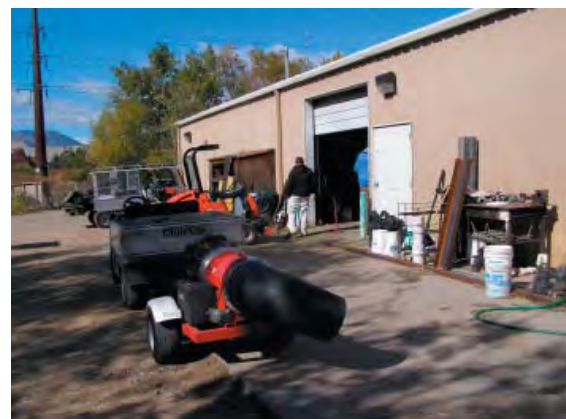
A typical maintenance facility for an 18-hole golf course would generally include approximately 2,000 square feet of heated office and shop space, 4,000 square feet of equipment cold storage space, a chemical storage facility and exterior storage bins for topdressing mix and bunker sand. The existing maintenance facility at Coal Creek is somewhat undersized to accommodate basic maintenance operations and equipment storage. In addition, the facility lacks an adequate chemical storage facility and exterior storage bins.

*Maintenance facility is undersized to accommodate equipment storage.*

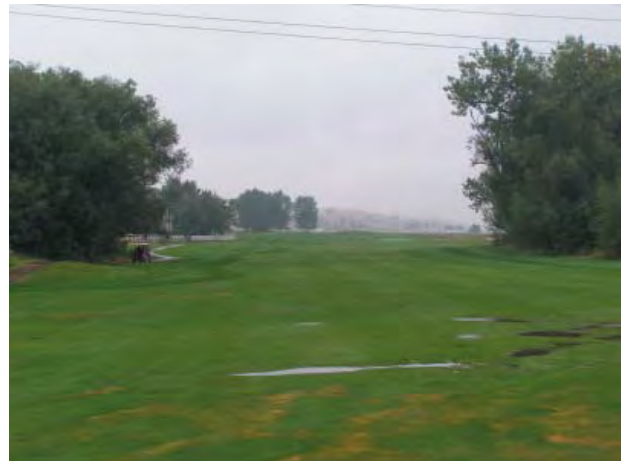
*Drainage issue on Hole 14 fairway.*

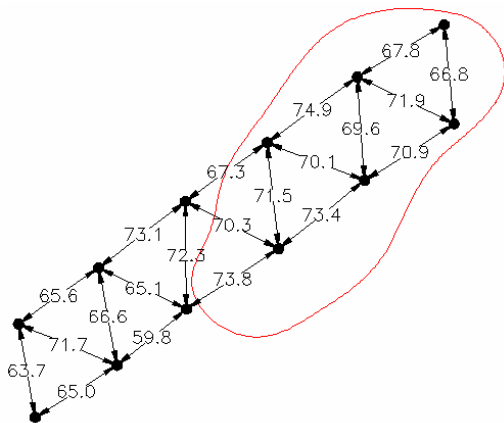
Illustration. 1 Typical head spacing (10 Fairway)

The majority of the sprinkler heads are the original installed equipment, Rainbird 51 (full circle), and Rainbird 47 or 95 (part circle). The heads are spaced throughout the golf course at about 70' in most areas (see illustration. 1). There are some areas, such as greens that the head spacing exceeds the typical spacing on the rest of the course (see illustration 2). Ideal spacing for this sprinkler head is 70'. This head will attain the highest level of distribution uniformity (DU) when spaced at a uniform 70' spacing. Areas that have heads "stretched" can be identified by having thin turf density, and require additional hand/spot watering.

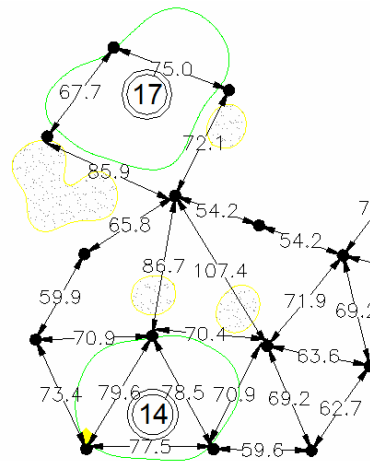
Illustration.2 Head spacing at 14, 17 green complex

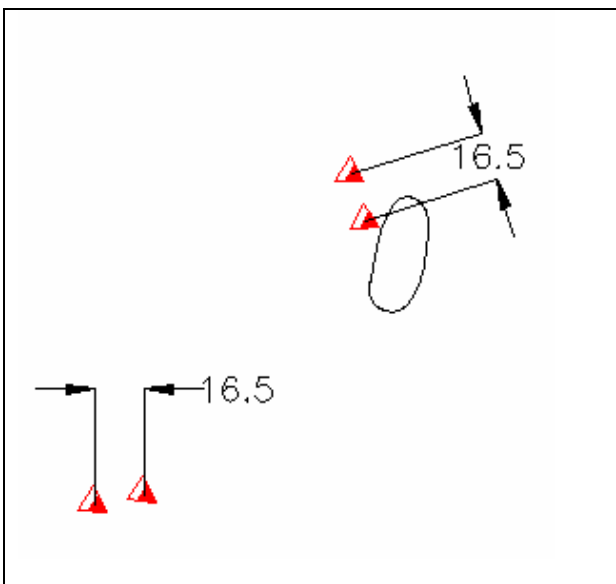
3, these heads are spaced 16.5'. Heads designed to throw 70' spaced this close together will always leave a wet area, as shown in Picture 1. This scenario is often seen on golf courses that when built, did not have houses adjacent to the property. As the homes were built, the interior head, originally a full circle head, needed to be changed to a part circle head. The change to a part circle head left an area behind the original head without irrigation. The solution that was chosen was to install a head that throws essentially 53.5' farther than needed. The result, an overwatered area in front of the two heads and a wet spot in front of heads. Coal Creek has many heads with this configuration. The proper solution is to install a short radius head along the golf course property line.

Illustration 3. Heads spaced too close together

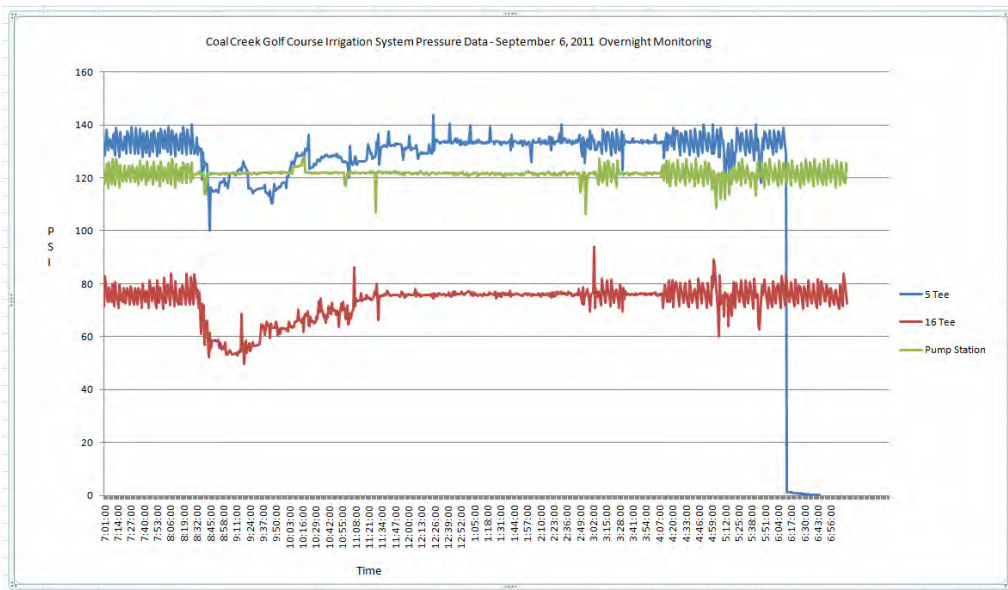
Illustration 4. 3 Pressure monitoring locations (full size graph in appendices)

The saw tooth pattern seen at the beginning of the graph indicates that the pumps are turning on/off with regular frequency. This is a sign of a “loose” system, one that has several leaks and/or weeping heads. The pumps are cycling to keep the irrigation system at the pressure set point. The next component of the graph begins around 8:15pm and coincides with the start of the overnight irrigation cycle. A dip in pressure on the blue line (5 tees) and the red line (16 tee). This indicates that the central computer is turning on more heads than the pipe network can supply. The central computer has a component that will manage the flow, hence the name “Flo Manager”. It is essentially a database that defines how many heads (flow) can be operational at any one time. If the flo manager component is allowed to operate too many heads, the pump station, or in this case the pipe network, will not be able to supply the needed volume. It becomes most important when the pressure drops below the recommended sprinkler pressure, 80psi. The resolution for 5 tees is to review the flo manager component of the database and provide proper flow limits given the existing mainline and lateral pipe sizes. The pressure is always below the 80psi level at the 16 tee site. The solution for 16 tee is to address the issues at the booster pump on hole 18 (see section D).

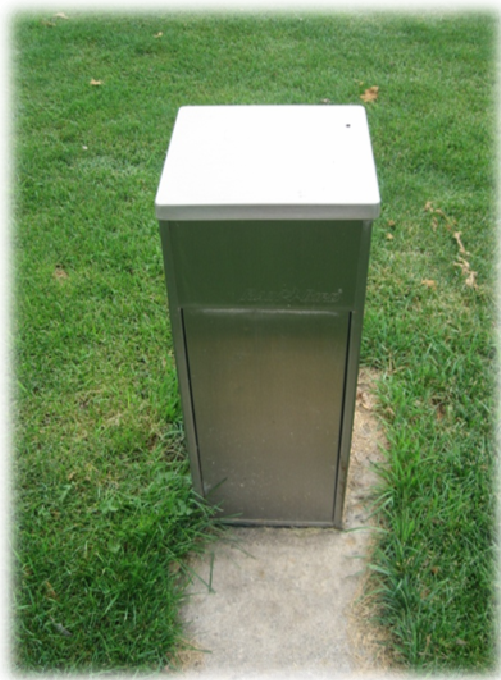
The irrigation system is controlled by a group of field controllers, commonly referred to as satellites. The Rainbird Par Plus satellites are the stainless steel pedestals located throughout the course. This satellite, (picture 3&4) is a generation behind the current Rainbird offering. Each satellite controls a group of heads within relative close proximity to the satellite. Each satellite is hard wired to the central computer and is identified with a group and channel number, essentially an IP address. The central is a PC based computer that can communicate with each of controllers. The central operates the Rainbird Nimbus II (current Rainbird offering) software to communicate with the satellites. During an overnight irrigation cycle, the central and satellite s communicate the activities of the irrigation cycle. A log file is generated during each irrigation cycle. This information is reviewed by the course superintendent every morning to make sure everything watered as planned. The central computer contains a database that identifies the head type, flow, controller address, flo manager branch/zone, sprinkler precipitation rates, default run times... for each station. After review of the central computer database, it is apparent that the database needs a thorough review focusing on heads type, precipitation rates and flo manager assignments and flow rates. The current build of flo zones is inadequate. Additional flo zone assignments will improve the system performance; reduce pump run time which in turn translates into a lower utility bill.

Picture 3. Irrigation satellite

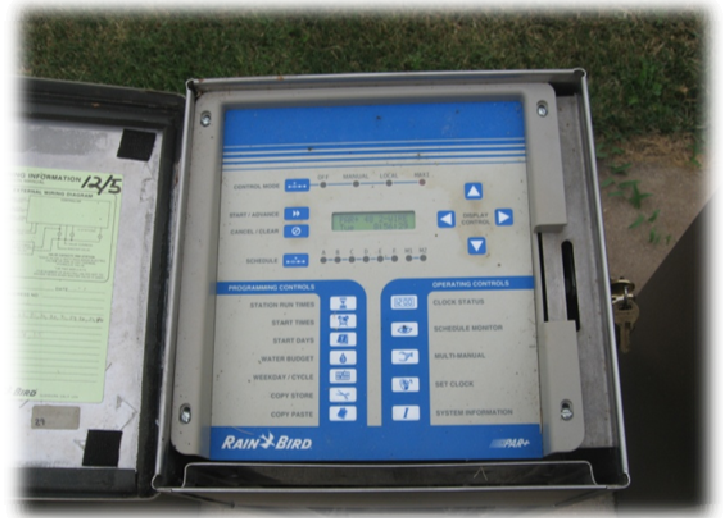
Picture 4. Satellite face plate

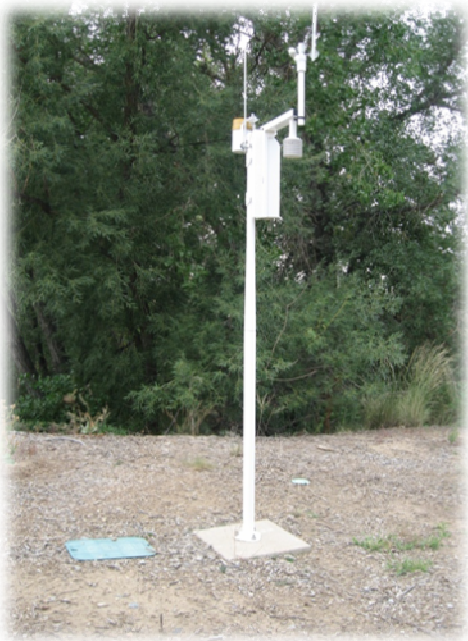
Another tool that Coal Creek has at its disposal is a weather station. The weather station, located just north of the maintenance building, monitors current environmental conditions, and is used to suspend, and in certain cases cease an irrigation cycle. It is used to help determine how much irrigation needs to occur to replace the water that has transpired through the plant, and evaporated from the soil during the past 24 hours. That term, Evapotranspiration (ET) is a calculation based on solar radiation, wind run, and air temperature. The ET value is downloaded daily to the central computer and the golf staff can then adjust the computer to match the days E.T. The current location (picture 7) of the weather station is not ideal. An ideal location is one that closely

Picture 7. Weather station

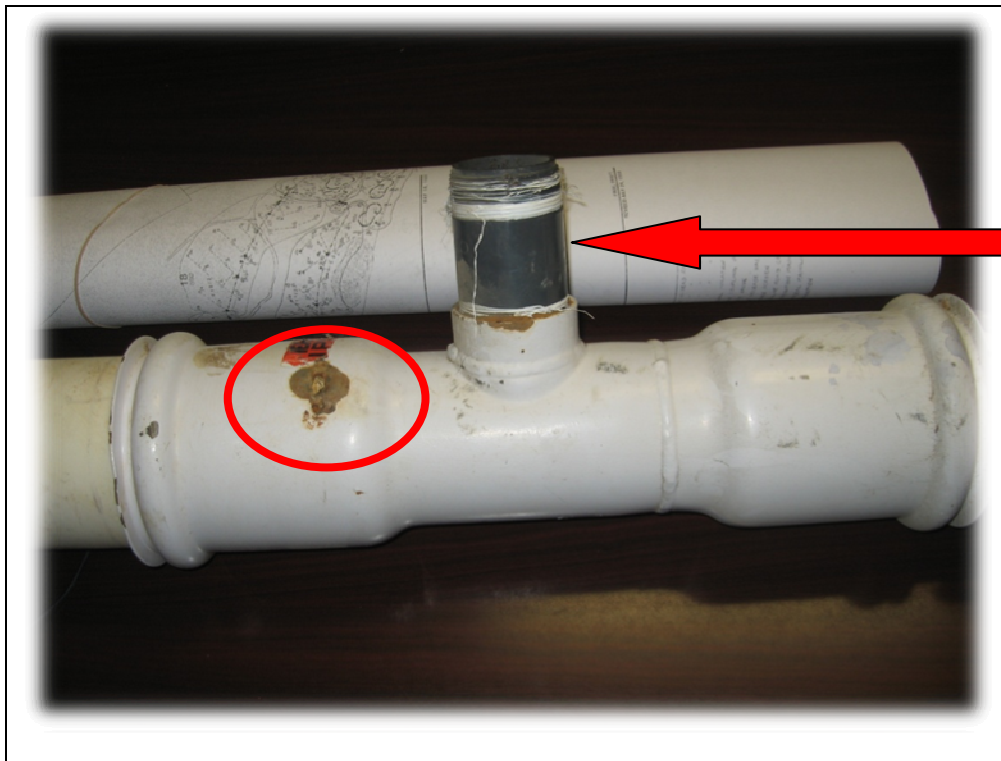
The transition between mainline and lateral pipe requires a service tee. The service tee is essentially a transition fitting from the large diameter mainline to the 2" pipe that supplies water to the sprinkler. The service tees used at Coal Creek are stamped steel fitting with an epoxy coat finish. The steel fitting has the strength to prevent any stress related failure, but is susceptible to oxidation when the epoxy coat finish fails (picture 8). After 23 years of direct moisture contact, that is exactly what is happening to the 300+(approx. 230 service tees approx. 70 mainline tees, elbows) fittings in the ground. Repair records indicate that there are 6-10 service tee/ mainline fitting failures per season. Coal Creek can expect the failure rate to hold steady and perhaps increase as these fittings continue to fail. There are other courses in the Denver Metro area that have this type of fitting and are experiencing similar failures. The solution to this issue is to repair the failed fittings with ductile iron fittings as they fail, and eventually replace the mainline with HDPE (high density polyethylene) pipe and fittings.

2" Nipple to  
Threaded Elbow  
(not shown) to  
Lateral Isolation  
Valve

The Red Oval  
Identifies A Dime  
Size Hole In The  
Service Tee

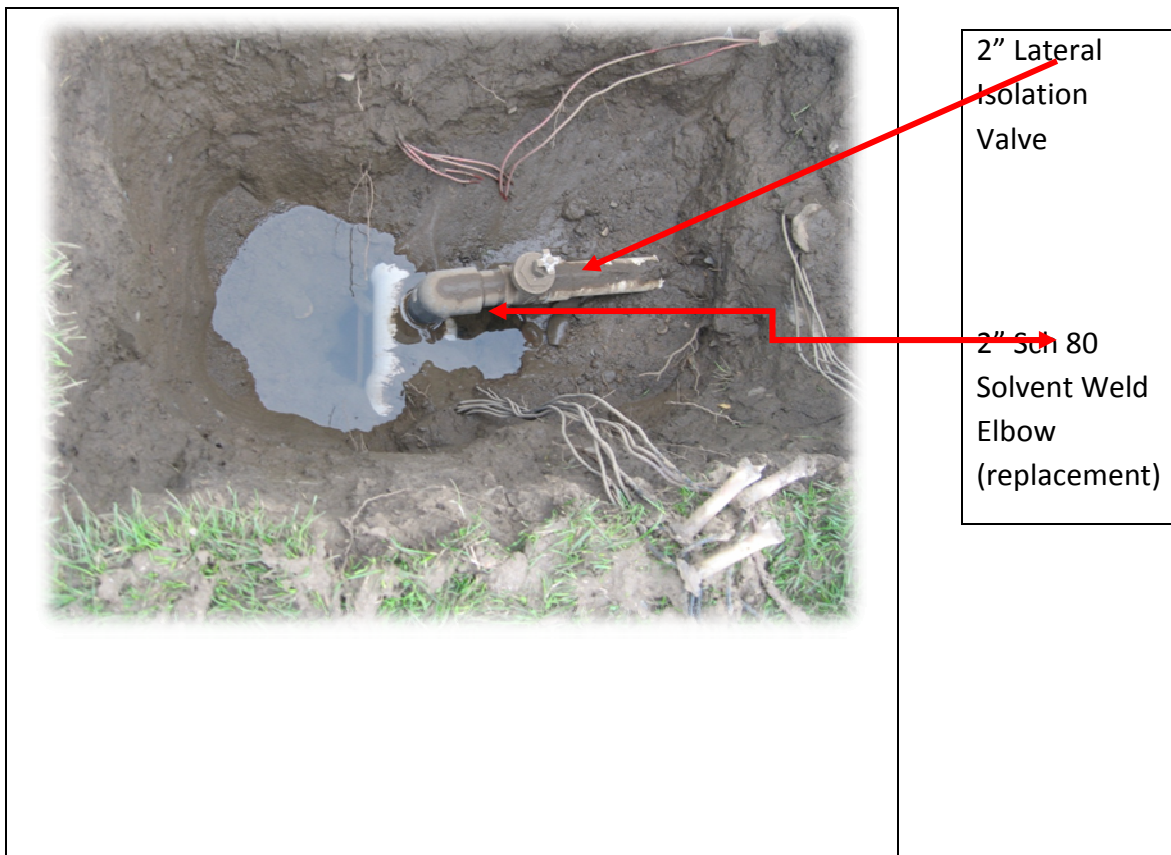
At each service tee is a lateral isolation valve (see picture 9). A 2" Schedule 80 (Sch80) nipple is threaded onto a 2" Sch40 elbow, (the schedule value relates to component strength, high Sch value equals greater strength). With increasing frequency the Sch40 elbow is split (appendices picture). A Sch40 threaded nipple was the wrong component to use in such a high stress area. As these are repaired, crews are using a solvent weld (can't be over tightened, greater strength) sch80 elbow. Research data indicates that a 2" Sch40 threaded elbow should not be exposed to an internal pressure greater than 83 psi. A Sch80 solvent weld elbow can be exposed to 243psi without expected failure (see appendices). Solution to this issue is to repair as they fail with solvent weld Sch80 elbows, with eventual replacement of the lateral isolation valve configured as a angle valve eliminating the elbow altogether. These recurring failures from this section are indicators that the irrigation system is reaching the end of its useable life.

Picture 9. Service tee/ lateral isolation valve assembly

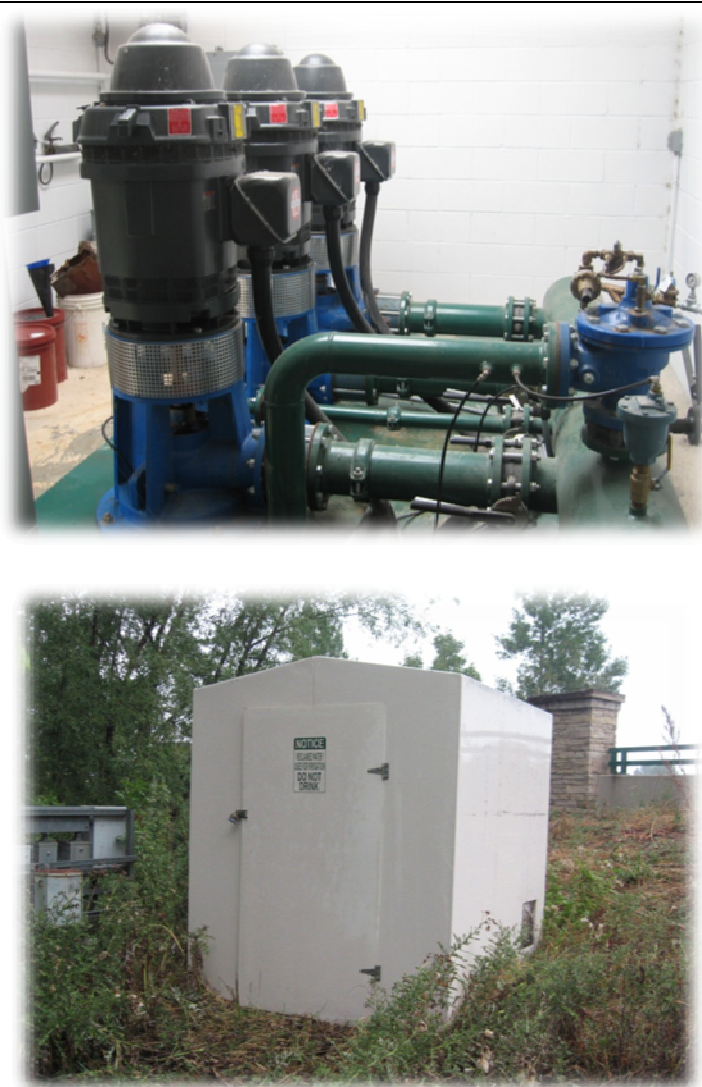
Picture 10 & 11 Main pump station & booster station building

The 25hp booster has not been in use since September 2010. There is a mainline leak underneath the structure that needs to be repaired for the pump to operate. This is a top priority repair. The main pump station cannot provide the needed pressure for upper portion of hole 15 and 16. Note Illustration 4 pressure graph earlier in this report.

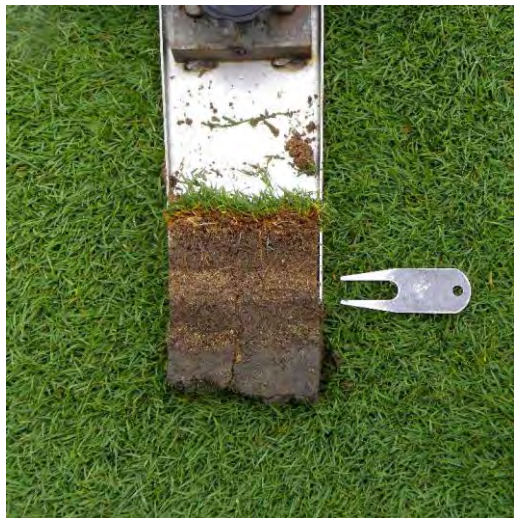
**Observations** – Many approaches on the golf course are much softer and contain much higher organic/thatch than the putting greens or fairways. This photo of the No. 4 approach shows a distinct layer a couple inches below a dramatic organic buildup in the top. Just gently squeezing this profile makes the water that was retained in this layer extremely visible.

Approach on No 4 green has various layers of organic buildup and some sand from previous years of some topdressing.

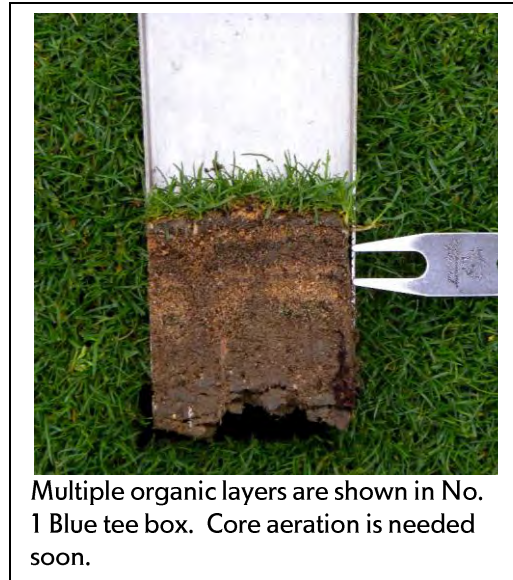
There is some layering in the upper profiles of tees. This indicates the need for increased aeration and topdressing. Tees are sometimes forgotten when it comes to cultural practices, but they need some attention for good turf health and playability.

**Recommendations** – Removing sod, leveling the subsoil and replacing sod would again provide level teeing ground.
