**SUBJECT: 917 REX STREET LANDMARK AND GRANT REQUEST**

- i. **RESOLUTION NO. 42, SERIES 2024– A RESOLUTION APPROVING THE LANDMARK DESIGNATION FOR 917 REX STREET, THE WAREMBOURG HOUSE**
- ii. **RESOLUTION NO. 43, SERIES 2024 – A RESOLUTION APPROVING A GRANT REQUEST FOR THE PROPERTY AT 917 REX STREET**

**DATE: SEPTEMBER 17, 2024**

917 REX STREET, LOUISVILLE, COLORADO

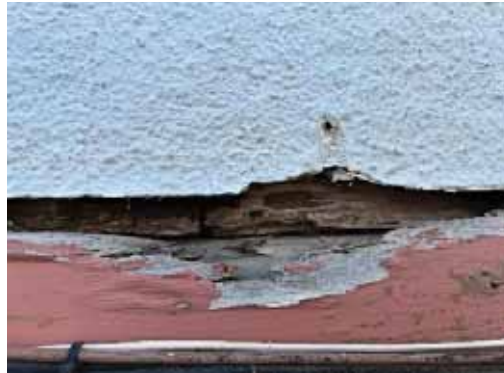
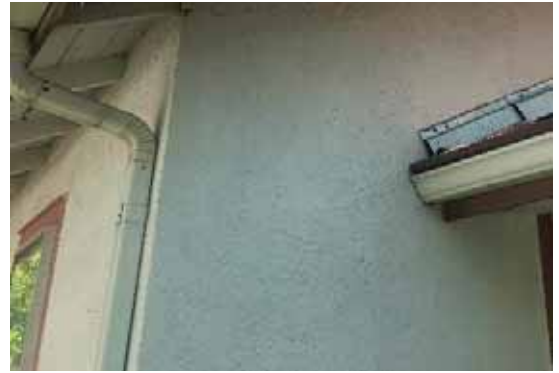
The entirety of the house is clad in painted stucco. The stucco was most likely added ca. 1940's, as was common in the Louisville area. The 1948 Assessor's card image shows the stucco surface. Areas of damaged stucco appear to show a wood siding beneath, which would be consistent with the garage and other historic homes of similar dates around the Louisville area. It is likely that the original wood siding still exists beneath the stucco across the entire house and that the wood siding was attached directly to the wall framing. Additionally, all window trim is nearly flush with the stucco surface, further indicating that the stucco was applied directly over original wood siding. Furthermore, wood siding appeared to be present in the gable ends as seen in the attic.

Since the Garage is clad in Dutch cove siding, it is likely that this is the type of siding underneath the stucco. However, there is also precedent for the stucco being original, given the comparatively late build date of 1936.

The stucco siding is in fair condition. There are a few water-damaged areas and some areas of cracking, particularly at the base of the stucco.

Investigative deconstruction is recommended in an inconspicuous area to determine if siding exists beneath the stucco cladding. If so, it is recommended that the stucco siding be removed from the entire house. With the removal of the stucco siding, it is likely that an original wood siding will be exposed. Repair, refinish, or replace the original wood siding.

Alternately, if the stucco is determined to be original, repair and restore as necessary.

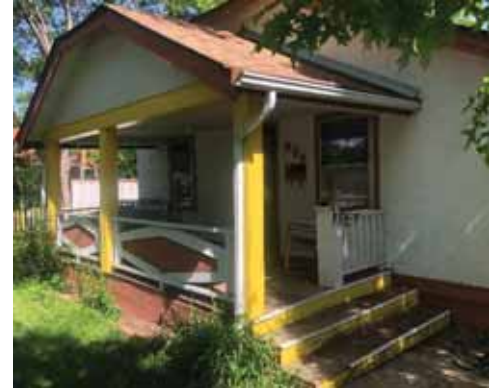
A covered porch is attached to the front of the house and appears to be original based on construction techniques and available information. The porch is pictured on the assessor's card and matches the detailing of the main structure. The porch appears to sit on a concrete slab, although a layer plywood floor prohibits analysis of the main, original floor structure. The floor appears to slope evenly away from the house for drainage. The columns are wrapped 8x8 posts which likely replace original battered columns. The railings are not original and were likely added ca. 1960. It is possible the original house did not have railings, but if they existed, it would have most likely been a low enclosed wall. The front porch ceiling is stucco, matching the main house siding. There might be an original beadboard ceiling beneath the stucco.

A carport was added to the east elevation of the building in 1985, according to building records. The carport rafters are 2x6 supported by a 4x8 beam. The carport rests directly atop a concrete slab which may have once held a coal bunker, as is noted on the 1948 assessor's card. The 4x4 posts supporting the carport are placed irregularly and sit directly on the concrete slab.

The front porch floor appears to be a single layer of plywood sitting on concrete and is in poor condition with significant water damage. Though the floor slopes, it does not properly drain water that has caused damage over the lifespan of the floor. The original floor was impossible to analyze but is likely concrete formwork. It is possible that the concrete floor structure is in a deteriorated state and that the plywood floor was added as a remedy. The front porch railings are in poor condition with missing moldings and water damage to the wood. It is unknown when the railings were installed, but they are neither original nor stylistically appropriate to the period of significance. The covered front porch ceiling is in poor condition. The ceiling is sagging in the center, possibly caused by poor weight distribution of the roof structure. Some cracking in the stucco ceiling has occurred.

1. Remove the non-original plywood floor to access the original concrete floor and evaluate its condition. The original floor structure should be evaluated and repaired as prescribed by a licensed structural engineer.
2. Replace the current columns with new tapered wood columns and caps based on other historic examples that can be found throughout the Louisville area.
3. Investigative deconstruction should be used to determine the original finish of the porch ceiling. Depending on the results of this analysis, the stucco ceiling should be restored or replaced with beadboard, if originally present.
4. Remove the carport as it is non historic, in poor condition, and poorly constructed. Removing the carport would significantly improve the historic integrity of the home.

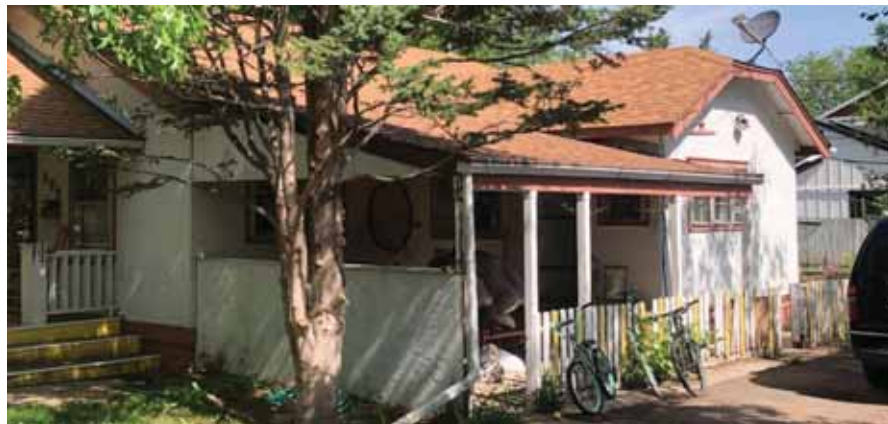
The entire house roof is covered with an asphalt composite shingle roof that was added in 2019, according to building records. This roof was likely replaced due to hail damage, as was common in the Louisville area at this time. The 1948 Boulder County Assessor's card shows that in 1948 the roof material was wood shingles.

The asphalt composition shingle roof is in good condition.

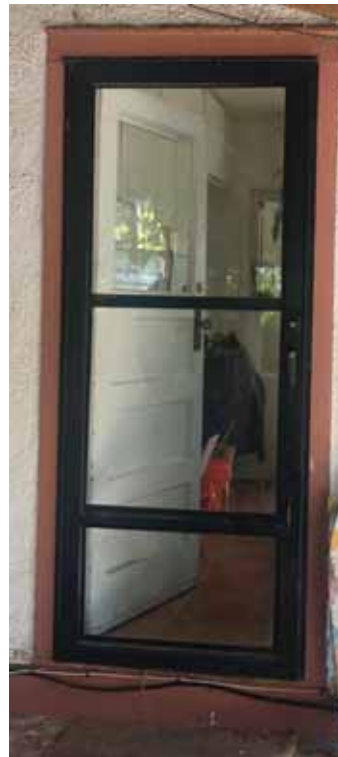
*Side door.*

The side entrance door to the mudroom is a ¼ -lite painted wood door with three panels below. Although not pictured in 1948, the door again appears to be original based on the consistent trim and construction. The hardware appears to be original. This door also has an aluminum, full-lite storm door.

The two wood doors are in fair condition. Both wood doors work properly and appear to create acceptable seals. The aluminum storm doors are in fair condition and appear to operate properly.

1. Remove the aluminum storm doors from both doors. These doors are in well covered areas that do not need storm doors for weather protection. If screen doors are desired, a minimally framed screen door could be added.
2. Repair and refinish both wood doors.
