**ITEM:** 600 Pine Street Landmark, Alteration Certificate, & Grant Request

**REQUEST:** A request to Landmark 600 Pine Street, and requests for an Alteration Certificate and Preservation and Restoration Grant

# 600 Pine Street

## Historic Structure Assessment

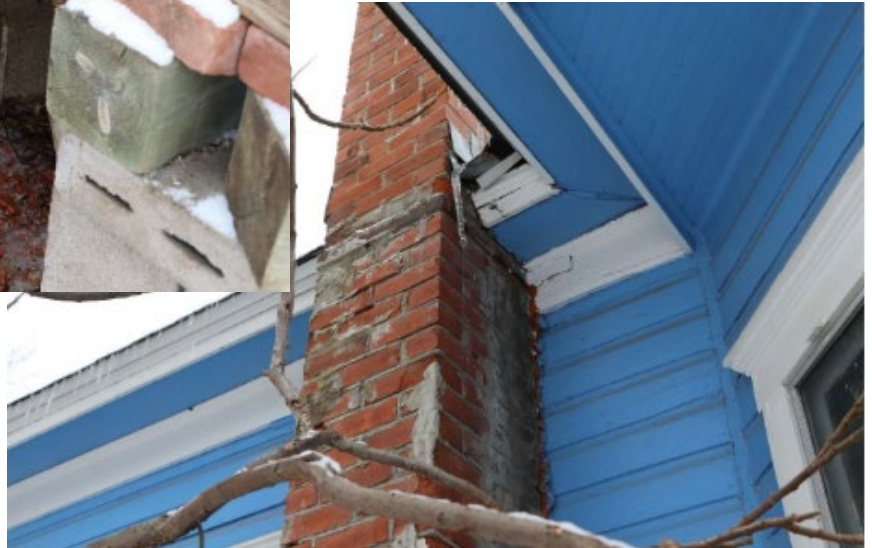
*Photos of the chimney in disrepair from the 2024 HSA.*

| Criteria and Standards | Met? | Evaluation |
|---|---|---|
| 6. <i>The condition of existing improvements and whether they are a hazard to public health and safety.</i> | <b>Yes</b> | The existing conditions of the chimney could provide a hazard because it is currently not structurally sound. |

**Exterior Chimney:** The exterior chimney has a clay tile flue liner. The chimney is in good condition above the roof line. It is in poor condition below the roof line as the valley drains onto the chimney and it in turn suffers freeze-thaw damage. Many of the bricks at the base have been lost (Figure 3). The chimney is unsafe.

The proposed Alteration Certificate is to repair the existing chimney on the property. The proposal includes breaking down the chimney to the ground level and rebuilding the chimney to the same height using the same brick material as the original.

- A. Chimney.
1. Bricks (500) – including delivery.
  2. Scaffolding setup/breakdown.
  3. Cover solar panels with protective boards.
  4. Take chimney down to ground level.
  5. Haul off brick and rubble.
  6. Create/repair foundation.
  7. Rebuild chimney to same height.
  8. Seal off chimney at top completely.

Rebuild with orange hard press bricks the same as original.

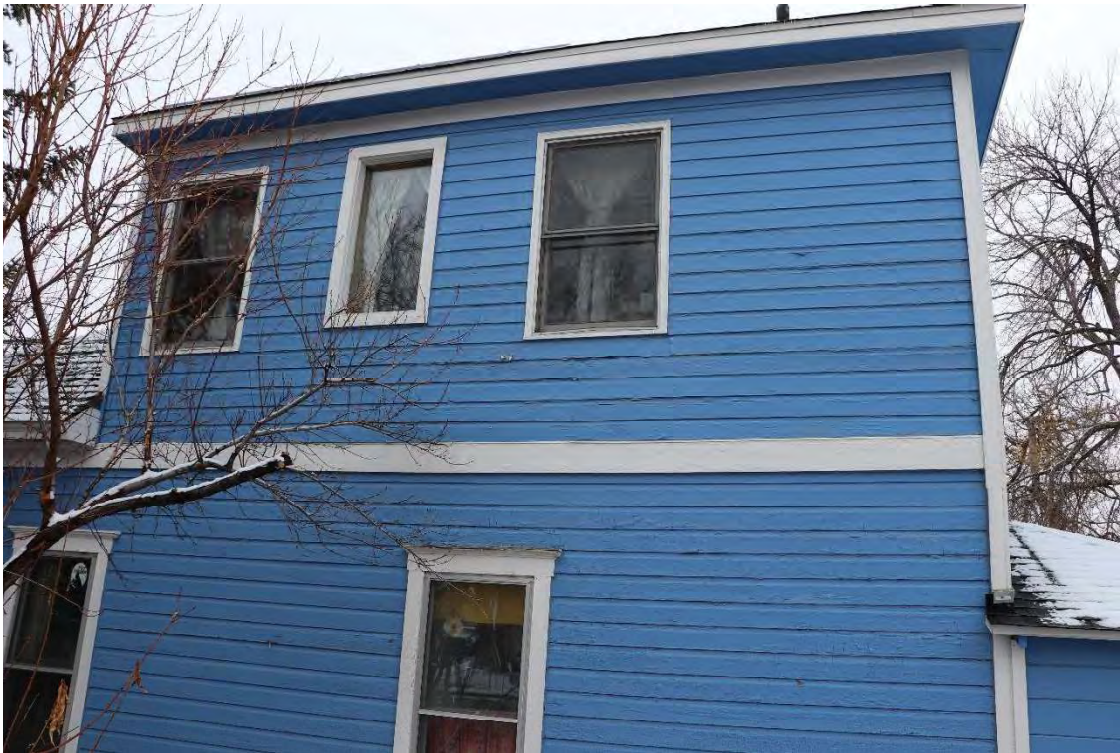
Image 11: Grant Street elevation. The white belt course separates the upper addition from the original first floor. Note the similar but distinct wood siding and window casing on each section

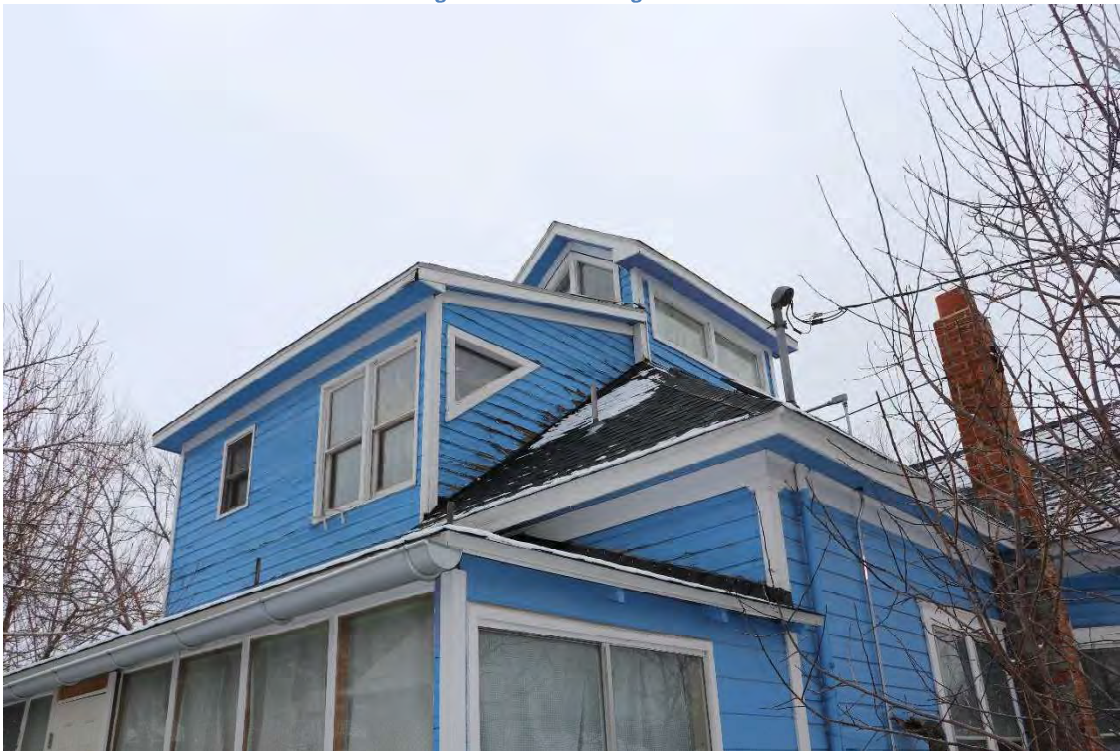
Image 12: South elevation. Original portion of the building is bottom right with corner pilaster. Note the wider siding on the enclosed porch

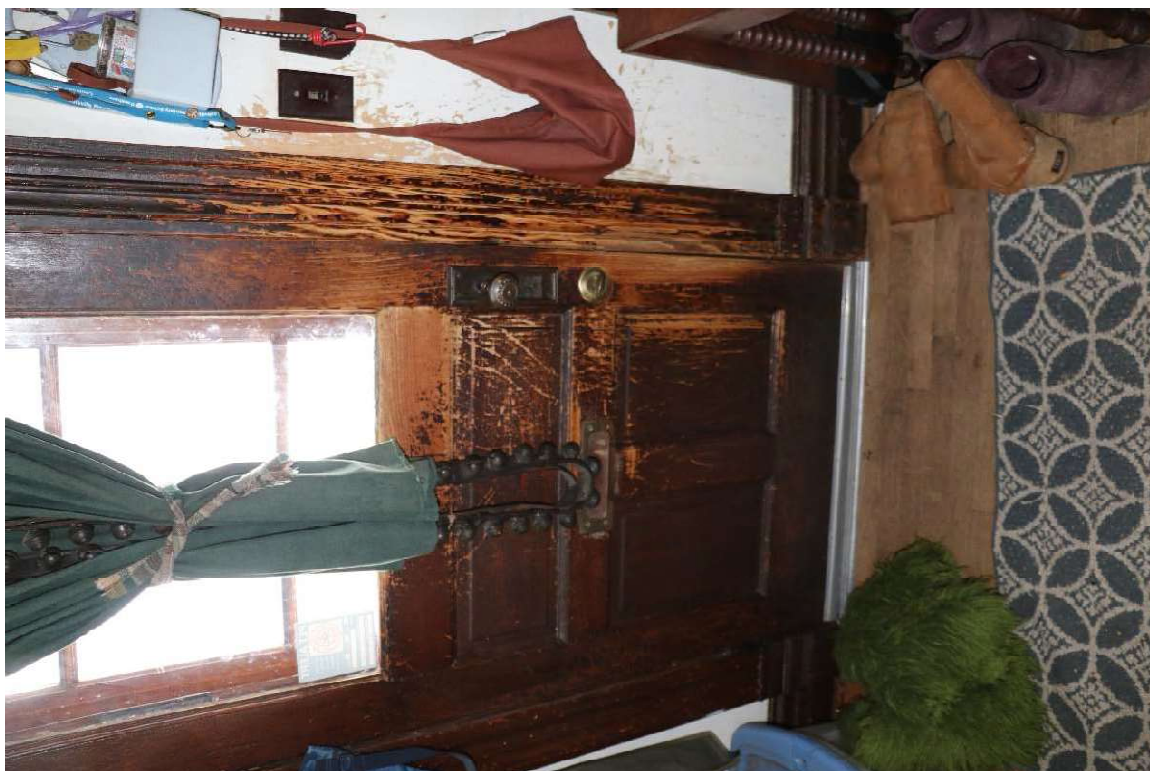
Image 23: Doors. Front Door

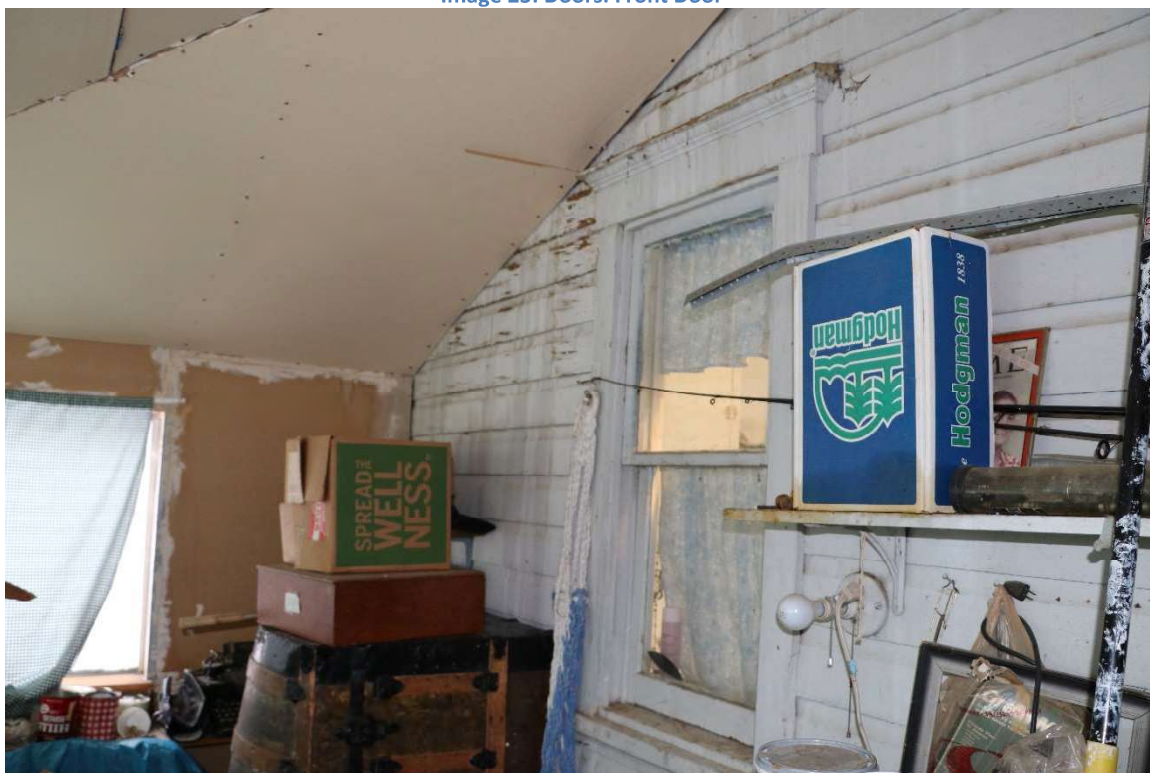
Image 24: Windows. South Elevation Exterior. Inside of enclosed porch

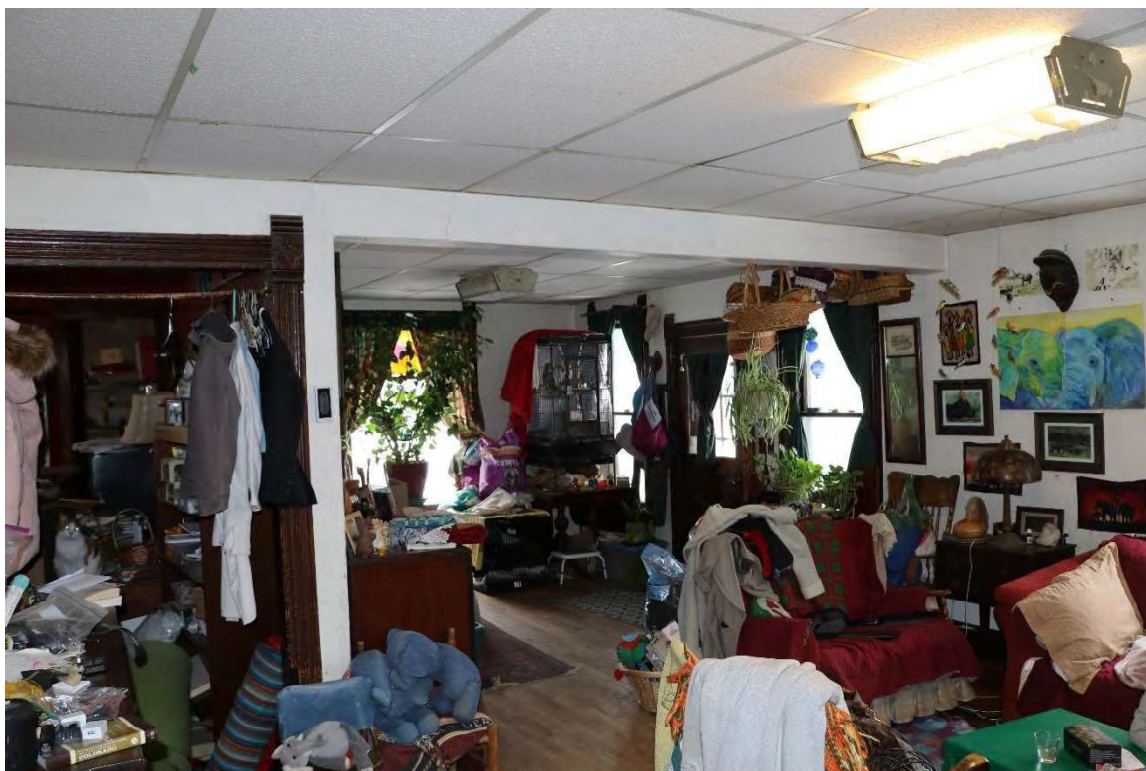
| Element | Description & Condition | Evaluation | Recommendation |
|---|---|---|---|
| Ceiling Finish Materials | Mix of drywall and plaster. The additions are drywall. The living room ceiling is obscured by a tile drop ceiling. Above the drop ceiling some wallpaper fragments remain which could provide additional detail on an earlier design scheme. At the north end of the ceiling plaster is missing down to the wood lath, with evidence that damage was caused by a water leak. The leak appears to have been addressed as no recent damage was noted | Poor | This component is structurally stable but would benefit from being properly repaired. |

Image 30: Ceiling finishes. Living room. Drop ceiling detail

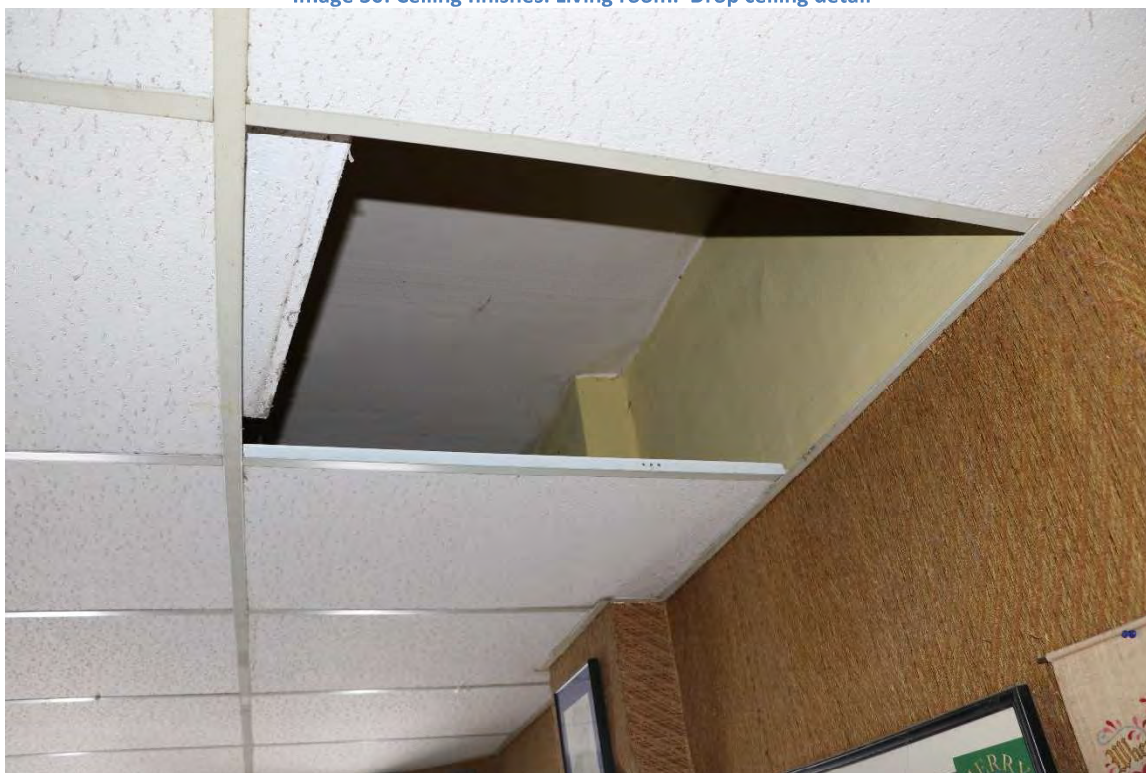
Image 31: Ceiling finishes. Living room. Drop ceiling detail

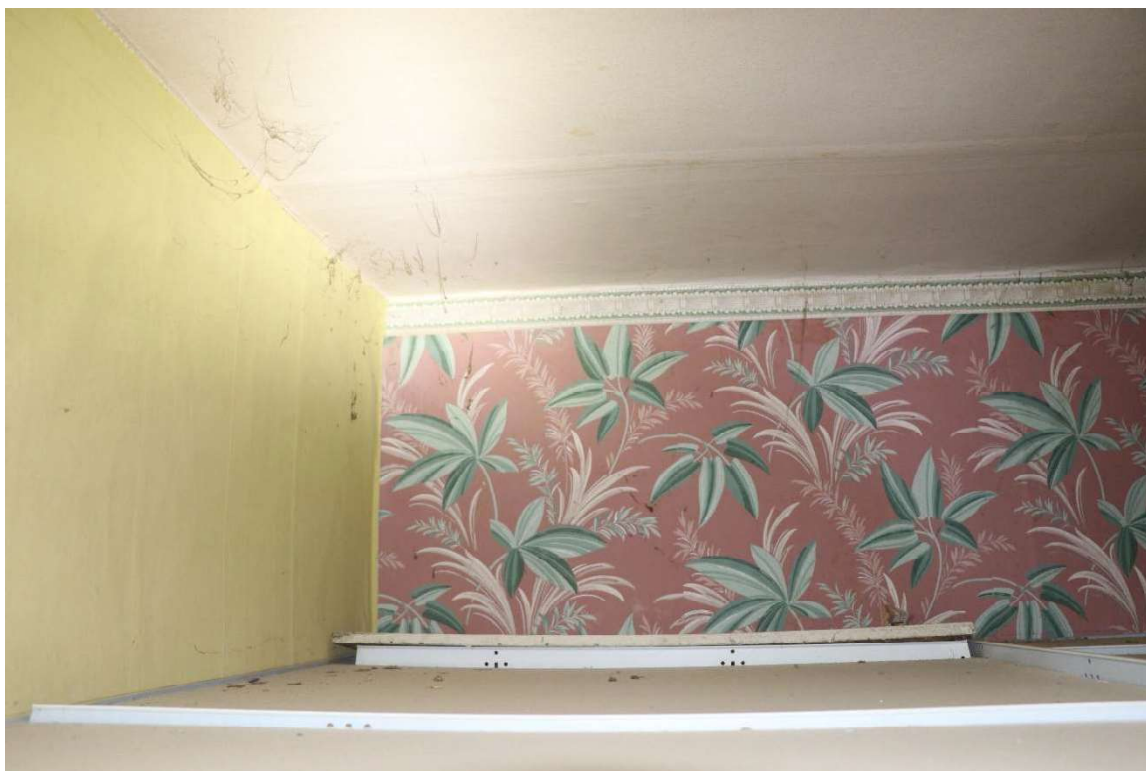
Image 32: Ceiling finishes. Living room. Wallpaper over drop ceiling

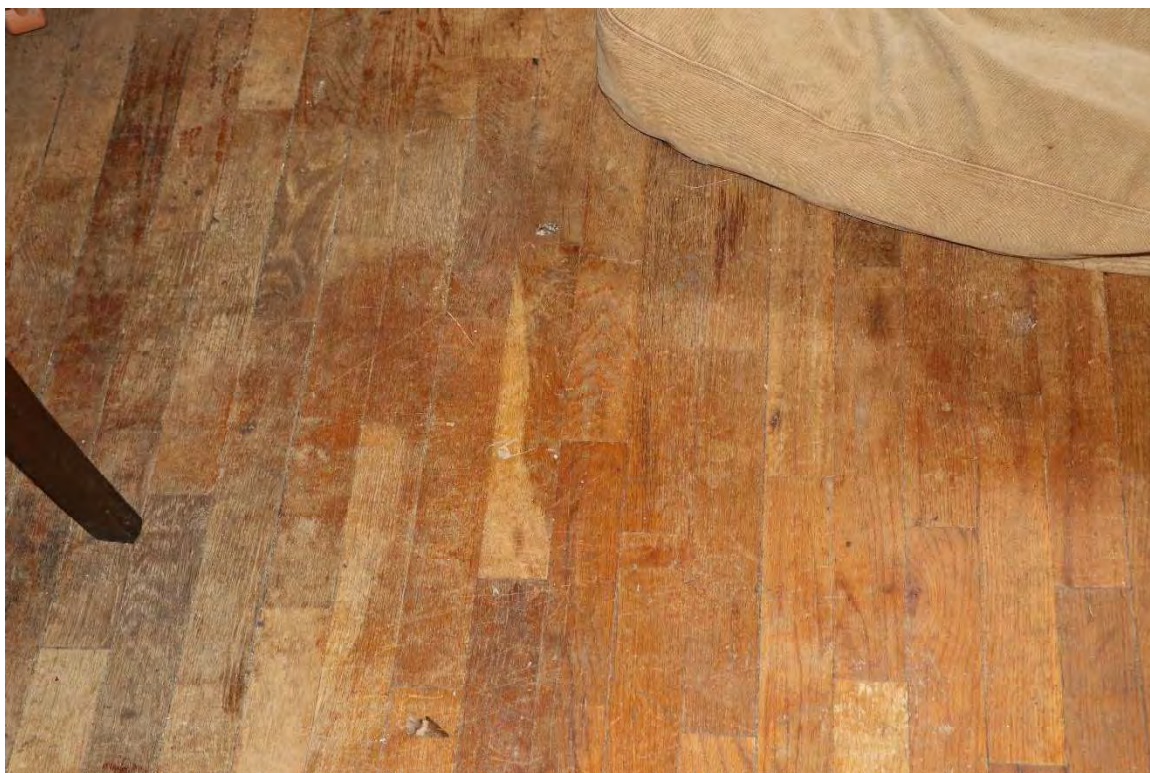
| Element | Description & Condition | Evaluation | Recommendation |
|---|---|---|---|
| Floor Finish Materials | The first floor is finished wood floors with vinyl flooring in the bathroom. The finish shows typical signs of wear from age and use. The upstairs flooring is carpeted | Fair | Light sand, finish, and reseal the wood flooring to extend the life of the floor. |

Image 36: Floor finishes. Wood floor. Typical condition

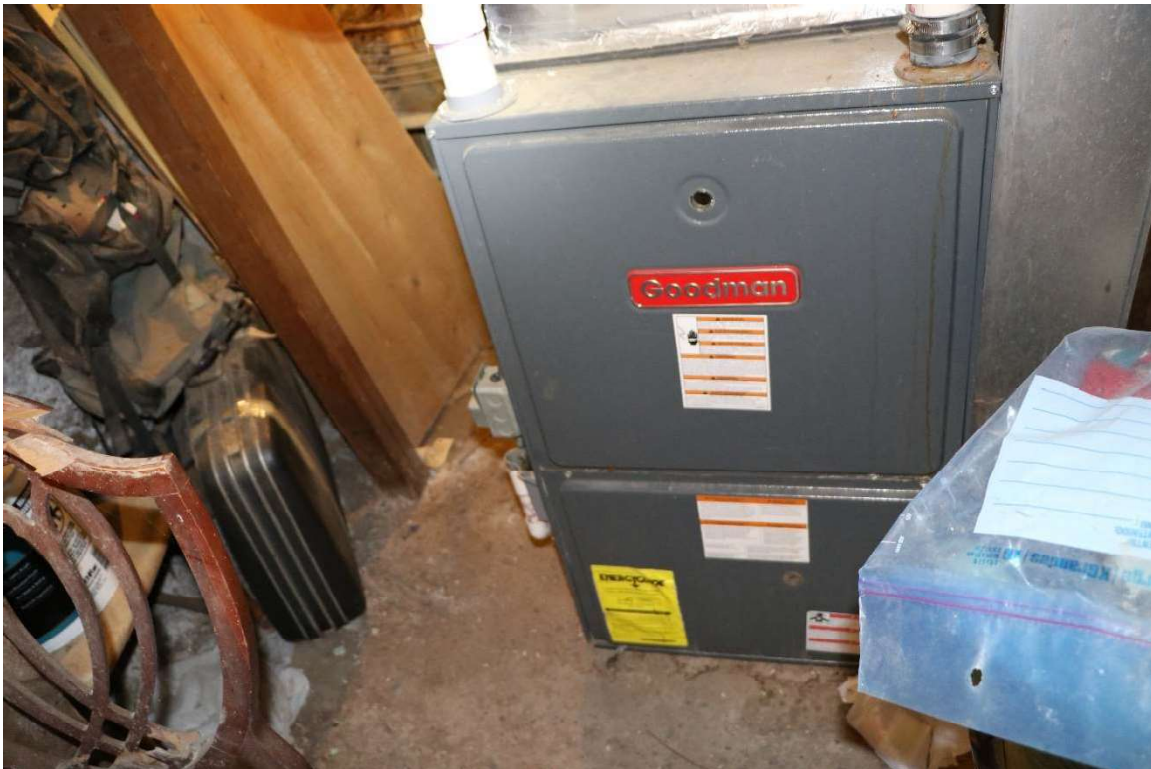
| Element | Description & Condition | Evaluation | Recommendation |
|---|---|---|---|
| Heating & Air-Conditioning | <p>No air conditioning systems were noted.</p> <p>A modern 92.1 AFUE Goodman brand furnace is installed in the basement.</p> <p>There is a US Craftmaster hot water heater adjacent to the furnace that also appears to be a recent addition. The serial number indicates that it was manufactured in 2012.</p> <p>Both the furnace and the water heater appear to be in good working order.</p> | Good | Perform annual maintenance as needed |

Image 37: Heating and Air Conditioning. Furnace

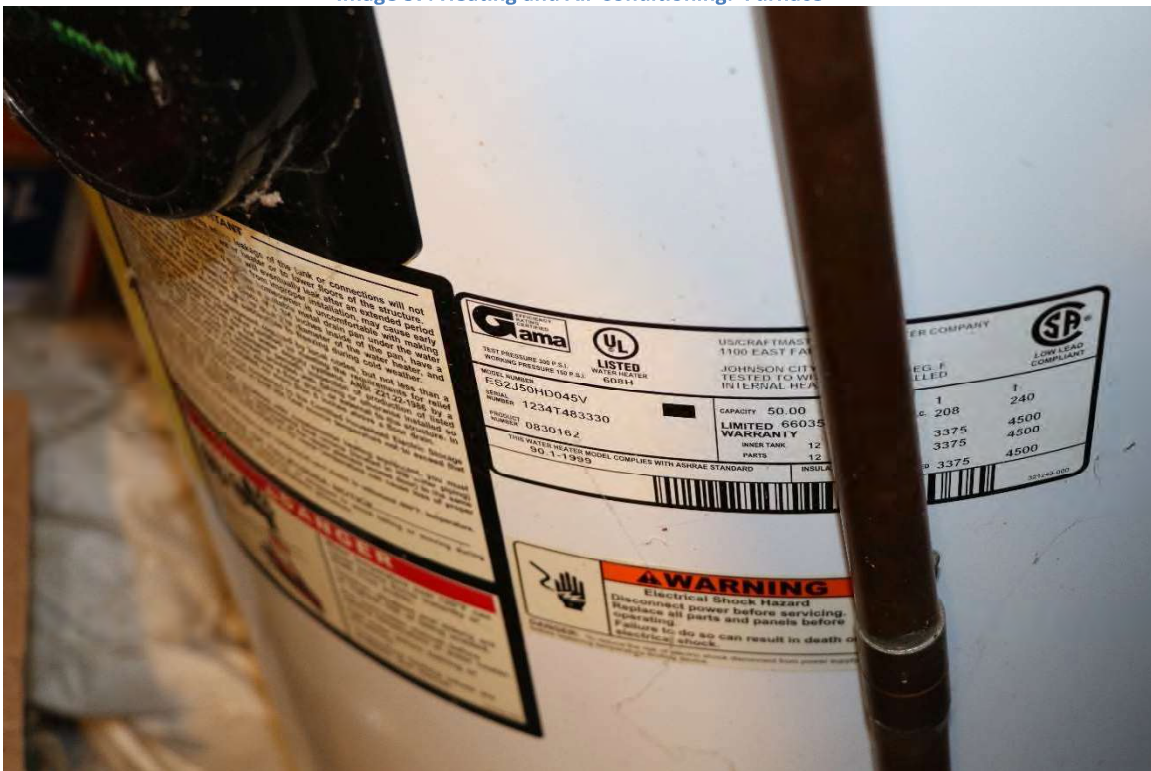
Image 38: Heating and Air Conditioning. Hot water heater

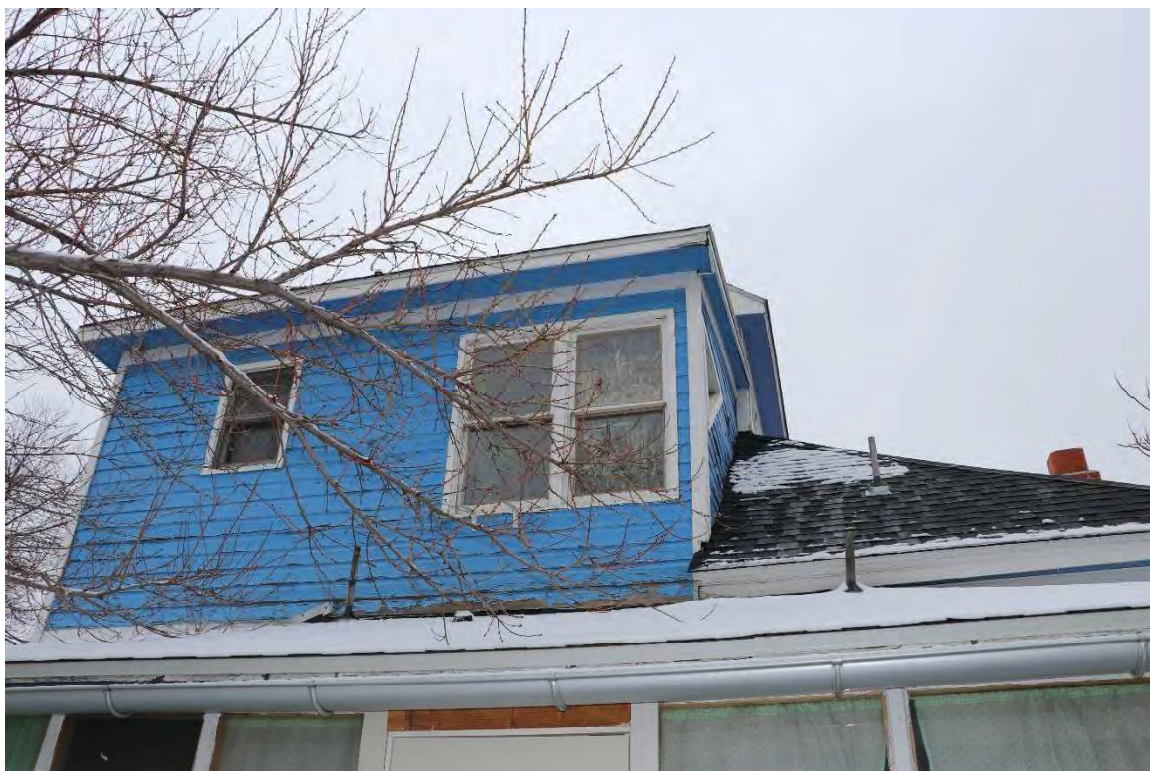
| Element | Description & Condition | Evaluation | Recommendation |
|---|---|---|---|
| Ventilation | <p>No basement vent panels were noted. There is one basement window. Plumbing vents protrude through the roof. No other roof venting was noted</p> | Fair | Monitor interior spaces for moisture build up. If moisture issues are noted, install additional ventilation to correct the issue |

Image 39: Ventilation. Plumbing vents

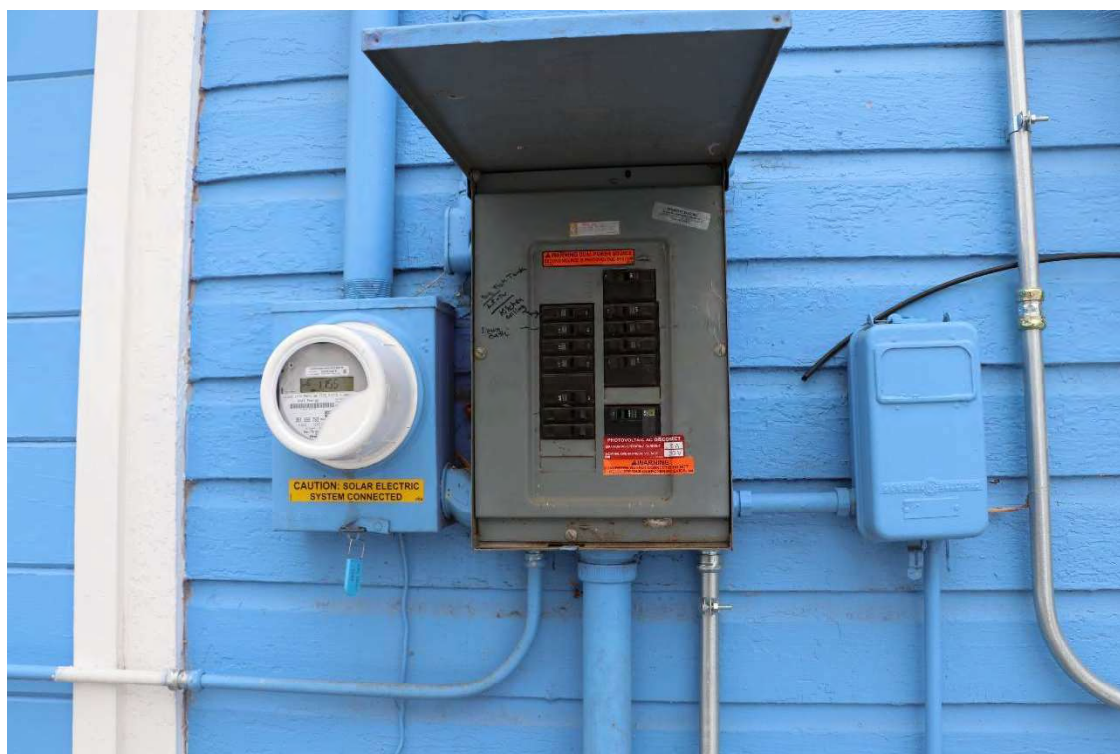
| Element | Description & Condition | Evaluation | Recommendation |
|---|---|---|---|
| Electrical Service & Panels | Electrical service enters the home at the east elevation at the roof level. The meter and breaker panel are modern and in good condition. A solar array is connected to the main panel, with the panels on the roof directly above. | Good | No work needed |

Image 41: Electrical Service and Panels

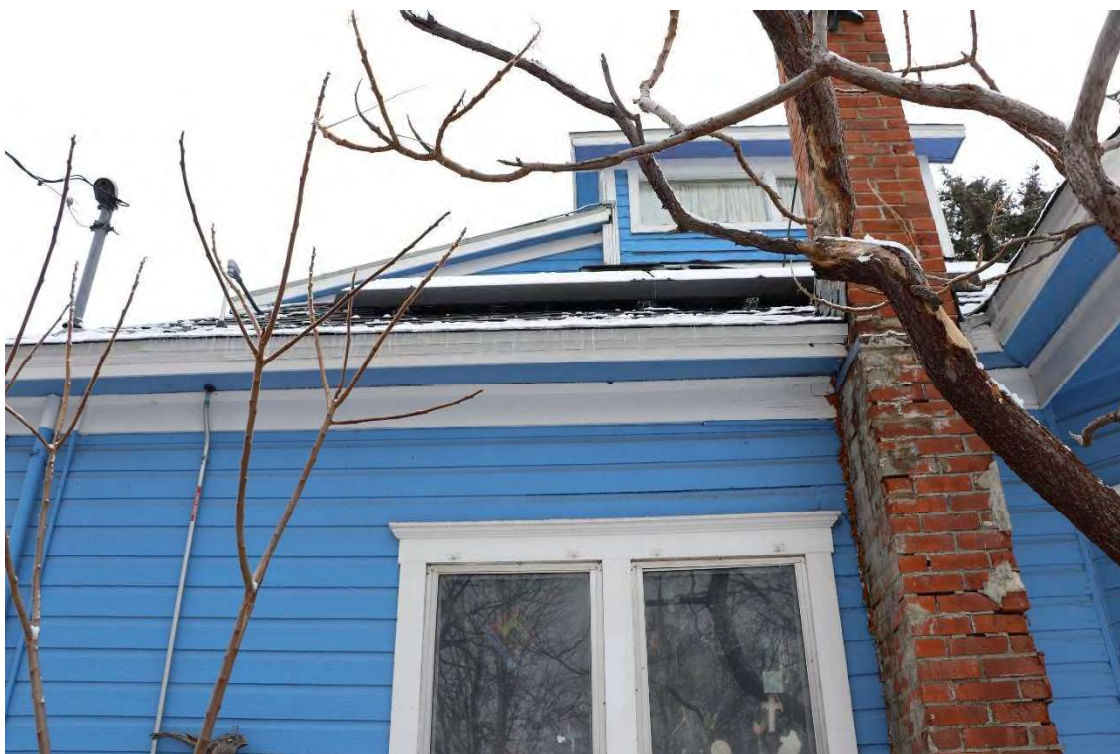
Image 42: Electrical Service and Panels. Service connection visible on left above roofline. Solar panels are flat to the roof to the left of the chimney
