**SUBJECT: LANDMARK DESIGNATION & GRANT REQUEST – 600 PINE ST.**

- i. RESOLUTION NO. 26, SERIES 2025– A RESOLUTION APPROVING A LANDMARK DESIGNATION FOR A HISTORICAL RESIDENTIAL PROPERTY LOCATED AT 600 PINE STREET
- ii. RESOLUTION NO. 27, SERIES 2025 – A RESOLUTION APPROVING A PRESERVATION AND RESTORATION GRANT FOR THE MALCOLM HOUSE LOCATED AT 600 PINE STREET

# 600 Pine Street

## Historic Structure Assessment

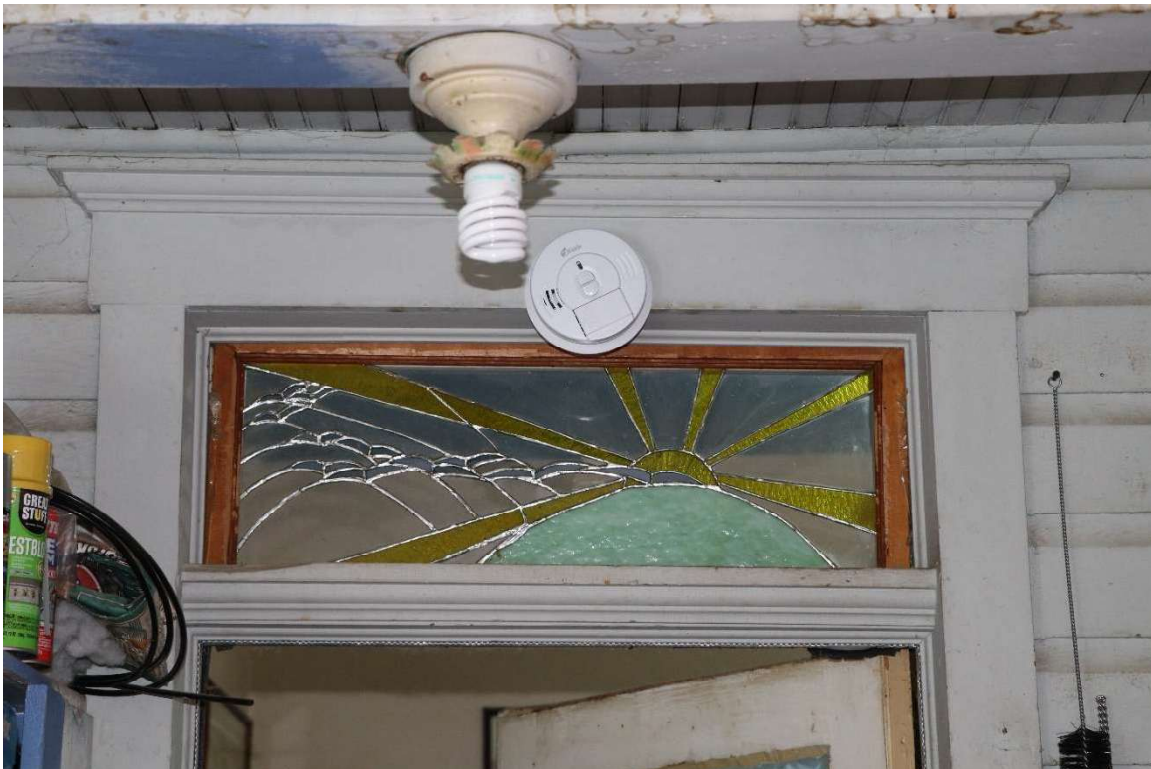
Image 10: Entry porch. Transom and casing detail

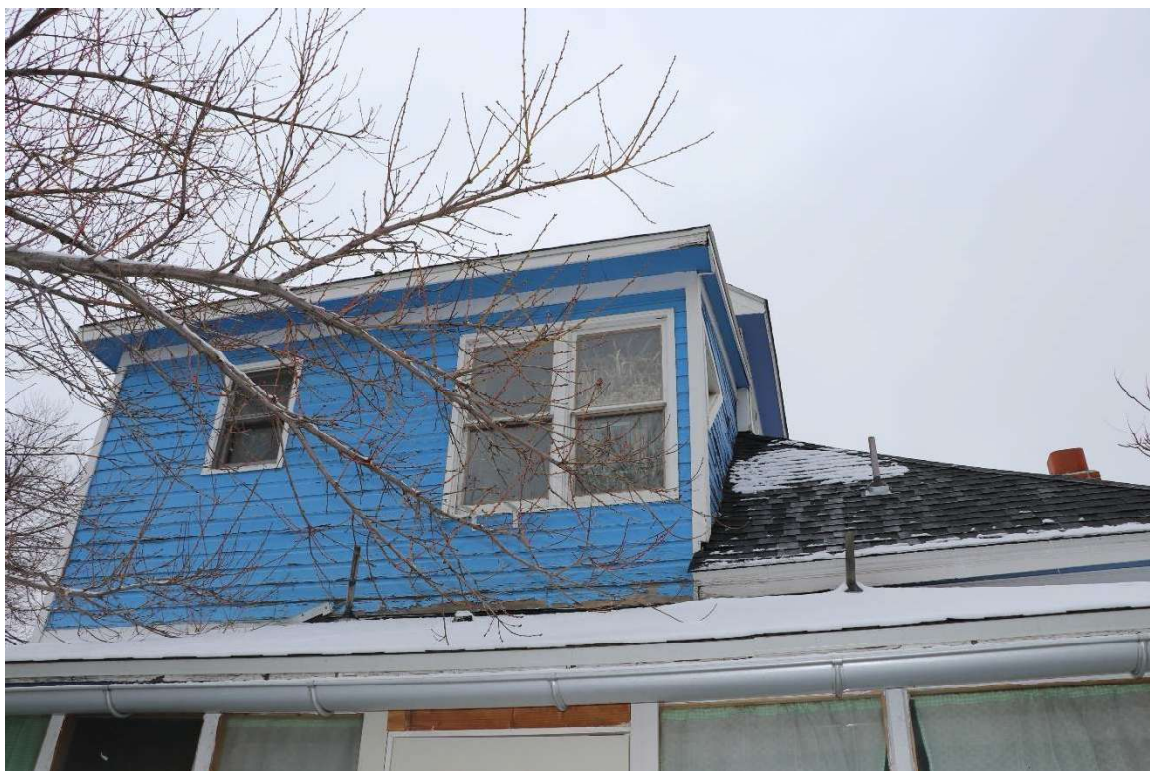
Image 18: Asphalt shingle roofing

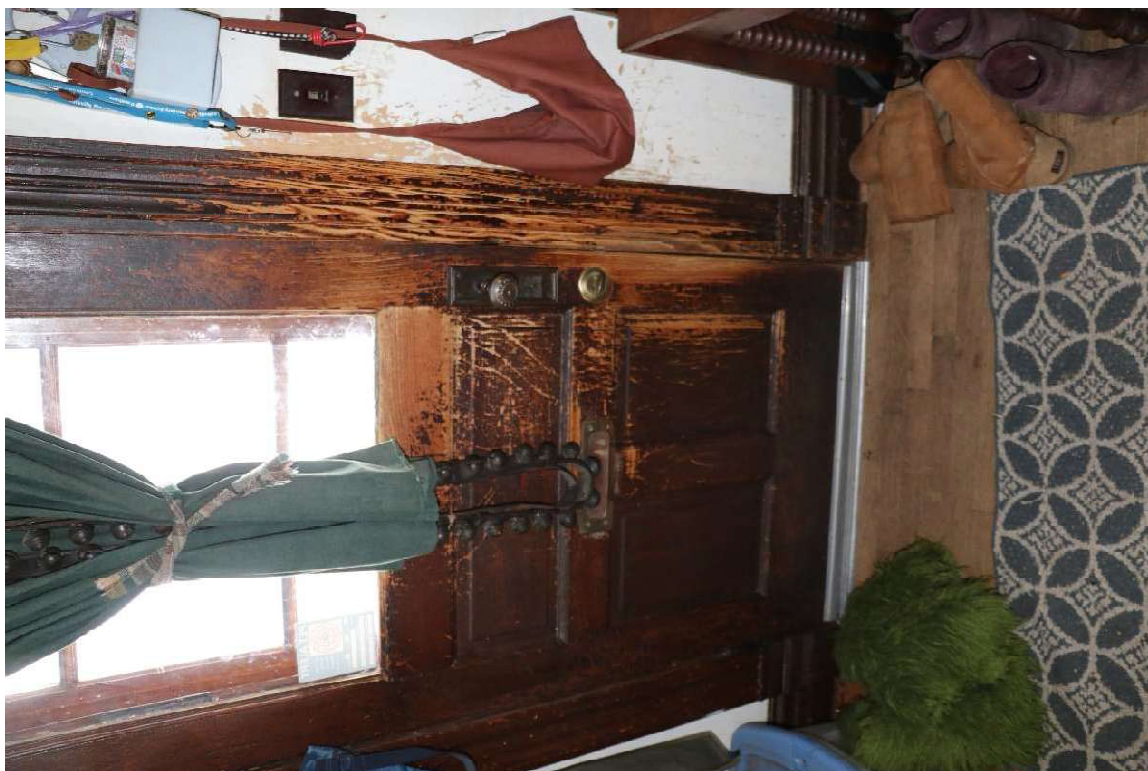
Image 23: Doors. Front Door

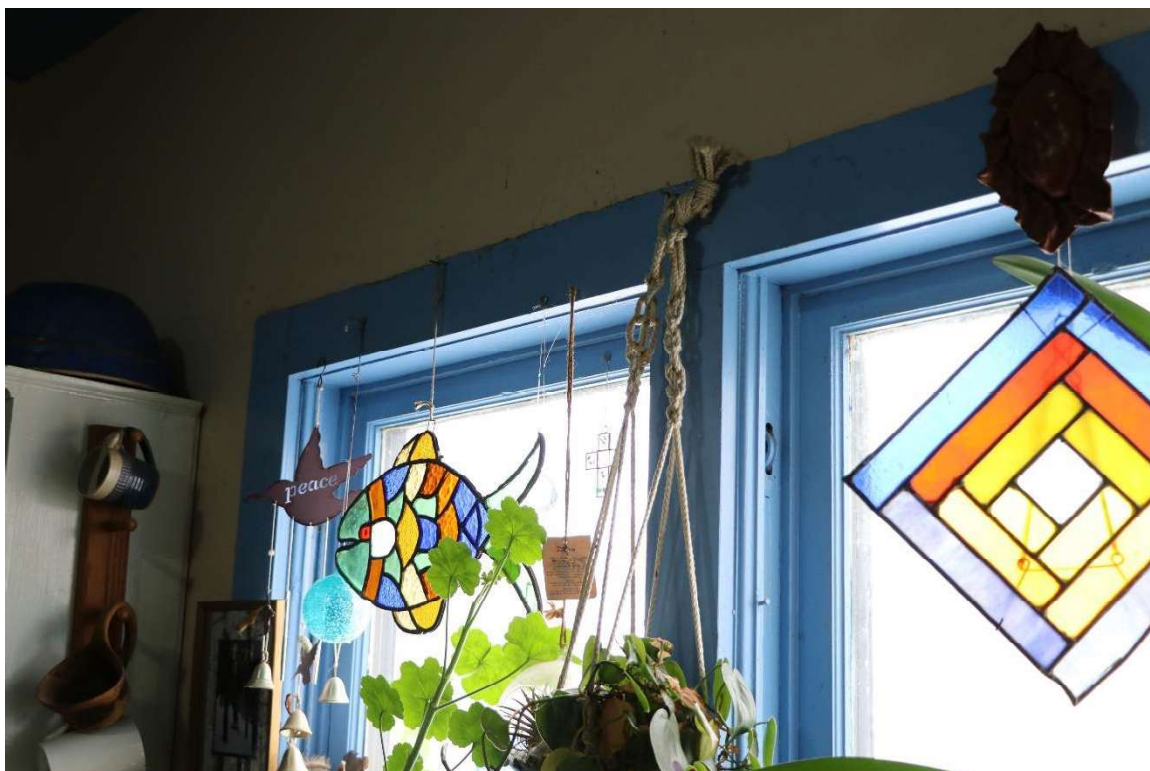
Image 25: Windows. Kitchen. Casing and sash detail

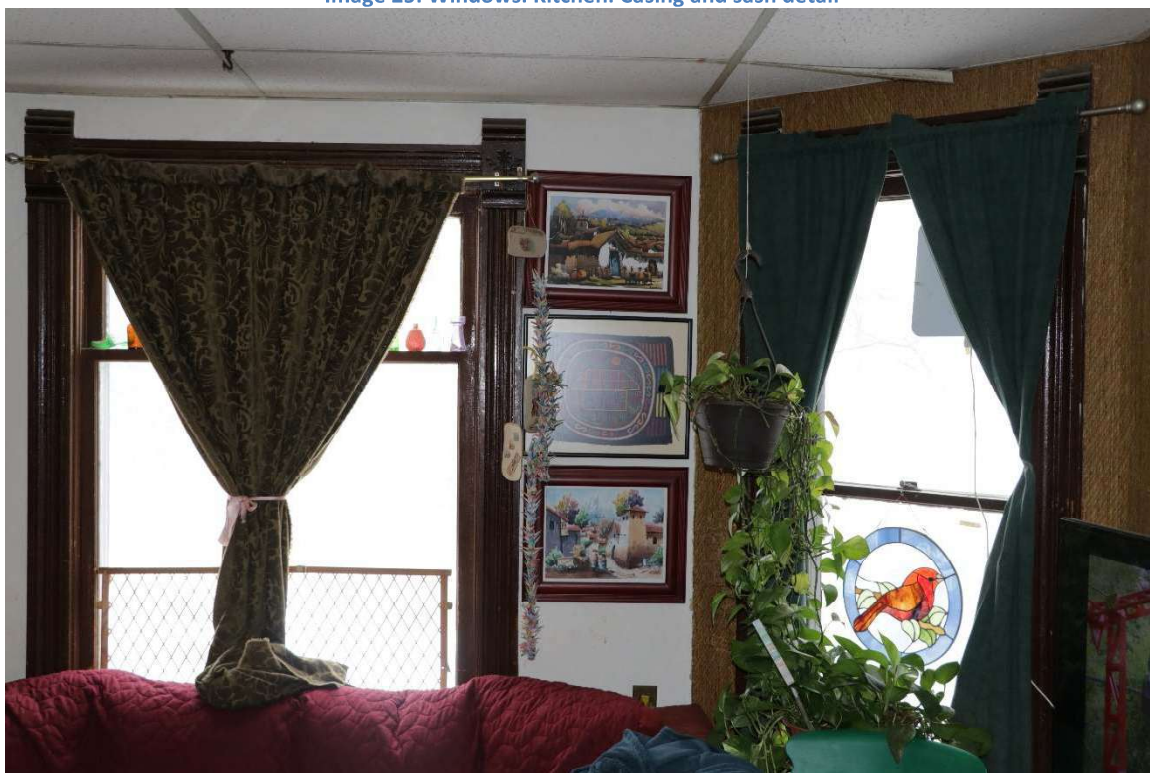
Image 26: Windows. Living Room

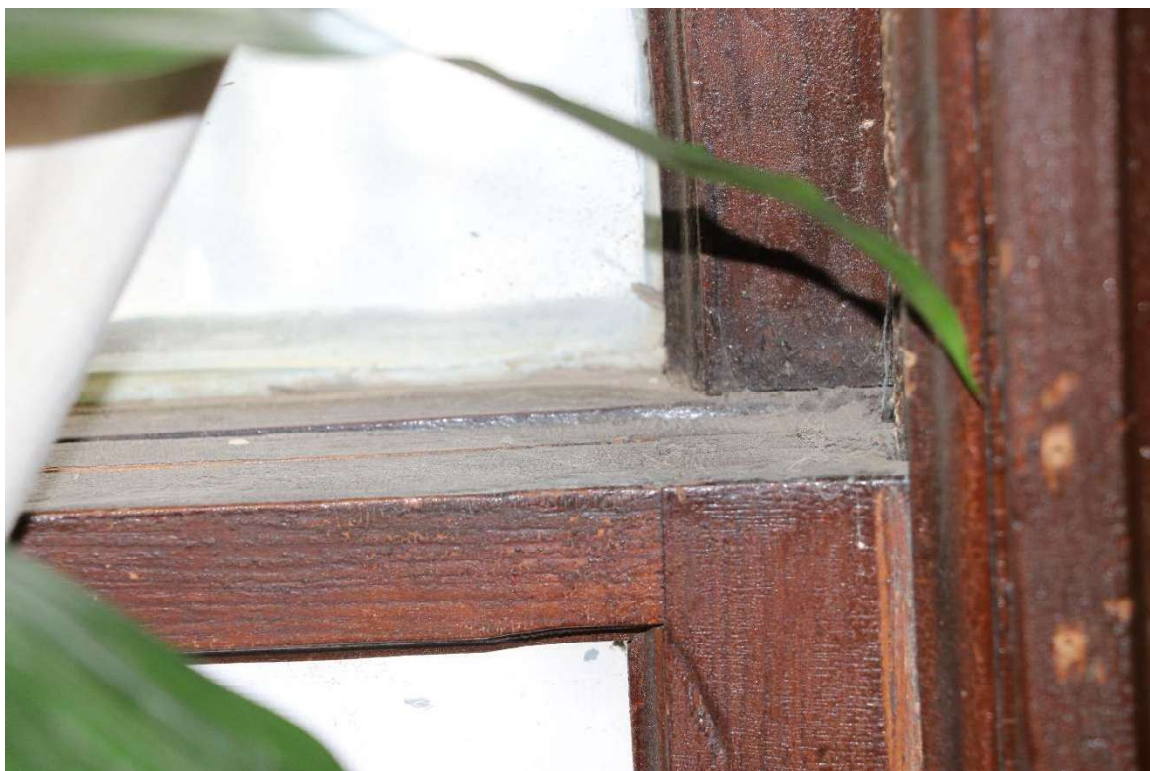
Image 27: Windows. Living Room. Sash detail

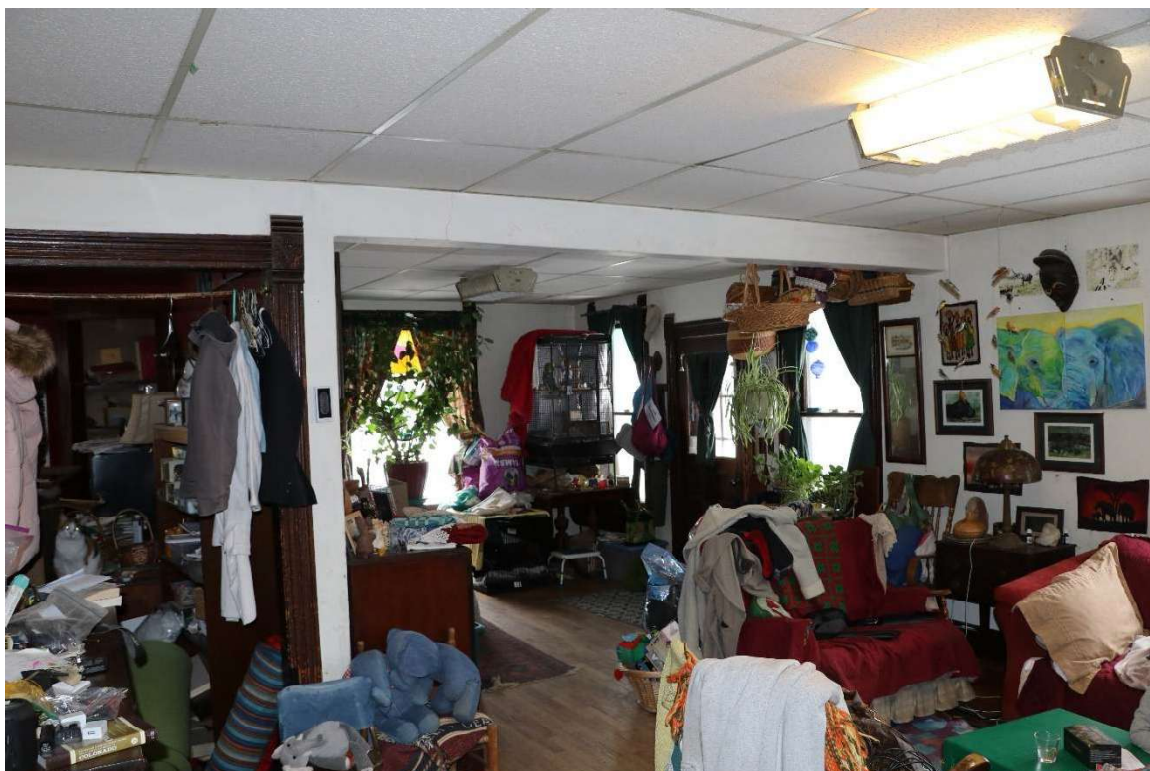
| Element | Description & Condition | Evaluation | Recommendation |
|---|---|---|---|
| Ceiling Finish Materials | Mix of drywall and plaster. The additions are drywall. The living room ceiling is obscured by a tile drop ceiling. Above the drop ceiling some wallpaper fragments remain which could provide additional detail on an earlier design scheme. At the north end of the ceiling plaster is missing down to the wood lath, with evidence that damage was caused by a water leak. The leak appears to have been addressed as no recent damage was noted | Poor | This component is structurally stable but would benefit from being properly repaired. |

Image 30: Ceiling finishes. Living room. Drop ceiling detail

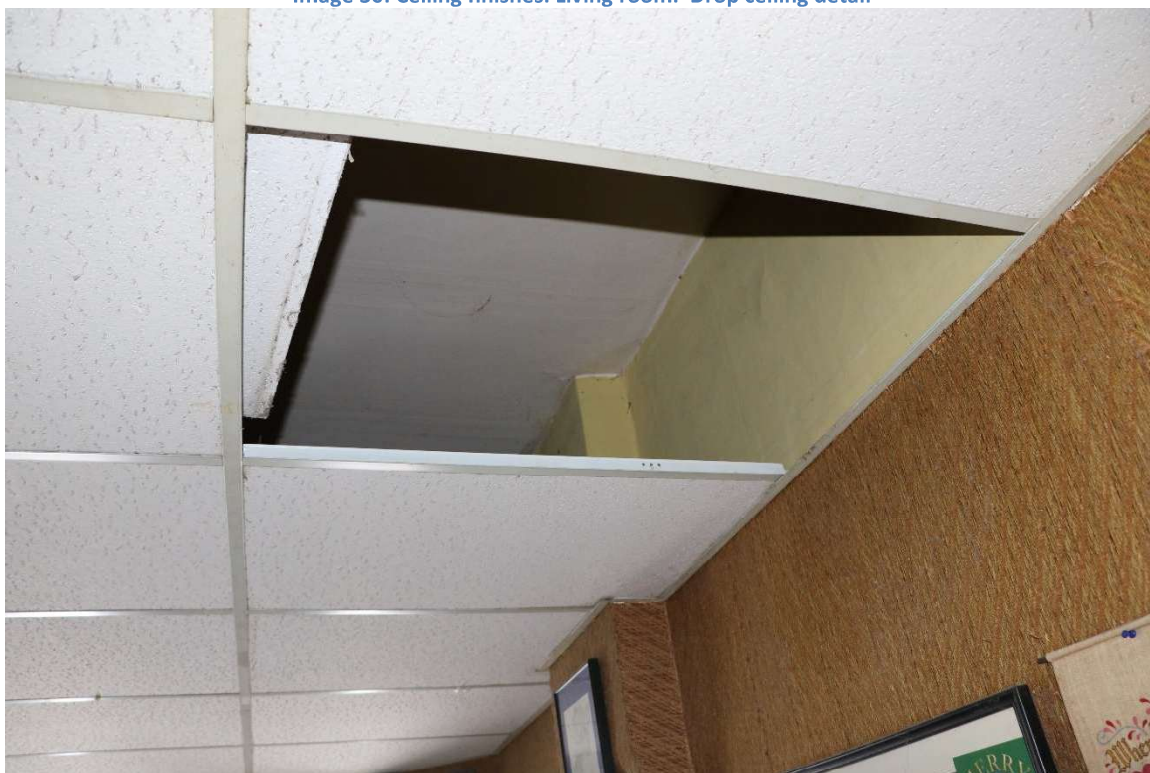
Image 31: Ceiling finishes. Living room. Drop ceiling detail

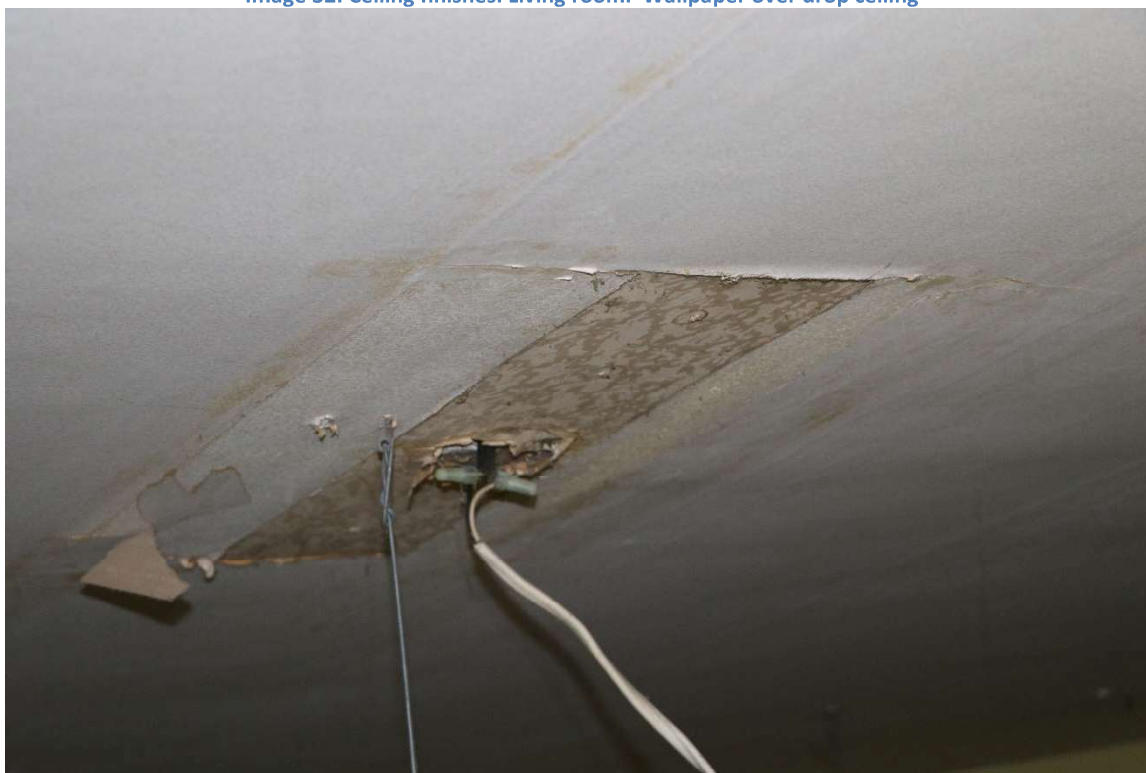
Image 33: Ceiling finishes. Living room. Ceiling wallpaper

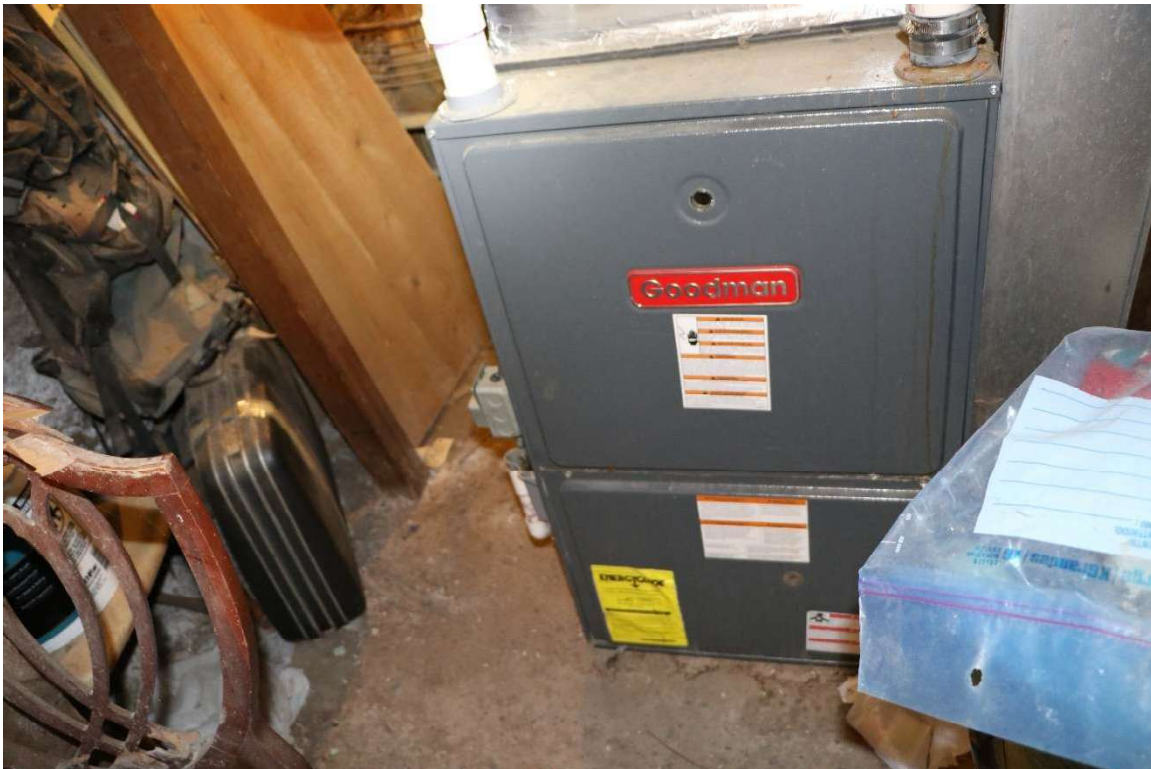
| Element | Description & Condition | Evaluation | Recommendation |
|---|---|---|---|
| Heating & Air-Conditioning | <p>No air conditioning systems were noted.</p> <p>A modern 92.1 AFUE Goodman brand furnace is installed in the basement.</p> <p>There is a US Craftmaster hot water heater adjacent to the furnace that also appears to be a recent addition. The serial number indicates that it was manufactured in 2012.</p> <p>Both the furnace and the water heater appear to be in good working order.</p> | Good | Perform annual maintenance as needed |

Image 37: Heating and Air Conditioning. Furnace

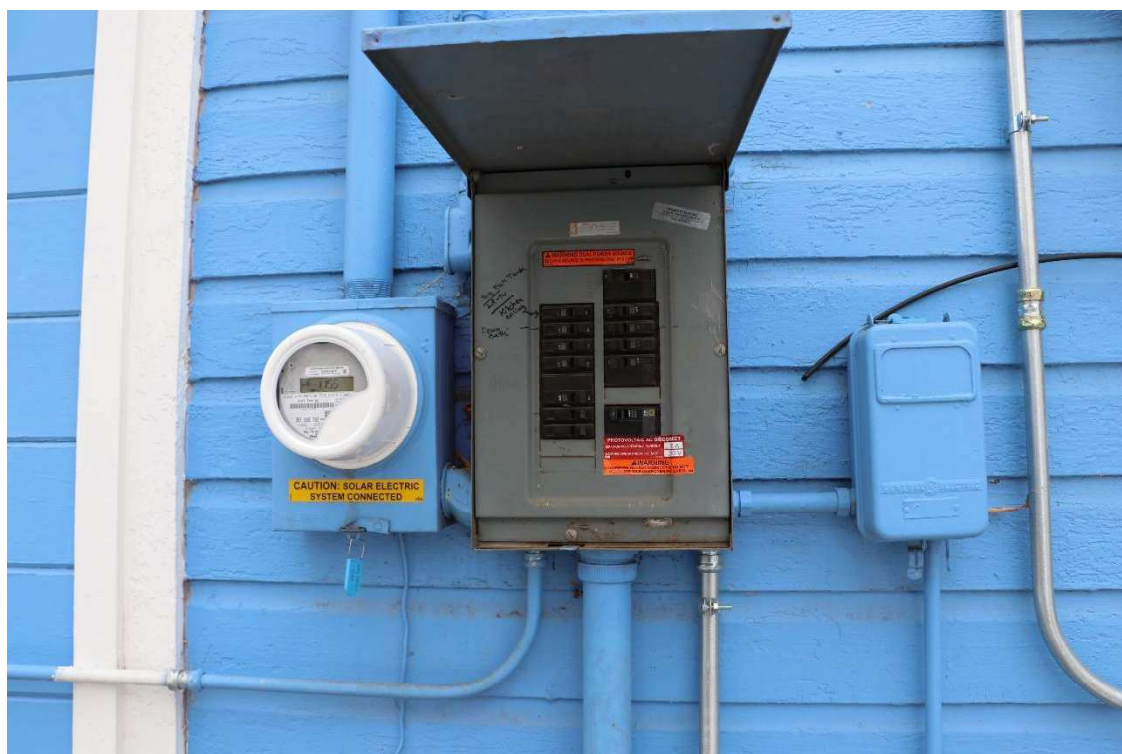
| Element | Description & Condition | Evaluation | Recommendation |
|---|---|---|---|
| Electrical Service & Panels | Electrical service enters the home at the east elevation at the roof level. The meter and breaker panel are modern and in good condition. A solar array is connected to the main panel, with the panels on the roof directly above. | Good | No work needed |

Image 41: Electrical Service and Panels

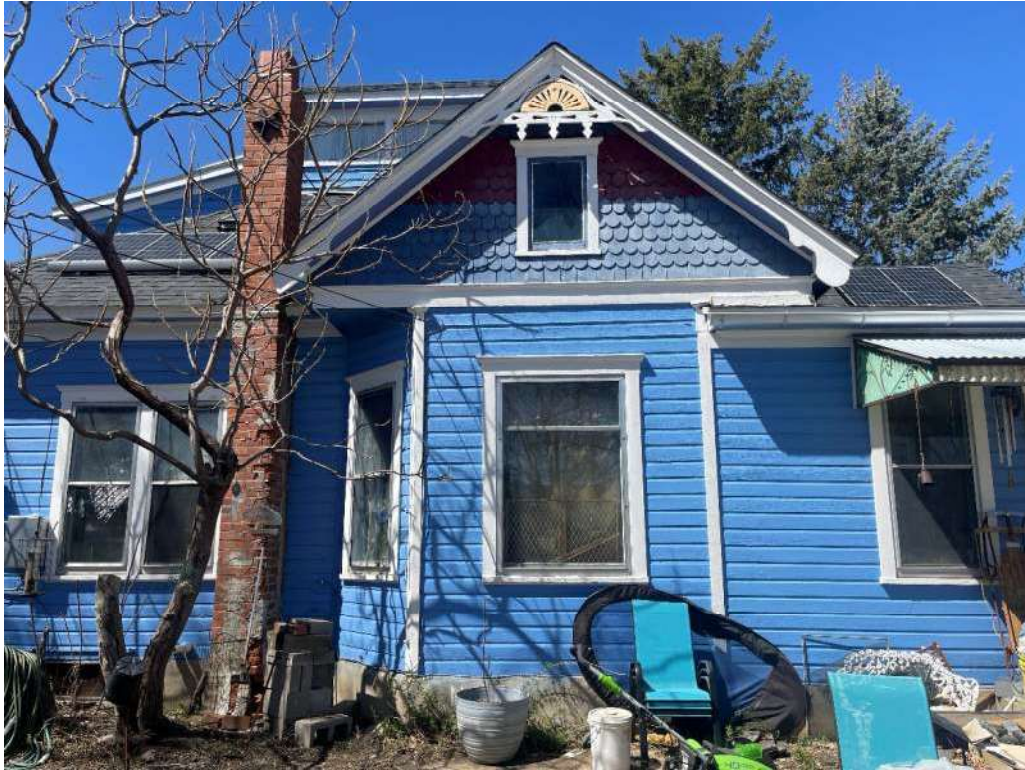
At the northeast corner, there is an addition where there was likely once a front porch (Figure 1). The addition floor appears to be a concrete slab on grade and the walls and roof are wood framed. The addition's roof eave is discernable in the 1948 Real Estate Appraisal Card photograph.

Figure 1: East elevation. Note northeast addition and chimney at roof valley

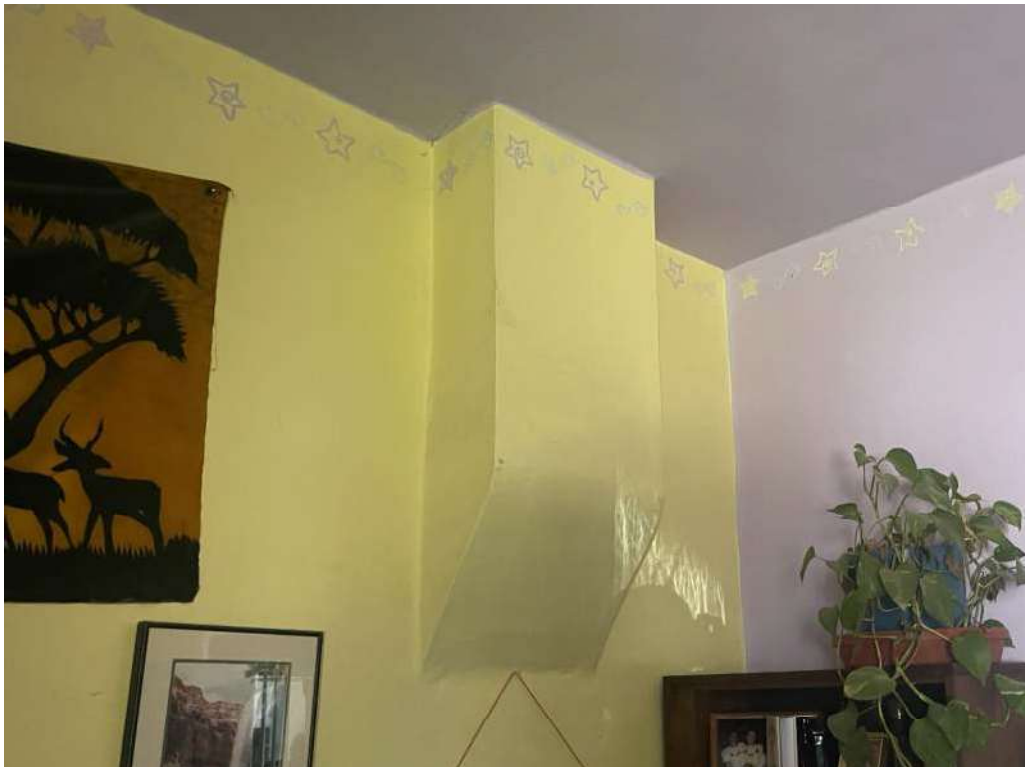
**Interior Chimneys:** The interior chimneys corbel inward to bear on the interior partition walls (Figure 2/Figure 1). The chimneys terminate somewhere in the attic space. There is minor finish staining/damage on the walls near one of the interior chimneys indicating former water leaks at the roof-to-chimney interfaces. There are no cracks in the walls near the chimneys that would indicate insufficient support or rotation.

Figure 2: Interior chimney corbel at partition wall
