**ITEM:** 1016 Main Street

**REQUEST:** A request for a demolition review to demolish the existing house and garage.

DAJ Design conducted an Historic Structural Assessment for the structure located at 1016 Main Avenue, Louisville, Colorado to determine its feasibility as a candidate for historic landmark designation as defined under the Historic Preservation program of the City of Louisville. The structure is a residential property. The City of Louisville Historic Preservation Commission found probable cause that the building may be eligible for landmarking under criteria in section 15.36.050 of the Louisville Municipal Code. Therefore, the Commission approved the Historic Structural Assessment to be paid for by the Louisville Preservation Fund grant.

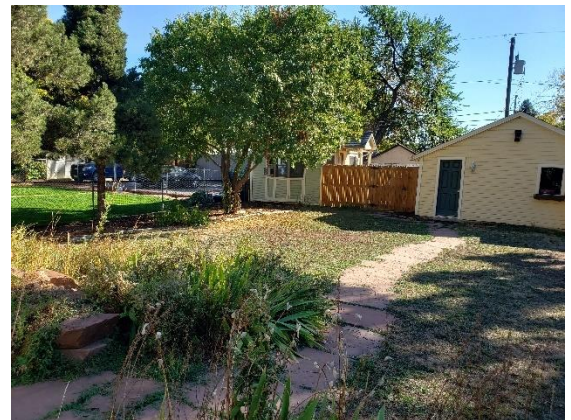
*Rear yard looking towards the garage & studio.*

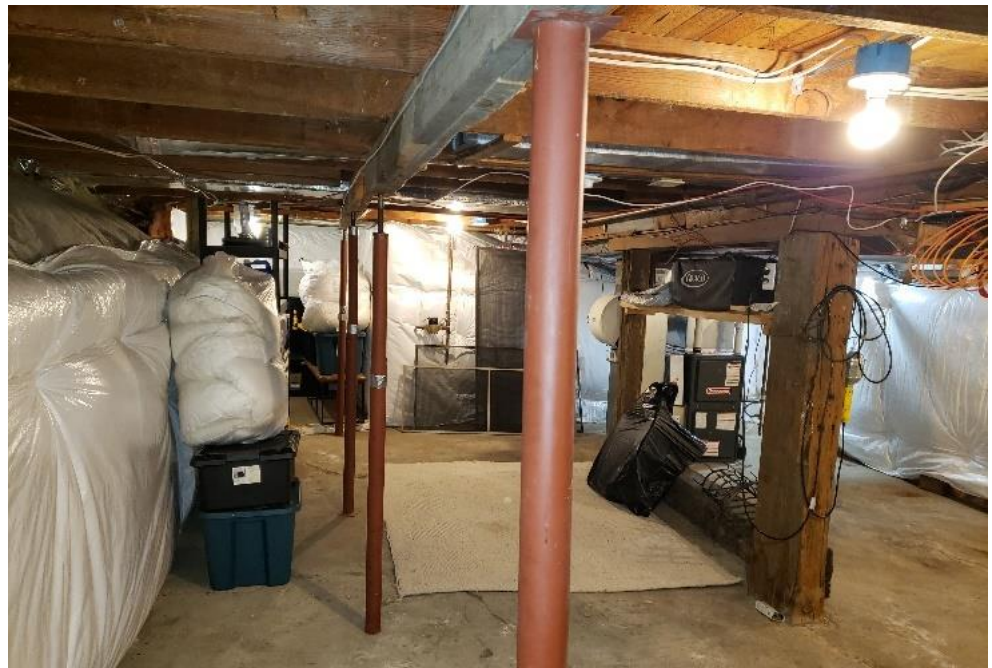
*Two beam lines supporting the main floor joists with columns bearing on a concrete slab floor.*

4. If the main floor deflection is inadequate, consult a licensed structural engineer for additional support design options.
5. New beams may need to be added to support the point and distributed loads from the roof framing as specified in the recommendations of the 'Roof Framing Systems' section of this report.

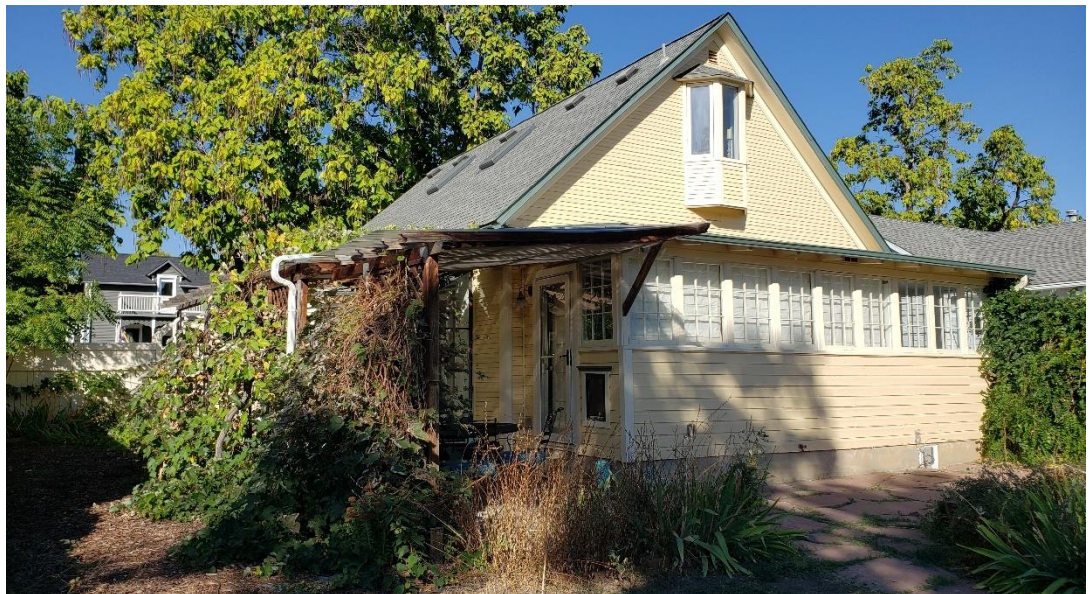
A trellis structure in the southeast corner and a bay window on the upper floor, neither of which are original.

The concrete patio and trellis structure that were added in 1967 are in fair condition. The concrete slab is cracked but relatively level and does not slope water to the house foundation. The wood trellis appears to be properly supported, partially by the house, but the wood stain is weathered, especially on the members that are not covered by the corrugated roof. There are also numerous vines growing on the trellis, but these do not appear to be encroaching on the original house nor do they appear to be damaging the trellis.

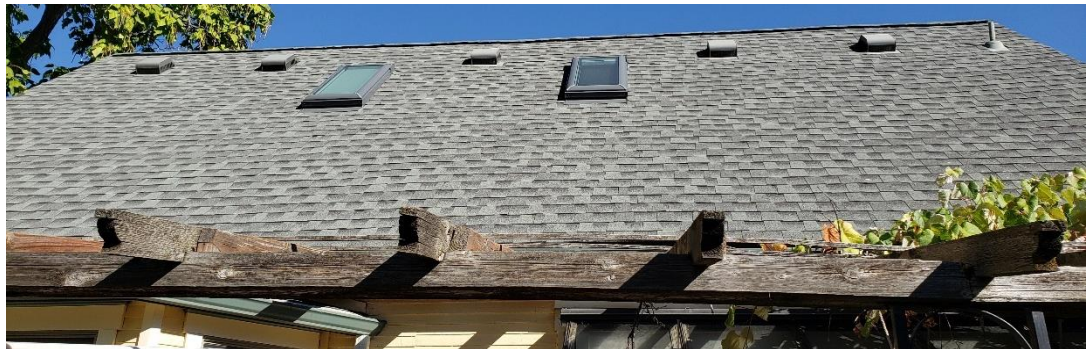
Overall, the skylights appear to be in good condition and create proper seals, but operability was not tested. There is likely flashing around the skylights that were inspected or replaced in 2018 as part of a re-roof that would have been required by code.

*Operable skylights on the south roof aspect.*

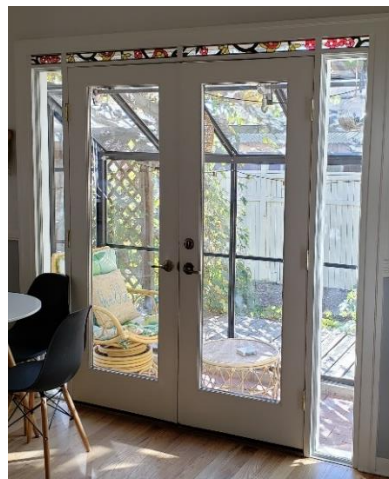
*Double doors to greenhouse.*

The French doors accessing the greenhouse are in good condition. These doors, along with the transom and sidelites appear to have been added relatively recently, possibly in 1989, and are protected from weather by the greenhouse.

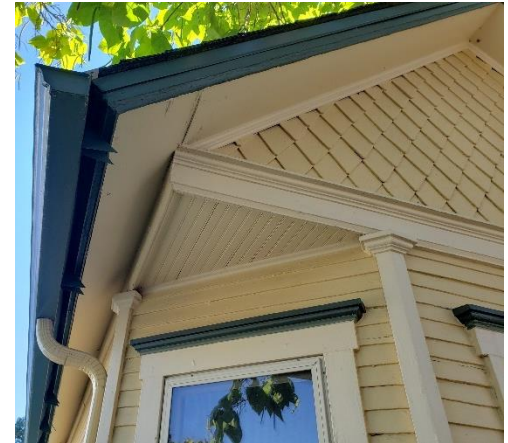
Overall, the soffits are in fair condition. The soffits have been well maintained and are protected from the elements. However, it is likely that the soffits are original and therefore the painted wood is over 100 years old. Some chipping and cracking of the wood is present and some of the seams are not flush.

The fascia was minimally exposed for analysis due to being covered by gutters and aluminum drip edge. Where visible the fascia is in good condition. Further analysis is required when the k-style gutters are removed.

*Painted wood 1x soffit & fascia at the eaves and rakes with beadboard soffit at some locations.*

1. Scrape, repair, refinish, or replace all painted wood soffits.
2. The fascia should be fully evaluated when the k-style gutters are removed. The fascia may need to be repaired or replaced and properly reinforced for new gutter attachment.
