# ***Historic Preservation Commission***

**ITEM:** 1016 Main Street

**REQUEST:** A request for a demolition review to demolish the existing house and garage.

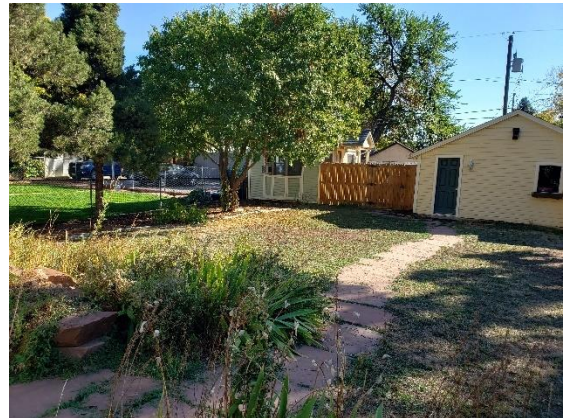
*Rear yard looking towards the garage & studio.*

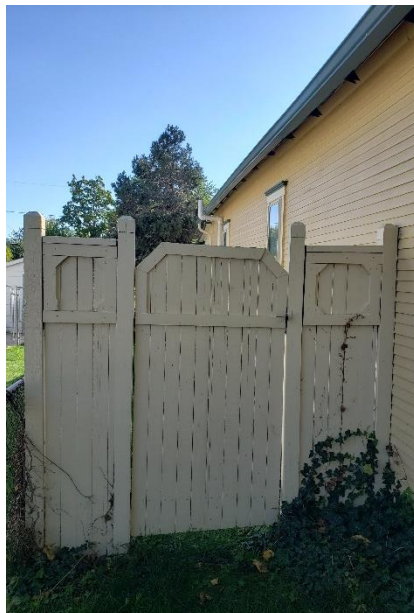
*6-foot painted wood fence & gate.*

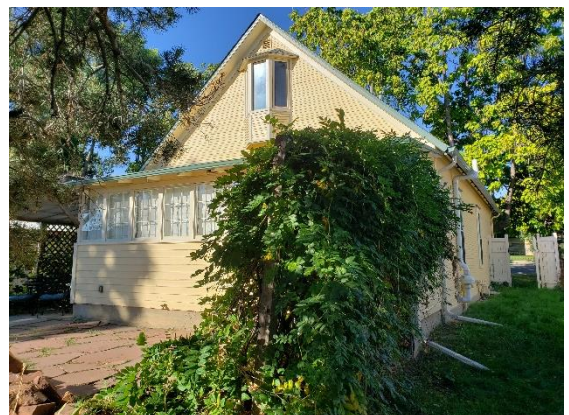
*Vines growing on trellis structure.*

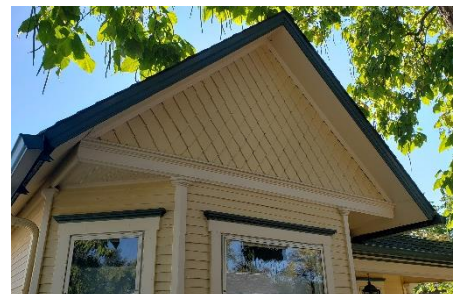
*Wood shingle siding in the smaller gable end.*

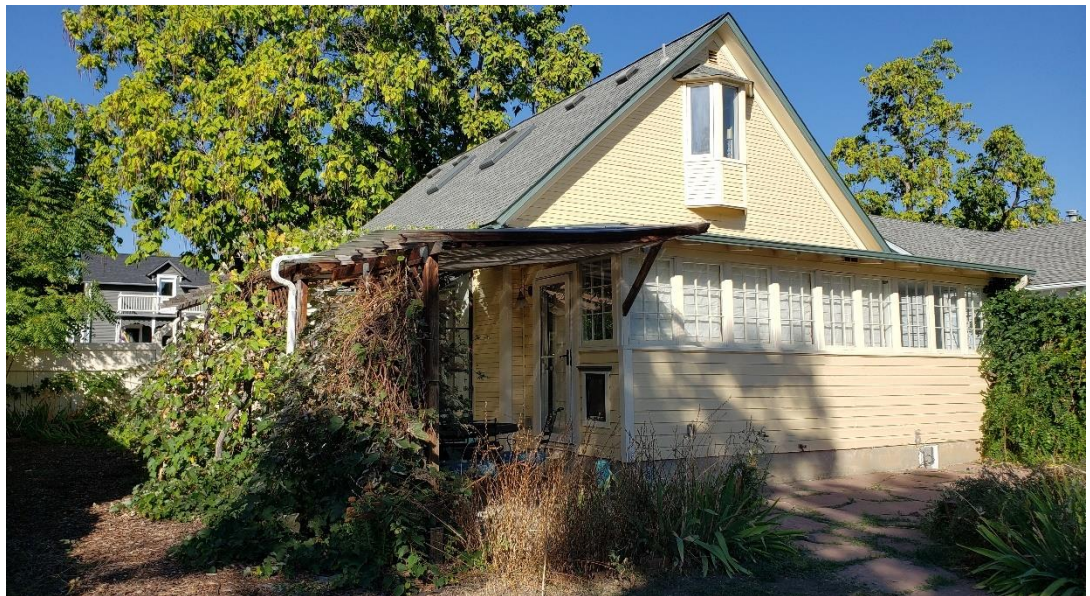
A trellis structure in the southeast corner and a bay window on the upper floor, neither of which are original.

The concrete patio and trellis structure that were added in 1967 are in fair condition. The concrete slab is cracked but relatively level and does not slope water to the house foundation. The wood trellis appears to be properly supported, partially by the house, but the wood stain is weathered, especially on the members that are not covered by the corrugated roof. There are also numerous vines growing on the trellis, but these do not appear to be encroaching on the original house nor do they appear to be damaging the trellis.

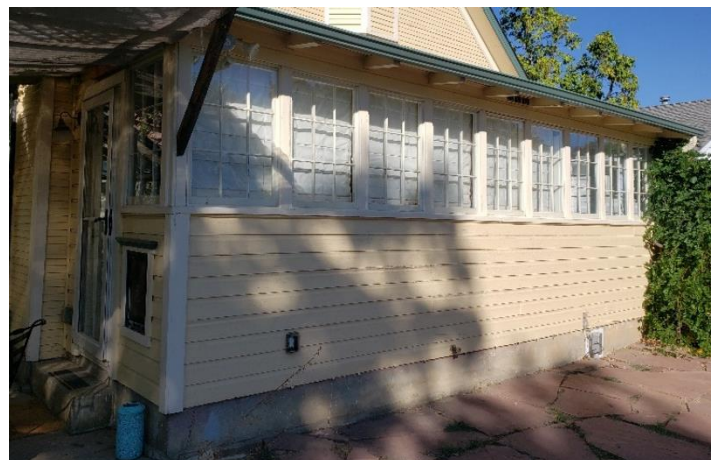
Overall, the windows are in various conditions based on their time of construction. The newer windows on the upper floor and the south bay window are all in good condition as these would have all been added in 1989 or 1992. The windows on the original house and east addition are in fair condition. These windows are all well beyond the expected lifespan of painted wood windows. However, these windows appear to have been well maintained over the years and the aluminum storm windows have likely prolonged their lifespan.

*Single-pane 3-over-3 fixed windows at the east addition.*

1. The original wood double-hung and fixed windows should be properly restored as described below. Windows should be made to be operable, create proper seals, and only use replacement parts where no other option is available.

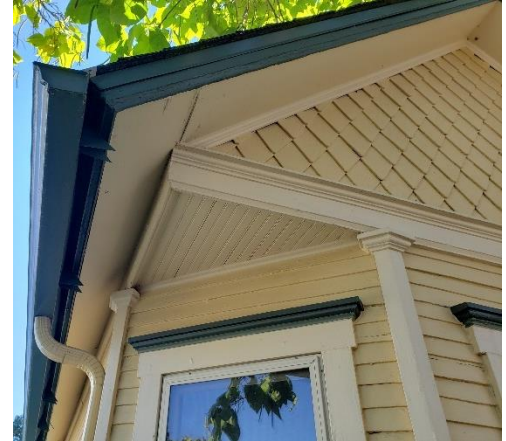
Overall, the soffits are in fair condition. The soffits have been well maintained and are protected from the elements. However, it is likely that the soffits are original and therefore the painted wood is over 100 years old. Some chipping and cracking of the wood is present and some of the seams are not flush.

The fascia was minimally exposed for analysis due to being covered by gutters and aluminum drip edge. Where visible the fascia is in good condition. Further analysis is required when the k-style gutters are removed.

*Painted wood 1x soffit & fascia at the eaves and rakes with beadboard soffit at some locations.*

1. Scrape, repair, refinish, or replace all painted wood soffits.
2. The fascia should be fully evaluated when the k-style gutters are removed. The fascia may need to be repaired or replaced and properly reinforced for new gutter attachment.

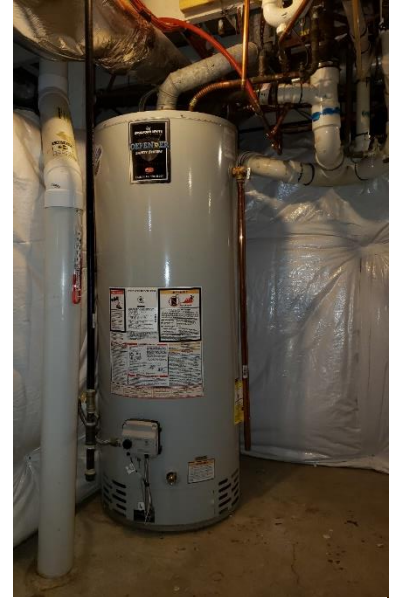
Water heater, supply, and waste lines in the basement.

Consider replacing the water heater with a high-efficiency unit with a sealed combustion intake/exhaust system.
