**ITEM:** 1155 Pine Street Landmark & Alteration Certificate Request

**REQUEST:** A request to landmark the building at 1155 Pine Street, and request for an alteration certificate.

DAJ Design conducted an Historic Structural Assessment for the structure located at 1155 Pine Street, Louisville, Colorado to determine its feasibility as a candidate for historic landmark designation as defined under the Historic Preservation program of the City of Louisville. The structure is a residential property. The City of Louisville Historic Preservation Commission found probable cause that the building may be eligible for landmarking under criteria in section 15.36.050 of the Louisville Municipal Code. Therefore, the Commission approved the Historic Structural Assessment to be paid for by the Louisville Preservation Fund grant.

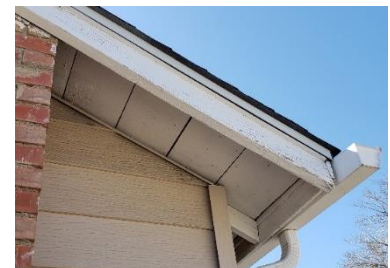
*Exposed roof sheathing and rafter tails.*
