# ***Historic Preservation Commission***

**ITEM:** 1040 LaFarge Avenue Demolition Review

**ADDRESS:** 1040 LaFarge Avenue  
**LEGAL DESCRIPTION:** Lots 13-14, Block 1, Barclay Place  
**DATE OF CONSTRUCTION:** ca. 1912

**REQUEST:** A request for a demolition review to demolish parts of the existing structure.

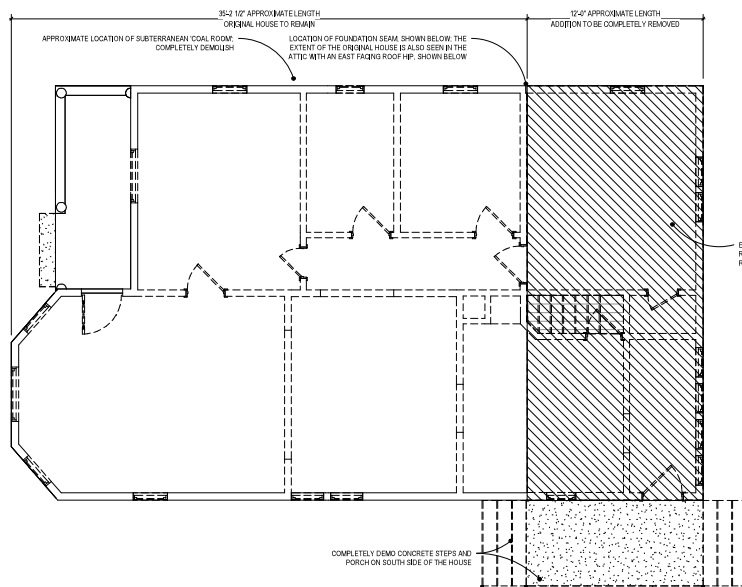
1  
D1 MAIN LEVEL DEMOLITION FLOOR PLAN  
SCALE: 1/4" = 1'-0"

EAST ADDITION TO BE ENTIRELY REMOVED.  
REFERENCE FOUNDATION SEAM AND ORIGINAL HIPPED  
ROOF, SHOWN BELOW, FOR EXTENT OF DEMOLITION

COLD JOINT SEAM IN THE CONCRETE FOUNDATION INDICATES THE EXTENT OF THE ORIGINAL HOUSE.

CONCRETE SUBTERRANEAN COAL ROOM ON NORTH SIDE OF THE HOUSE TO BE COMPLETELY DEMOLISHED.

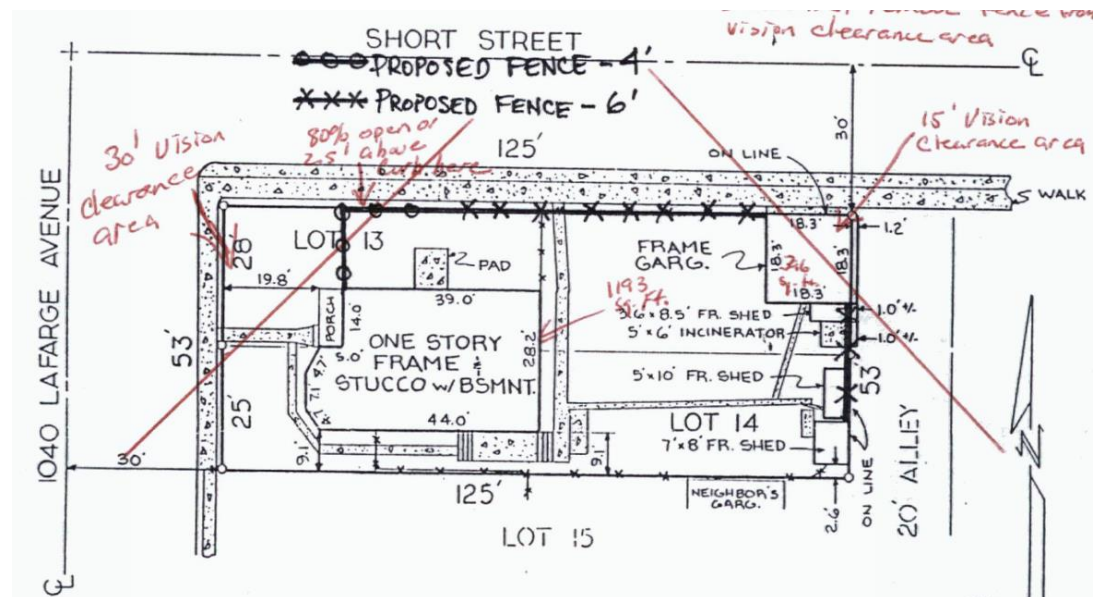
1986 ILC with markings regarding the fence added in 1998. Two of the sheds and the incinerator shown at the east property line do not exist in 2024.

Overall, the landscape features are in good condition. The trees and large shrubs appear to be healthy and well maintained and the landscaping is not overgrown around the house foundation. There are some larger shrubs around the property line, primarily along the alley, that are overgrown but do not pose a risk to any of the structures. Furthermore, some of the hardscape walking surfaces throughout the site may pose tripping hazards as they are not level throughout but again, they do not pose any danger to the buildings.

1. Work with a licensed arborist to maintain the mature trees and shrubs. Ensure that growth does not interfere with the house roof, siding, or foundation.
2. Keep overgrowth trimmed away from the house and overhead electrical lines and remove any overhead branches.
3. Consider replacing the hardscape walking surfaces throughout the rear and side yards with new surfaces that are level.

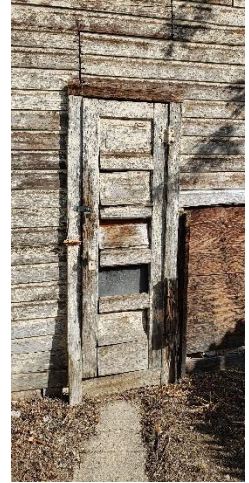
*Person door on south side of the garage.*

The entire garage is in poor condition. The framing does not meet current code by today's standards. The roofing is significantly deteriorated and there is sagging of the roof framing. The shiplap wood siding has not been maintained and such is worn beyond the expected lifespan. The person door is operable but does not create a good seal while the overhead door was not tested but appears to be minimally operable, if at all.

The garage likely meets the age to qualify as a historic element of the site. However, the garage was not originally constructed in a manner to have a long life expectancy and has subsequently been poorly maintained. The size and location of the overhead garage door only provides for one on-site parking space, though it appears that the overhead door is no longer operable, and the condition of the roof poses a safety concern. For these reasons, we recommend removing the garage at this time.

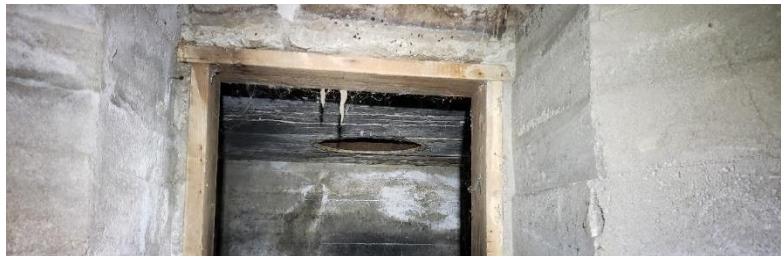
Finally, there is a coal room at the north end of the basement that extends beyond the exterior face of the foundation. The coal room is the same depth as the basement with poured concrete walls and a concrete slab floor. The coal room is capped with a concrete ceiling that is visible from the exterior.

*View inside the coal room looking up towards the ceiling. The concrete ceiling and cap are visible from above.*

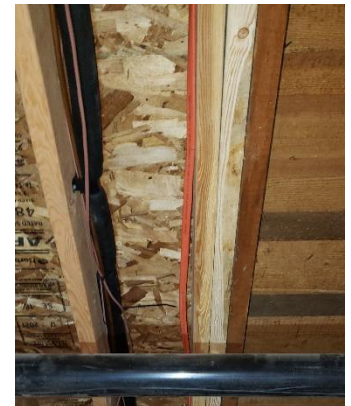
*OSB sheathing left and original sheathing right.*

The floor sheathing appears to be in fair condition. The sheathing appears to be performing adequately, but the extent of the sheathing and the number of layers on top of the sheathing could not be determined. The floor sheathing does meet the minimum IRC code requirements for today's standards and appears to be performing adequately.

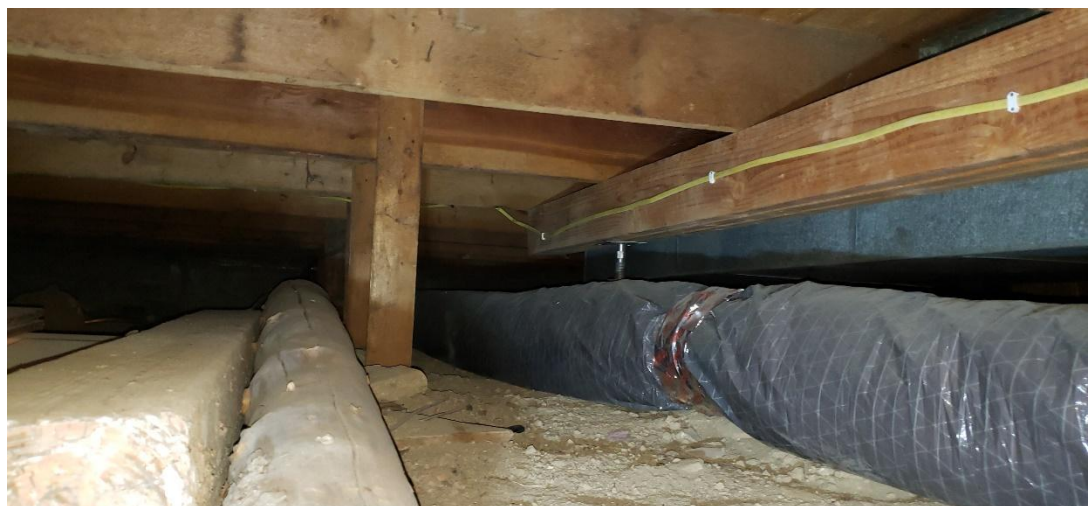
Where the floor joists span over crawlspace areas, they are supported by 1x wood posts bearing on rock or wood on grade. These supports could be original or added later to help reduce floor deflection. It is likely that such supports were used throughout, prior to the basement being dug out. The floor joists spanning over the basement are supported by several beams and columns that appear to be added at various times. Older beams and columns appear to have been removed and stored in the basement. There is a center W6 steel beam with intermediate 3-ply 2x6 beam lines on each side to stiffen the floor. The beams are supported by 2 1/2" diameter adjustable steel pipe columns. The pipe columns sit on small baseplates with no fasteners though some appear to be poured into the concrete slab floor and may bear on footings, but this could not be determined. The central steel beam ends at the crawlspace where the joists transition to being supported by an original 3-ply 2x6 wood beam. There are other posts throughout the basement of various materials that appear to support the floor opening and stiffen the floor where needed.

*3-ply 2x6 beam, 1x joist supports, and what might have been original columns stored in the crawlspace.*

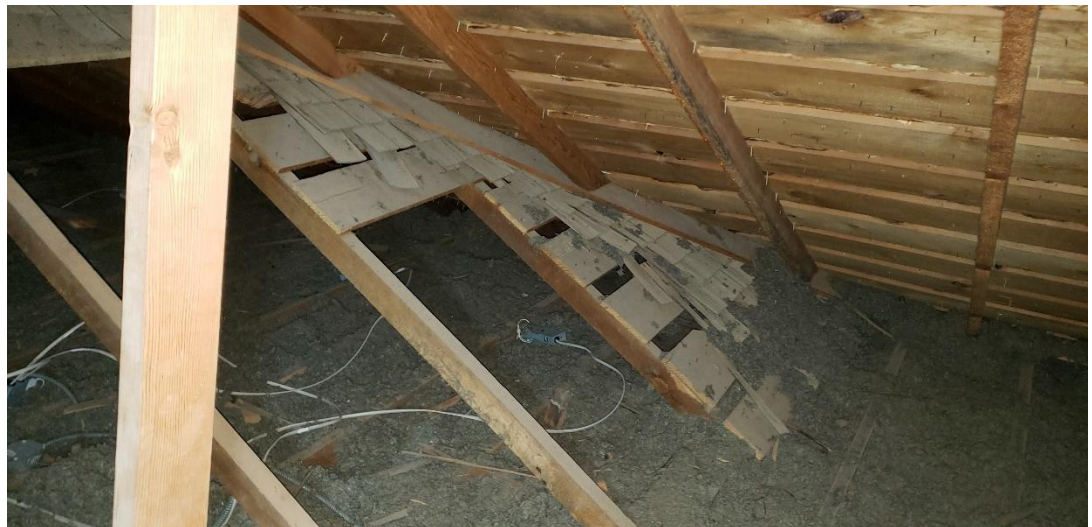
The original roof framing is clearly defined within the attic space as the east facing roof aspect is still mostly intact within the attic, including the original wood shake shingles. This further defines the original structure and the east addition in conjunction with observations made in the foundation and main floor framing. The original roof is a hipped roof with 2x4 hip members and a single 4-foot ridge running east-west. The original ridge beam is broken and has been held together with a single 1x6 joiner. The roof rafters are 2x4 at 24-inches on-center spacing and the ceiling joists are 2x4 at 16-inches on-center running north-south. The ceiling joists are spliced midspan and bear on a central bearing wall below. There are also four diagonal struts supporting the roof and bearing to the same bearing wall below, (one at each hip roof surface). There is a layer of OSB sheathing on top of an original layer of 1x skip sheathing. The skip sheathing ranges in widths from 6 to 12 inches.

*The east aspect of the original roof is visible in the attic. Some of the original skip sheathing was removed and repurposed while some of the original wood shake shingles still remain.*

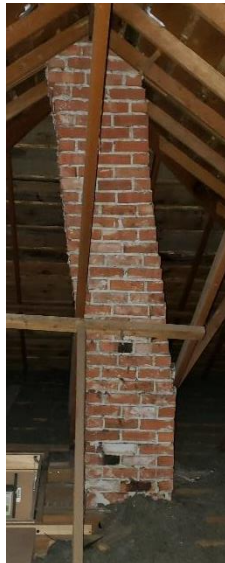
The chimney is in fair condition where visible. The chimney is enclosed on the main floor so the condition of this part of the chimney cannot be assessed.

*Chimney in the attic.*

The chimney's masonry should be tuck-pointed to stabilize its condition.

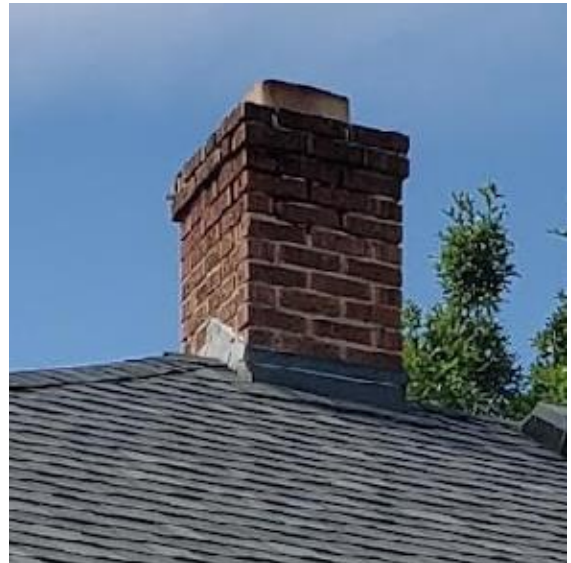
*Chimney above the roof that appears to be original.*

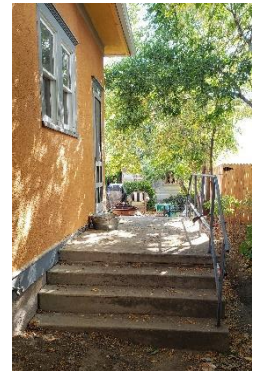
The concrete stoop on the south side of the house is in fair condition. The concrete appears to be well maintained, but the stoop was poured against finish materials of the house. It is unclear if proper waterproofing of the house was completed prior to pouring the concrete stoop, but it appears unlikely due to the age of construction. There are likely rotting wood elements on the house beneath the concrete.

*Concrete stoop on the south side of the house.*

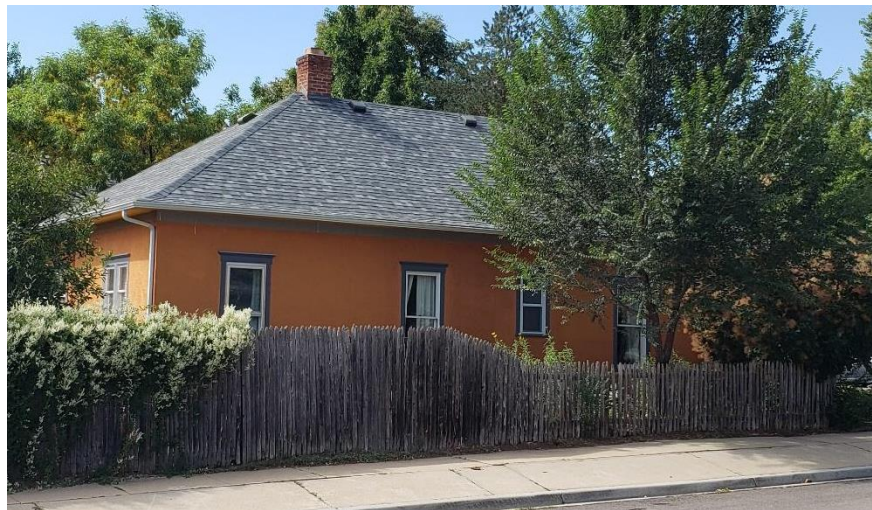
*Asphalt roof and upper roof venting, both added in 2021.*

The asphalt composition shingle roof is in good condition. The small area of corrugated metal roof appears to be in good condition as well but is not historic. Roof venting does not appear to be adequate for the amount of attic space and there is no low roof venting.

1. The corrugated metal roof should be removed. The original roofing may still exist beneath the metal roof and if so should be repaired or replaced. Otherwise, wood sawn-shingle or asphalt shingles should be added as seen in the photograph from the 1970's.
2. Roof venting should be increased with the addition of low and high venting as required by code.

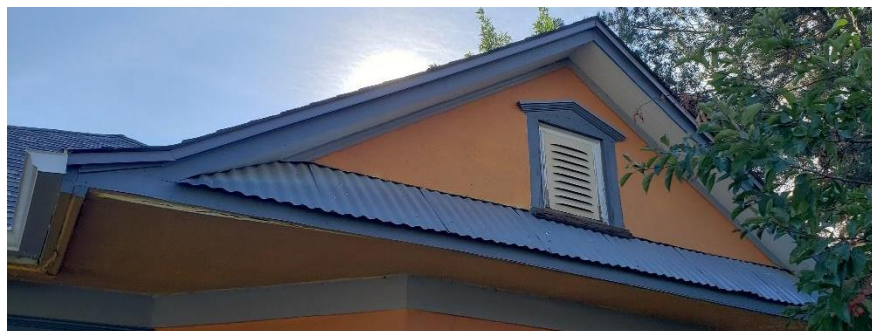
*Corrugated metal roof at west facing Dutch gable.*

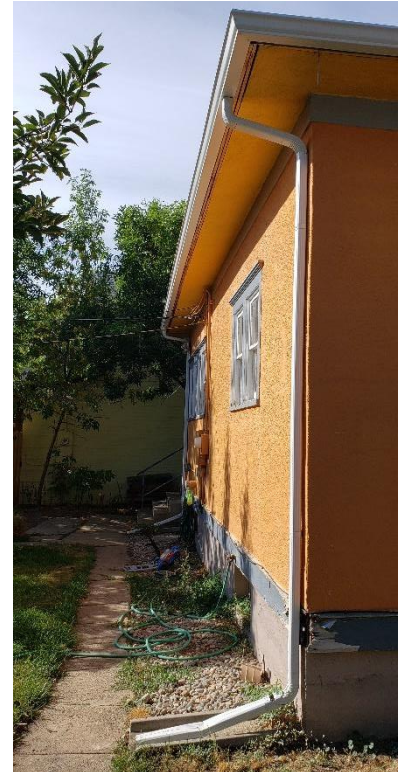
Overall, the gutters are in fair condition. Gutters can be difficult to assess outside of significant rain or snow events, but they appear to be properly attached, and no visible signs of leaking were present. Since we were unable to observe the gutters from above, it could not be determined whether the gutters are kept clear of debris or if any areas of standing water were present.

The downspouts are in fair condition as they appear to be of an adequate amount and in proper locations. Some of the downspout extensions are dented or otherwise damaged though it does not appear that the damage prevents proper water flow.

*K-style gutters & 2x3 downspouts with downspout extensions.*

1. Ensure that all gutters, downspouts, and downspout extensions are maintained to discharge water away from the building foundation and are kept clear of debris.
2. Consider replacing the gutters with half-round gutters to match the historic style typical of Louisville. Downspouts should be replaced with round downspouts.

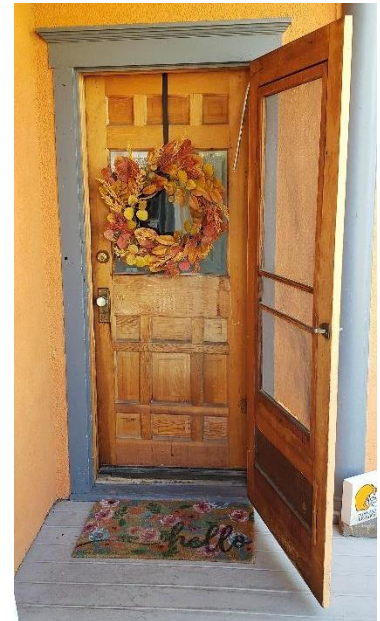
*Front door and screen door.*

The wood doors and associated wood screen doors should be fully restored. The wood door parts should be further inspected and repaired with replacement parts used only where necessary. All of the wood should be stained and sealed to resist weathering. The door hardware should also be repaired to remain functional. The weatherstripping around the doors should be replaced to create proper seals and a door threshold at the south facing door should be added to create a proper seal.

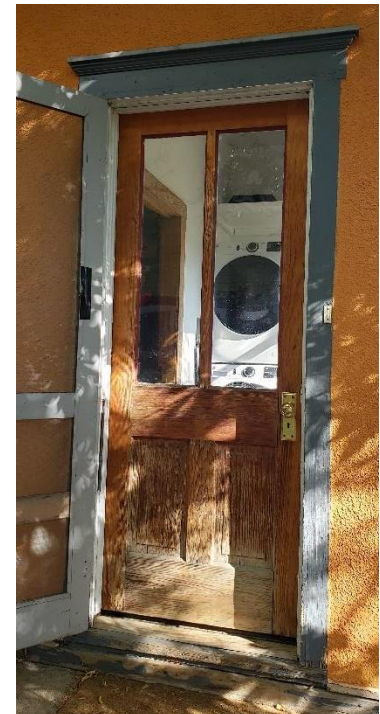
*South entrance door and screen door.*

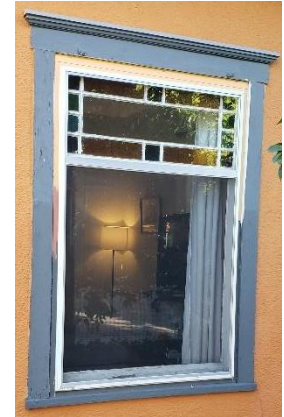
*Carriage window with stained glass.*

1. All of the windows should be properly restored as described below. Windows should be made to be operable, create proper seals, and only use replacement parts where no other option is available.

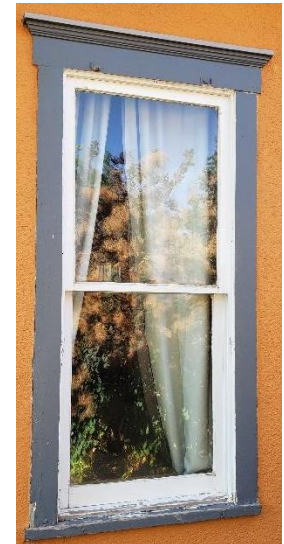
*Single-hung wood window.*

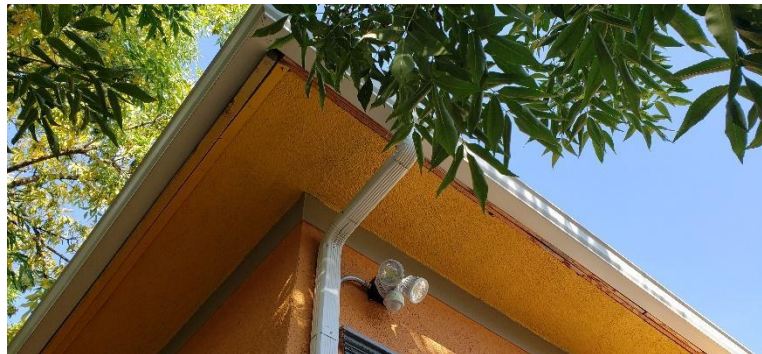
The fascia throughout the house is minimally exposed as it is covered at nearly all locations with gutters. The fascia is partially exposed from underneath, but assessment is limited. The fascia appears to be 1x wood fascia, flush with the stucco soffit, and attached to plumb-cut rafter ends. The gutters appear to be attached directly to the fascia and in some areas, there appears to be two fascia boards. The fascia of the west facing gable is painted wood 1x4.

*Stucco soffit and fascia ends. The fascia is minimally visible beneath the gutters.*

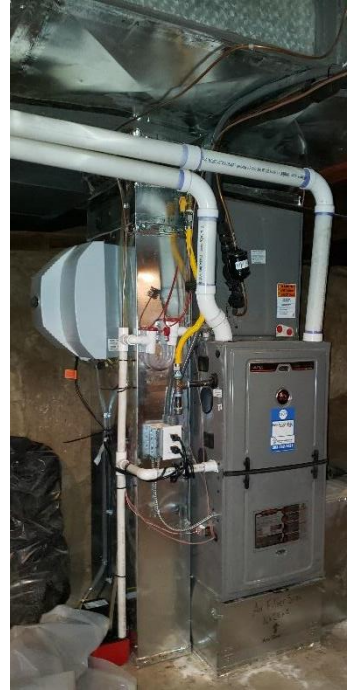
*Gas furnace in the basement.*

1. Continue to perform routine maintenance on the furnace to prolong the lifespan.
2. If heating or cooling does not perform to the homeowner's satisfaction, consult with a licensed mechanical designer for upgrade options.

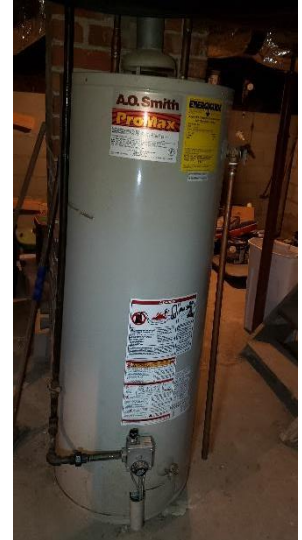
*Water heater in the basement.*

Consider replacing the water heater with a high-efficiency unit with a sealed combustion intake/exhaust system.

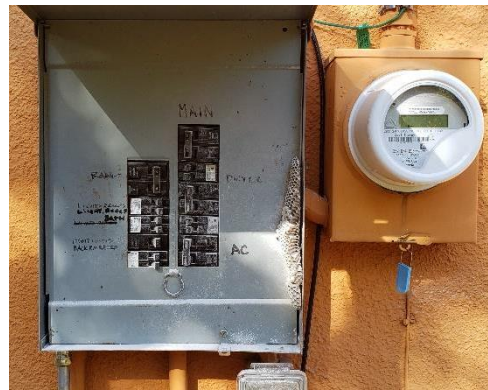
*Electrical panel & meter.*

1. The electrical service panel should be replaced by a licensed electrical engineer with a new 200-amp panel compliant with current codes.
2. Consider replacing the overhead electrical service with a new underground electrical line compliant with current codes and replaced by a licensed electrical engineer.
