**ITEM:** 1040 LaFarge Avenue Demolition Review

**REQUEST:** A request for a demolition review to demolish parts of the existing structure.

DAJ Design conducted an Historic Structural Assessment for the structure located at 1040 LaFarge Avenue, Louisville, Colorado to determine its feasibility as a candidate for historic landmark designation as defined under the Historic Preservation program of the City of Louisville. The structure is a residential property. The City of Louisville Historic Preservation Commission found probable cause that the building may be eligible for landmarking under criteria in section 15.36.050 of the Louisville Municipal Code. Therefore, the Commission approved the Historic Structural Assessment to be paid for by the Louisville Preservation Fund grant.

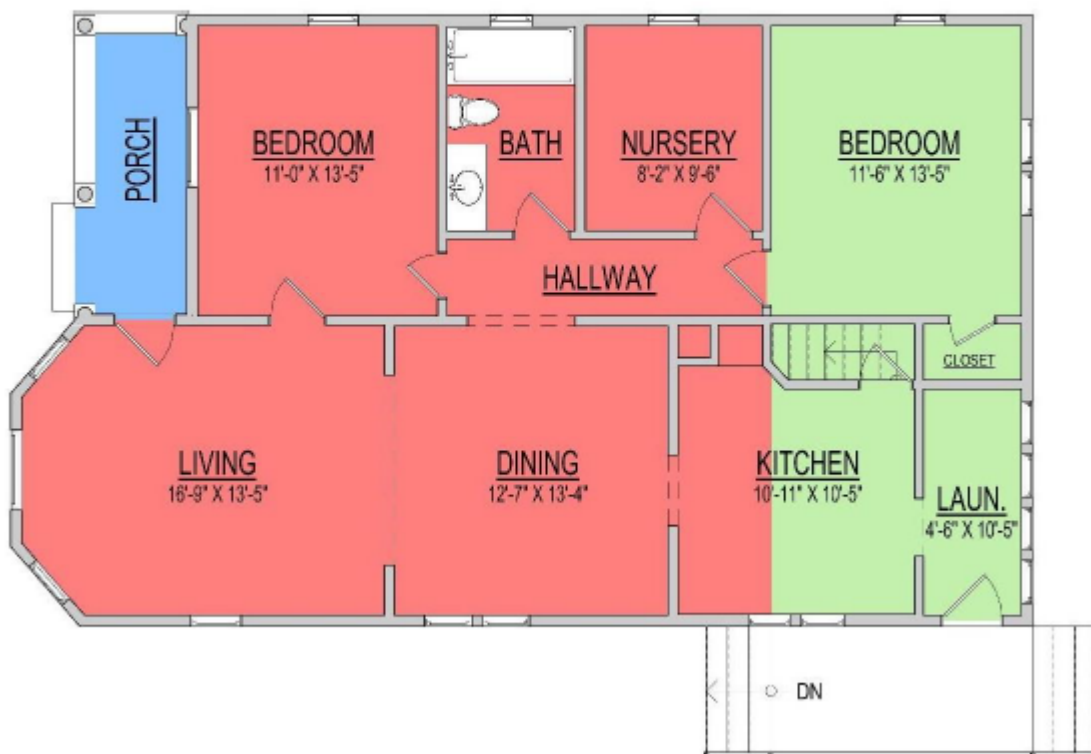
- Original house (RED): 1912
- Original front porch (BLUE): 1912
- East addition (GREEN): Unknown, prior to 1948

The applicant also notes that the eastern addition is clearly delineated from the interior when observing the original roof from the attic, as well as the original foundation which can be distinguished between the main house and the eastern addition.

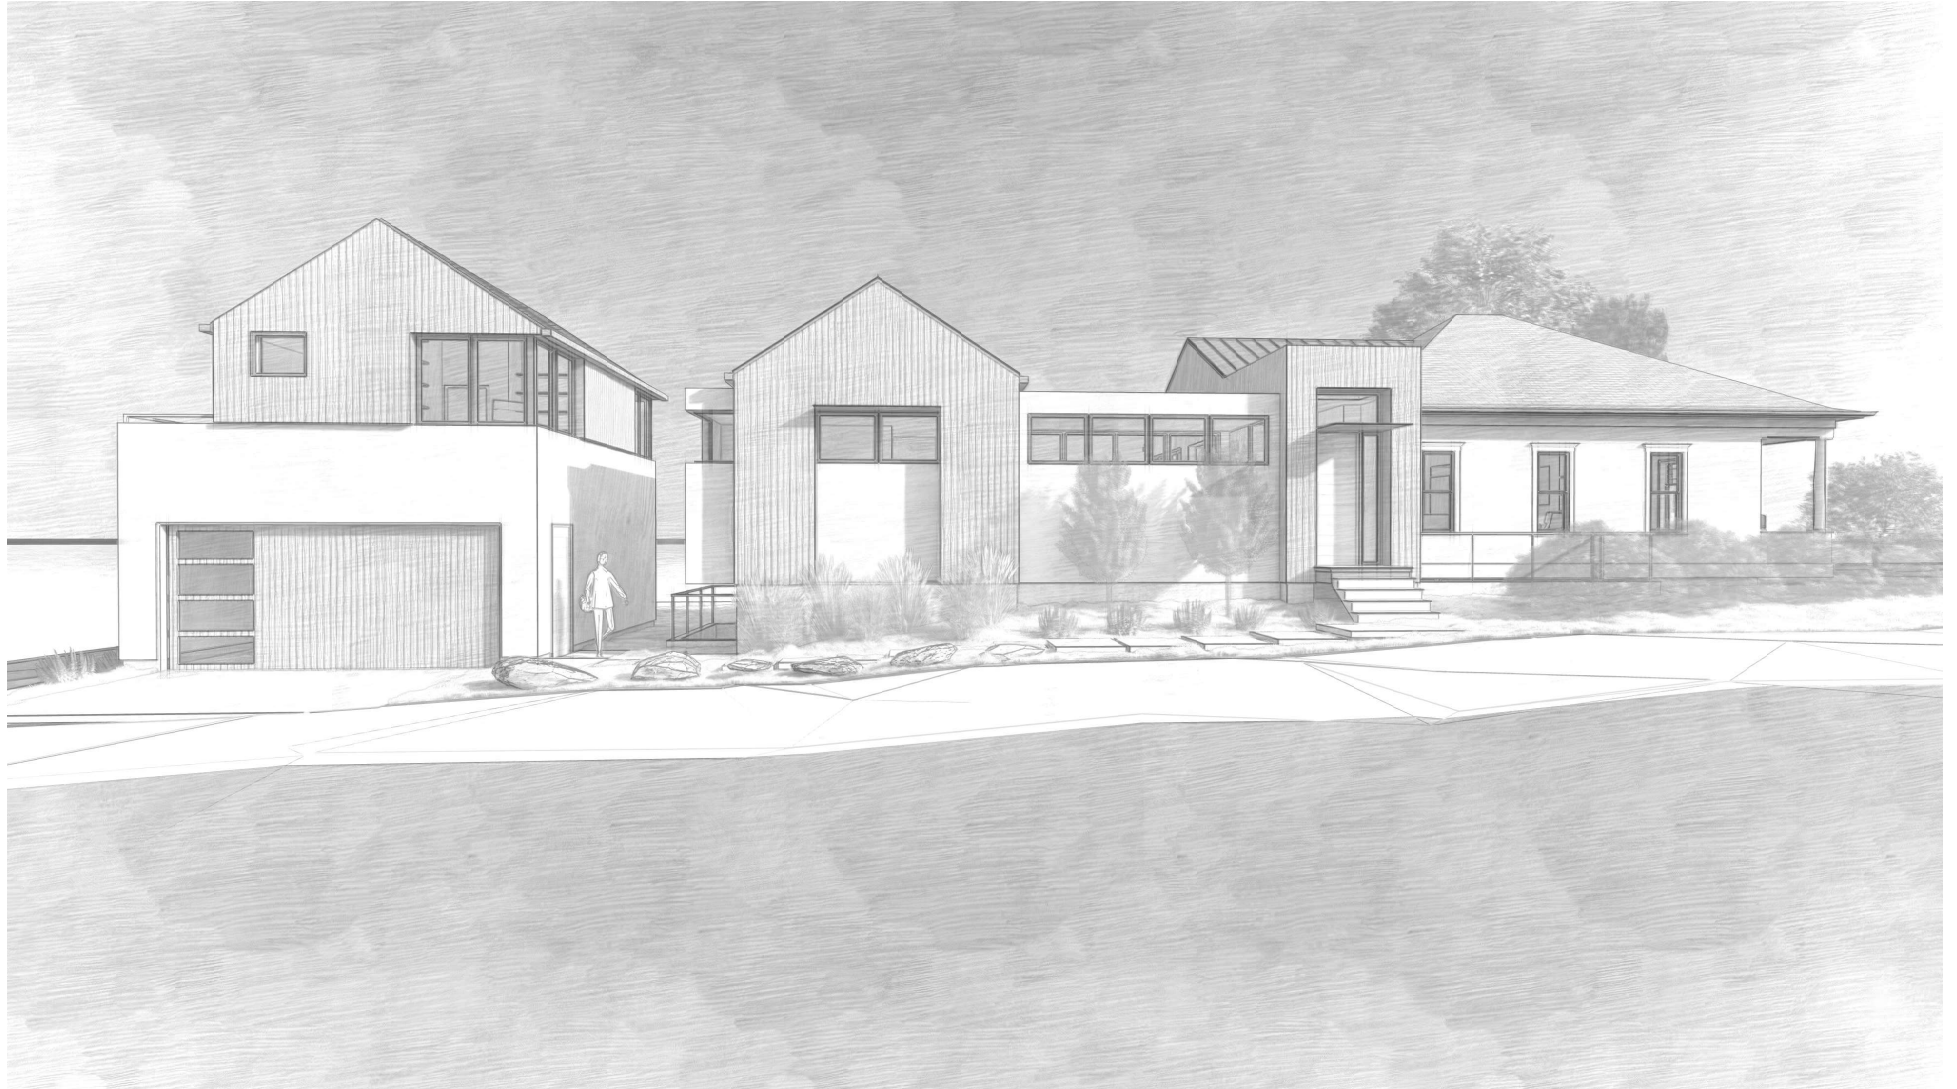
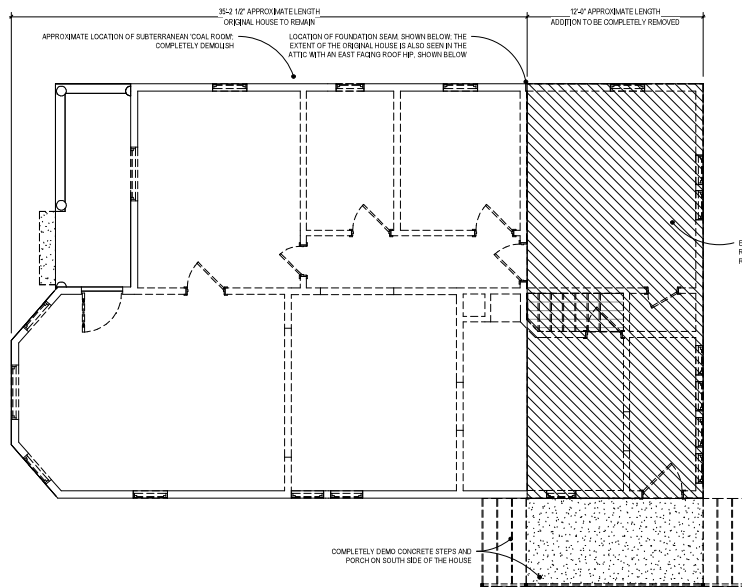
1  
D1 MAIN LEVEL DEMOLITION FLOOR PLAN  
SCALE: 1/4" = 1'-0"

EAST ADDITION TO BE ENTIRELY REMOVED.  
REFERENCE FOUNDATION SEAM AND ORIGINAL HIPPED  
ROOF, SHOWN BELOW, FOR EXTENT OF DEMOLITION

COLD JOINT SEAM IN THE CONCRETE FOUNDATION INDICATES THE EXTENT OF THE ORIGINAL HOUSE.

CONCRETE SUBTERRANEAN COAL ROOM ON NORTH SIDE OF THE HOUSE TO BE COMPLETELY DEMOLISHED.

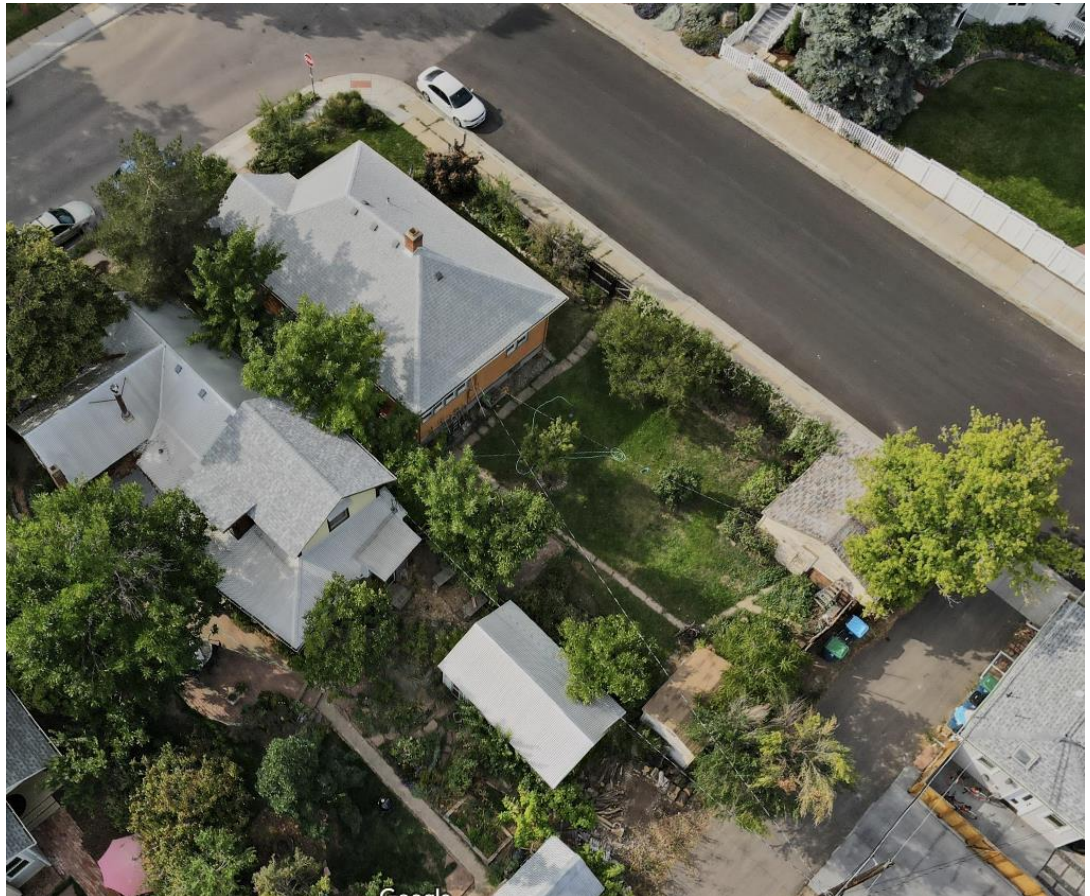
Overall, the landscape features are in good condition. The trees and large shrubs appear to be healthy and well maintained and the landscaping is not overgrown around the house foundation. There are some larger shrubs around the property line, primarily along the alley, that are overgrown but do not pose a risk to any of the structures. Furthermore, some of the hardscape walking surfaces throughout the site may pose tripping hazards as they are not level throughout but again, they do not pose any danger to the buildings.

*Aerial view of the site looking northwest towards the intersection of LaFarge Avenue and Short Street.*

1. Work with a licensed arborist to maintain the mature trees and shrubs. Ensure that growth does not interfere with the house roof, siding, or foundation.
2. Keep overgrowth trimmed away from the house and overhead electrical lines and remove any overhead branches.
3. Consider replacing the hardscape walking surfaces throughout the rear and side yards with new surfaces that are level.

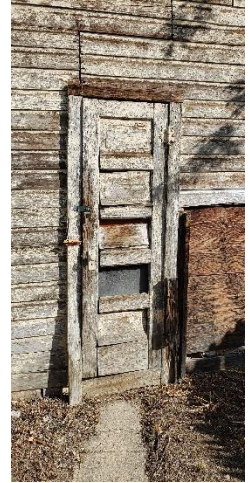
*Person door on south side of the garage.*

The entire garage is in poor condition. The framing does not meet current code by today's standards. The roofing is significantly deteriorated and there is sagging of the roof framing. The shiplap wood siding has not been maintained and such is worn beyond the expected lifespan. The person door is operable but does not create a good seal while the overhead door was not tested but appears to be minimally operable, if at all.

The garage likely meets the age to qualify as a historic element of the site. However, the garage was not originally constructed in a manner to have a long life expectancy and has subsequently been poorly maintained. The size and location of the overhead garage door only provides for one on-site parking space, though it appears that the overhead door is no longer operable, and the condition of the roof poses a safety concern. For these reasons, we recommend removing the garage at this time.

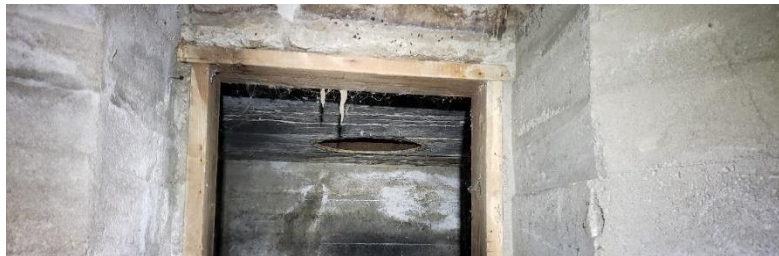
Finally, there is a coal room at the north end of the basement that extends beyond the exterior face of the foundation. The coal room is the same depth as the basement with poured concrete walls and a concrete slab floor. The coal room is capped with a concrete ceiling that is visible from the exterior.

*View inside the coal room looking up towards the ceiling. The concrete ceiling and cap are visible from above.*

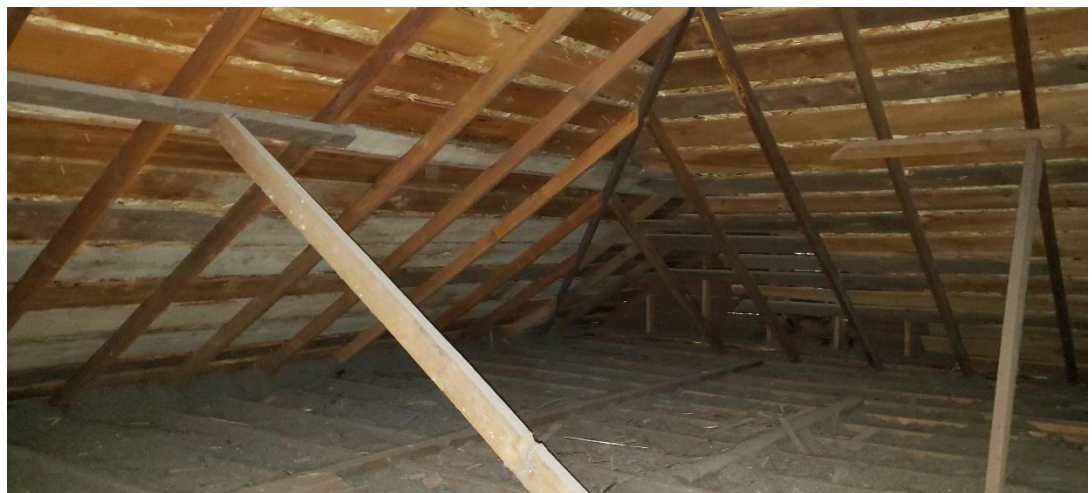
Overall, the roof is in fair condition and is constructed of typical materials and methods for houses built around the same time in the Louisville area. The roof member sizing, spans, and spacing do not meet the minimum IRC code for today's standards. Some roof areas were minimally assessed due to limited access to observe the structural members, primarily at the roof overhangs and the overhang supports of the west facing gable. These roofs appear to be constructed using similar materials and techniques as those areas observed and appear to be performing adequately.

*Original roof framing looking towards the west facing gable.*

The attic insulation is in poor condition as it appears to be providing a minimal insulation R-value that does not meet current code standards.

The roof and ceiling structure is not to current code standards. Since Louisville did not likely have a building code at the time of construction, we are unable to determine if it was built to a code or engineered. The original roof is built to a similar standard of other buildings typical of this type and age. All new repairs should be specified by a licensed structural engineer. Repair details should be provided and submitted to the City of Louisville for review and be observed by the engineer and city inspectors during construction.

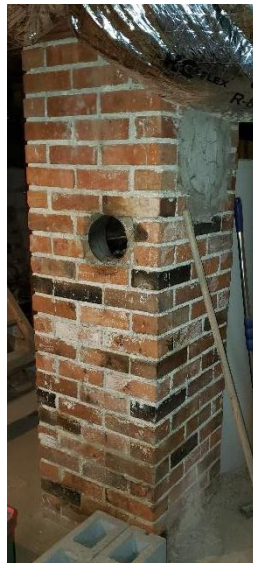
The chimney is in fair condition where visible. The chimney is enclosed on the main floor so the condition of this part of the chimney cannot be assessed.

*Chimney in the basement.*

The chimney's masonry should be tuck-pointed to stabilize its condition.

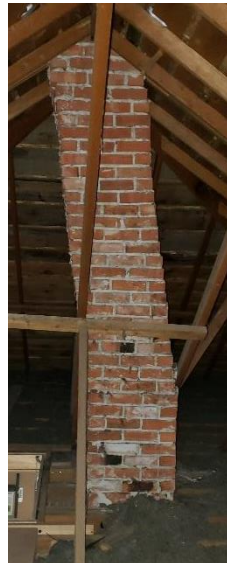
*Chimney in the attic.*

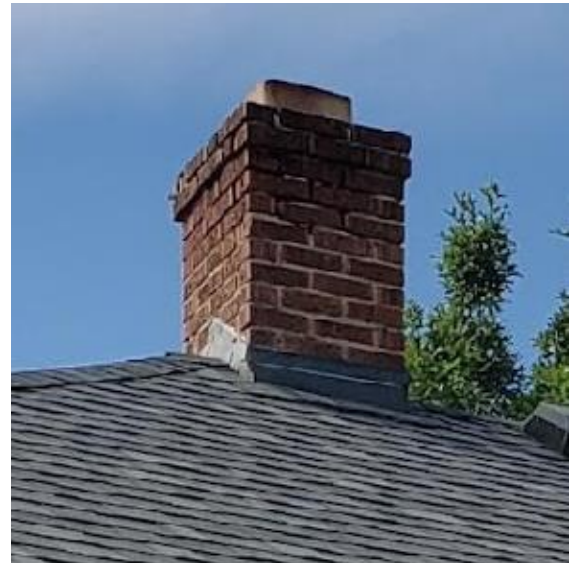
*Chimney above the roof that appears to be original.*

The metal flashing at the chimney is in fair condition. The flashing appears to be older but not original and was likely not replaced during the most recent re-roof as removal and replacement could damage the chimney.

1. Replace the metal flashing around the chimney when the chimney is tuck-pointed as discussed above.
2. Removal of other finish materials may expose other unseen areas of metal flashing. If this occurs, the exposed flashing should be analyzed by a licensed professional and may need replacement.

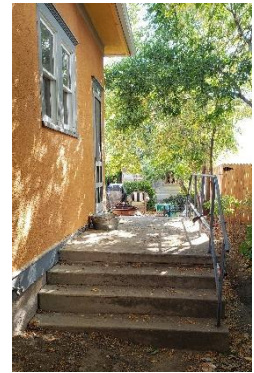
The concrete stoop on the south side of the house is in fair condition. The concrete appears to be well maintained, but the stoop was poured against finish materials of the house. It is unclear if proper waterproofing of the house was completed prior to pouring the concrete stoop, but it appears unlikely due to the age of construction. There are likely rotting wood elements on the house beneath the concrete.

*Concrete stoop on the south side of the house.*

1. Further deconstructive investigation is necessary to properly analyze the covered front porch. The beams, columns, knee-wall construction, support, and attachments need to be verified and analyzed by a licensed structural engineer. The porch floor may be constructed of wood framing sitting on concrete or dirt and therefore has the potential to contain rot. The condition of these elements needs to be verified with deconstructive investigation.
2. The concrete stoop on the south side of the house should be removed and replaced with a similar element. The stoop is not historic and is likely trapping water along wood elements of the house and possibly applying added forces against the concrete foundation. Any repairs or replacement should be coordinated with a licensed architect, a licensed structural engineer, and licensed geotechnical engineer.

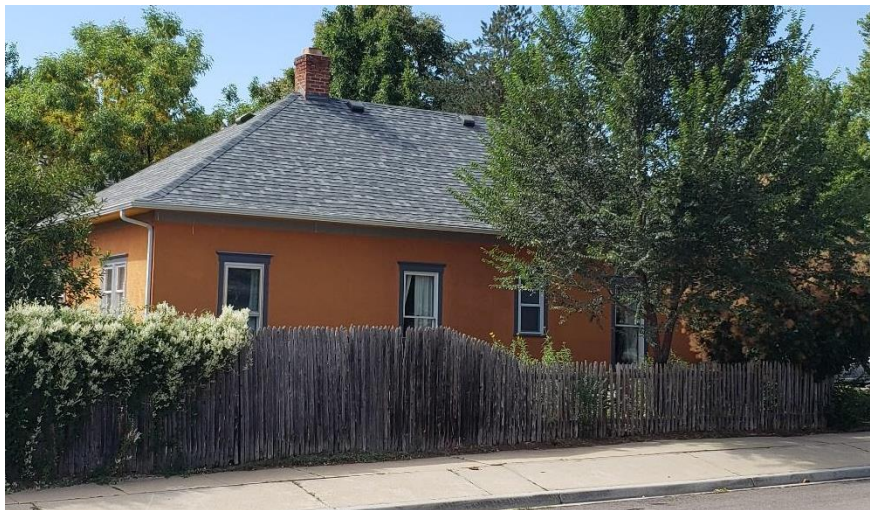
*Asphalt roof and upper roof venting, both added in 2021.*

The asphalt composition shingle roof is in good condition. The small area of corrugated metal roof appears to be in good condition as well but is not historic. Roof venting does not appear to be adequate for the amount of attic space and there is no low roof venting.

1. The corrugated metal roof should be removed. The original roofing may still exist beneath the metal roof and if so should be repaired or replaced. Otherwise, wood sawn-shingle or asphalt shingles should be added as seen in the photograph from the 1970's.
2. Roof venting should be increased with the addition of low and high venting as required by code.

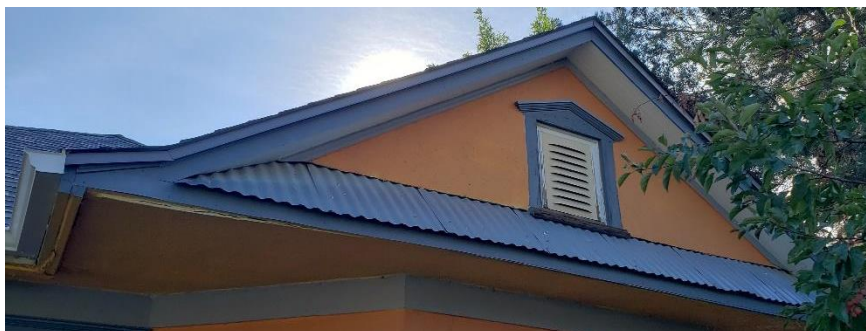
*Corrugated metal roof at west facing Dutch gable.*

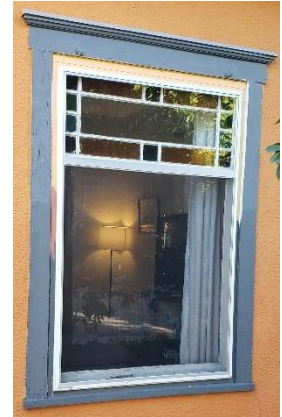
*Carriage window with stained glass.*

- g. Install new storm and screen windows with minimal frames.
2. Alternatively, all of the windows could be replaced with fiberglass or aluminum-clad wood windows. The replacement windows should match the size, location, and style of each existing window.

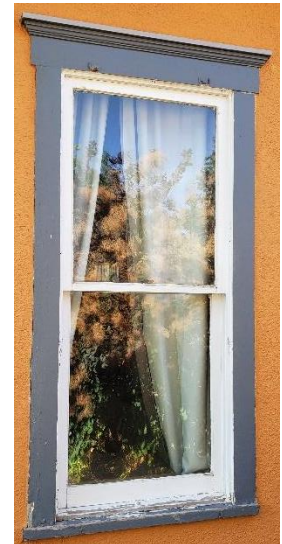
*Single-hung wood window.*

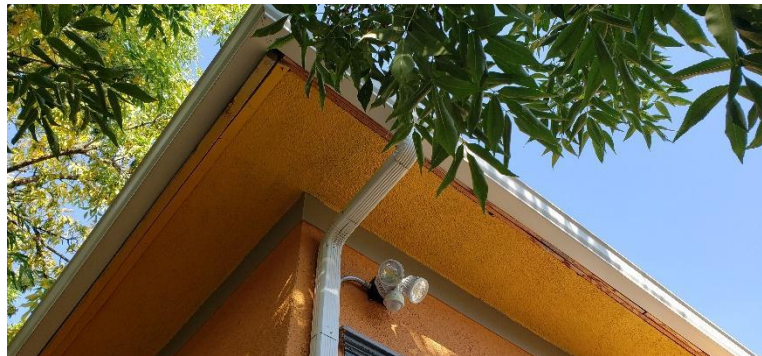
*Stucco soffit and fascia ends. The fascia is minimally visible beneath the gutters.*

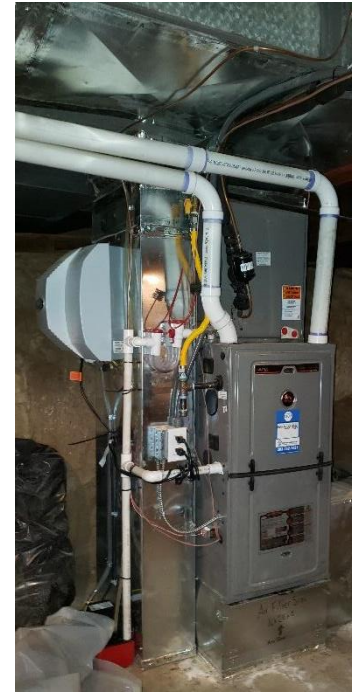
*Gas furnace in the basement.*

1. Continue to perform routine maintenance on the furnace to prolong the lifespan.
2. If heating or cooling does not perform to the homeowner's satisfaction, consult with a licensed mechanical designer for upgrade options.

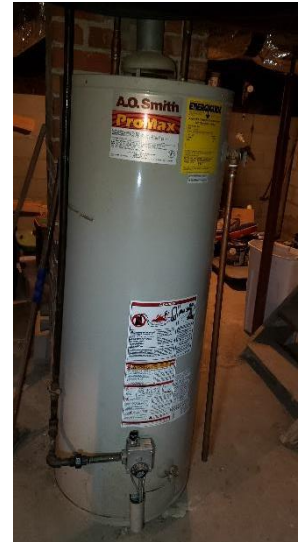
*Water heater in the basement.*

Consider replacing the water heater with a high-efficiency unit with a sealed combustion intake/exhaust system.

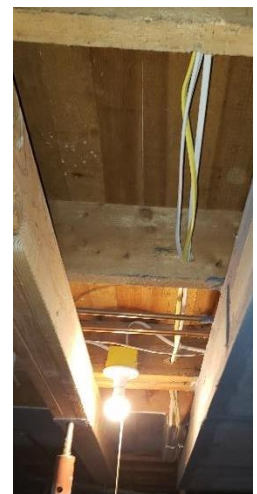
*Romex wiring is seen in the basement & attic.*

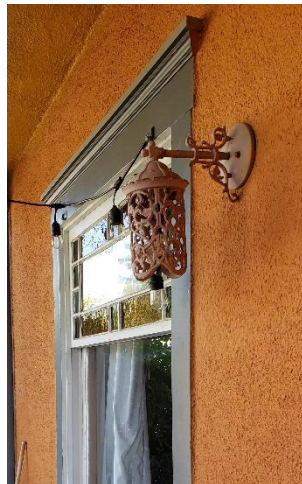
*Wall sconce at front porch.*

Consider installing new exterior lighting that complies with Dark Sky regulations.

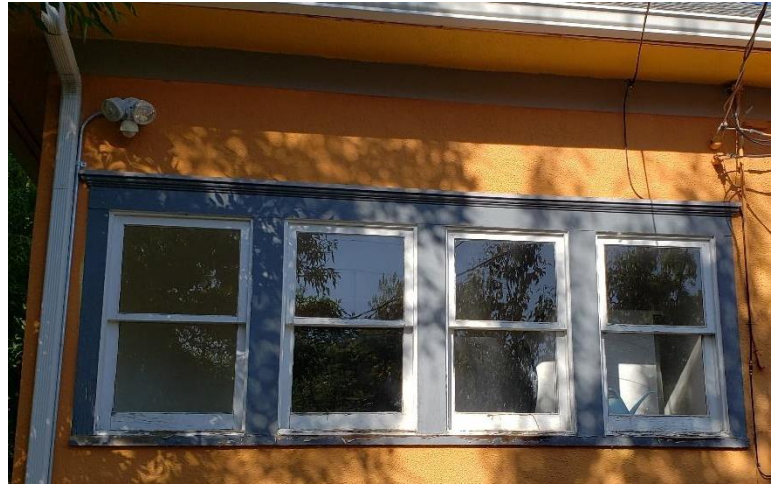
*Flood light with motion detection in the southeast corner.*
