**ITEM:** 1155 Pine Street Landmark, Alteration Certificate, Grant, and Probable Cause Request

**REQUEST:** A request to landmark 1155 Pine Street, a request for an Alteration Certificate, Preservation & Restoration and New Construction Grant requests, and a Probable Cause request.

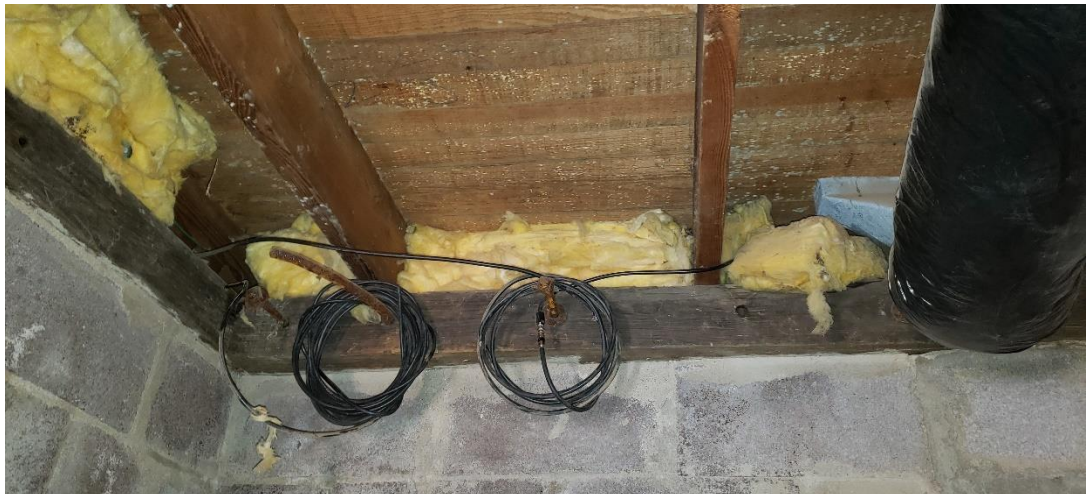
*Original flooring, 2x8 floor joists, and sill plate. The sill plate appears to be taken from a boxcar frame.*

The 2x8 floor joists are in fair condition. The 2x8 size of the joists are a-typical for houses built around the same time in the Louisville area. It is likely that the floor joists are not original and replaced original floor joists that were 2x6 on regular spacing. The joist sizing and spacing do not meet minimum IRC code requirements for today's standards. The floor on the main level has some bulging in areas, indicating that the floor framing needs further strengthening. Similarly, the 2x4 floor joists in the northwest addition are in fair condition. The joists sizing and spacing do not meet minimum IRC code requirements for today's standards.

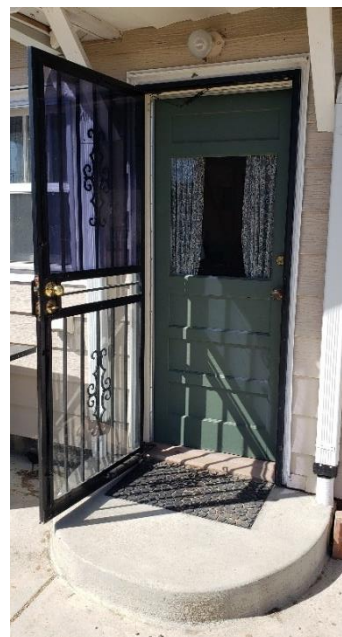
*East side door and storm door.*
