**ITEM:** 1016 Main Street Landmark Request

**REQUEST:** A request to Landmark 1016 Main Street

DAJ Design conducted an Historic Structural Assessment for the structure located at 1016 Main Avenue, Louisville, Colorado to determine its feasibility as a candidate for historic landmark designation as defined under the Historic Preservation program of the City of Louisville. The structure is a residential property. The City of Louisville Historic Preservation Commission found probable cause that the building may be eligible for landmarking under criteria in section 15.36.050 of the Louisville Municipal Code. Therefore, the Commission approved the Historic Structural Assessment to be paid for by the Louisville Preservation Fund grant.

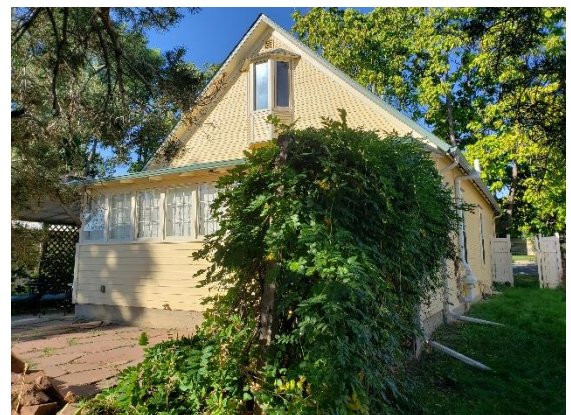
*Vines growing on trellis structure.*

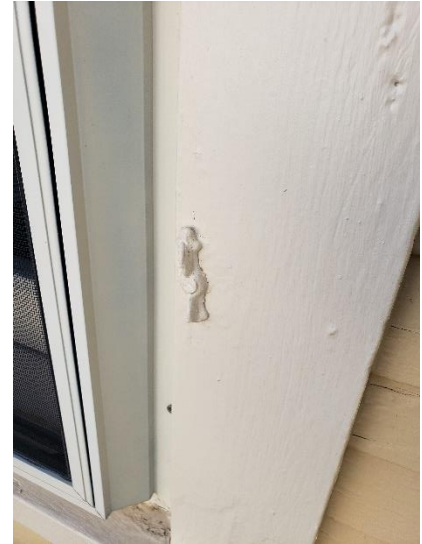
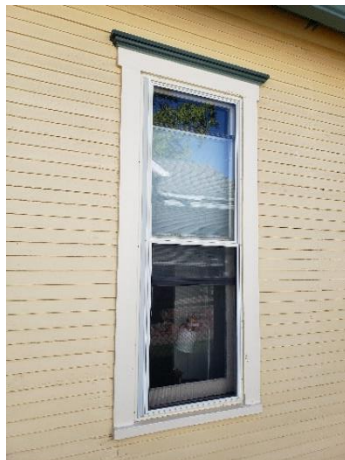
Overall, the windows are in various conditions based on their time of construction. The newer windows on the upper floor and the south bay window are all in good condition as these would have all been added in 1989 or 1992. The windows on the original house and east addition are in fair condition. These windows are all well beyond the expected lifespan of painted wood windows. However, these windows appear to have been well maintained over the years and the aluminum storm windows have likely prolonged their lifespan.

*Exterior hardware previously used to hold window screens.*

*Wood window with aluminum frame storm window and screen.*

*Single-pane 3-over-3 fixed windows at the east addition.*

*Double-hung wood windows with aluminum frame screen windows.*

1. The original wood double-hung and fixed windows should be properly restored as described below. Windows should be made to be operable, create proper seals, and only use replacement parts where no other option is available.

- a. Remove and replace all window putty.
  - b. Clean and restore all glass panes with special care given to stained glass.
  - c. Repair and refurbish all wood window sash elements including stiles, rails, and muntins.

- d. Repair and refurbish all wood window frames.
  - e. Repair and refurbish all counterweights and restore to operability.
  - f. Repair and refurbish all hardware including locking mechanisms.

- g. Install new storm and screen windows with minimal frames.
2. Alternatively, all of the windows could be replaced with fiberglass or aluminum-clad wood windows. The replacement windows should match the size, location, and style of each existing window.

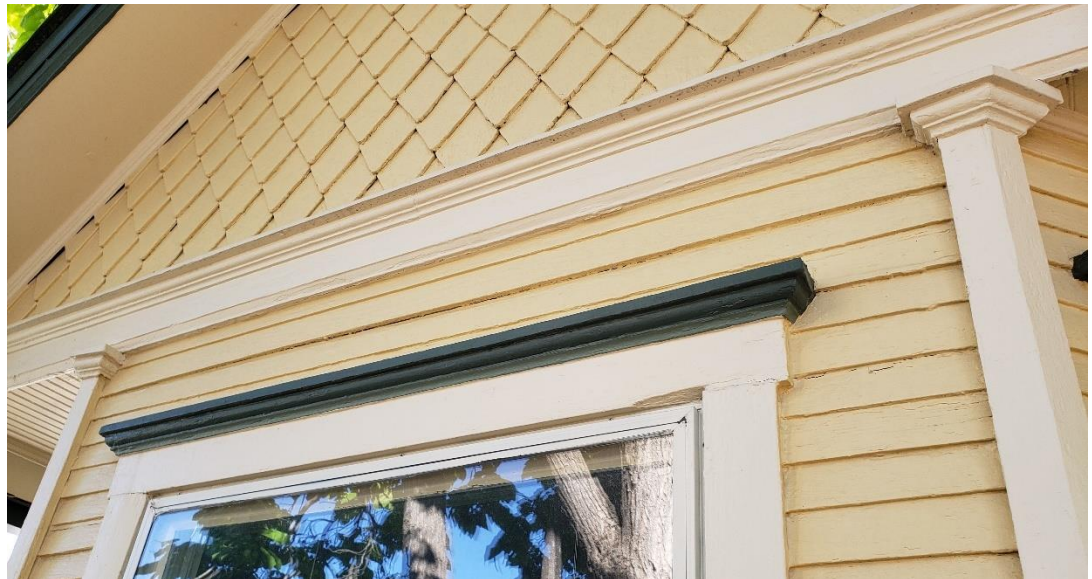
*Decorative painted wood trim is found at the windows, doors, corners, and gable ends.*

Overall, the painted wood trim is in fair condition. The wood trim has been well maintained over its lifespan and has been protected by the roof overhangs. There are some signs of chipping and cracking as would be expected of wood trim that is likely over 100 years old.

Repair, restore or replace all of the painted wood trim as necessary.

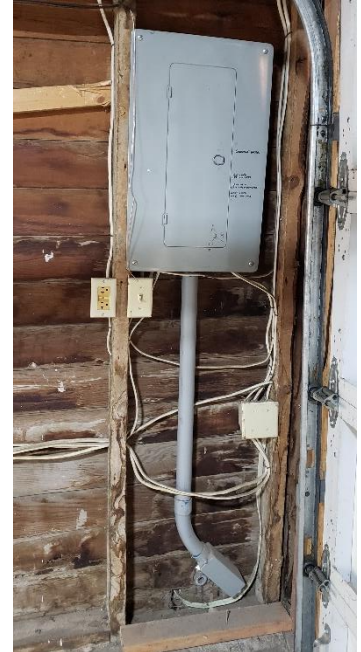
*Main electrical panel in the garage.*

We do not have any recommendations at this time. Any future plans to remove the garage or construct a new garage should keep the main electrical panel on the garage with sub-panels in the house and studio. Future electrical work should be performed by a licensed electrical engineer and shall meet all applicable building codes.
