**ITEM:** 728 Grant Avenue Landmark, Alteration Certificate, & Grant Request

**REQUEST:** A request to Landmark 728 Grant Avenue, and requests for an Alteration Certificate and Preservation and Restoration Grant

**728 GRANT AVENUE**  
**HISTORIC STRUCTURE ASSESSMENT**  
LOUISVILLE, CO

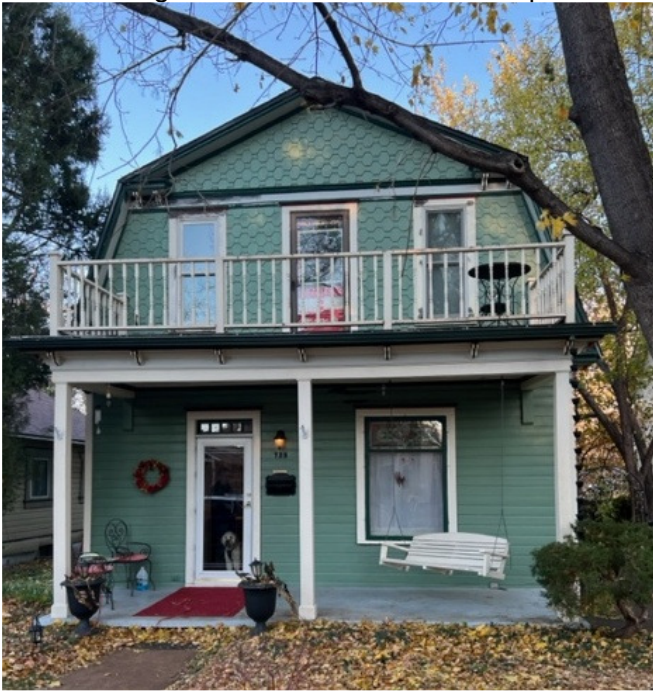
Figure 1: Front of House

This is a two-story wood-framed house with a framed front porch and a 2<sup>nd</sup> level deck along the front facade. The main level floor is over a combination of crawlspace and a dug-out cellar at the back of the original section of the house. A 2-story addition containing over a full height basement is on the rear of the house and constructed in 2011.

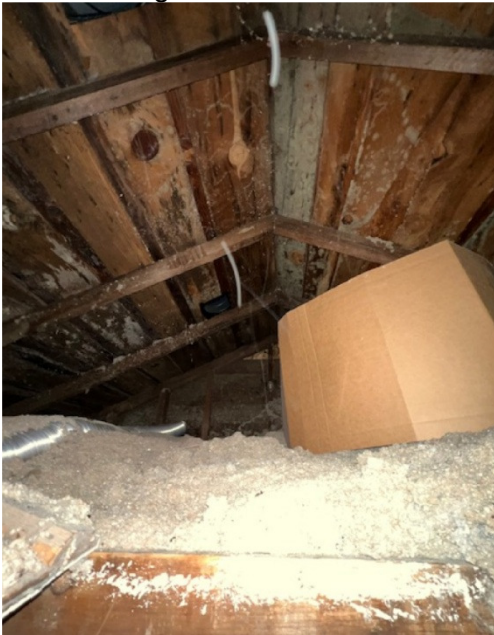
Figure 6: Roof Framing

The roof framing consists of a gambrel roof framed with 2x4 roof joists at 24" centers, and an integrated ceiling diaphragm framed with 2x rafters at running in the north/south direction. The roof sheathing consists of 1x "skip sheathing" but it was overlaid with ½" OSB (Oriented Strand Board) during a re-roofing at some point. The ceilings all consist of a plaster or drywall finish.

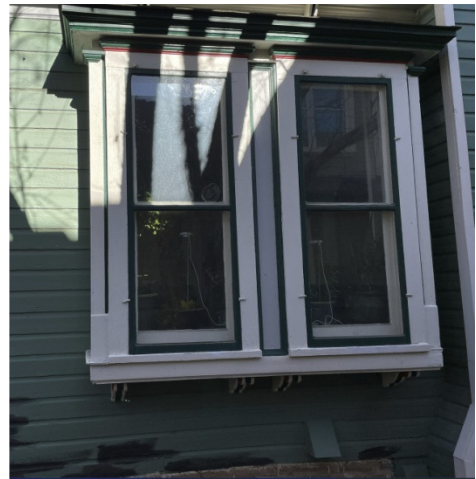
image 2 – original s. windows-3.5.2

The double hung windows on the south side of the house are both new at the east end and original at the west end. The windows that are part of the original construction are in fair condition. The paint is exhibiting aligatoring as described in Section 3.4.2 and some rot is apparent on portions of the glazing stops. The windows have what appear to be original wood storm sashes. The windows are not currently operable which may be due to being painted shut or the counterweight system may be broken. (image 2 – original s. windows-3.5.2)

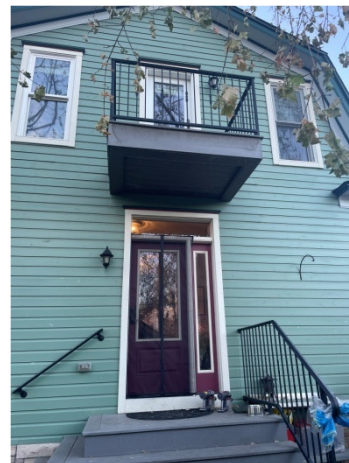
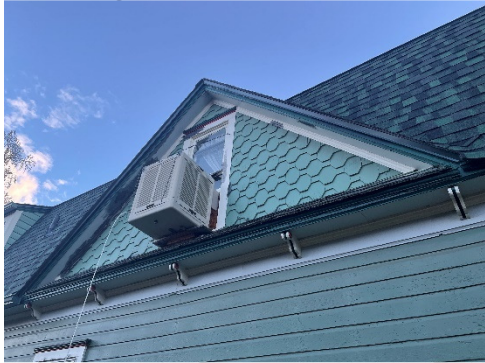
image 4 – new east windows – 3.5.2

The windows on the east elevation are part of the recent addition and are white vinyl double pain windows. These windows are in good condition. (image 4 – new east windows – 3.5.2)

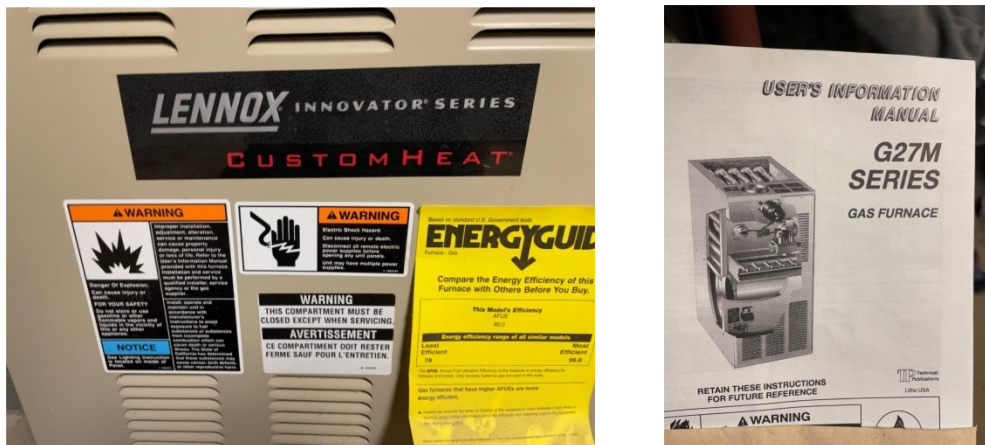
The space is served by a gas fired Lennox G27M Furnace located in the partial basement space. The furnace is gravity vented, 80% efficient, 120 MBH input model, and appears to be in fair to good condition. A smoke duct detector was observed on the return which is a safety feature in excess of code requirements. Photos of the furnace and owner's manual appear below.

*Furnace and Owner's Manual*

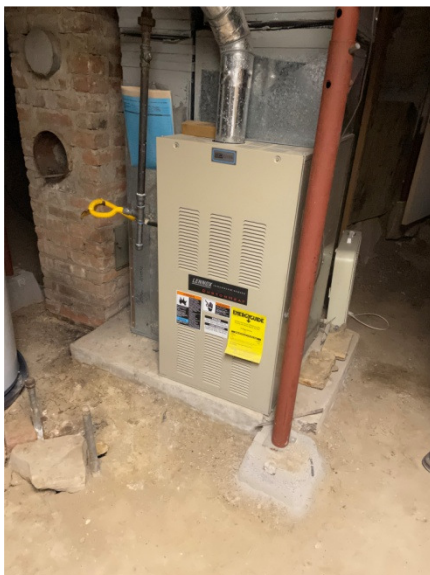
*Furnace*

The systems appear to be in good condition. The system has had regular service and does not show any signs of deterioration.

- The addition of hard wired carbon monoxide detectors in the space would be advisable to protect against low combustion air available – particularly if upgrades to the envelope were made that resulted in a tighter building construction.
- Conduct a balance report to check duct leakage into crawl space and satisfactory return air availability.
- The crawlspace where the water heater and the furnace is located is unventilated and spray foam insulation has been added at the inside face of the original masonry foundation. Code requires that if a crawlspace is not ventilated then it must be conditioned. No supply air is currently being provided into the crawlspace. Also, no transfer grills are present from the crawlspace into the remaining portions of the house.

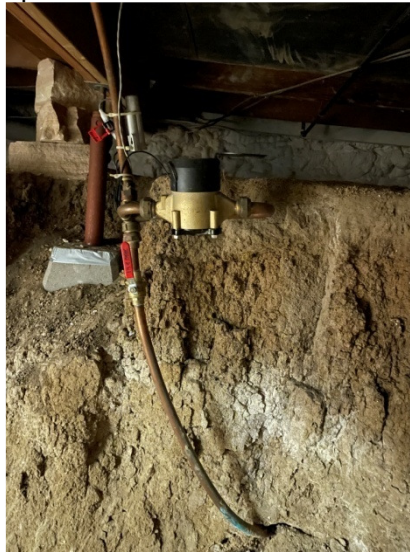
*Domestic water tap and meter*

The building has a 5/8" water service with newer meter located in the crawl space. The water service size is typical for a residence and is adequate for the building. Photos of the service entrance are below.

- An overflow pan and proper drainage to the sewer for the water heater is recommended. In this instance, however, it would be very problematic to achieve and would most likely require a lift station.
- The water service line is unsupported but does not show signs of any imminent failure. Regular inspections are proposed.

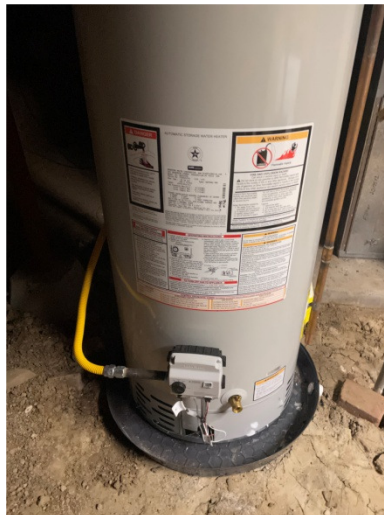
*Water Heater*

The domestic hot water is provided by an electric water heater located in the crawl space. It is a Bradford White 50 gallon, natural gas model and the nameplate is shown below.

It is in good condition and provided enough hot water for the current space. However, the water heater has overflow drainage directly into the crawlspace dirt. The water heater is at the very lowest part of the house and below the main sewer. It would be difficult to properly dispose of any overflow when regular maintenance is performed to drain down the water heater. A dry pit can be observed in the crawlspace where water has been previously expelled. We do not propose changes at this time.

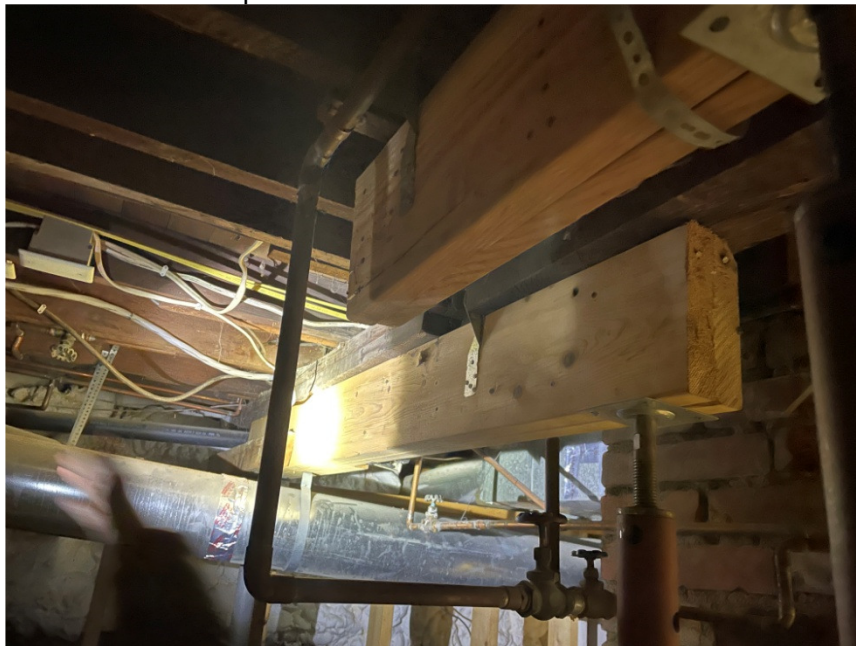
*Sewer Pipe*

The buildings sanitary lines and some exhaust ventilation lines are located in-line with key structural members of the house. Some structural members have been retrofitted to around the location of existing sewer lines. Structural recommendations have been provided in section 3.2.4.

The sewer and vent systems visible in the crawlspace are very difficult to access but what can be observed appears to be in good condition. The condition of the underground sewer and vent systems is unknown. No failures or imminent problems were observed and the age of the piping appeared to be newer and show signs of repair so it is expected that regular maintenance has been performed.

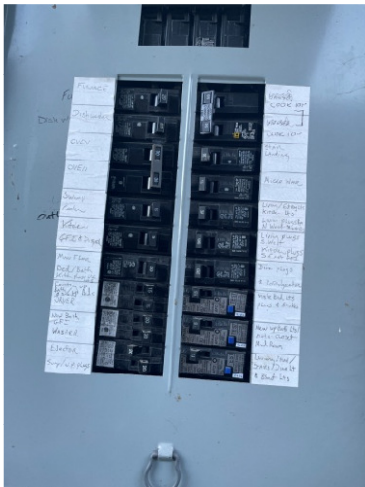
*Main electrical panel*

Both of the electrical panels were manufactured by Siemens, are estimated to be 10-15 years old and appear to be in good condition, showing some signs of wear but still performing its intended purpose.

The panels appear to be in good condition, showing some signs of wear but still performing its intended purpose. With regular maintenance could continue to be used to serve the current building loads.

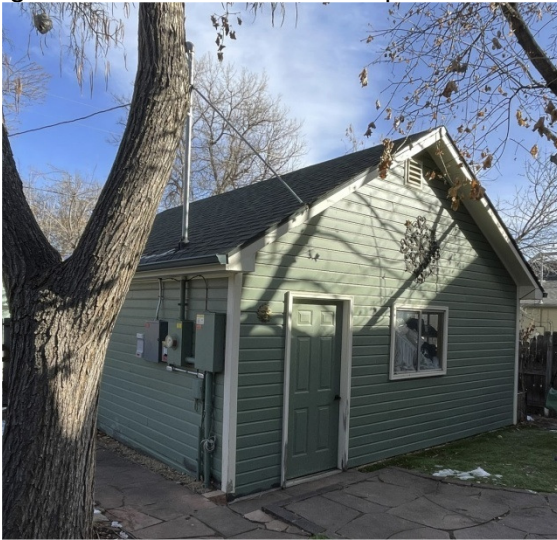
*Electrical masthead and garage subpanel*

The electrical service appears to be adequately sized for the current building loads and has been reconfigured from the original house electrical when the previous renovation and addition was performed.

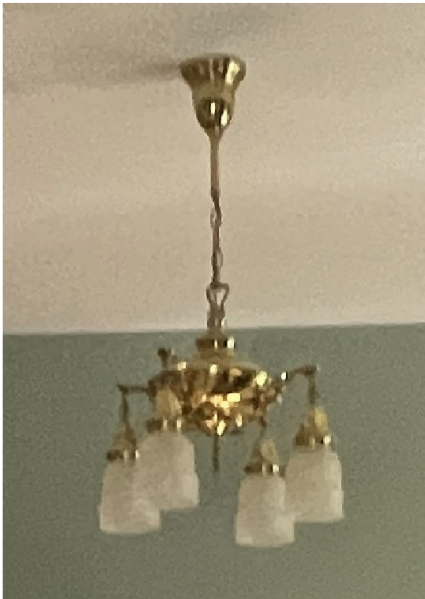
*Typical interior light fixtures*

The general lighting appears to be in good working condition.

No recommendations at this time.
