**SUBJECT:** RESOLUTION NO. 97, SERIES 2025 – A RESOLUTION  
DESIGNATING THE RESIDENCE LOCATED AT 1016 MAIN  
STREET A HISTORIC LANDMARK

DAJ Design conducted an Historic Structural Assessment for the structure located at 1016 Main Avenue, Louisville, Colorado to determine its feasibility as a candidate for historic landmark designation as defined under the Historic Preservation program of the City of Louisville. The structure is a residential property. The City of Louisville Historic Preservation Commission found probable cause that the building may be eligible for landmarking under criteria in section 15.36.050 of the Louisville Municipal Code. Therefore, the Commission approved the Historic Structural Assessment to be paid for by the Louisville Preservation Fund grant.

The primary purpose of this HSA is to evaluate the property's current condition and to identify preservation priorities for the best use of rehabilitation funds. DAJ Design inspected 1016 Main visually to identify areas of necessary maintenance and repair. It is possible that complications exist that were not visible and therefore it is recommended that the property owner includes contingency funding in any repai

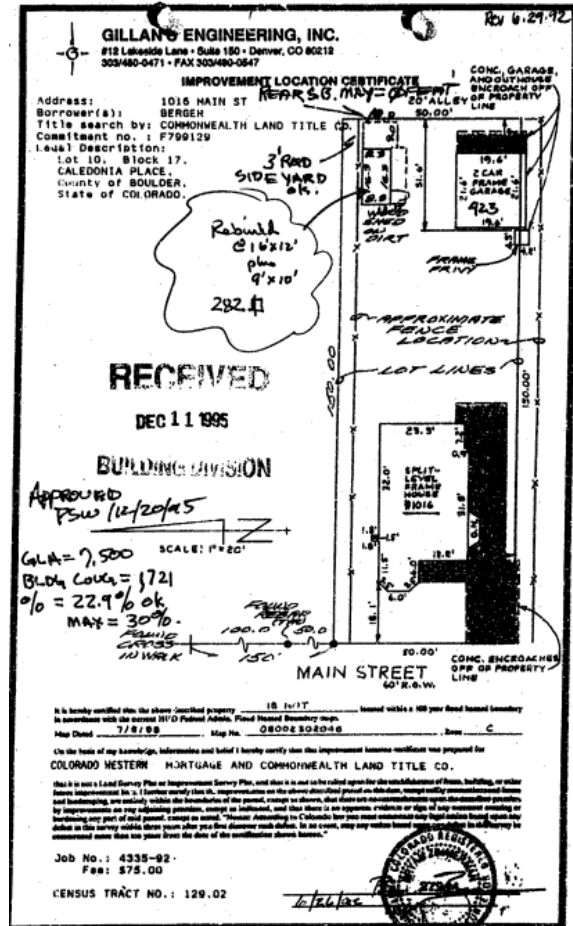
The studio in the northeast corner of the property appears to have been built in 1995. There was a shed in this location prior, and plans indicate that the shed was expanded and remodeled as a studio, although it may have been altogether rebuilt. As this structure was built in 1995, it does not meet the minimum requirements for historic designation, nor is it listed on any register. Therefore, the structure was minimally assessed.

Site plan indicating a shed in the northwest property corner that was rebuilt and expanded.

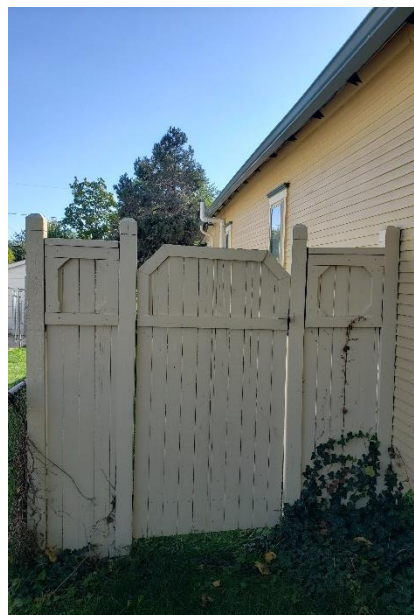
*6-foot painted wood fence & gate.*

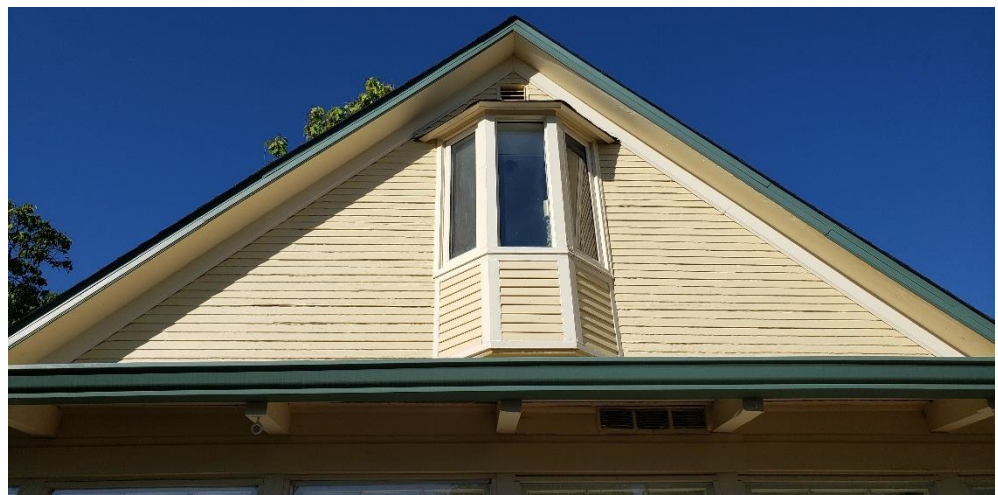
*The original roof is a steep gable & the east addition roof is a low pitch with exposed rafter tails.*

6. Attic insulation should be added to achieve an R-value as close as possible to current code standards. The maximum insulation possible should be added at the perimeter of the roof as the roof depth in this location does not allow for the minimum required by code. Any energy upgrades, such as increased insulation in the attic, could result in prolonged snow retention on the roof and could ultimately affect roof performance without first completing structural reinforcement.

7. It is not recommended to add additional roofing materials such as an additional layer of shingles, or solar panels without the additional structural support mentioned above.

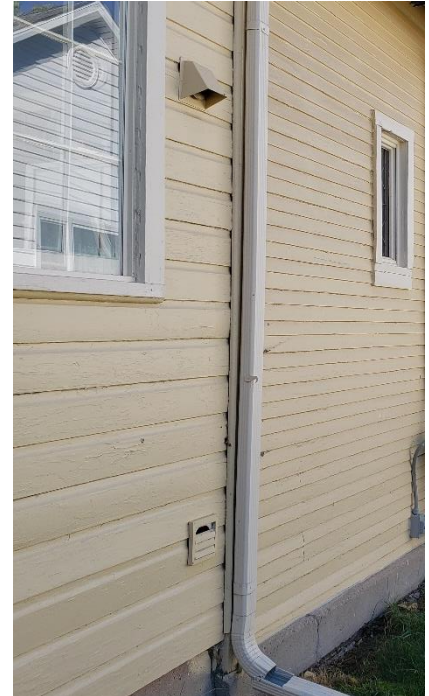
*Clapboard siding (right) on the original house and shiplap (left) on the addition.*

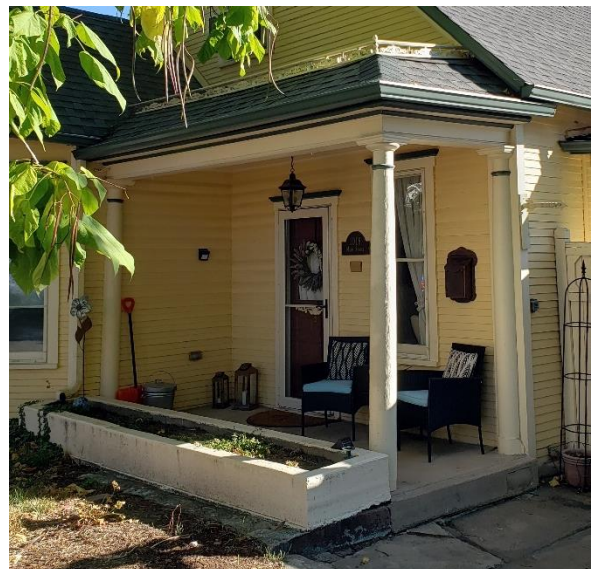
*The covered front porch is mostly original with a concrete floor and planter that are not original.*

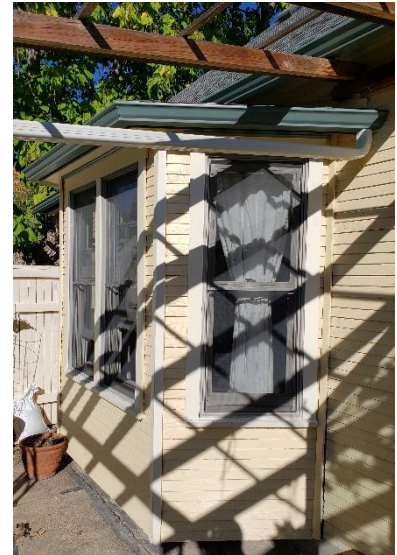
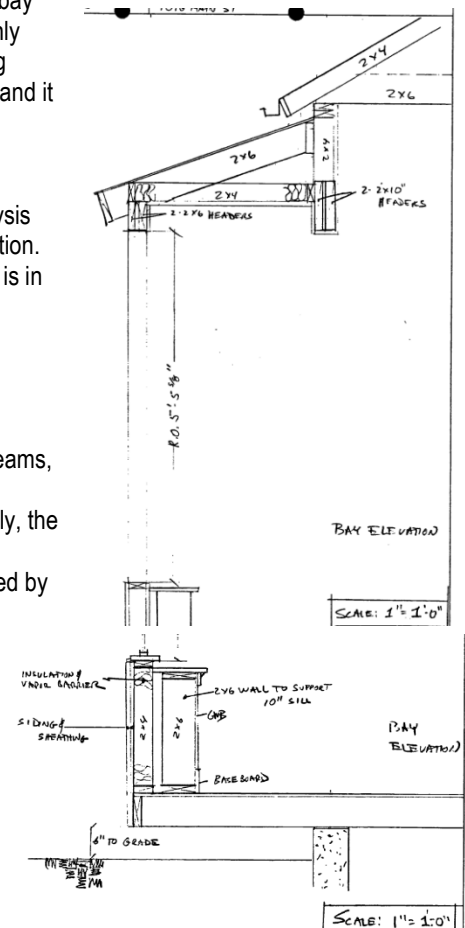
The south side bay window is in good condition. This element was added in 1989 and appears to be well maintained, though not historic. The greenhouse, also added in 1989, is in good condition. The bay window structure and the foundation of the greenhouse were only partially visible for analysis. Building details found in the building records indicate how both of these elements were constructed, and it appears that both were engineered to a code at the time of construction.

*The bay window was designed to match the historic house.*

*Bay window construction details.*

5. The south side bay window should be removed. This is not an historic element though the appearance was intended to match the historic house. The bay window should be removed, and new windows should be added in this location that match the windows seen in the early 1900's photograph.

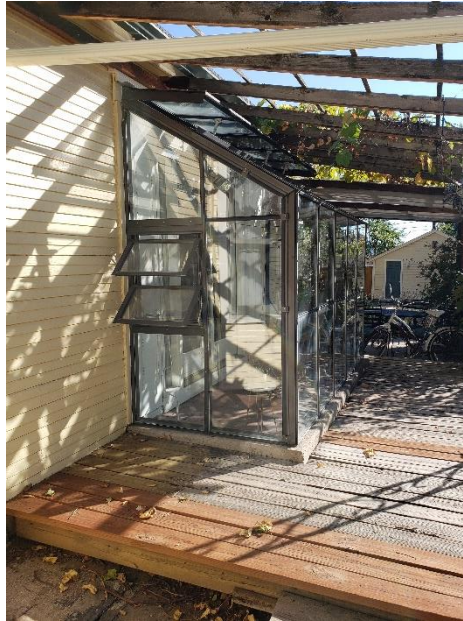
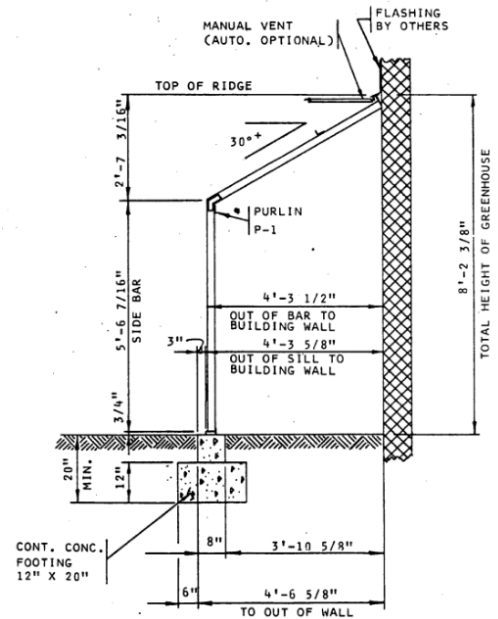
*Greenhouse attached to the south of the house.*

*Details for the greenhouse added in 1989.*

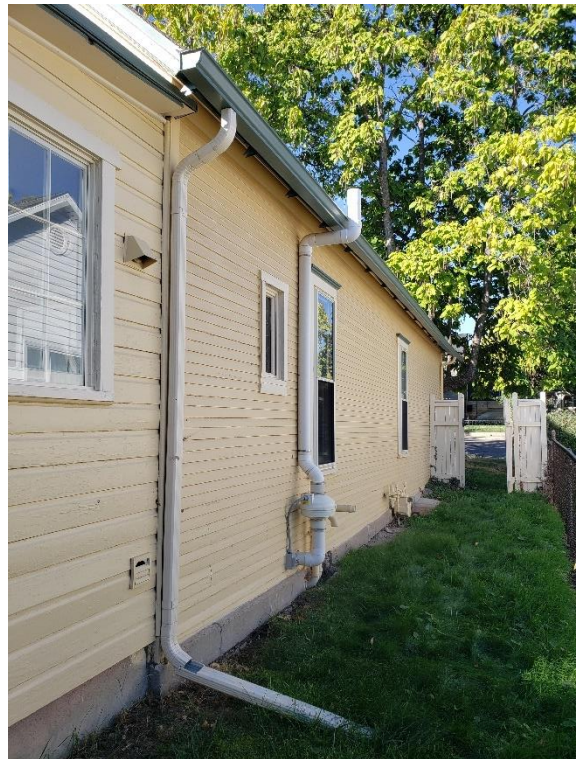
*Typical K-style gutter, downspout, & downspout extension.*

Overall, the gutters are in fair condition. Gutters can be difficult to assess outside of significant rain or snow events, but they appear to be properly attached, and no visible signs of leaking were present. Since we were unable to observe the gutters from above, it could not be determined whether the gutters are kept clear of debris or if any areas of standing water were present.

The downspouts are in fair condition as they appear to be of an adequate amount and in proper locations. Downspouts have extensions or are otherwise routed to direct water well beyond the house foundation.

1. Ensure that all gutters, downspouts, and downspout extensions are maintained to discharge water away from the building foundation and are kept clear of debris.
2. Consider replacing the gutters with half-round gutters to match the historic style typical of Louisville. Downspouts should be replaced with round downspouts.

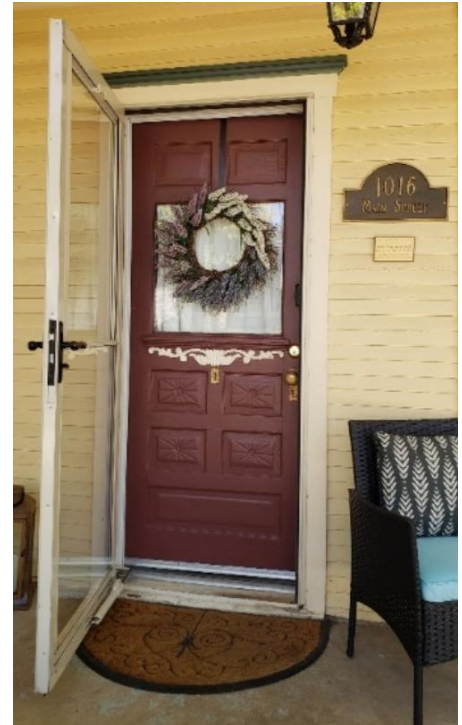
The front door is in good condition. This door has been well maintained and the lifespan has been extended by the covered front porch and aluminum storm door.

*Front door.*

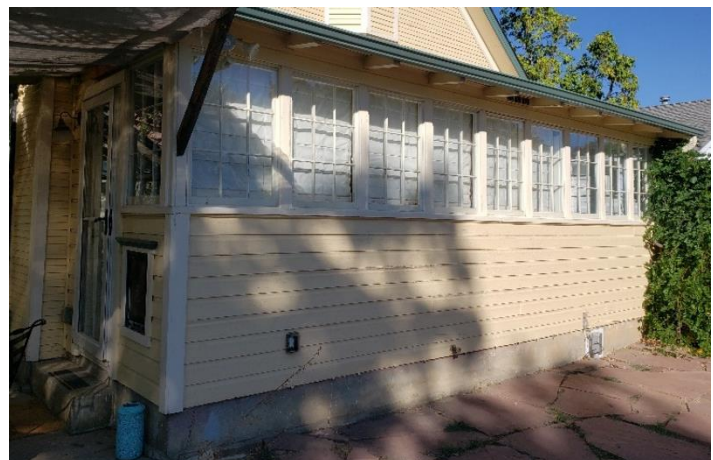
Overall, the windows are in various conditions based on their time of construction. The newer windows on the upper floor and the south bay window are all in good condition as these would have all been added in 1989 or 1992. The windows on the original house and east addition are in fair condition. These windows are all well beyond the expected lifespan of painted wood windows. However, these windows appear to have been well maintained over the years and the aluminum storm windows have likely prolonged their lifespan.

*Single-pane 3-over-3 fixed windows at the east addition.*

1. The original wood double-hung and fixed windows should be properly restored as described below. Windows should be made to be operable, create proper seals, and only use replacement parts where no other option is available.

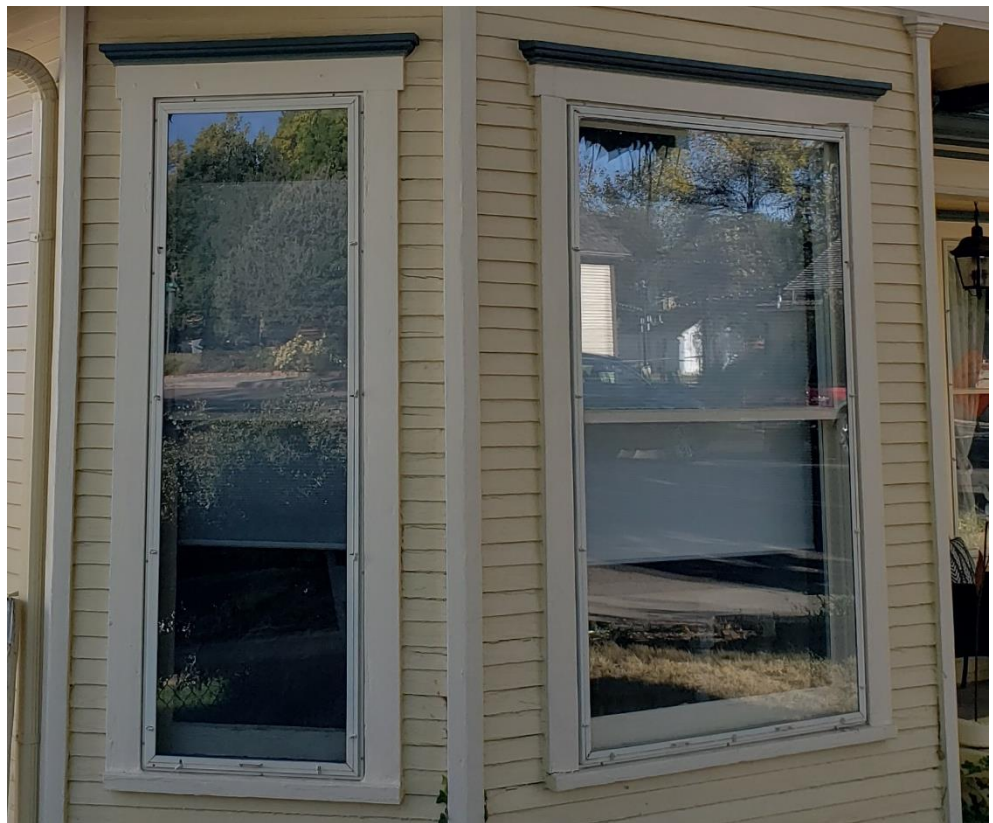
*Wood window with aluminum frame storm window and screen.*

*Double-hung wood windows with aluminum frame screen windows.*

- a. Remove and replace all window putty.
  - b. Clean and restore all glass panes with special care given to stained glass.
  - c. Repair and refurbish all wood window sash elements including stiles, rails, and muntins.

- d. Repair and refurbish all wood window frames.
  - e. Repair and refurbish all counterweights and restore to operability.
  - f. Repair and refurbish all hardware including locking mechanisms.

- g. Install new storm and screen windows with minimal frames.
2. Alternatively, all of the windows could be replaced with fiberglass or aluminum-clad wood windows. The replacement windows should match the size, location, and style of each existing window.

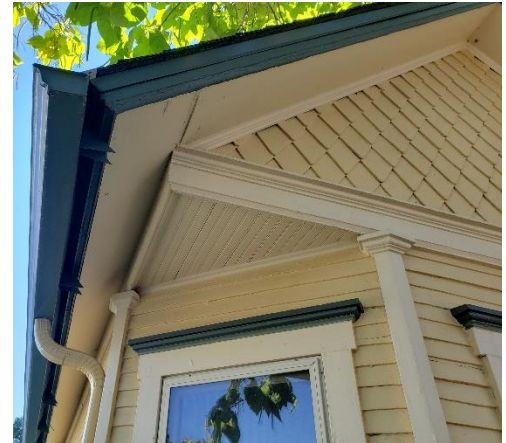
Overall, the soffits are in fair condition. The soffits have been well maintained and are protected from the elements. However, it is likely that the soffits are original and therefore the painted wood is over 100 years old. Some chipping and cracking of the wood is present and some of the seams are not flush.

The fascia was minimally exposed for analysis due to being covered by gutters and aluminum drip edge. Where visible the fascia is in good condition. Further analysis is required when the k-style gutters are removed.

*Painted wood 1x soffit & fascia at the eaves and rakes with beadboard soffit at some locations.*

1. Scrape, repair, refinish, or replace all painted wood soffits.
2. The fascia should be fully evaluated when the k-style gutters are removed. The fascia may need to be repaired or replaced and properly reinforced for new gutter attachment.

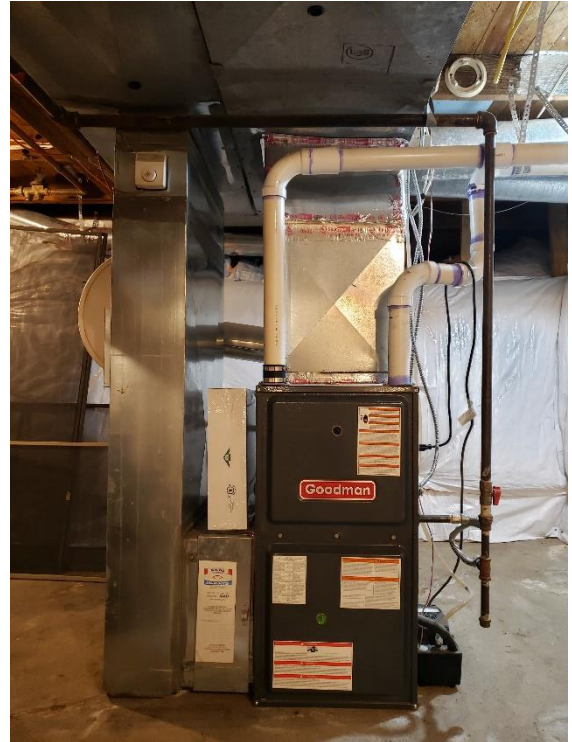
*Furnace and ductwork in the basement.*

1. Continue to perform routine maintenance on the furnace to prolong the lifespan.
2. If heating or cooling does not perform to the homeowner's satisfaction, consult with a licensed mechanical designer for upgrade options.

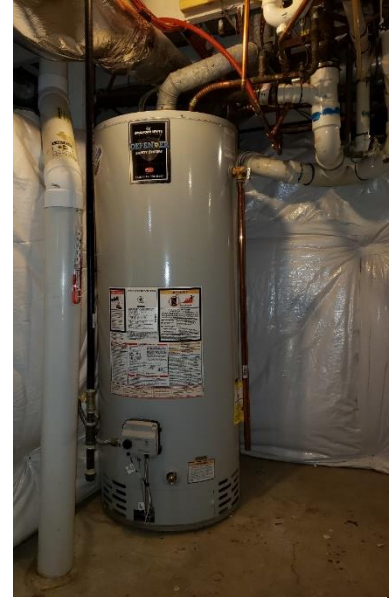
A standard 50-gallon gas-fired water heater is located in the basement and is atmospherically vented through the roof. Building records indicate that the unit was installed in 2006. Building records also indicate that there was water damage in the bathroom which required new sheathing, insulation, plaster/drywall, and finishes. These support what was seen for floor sheathing as noted in the *Structural System* part of this report. The water delivery system is a combination of copper and PEX pipes with the waste lines being PVC, ABS plastic and cast-iron. The sewer line exits the house as cast iron on the east side, at a relatively low depth which is common for similar houses in Louisville. Building records state that the sewer line was replaced and a water line was run to the garage in 2009. It appears that the water line and sewer were actually run to the studio at the time that it was remodeled with a bathroom added. The extent of the sewer line replacement and the material used could not be determined. Additionally, there is no fire sprinkler system in the house.

Water heater, supply, and waste lines in the basement.

Consider replacing the water heater with a high-efficiency unit with a sealed combustion intake/exhaust system.

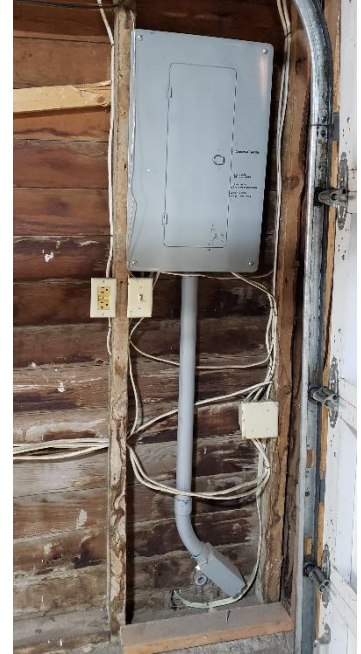
*Main electrical panel in the garage.*

We do not have any recommendations at this time. Any future plans to remove the garage or construct a new garage should keep the main electrical panel on the garage with sub-panels in the house and studio. Future electrical work should be performed by a licensed electrical engineer and shall meet all applicable building codes.
