**SUBJECT:** RESOLUTION NO. 9, SERIES 2026 – A RESOLUTION DESIGNATING THE RESIDENCE LOCATED AT 728 GRANT AVENUE A HISTORIC LANDMARK TO BE NAMED THE KOEPLER HOUSE AND APPROVING A PRESERVATION AND RESTORATION GRANT

**728 GRANT AVENUE**  
**HISTORIC STRUCTURE ASSESSMENT**  
LOUISVILLE, CO

Date: July 14, 2023

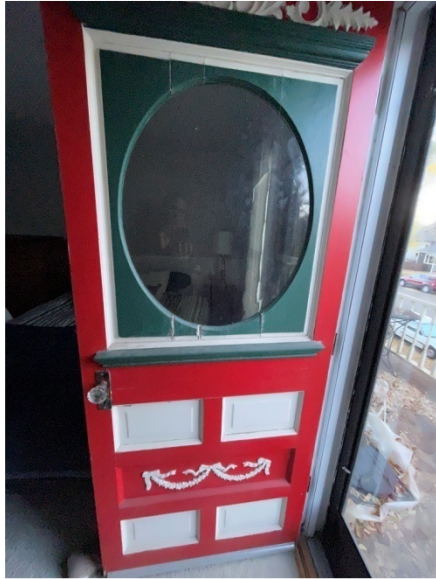
Image 1 – west side 2<sup>nd</sup> floor - 3.5.1

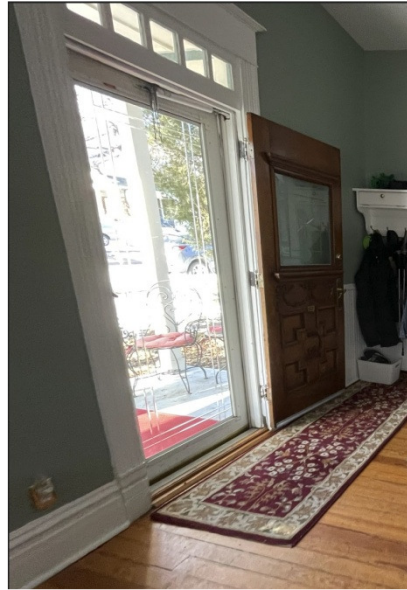
image 2 – west side 1<sup>st</sup> floor – 3.5.1

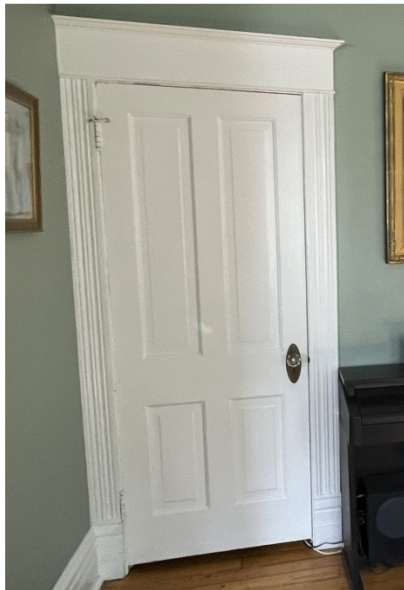
The doors are not in need of immediate replacement and are typically in good shape.

image 3 – original interior door  
1<sup>st</sup> floor – 3.5.1

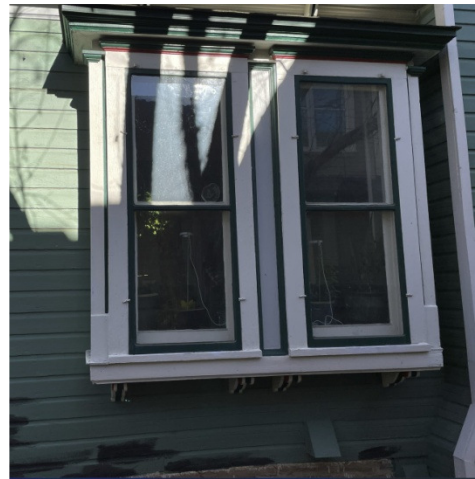
The double hung windows on the south side of the house are both new at the east end and original at the west end. The windows that are part of the original construction are in fair condition. The paint is exhibiting aligatoring as described in Section 3.4.2 and some rot is apparent on portions of the glazing stops. The windows have what appear to be original wood storm sashes. The windows are not currently operable which may be due to being painted shut or the counterweight system may be broken. (image 2 – original s. windows-3.5.2)

image 2 – original s. windows-3.5.2

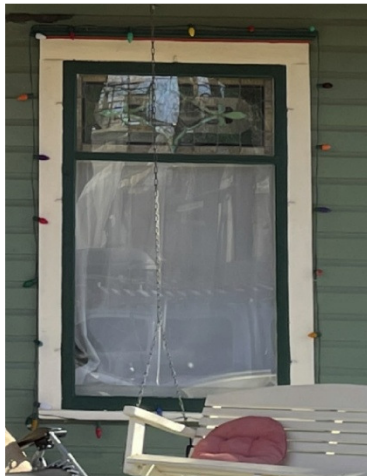
image 3 – original w. window

Newer second floor windows are in good shape and need no repair. Inspect sash and repair glazing stops/glazing putty where needed. When the time comes to repaint the building, we would recommend the windows, sashes, jambs, and sills be properly prepared for repainting per *Preservation Brief #10* which includes sanding of loose, peeling paint only. Removing paint should be avoided and should only be removed to the next sound layer of paint. Sanding and scraping should be done carefully to avoid damaging wood and original profiles.

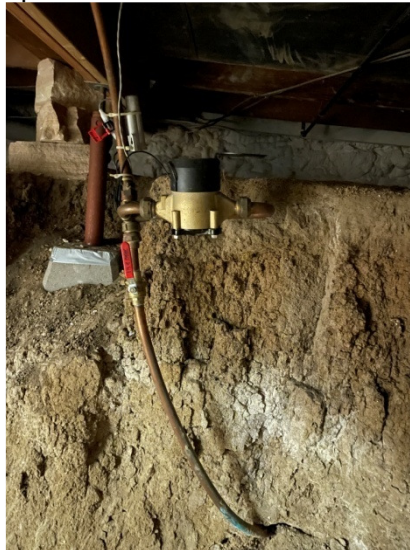
The building has a 5/8" water service with newer meter located in the crawl space. The water service size is typical for a residence and is adequate for the building. Photos of the service entrance are below.

*Domestic water tap and meter*

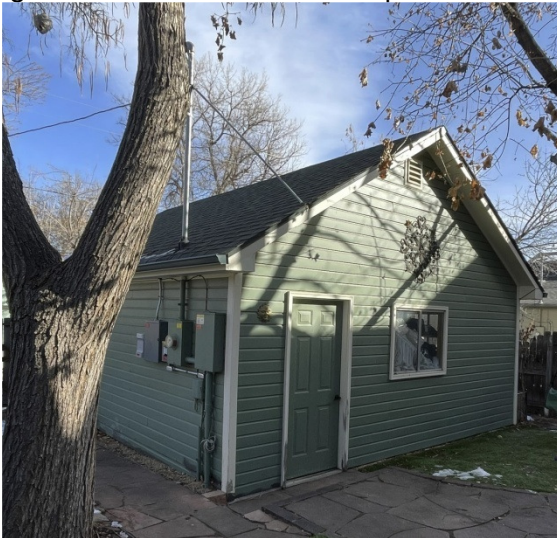
Both of the electrical panels were manufactured by Siemens, are estimated to be 10-15 years old and appear to be in good condition, showing some signs of wear but still performing its intended purpose.

*Electrical masthead and garage subpanel*

The electrical service appears to be adequately sized for the current building loads and has been reconfigured from the original house electrical when the previous renovation and addition was performed.

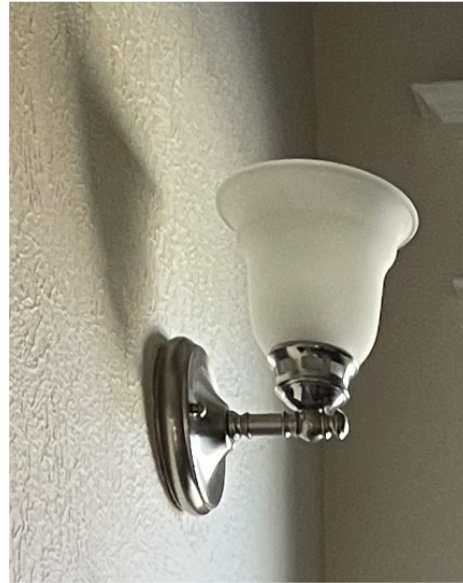
The general lighting appears to be in good working condition.

*Typical wall sconce*
