# ***Historic Preservation Commission Agenda***

**ITEM:** 1101 Main Street Probable Cause Determination

**REQUEST:** A request to find probable cause for a landmark designation to allow for funding of a historic structure assessment for 1101 Main Street.

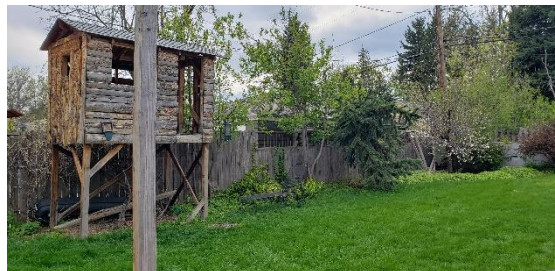
*Looking southwest towards the "treehouse".*

Overall, the landscape features are in good condition. None of the listed features meet historic requirements, nor were any historic features discovered, and therefore assessment was minimal.

No recommendations at this time.

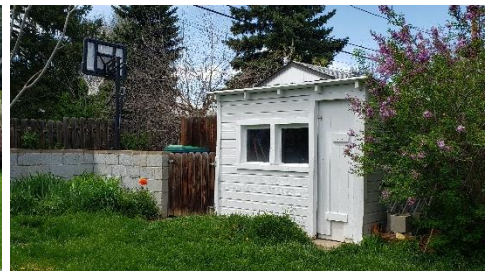
*Looking northwest towards the shed.*

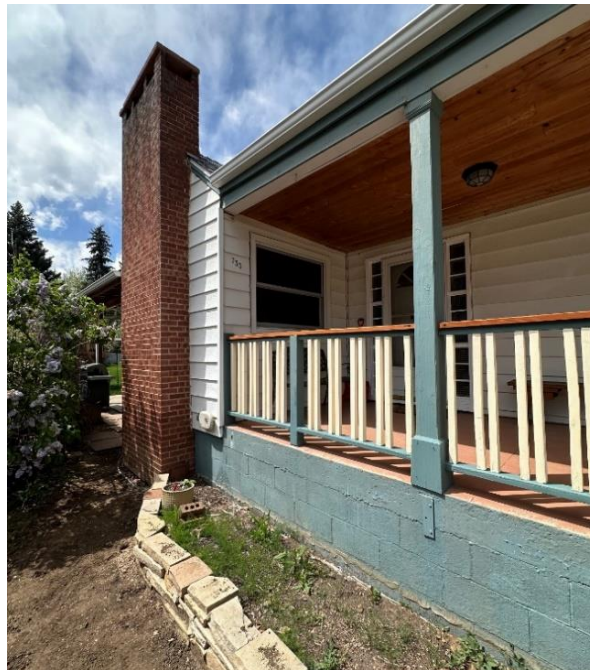
*CMU porch foundation.*

The concrete masonry unit foundations of the south addition and covered front porch also appear to be in fair condition. However, it is unknown if these foundation walls are supported by footings and whether the walls, or portions of the walls, are solid grouted.

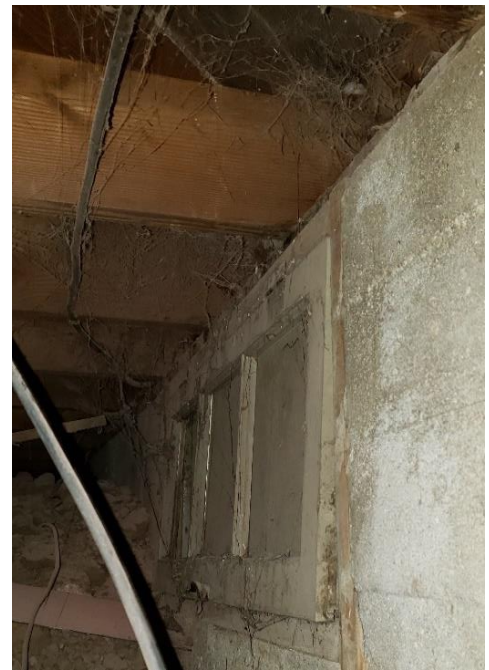
*Original board formed concrete foundation.*

Overall, the poured concrete foundation appears to be in fair condition. It is unknown what size and type of footings support the foundation walls, if any. It is also unknown whether the foundation has steel reinforcing included in the wall construction. Furthermore, the northeast corner of the original foundation appears to have been compromised due to poor drainage and a downspout discharge in this location. However, after speaking with the homeowner this seems to have been remedied by the addition of a downspout extension and it is apparent in the paint that erosion no longer occurs in this location.

3. The foundation walls showed various signs of damage that require further evaluation. No additional load should be added to the existing foundation system without a full analysis of the current foundation walls/footings.

5. The footings were not visible during the observation and should be verified and evaluated prior to any remodel or new construction.
6. The requirement of piers at the chimney in the past indicates the foundation is prone to movement and future similar movement should be expected. This does not pose an immediate structural deficiency and should be monitored over the course of the house and further structural evaluation should occur if additional movement is observed.

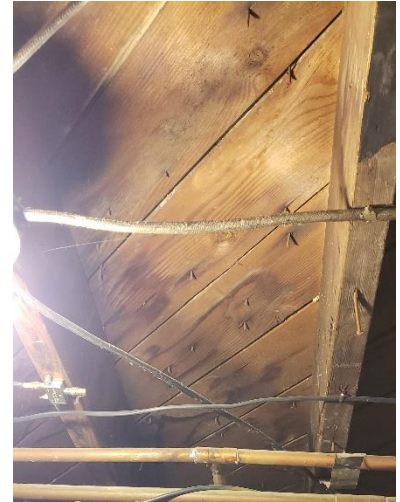
The 2x8 floor joists are in fair condition. The 2x8 size of the joists are typical for houses built around the same time in the Louisville area. The joist sizing and spacing generally meet IRC code requirements for today's standards. The main level floor felt sturdy, and no areas of bulging or sagging were observed.

The floor sheathing appears to be in good condition though not all areas were exposed for review. The floor sheathing does meet minimum IRC code requirements for today's standards and appears to be performing adequately.

*Original floor joists and sheathing.*

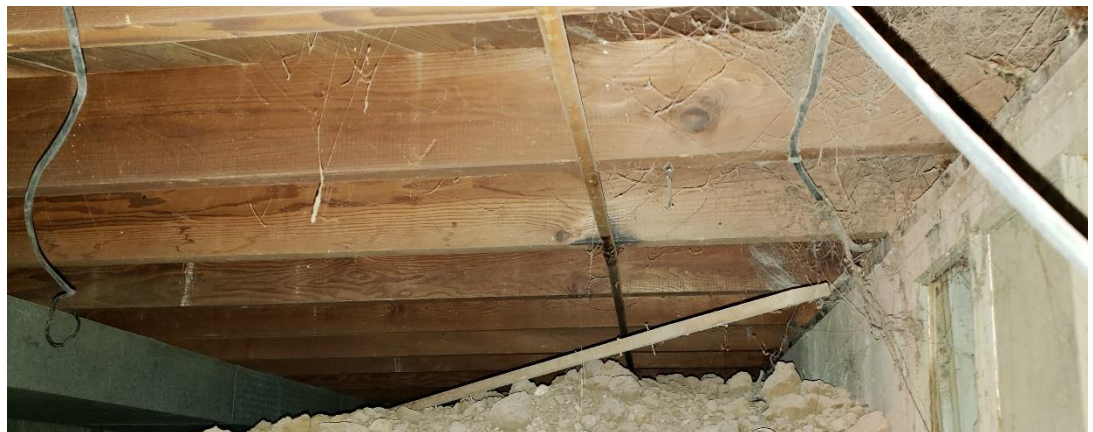
The center beam and columns supporting the floor joists are in fair condition. The spacing and sizing of the beams and columns are not adequate for the current loads that they are supporting and are not properly attached to their supports. The beam sizing, spacing, and spans does not meet minimum IRC code requirements for today's standards.

*Floor framing in the crawlspace.*

1. The center beam and beam supports should be replaced or reinforced as prescribed by a structural engineer. The best method is to construct new beams and beam supports that support the existing floor joists and remove the existing beams and beam supports as prescribed by a licensed structural engineer. These new supports should bear on footings as prescribed by a licensed structural engineer and located at a depth and soil bearing capacity as specified by a licensed geotechnical engineer.

2. The floor framing should be observed by a licensed engineer and repaired as needed. Special attention should be given to the connections between the foundation walls, floor joists, beams, and beam supports. The floors are not suitable for additional load resulting from a remodel or addition.

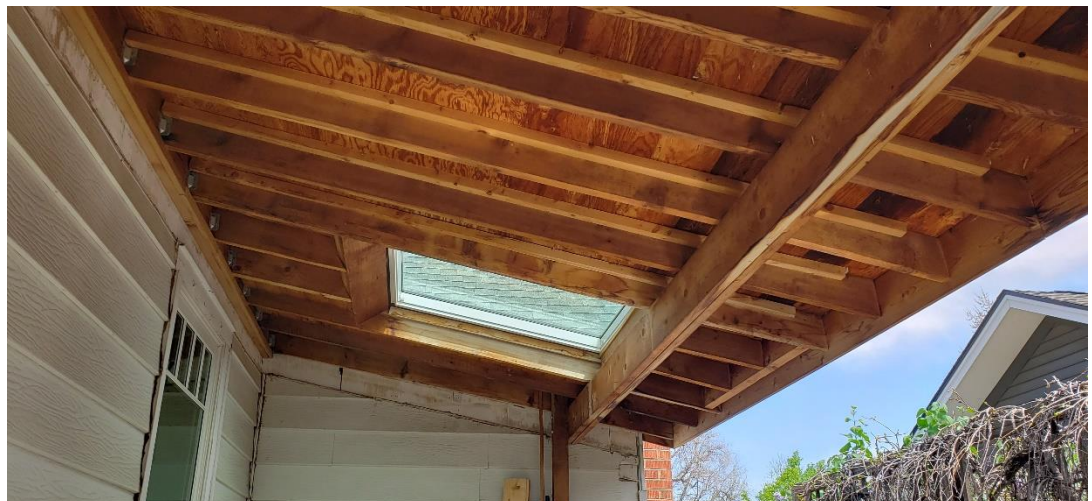
*Exposed roof structure of the south side covered patio.*

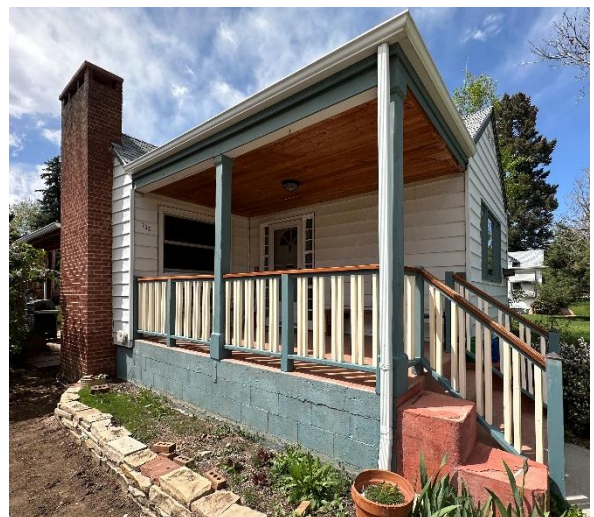
A covered porch is attached to the southeast corner of the house that is roughly 15'-6" deep and 7'-7" wide. The porch roof is a low-pitched hipped roof that slopes upward to the north and west. The porch roof appears to have been over-framed on top of an original shed roof. The porch is supported by two wood columns, the ceiling is wood tongue and groove, and the floor is a concrete slab supported by a CMU foundation. The porch sits well above grade with east facing steps and a wood guardrail. Building records for the front porch were approved in 1974, and this was built at that time, or shortly thereafter.

*Covered front porch.*

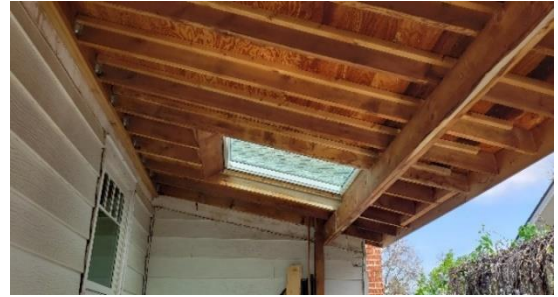
There is also a covered patio in the southwest corner. This patio has a concrete slab that may be original, but the roof framing (outlined above) is of more recent construction. There is evidence that there was a pre-existing roof over this area where the steel siding stops short of the roof structure, exposing the asbestos siding beneath. The current porch roof structure appears to be similar to the previous roof structure though set slightly higher. According to building records, this roof was replaced in 1995.

*Southwest porch roof structure.*

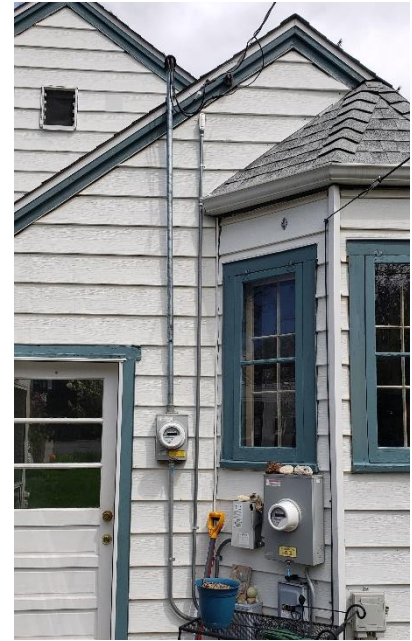
*Overhead electrical service, panel, and meter.*

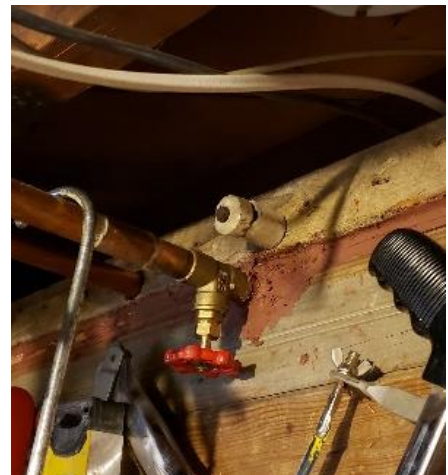
*Romex wiring with knob and tube remnants.*

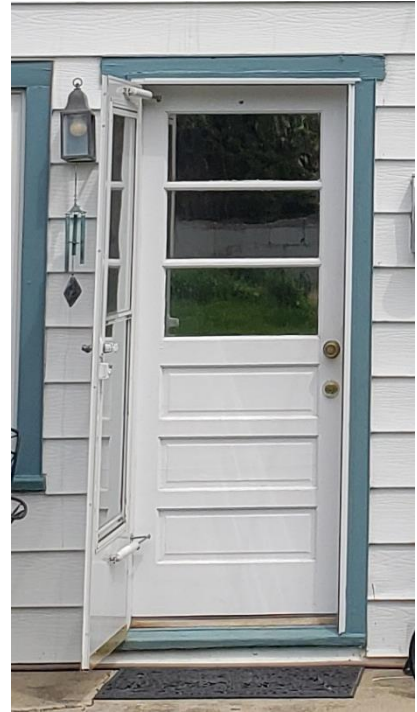
*Rear door and light fixture*

1. Removal of the aluminum and composite siding may reveal original light fixture locations apparent on the original wood siding. If the siding is removed and historic light fixture locations are determined, replace the exterior light fixtures with a full cutoff, high-efficiency unit.
2. Consider installing new exterior lighting that complies with Dark Sky regulations.
