# ***Historic Preservation Commission Agenda***

**REQUEST:** A request to Landmark 1016 Main Street

1016 Main Avenue, LOUISVILLE, COLORADO

DAJ Design conducted an Historic Structural Assessment for the structure located at 1016 Main Avenue, Louisville, Colorado to determine its feasibility as a candidate for historic landmark designation as defined under the Historic Preservation program of the City of Louisville. The structure is a residential property. The City of Louisville Historic Preservation Commission found probable cause that the building may be eligible for landmarking under criteria in section 15.36.050 of the Louisville Municipal Code. Therefore, the Commission approved the Historic Structural Assessment to be paid for by the Louisville Preservation Fund grant.

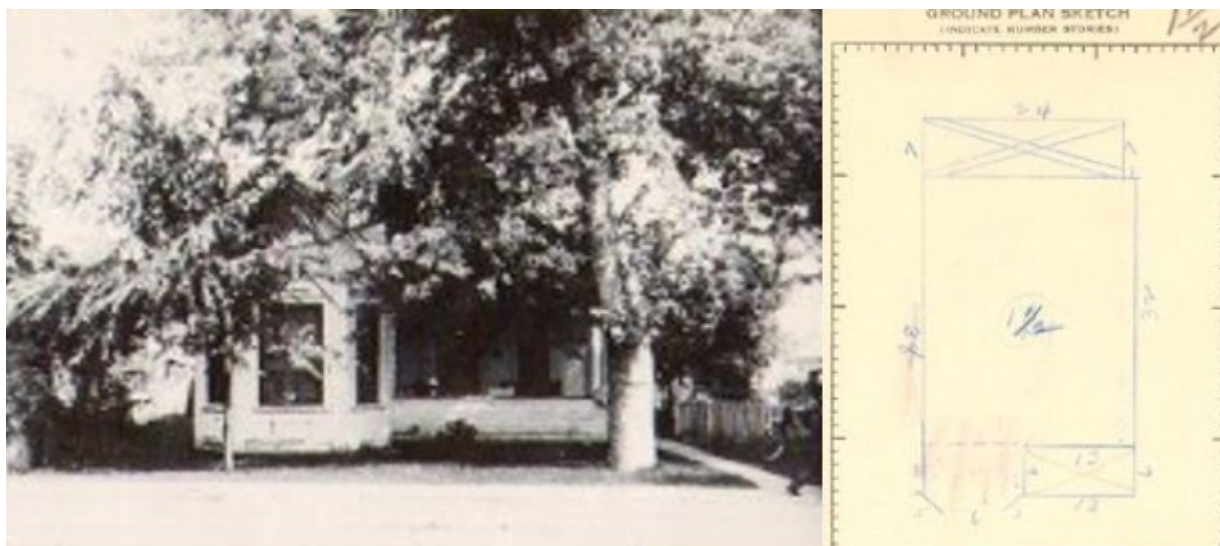
*Photo and floor plan of 1016 Main from the 1948 Assessor's Card.*

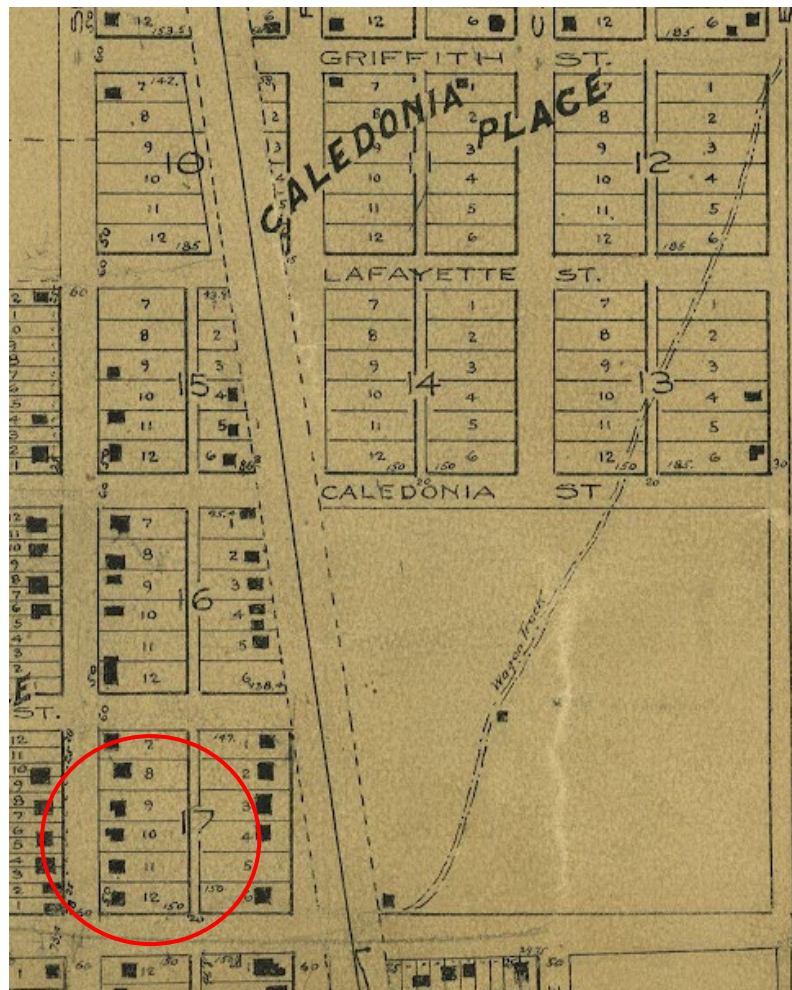
The 1909 Drumm's Map of Louisville shows a house located on Lot 10 Block 17 which also indicates that the house was constructed prior to 1909.

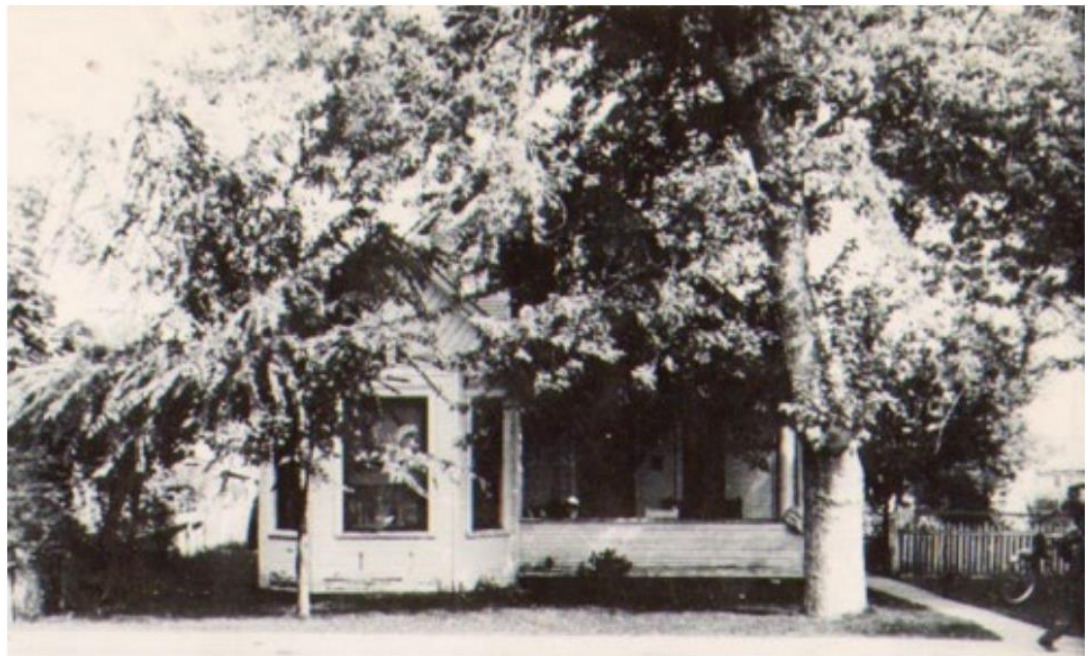
1950 Boulder County Assessor card photo of 1016 Main and floorplan.

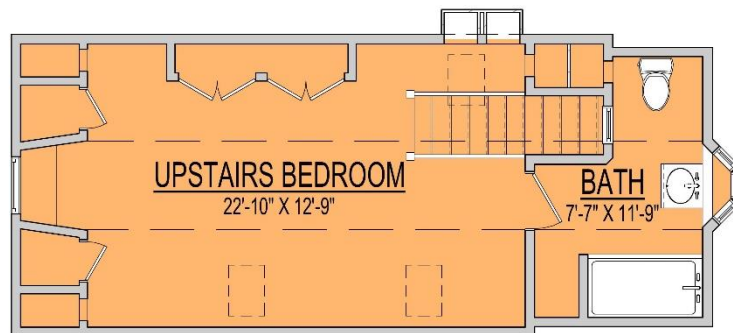
Primary Changes Occurring Over Time:

- Original house (RED): ca. 1895 - 1910
- Original front porch (RED): ca. 1895 - 1910
- East addition (BLUE): Unknown, prior to 1948, enclosed after 1948
- Bay window (GREEN): 1989
- Greenhouse (GREEN): 1989
- Upper floor remodel (ORANGE): 1992, may have been habitable space prior

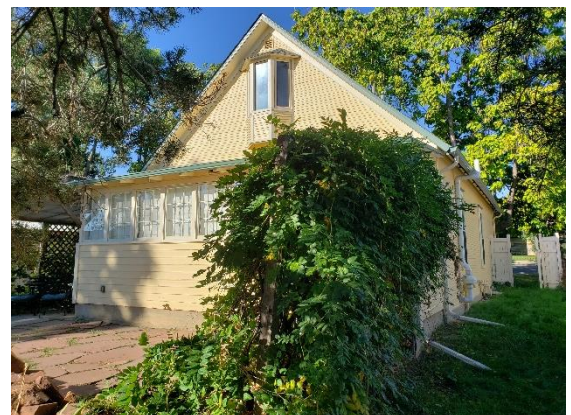
*Vines growing on trellis structure.*

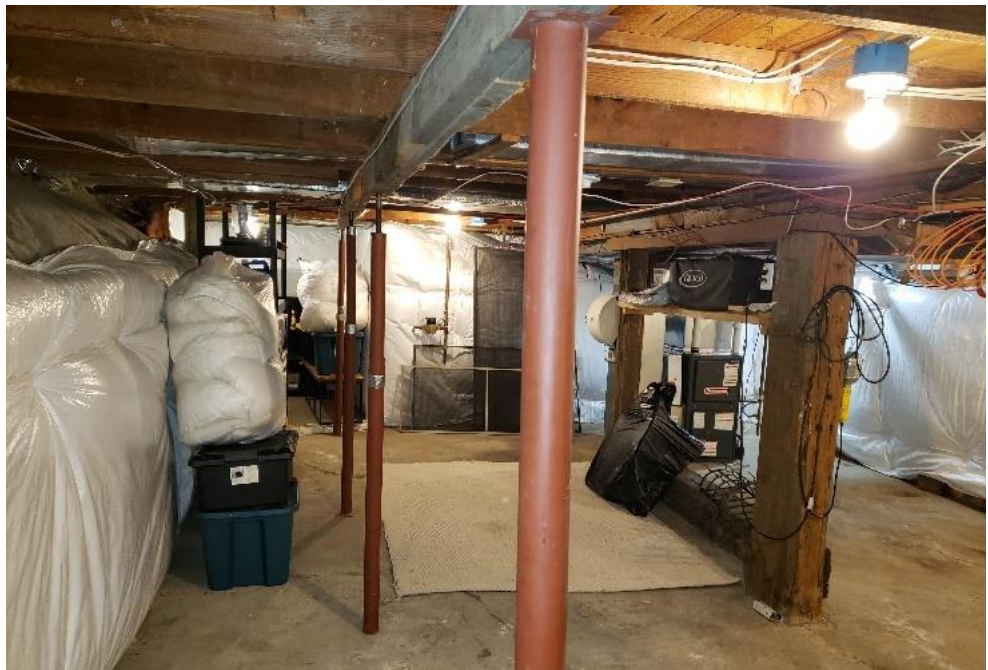
*Two beam lines supporting the main floor joists with columns bearing on a concrete slab floor.*

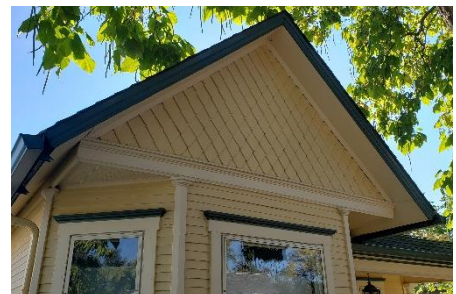
*Wood shingle siding in the smaller gable end.*

The original house is clad in painted wood clapboard siding that runs from the top of the foundation to the bottom of the roof eaves. The same clapboard siding is also present on the main roof gable ends on the east and west sides. However, the smaller gable end above the west bay has decorative painted wood shingle siding with a diamond face. The clapboard siding and the shingle siding appear to be original as both are seen in an early 1900's photograph of the house. The east addition siding is painted wood shiplap siding with a Dutch cove profile. This type of siding is commonly found throughout Louisville and is likely original to when this part of the house was enclosed.

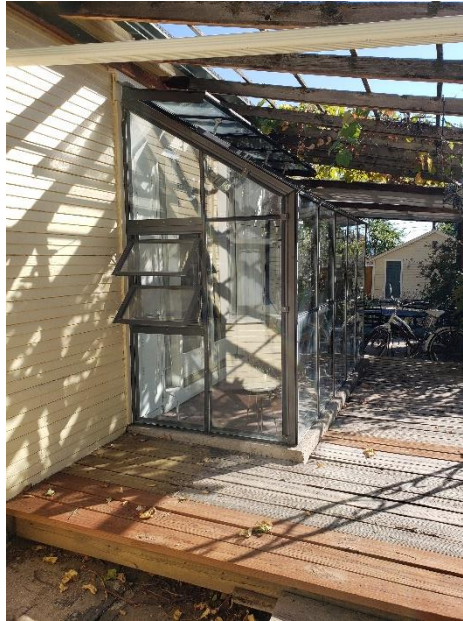
*Greenhouse attached to the south of the house.*

The south side bay window is in good condition. This element was added in 1989 and appears to be well maintained, though not historic. The greenhouse, also added in 1989, is in good condition. The bay window structure and the foundation of the greenhouse were only partially visible for analysis. Building details found in the building records indicate how both of these elements were constructed, and it appears that both were engineered to a code at the time of construction.

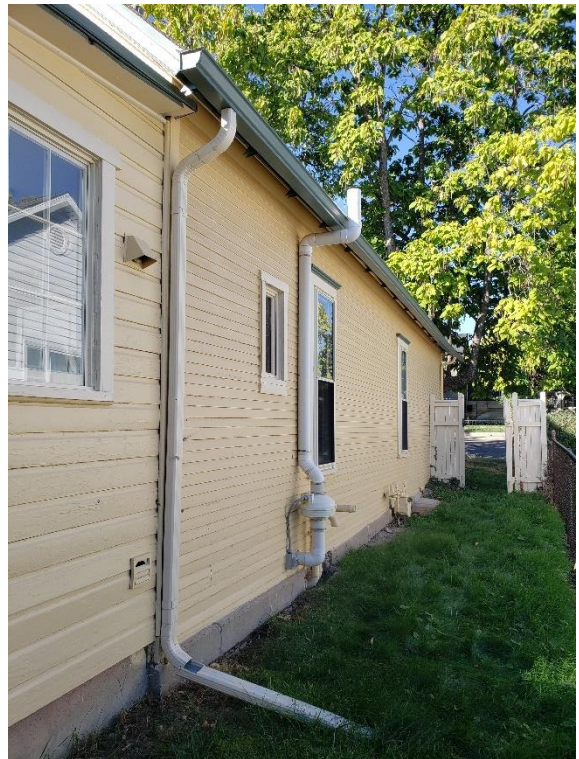
Painted k-style gutters are found throughout the house. Gutters are located at the end of all roof eaves in appropriate locations and of appropriate lengths for adequate water collection. The roof eaves of the gable roofs are square-cut and therefore the gutters are attached with standoffs at regular spacing.

2x3 downspouts are located throughout and appear to be of an adequate amount for proper drainage where located. Downspouts have downspout extensions at all locations to direct water away from the foundation. There are downspouts on the south side that are routed across the trellis structure to direct water beyond the south side patio. Part of the trellis has a corrugated metal roof that does not have gutters or downspouts, but water is carried by the roof away from the house foundation.

*Typical K-style gutter, downspout, & downspout extension.*

Overall, the gutters are in fair condition. Gutters can be difficult to assess outside of significant rain or snow events, but they appear to be properly attached, and no visible signs of leaking were present. Since we were unable to observe the gutters from above, it could not be determined whether the gutters are kept clear of debris or if any areas of standing water were present.

1. Ensure that all gutters, downspouts, and downspout extensions are maintained to discharge water away from the building foundation and are kept clear of debris.
2. Consider replacing the gutters with half-round gutters to match the historic style typical of Louisville. Downspouts should be replaced with round downspouts.

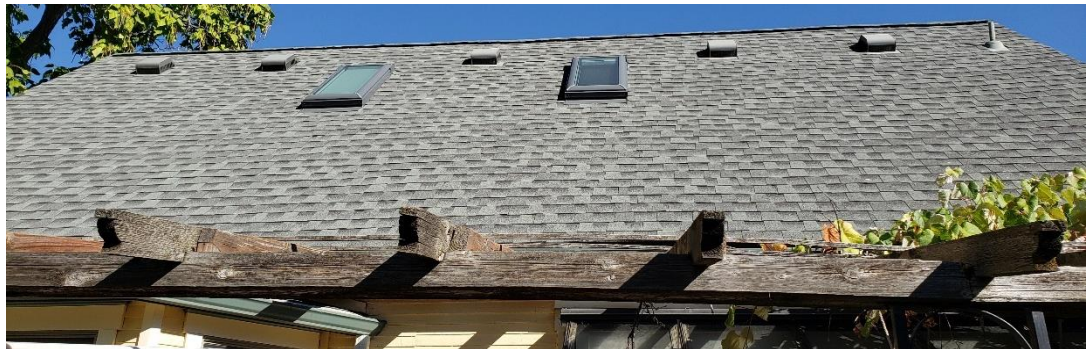
*Operable skylights on the south roof aspect.*

Overall, the skylights appear to be in good condition and create proper seals, but operability was not tested. There is likely flashing around the skylights that were inspected or replaced in 2018 as part of a re-roof that would have been required by code.

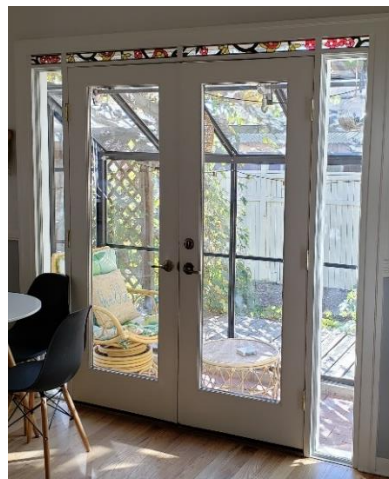
*Double doors to greenhouse.*

Also on the south side of the house is a double-panel French door that accesses the greenhouse. There are two single-pane side lites on either side of the French door and a stained-glass transom. This door and door location are not original. The doors may have existed prior to the greenhouse, providing access to a deck, or they might have been added in 1989 when the greenhouse was constructed.

The French doors accessing the greenhouse are in good condition. These doors, along with the transom and sidelites appear to have been added relatively recently, possibly in 1989, and are protected from weather by the greenhouse.

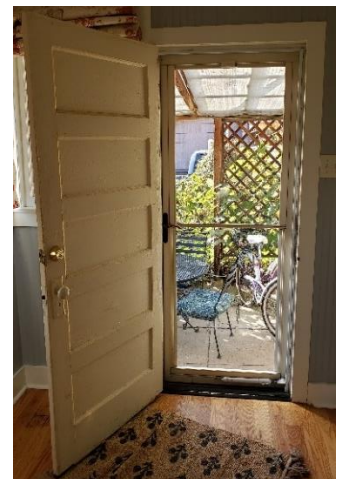
*Door at east addition.*

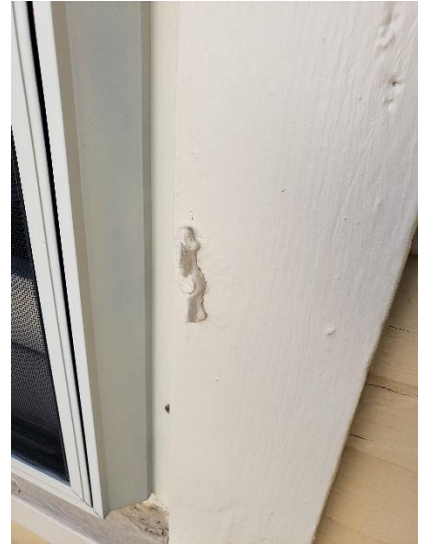
*Exterior hardware previously used to hold window screens.*

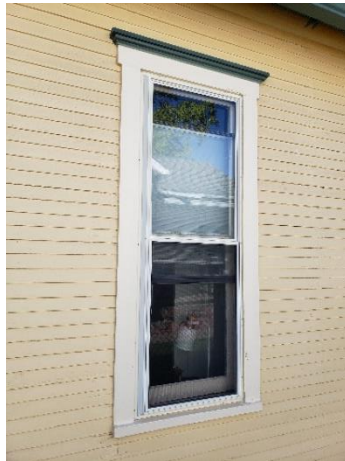
*Wood window with aluminum frame storm window and screen.*

Overall, the windows are in various conditions based on their time of construction. The newer windows on the upper floor and the south bay window are all in good condition as these would have all been added in 1989 or 1992. The windows on the original house and east addition are in fair condition. These windows are all well beyond the expected lifespan of painted wood windows. However, these windows appear to have been well maintained over the years and the aluminum storm windows have likely prolonged their lifespan.

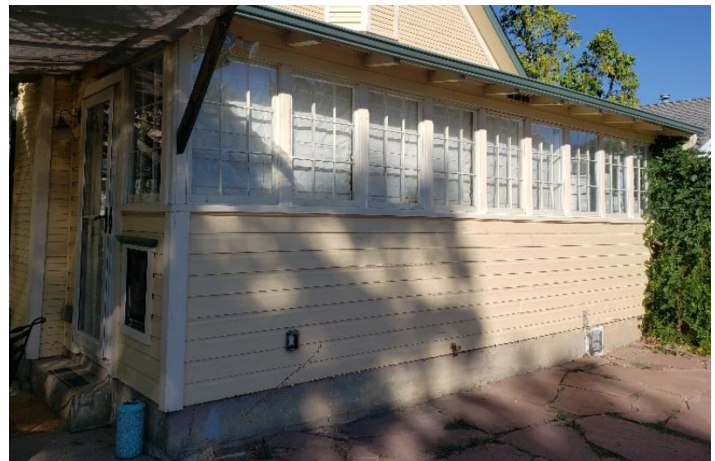
*Single-pane 3-over-3 fixed windows at the east addition.*

Most of the windows throughout the house are painted wood with single-pane glass. The windows in the original house are double-hung windows and the windows in the south bay window are single-hung. The east addition windows are all fixed three-over-three windows that are fixed, except for one casement window on the north side. There is also a fixed window on the north side of the original house with frosted glass. This window is in the bathroom and appears to be a replacement window, possibly in an original location, but does not match the original size. Two of the three windows in the upper floor bay window are casement windows while the third window is fixed.

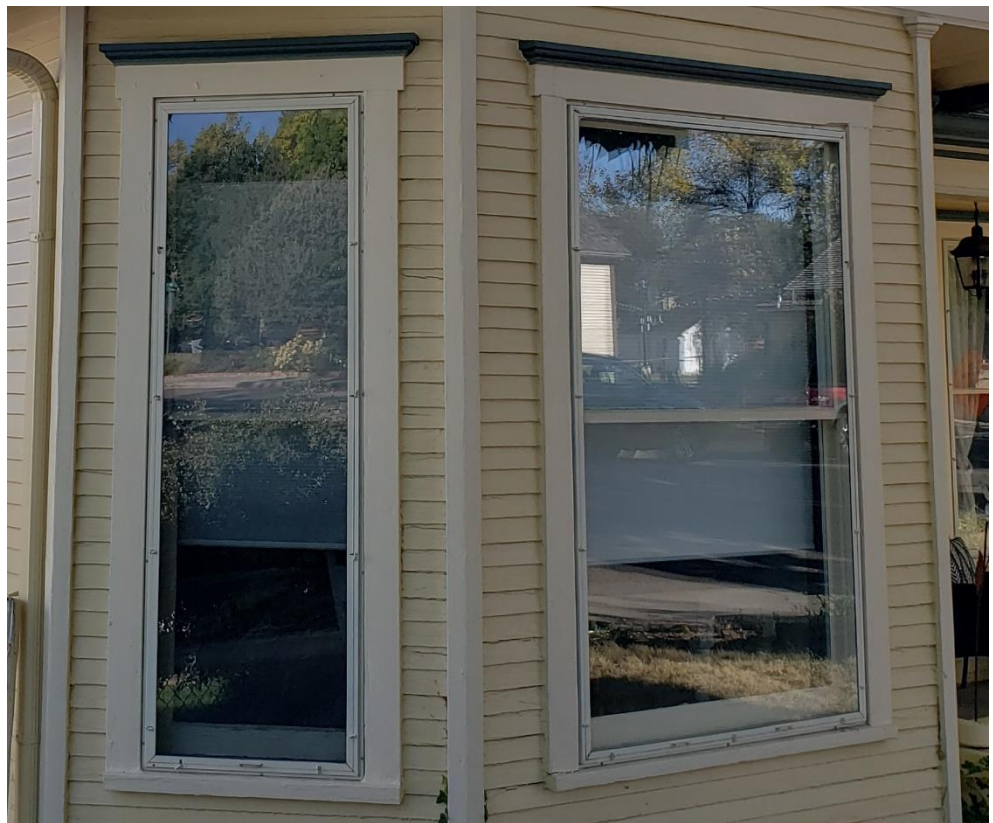
*Double-hung wood windows with aluminum frame screen windows.*

1. The original wood double-hung and fixed windows should be properly restored as described below. Windows should be made to be operable, create proper seals, and only use replacement parts where no other option is available.

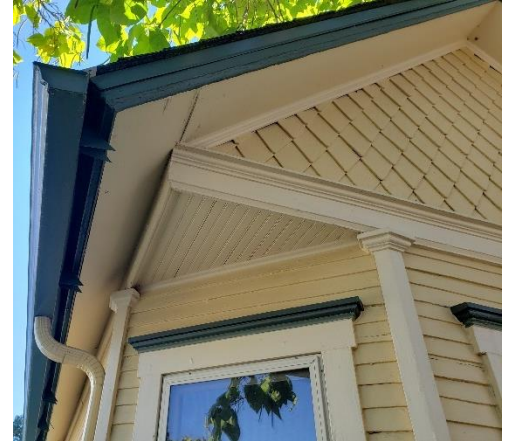
*Painted wood 1x soffit & fascia at the eaves and rakes with beadboard soffit at some locations.*

Overall, the soffits are in fair condition. The soffits have been well maintained and are protected from the elements. However, it is likely that the soffits are original and therefore the painted wood is over 100 years old. Some chipping and cracking of the wood is present and some of the seams are not flush.

The fascia was minimally exposed for analysis due to being covered by gutters and aluminum drip edge. Where visible the fascia is in good condition. Further analysis is required when the k-style gutters are removed.

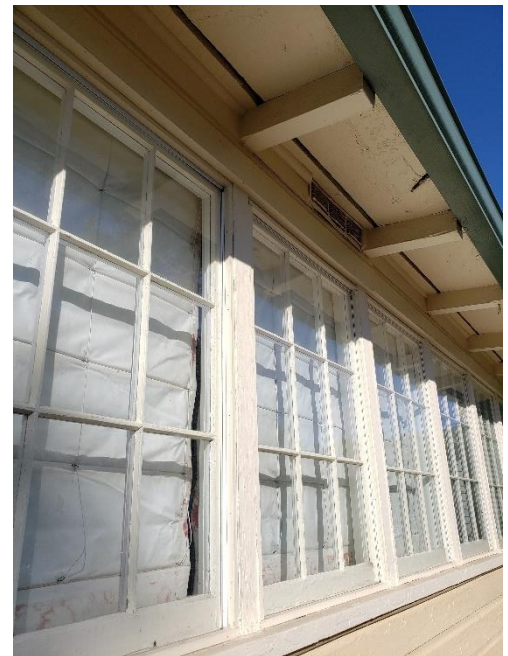
*Exposed painted rafter tails at the east addition.*

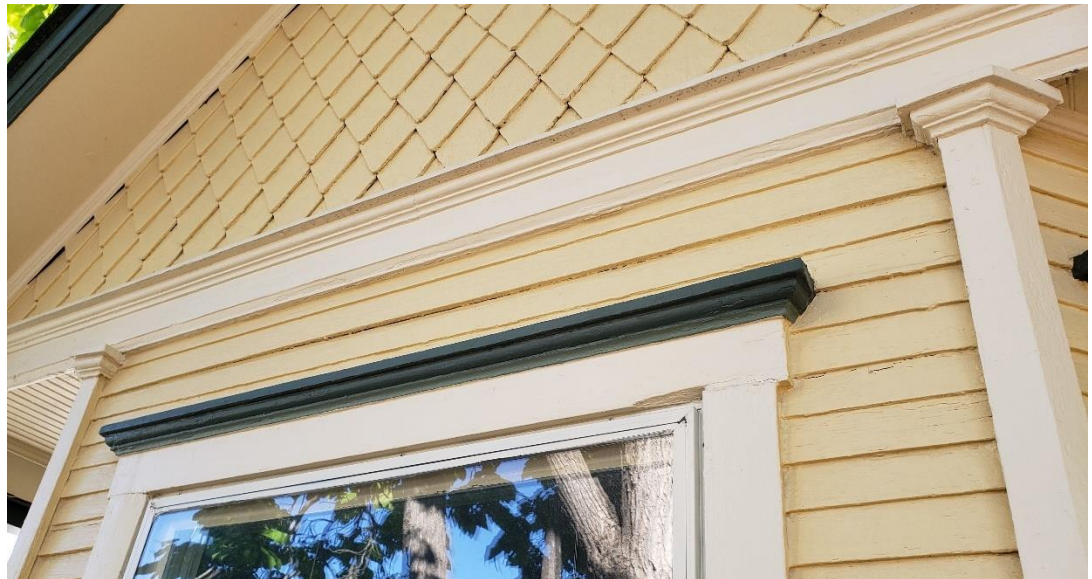
The window trim on all the original house window locations is painted wood 5-piece trim. The windowsills are 2x6 with 1x4 jamb and head trim and a decorative ogee header. This window trim is also what is found on the front door and was copied for the south bay windows.

*Decorative painted wood trim is found at the windows, doors, corners, and gable ends.*

Overall, the painted wood trim is in fair condition. The wood trim has been well maintained over its lifespan and has been protected by the roof overhangs. There are some signs of chipping and cracking as would be expected of wood trim that is likely over 100 years old.

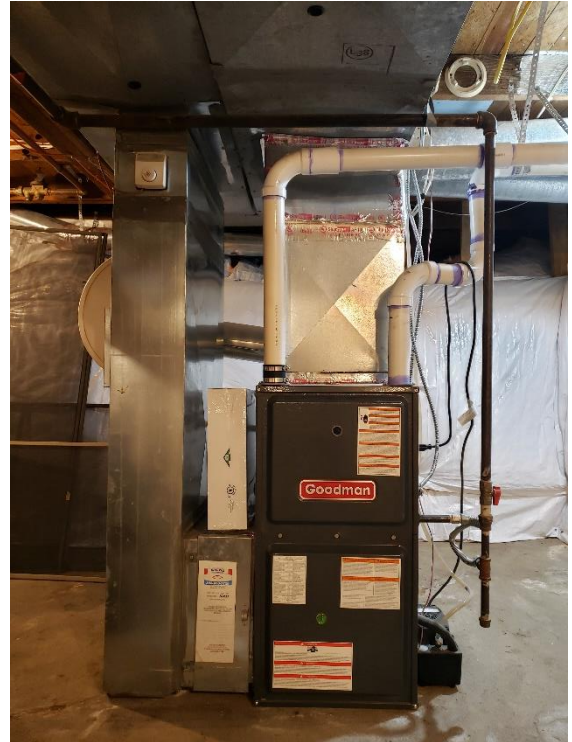
*Furnace and ductwork in the basement.*

Heating is provided to the entire house through a gas-fired forced-air furnace located in the basement. Building records do not indicate when the furnace was replaced but it appears to have been installed within the last ten years. The furnace is direct-vented out of the north wall of the basement. Air conditioning is not part of the forced-air system, but window air conditioning units were installed during the site visit. The furnace sits on the concrete slab floor in the basement with adequate space for servicing. A combination of rigid and insulated flexible ductwork runs throughout the basement to floor vents servicing the main floor. There are wall registers on the upper floor that also appear to be served by the basement furnace. Building records indicate that in 1996, a gas line was run, and a free-standing stove was installed. This appears to refer to the studio.

The furnace and air delivery system appear to be in good condition but were not tested. As the furnace is a newer unit, it is likely that performance is adequate for the current size of the house. Insulation upgrades mentioned elsewhere in this report will increase heating and cooling efficiency.

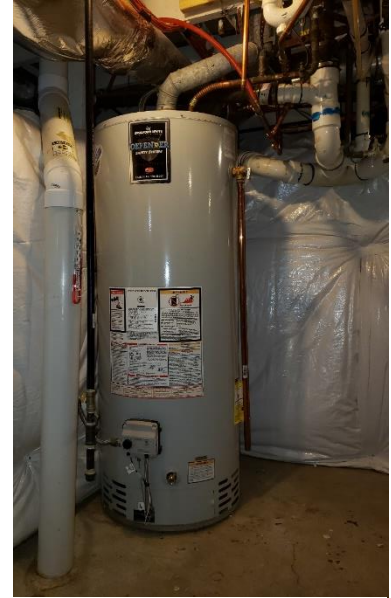
Water heater, supply, and waste lines in the basement.

A standard 50-gallon gas-fired water heater is located in the basement and is atmospherically vented through the roof. Building records indicate that the unit was installed in 2006. Building records also indicate that there was water damage in the bathroom which required new sheathing, insulation, plaster/drywall, and finishes. These support what was seen for floor sheathing as noted in the *Structural System* part of this report. The water delivery system is a combination of copper and PEX pipes with the waste lines being PVC, ABS plastic and cast-iron. The sewer line exits the house as cast iron on the east side, at a relatively low depth which is common for similar houses in Louisville. Building records state that the sewer line was replaced and a water line was run to the garage in 2009. It appears that the water line and sewer were actually run to the studio at the time that it was remodeled with a bathroom added. The extent of the sewer line replacement and the material used could not be determined. Additionally, there is no fire sprinkler system in the house.

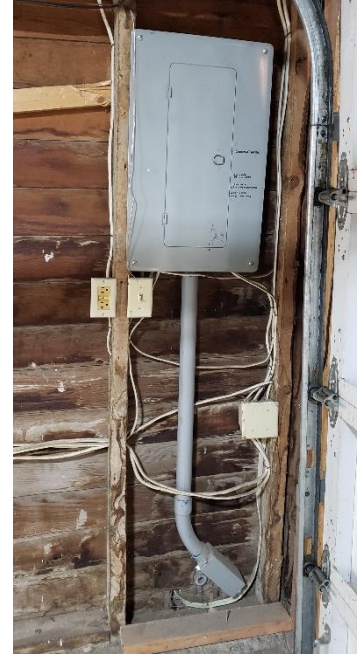
*Main electrical panel in the garage.*

We do not have any recommendations at this time. Any future plans to remove the garage or construct a new garage should keep the main electrical panel on the garage with sub-panels in the house and studio. Future electrical work should be performed by a licensed electrical engineer and shall meet all applicable building codes.

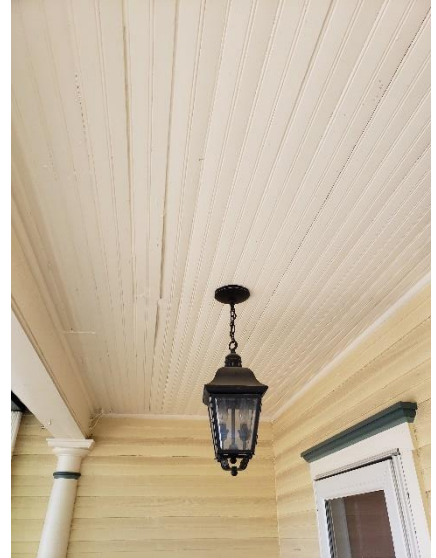
*Pendant light fixture at the front porch.*

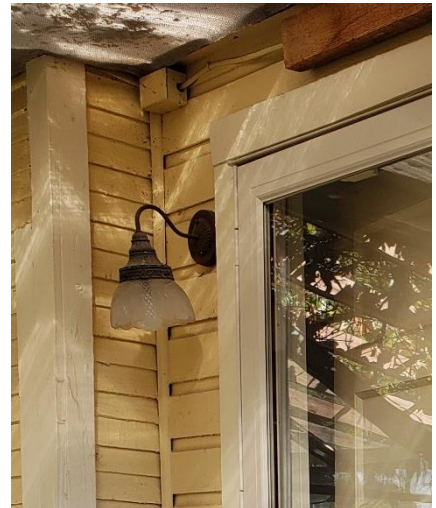
*Wall sconce at the east addition.*

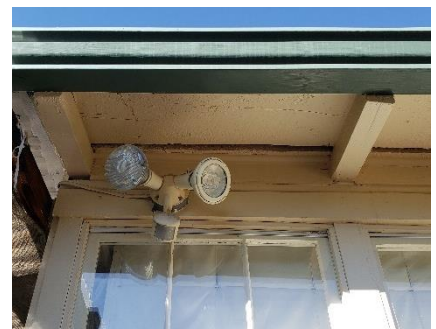
*Flood light at east exterior wall.*

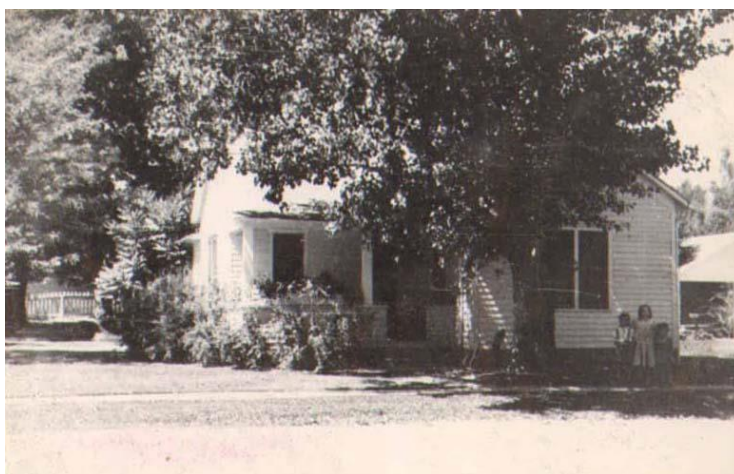
The Boulder County Assessor card for this property dates from 1948, when the property was owned by Ambrose and Audrey Vaughn. The following images show the front of the house on Lincoln as it appeared in 1948 along with the image of the ground layout at the time.

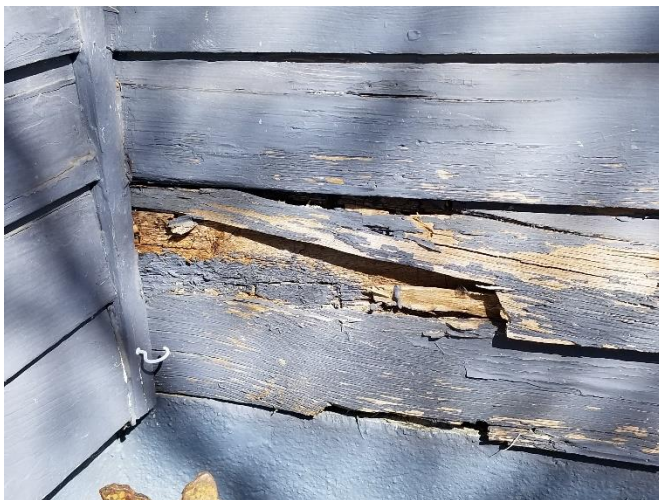
replace some siding

7. EXTERIOR SIDING & TRIM: Original siding is 6” soft wood lap, painted. There is cracking, rot and missing/peeling paint on all sides. Fascia, soffits, casing, corner boards are in decent shape. Recommend replacing a few boards, sand, patch, prime paint entire house siding/trim for preservation.

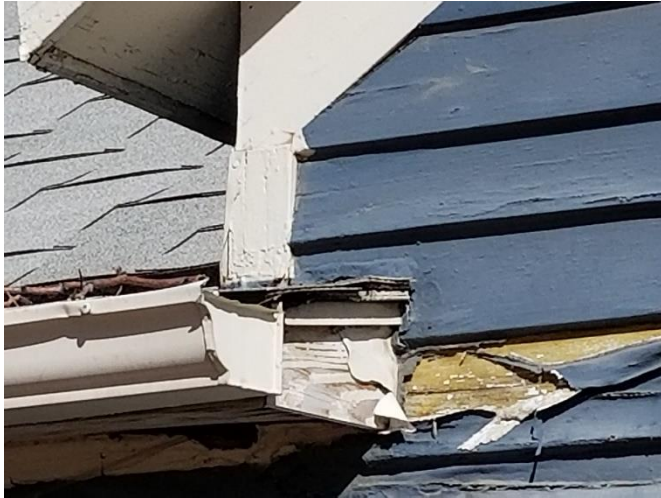
patch, sand, prime, paint

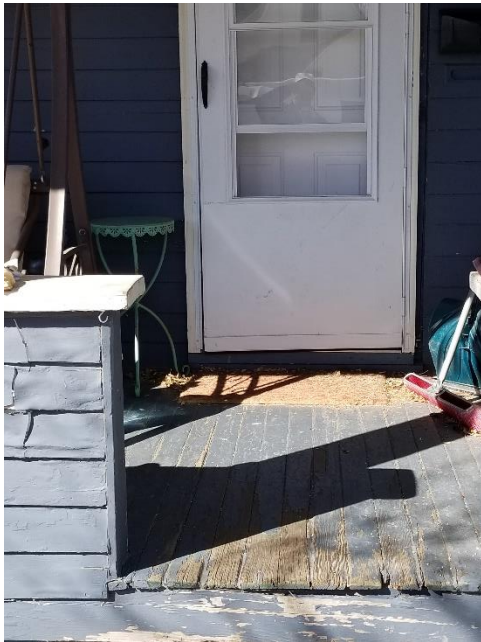
front porch siding, trim, floor, door

9. PORCHES: Recommend front porch (Pine St.) gets new wood floor, fix/paint trim and siding on low walls. Side porch should get horizontal lap siding and double hung windows to better compliment the historic home.

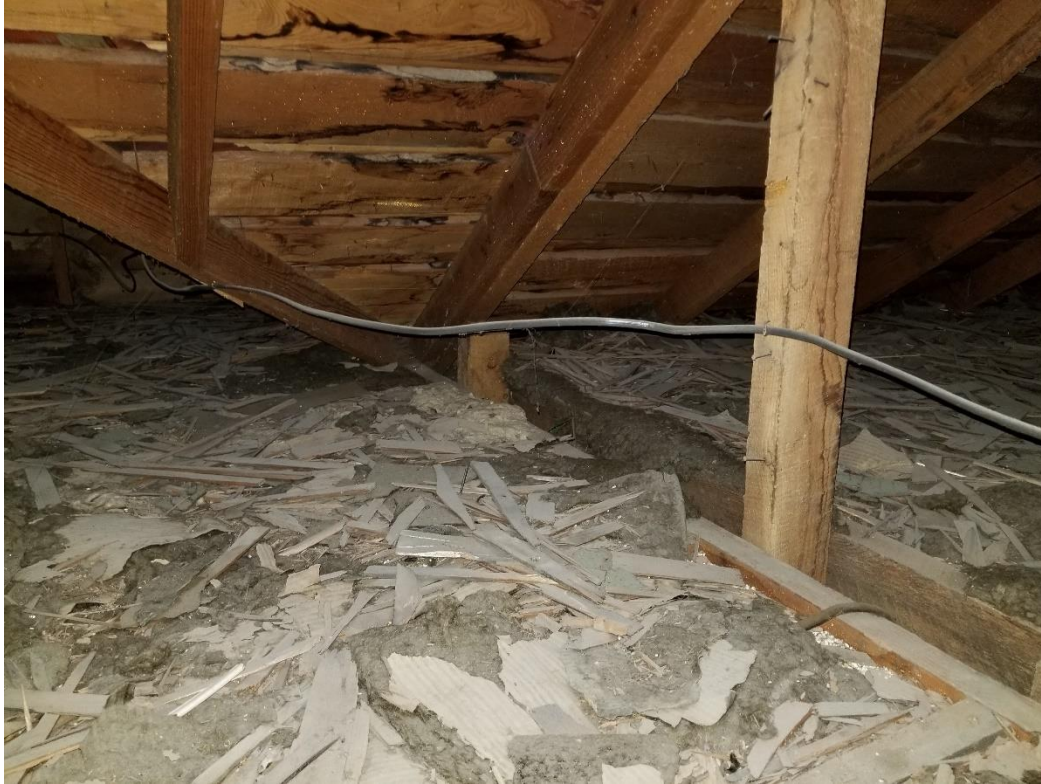
Attic framing, sheathing, debris

3. ROOF STRUCTURE: 2x6 rough sawn rafters @ 24" OC, with 1x6 board sheathing, four random diagonal or vertical braces to ceiling joists. No visible failure, cracking, sagging, but not to code. Recommend further evaluation by structural engineer, better bracing and perimeter metal collar ties. Also recommend eliminating flammable debris in attic (lightning/elec. fire hazard)

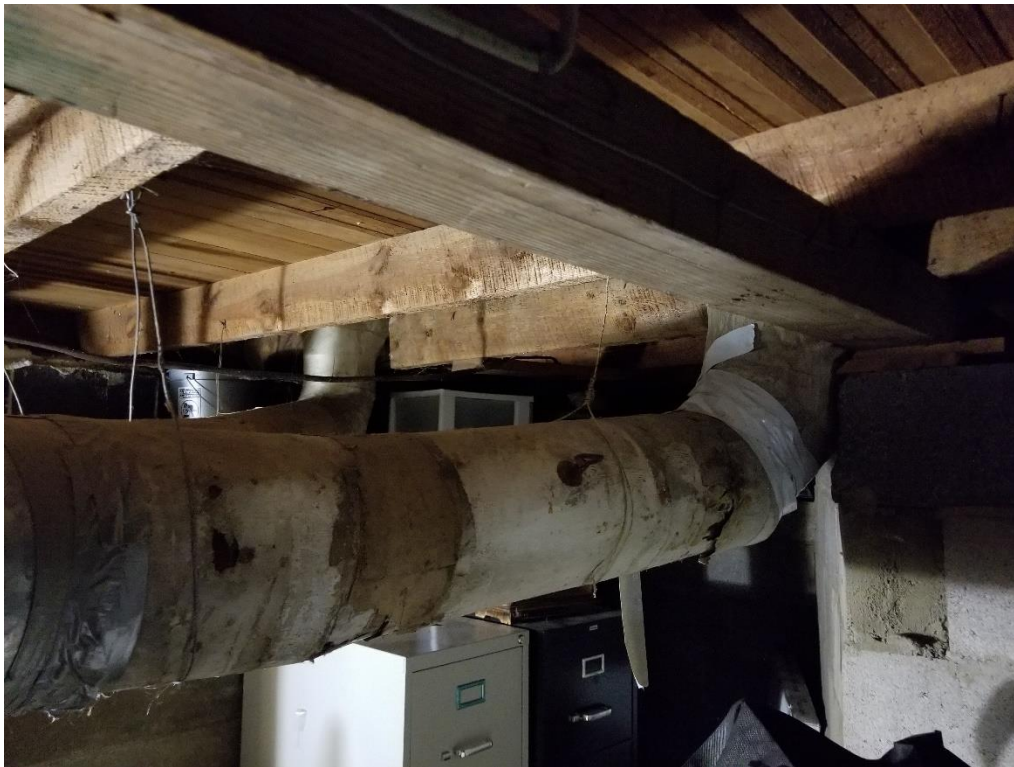
Basement framing

5. FLOOR STRUCTURE: original framing r.s 2x6 of 24"OC, with two 4x6 beams at mid-spans, and four vertical columns friction fit to floor and beams. This is all not to code, but no signs of cracking, sagging, failure. Recommend structural engineer evaluation, probably tie joists to foundation and sister some floor joists.

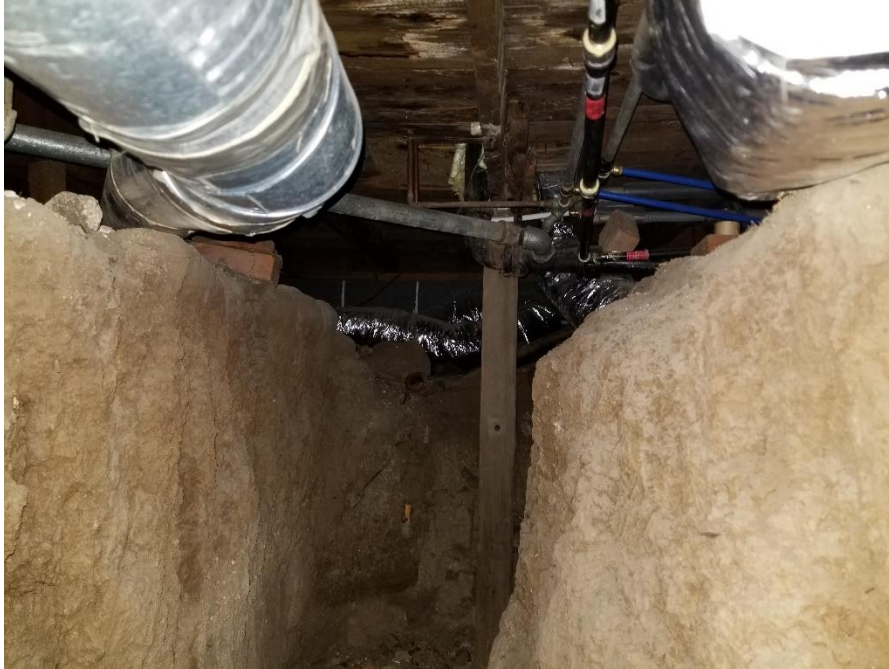
Basement framing
