## COLORADO CULTURAL RESOURCE SURVEY

### Architectural Inventory Form

1. Resource number: **5BL921**
2. Temporary number: **N/A**
3. County: **Boulder**
4. City: **Louisville**
5. Historic building name: **Stecker / Kerr / Brennan House**
6. Current building name: **McWilliams House**
7. Building address: **633 LaFarge Avenue**
8. Owner name: **Anne P. McWilliams**  
Owner address: **633 LaFarge Avenue**  
**Louisville, CO 80027**

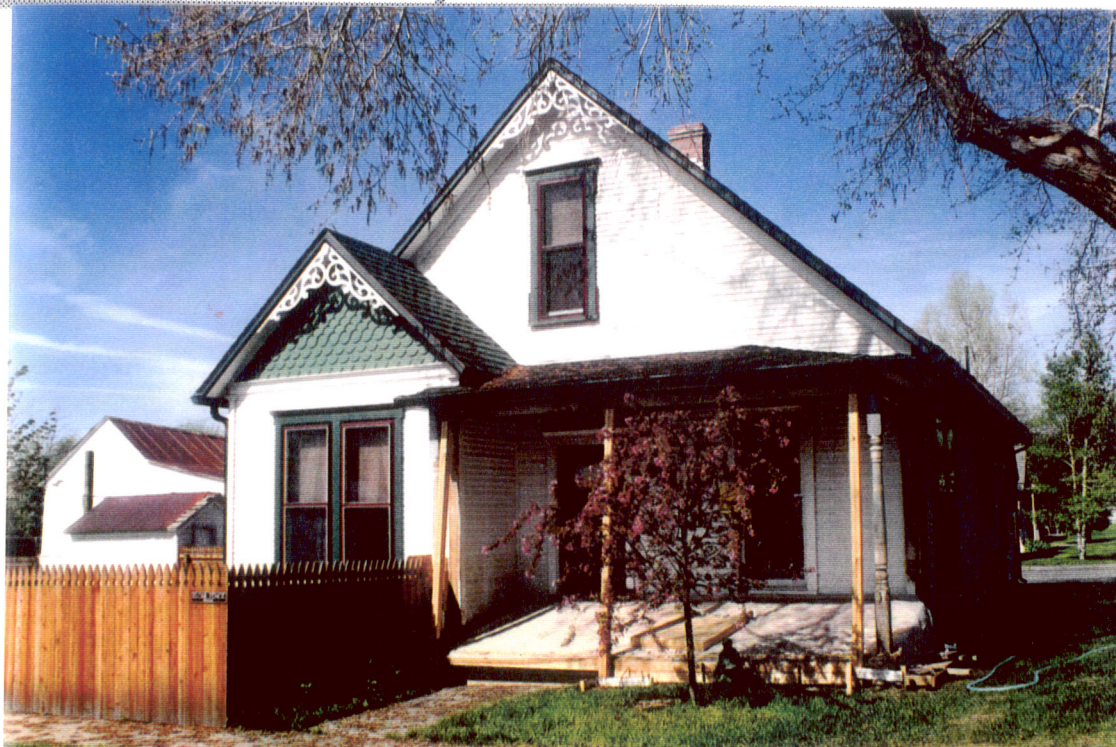
This wood frame residence is supported by a low sandstone foundation, and features painted white narrow horizontal wood siding exterior walls. A planted grass yard surrounds the house, with a large cottonwood tree located near the sidewalk along Pine Street. A large planted grass side yard to the south of the house is enclosed by a stained natural brown picket fence. The house is covered by a moderately-pitched front gable roof, with green asphalt shingles and boxed eaves. A red brick chimney, with a corbelled cap is located on the ridge. Richly decorated bargeboards appear in the upper gable ends on the east and west elevations, and a projecting gable on the east elevation features fishscale shingles as well. A low-pitched hipped-roof porch covers the northern 2/s of the facade on the east elevation. The porch roof is supported by turned columns, and leads to a painted black wood-paneled entry door. This distinctive door features one upper sash light, carved panels, and a dentil course and garland motif in the locking rail. A 24' by 10', one-story, enclosed hipped-roof rear porch addition to the original house's west (rear) elevation predates 1950. A band of four 4-light hopper windows, and one 1x1 horizontal sliding window, penetrate the porch's west elevation. Two additional 4-light hopper windows are located in the addition as well, at the far west end of the north elevation. A painted white wood-paneled door, with a white metal storm door, opens onto a concrete stoop, from the enclosed porch on the house's west elevation. The house's windows are little altered from their historic appearance, and include single, paired, and tripled 1/1 double-hung sash, with painted white wood frames, painted dark green wood surrounds, and painted burgundy wood cornices.

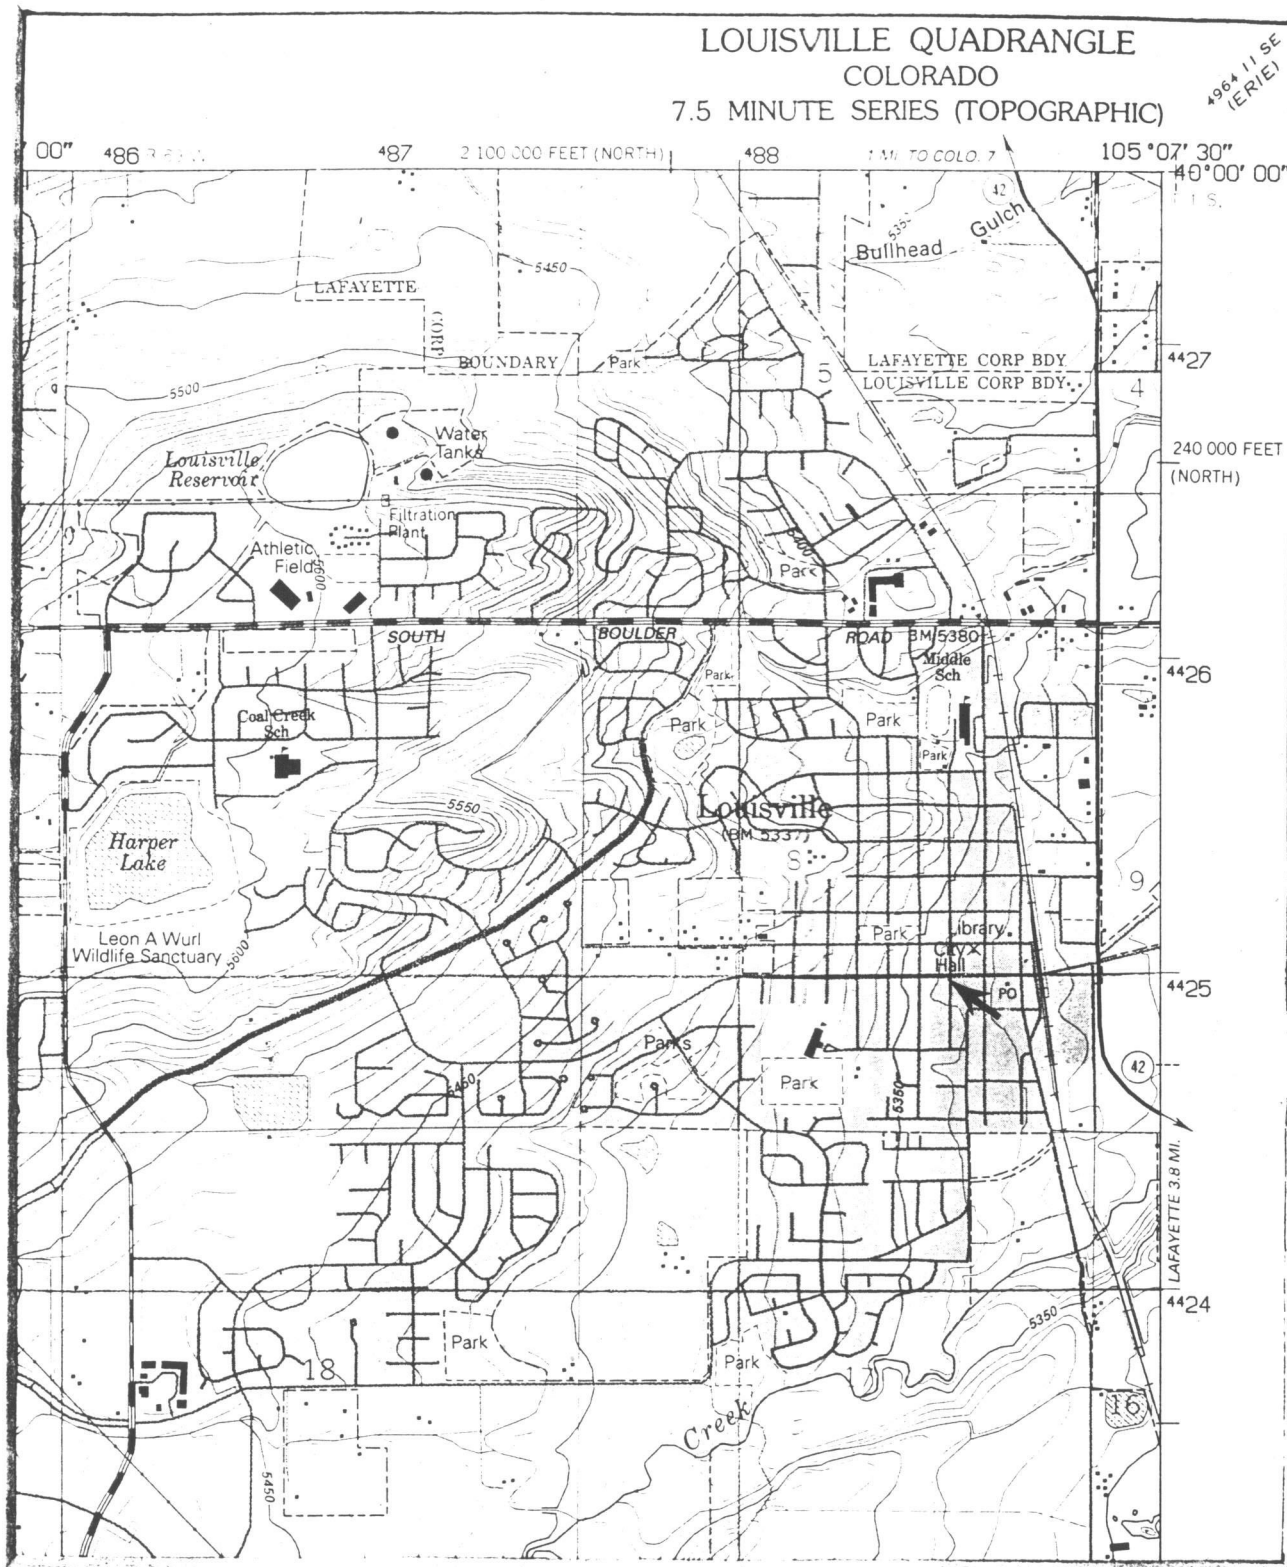
# SKETCH MAP

633 LaFarge Avenue, Louisville, Colorado
