## COLORADO CULTURAL RESOURCE SURVEY

### Architectural Inventory Form

1. Resource number: **5BL7980**
2. Temporary number: **N/A**
3. County: **Boulder**
4. City: **Louisville**
5. Historic building name: **Dionigi House**
6. Current building name: **Colacci House**
7. Building address: **721 LaFarge Avenue**
8. Owner name: **Mary Ann Colacci & Nancy Green**  
Owner address: **721 LaFarge Avenue**  
**Louisville, CO 80027**

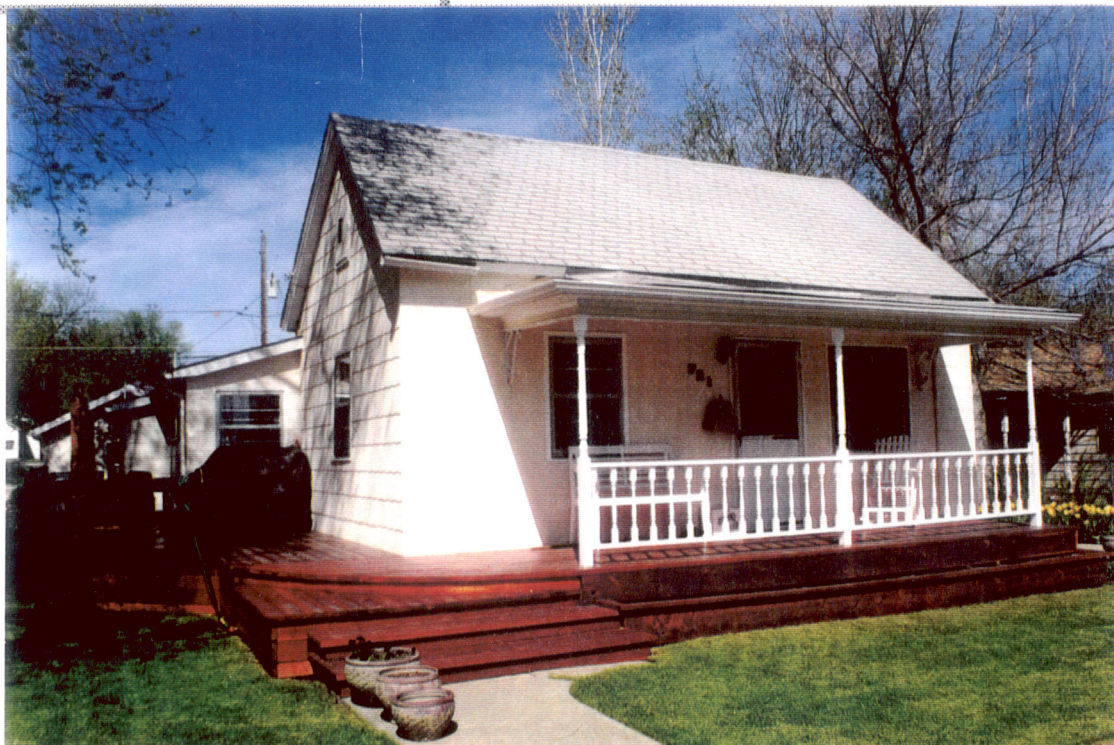
Located on the west side of LaFarge Avenue, the Colacci House is a wood-frame residence supported by a low concrete foundation. An unfenced planted grass front yard is located east and south of the house, while a planted grass backyard, to the west, is enclosed by a chain link fence. A concrete sidewalk, which parallels LaFarge Avenue, is separated from the curb by a narrow strip of grass. The house's exterior walls are undulated asbestos shingle siding. An intersecting gables roof has boxed eaves, and is covered with grey asphalt shingles. One red brick chimney is located on the exterior of the north elevation. Original windows are primarily single and paired 1/1 double-hung sash, with painted white wood frames and surrounds, and with exterior metal storm windows. A single-light fixed-pane window is located on the facade, and two 1x1 horizontal sliding windows are located on the south elevation. The house's front entry is located on the east elevation, where a solid wood door, with a white metal storm door, opens onto a non-original wood porch. The porch wraps around to cover part of the south elevation, and at its north end, it is covered by a hipped porch roof with painted white turned columns, and an open wood balustrade with turned balusters. A 19' by 10', shed-roofed, enclosed rear entry porch is located at the west end of the south elevation. A painted white wood-paneled door, with a white metal storm door, opens onto a concrete sidewalk on the house's west elevation.
