**ITEM:** 600 Pine Street Landmark, Alteration Certificate, & Grant Request

**REQUEST:** A request to Landmark 600 Pine Street, and requests for an Alteration Certificate and Preservation and Restoration Grant

# 600 Pine Street

## Historic Structure Assessment

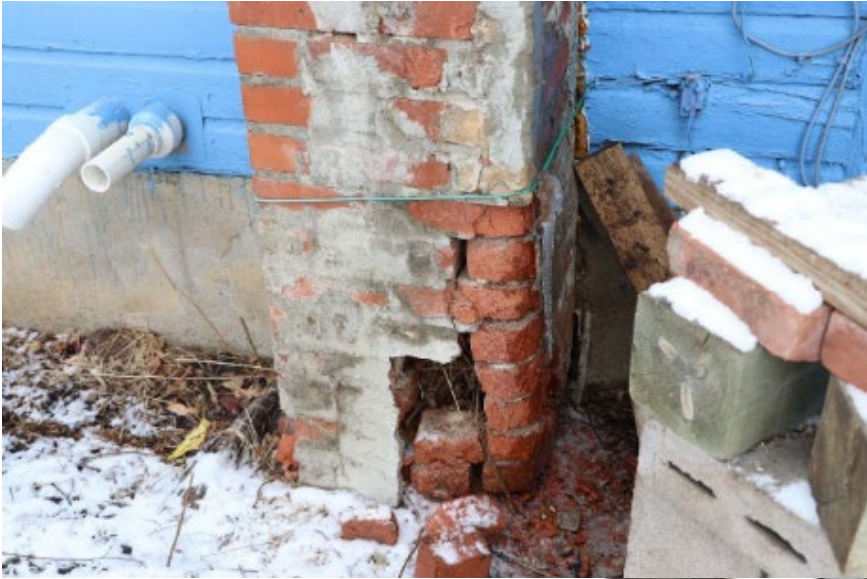
*Photos of the chimney in disrepair from the 2024 HSA.*

| Criteria and Standards | Met? | Evaluation |
|---|---|---|
| 6. <i>The condition of existing improvements and whether they are a hazard to public health and safety.</i> | <b>Yes</b> | The existing conditions of the chimney could provide a hazard because it is currently not structurally sound. |

**Exterior Chimney:** The exterior chimney has a clay tile flue liner. The chimney is in good condition above the roof line. It is in poor condition below the roof line as the valley drains onto the chimney and it in turn suffers freeze-thaw damage. Many of the bricks at the base have been lost (Figure 3). The chimney is unsafe.

The proposed Alteration Certificate is to repair the existing chimney on the property. The proposal includes breaking down the chimney to the ground level and rebuilding the chimney to the same height using the same brick material as the original.

- A. Chimney.
1. Bricks (500) – including delivery.
  2. Scaffolding setup/breakdown.
  3. Cover solar panels with protective boards.
  4. Take chimney down to ground level.
  5. Haul off brick and rubble.
  6. Create/repair foundation.
  7. Rebuild chimney to same height.
  8. Seal off chimney at top completely.

Rebuild with orange hard press bricks the same as original.

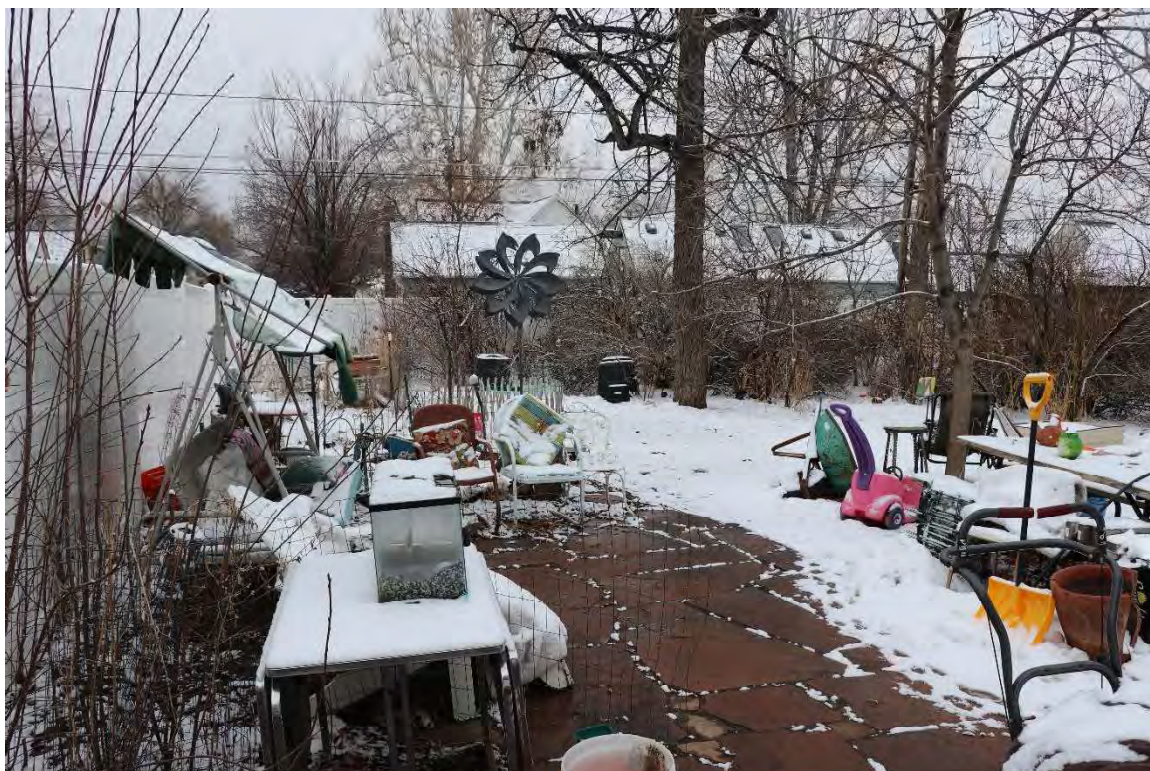
Image 1: Large rear lot

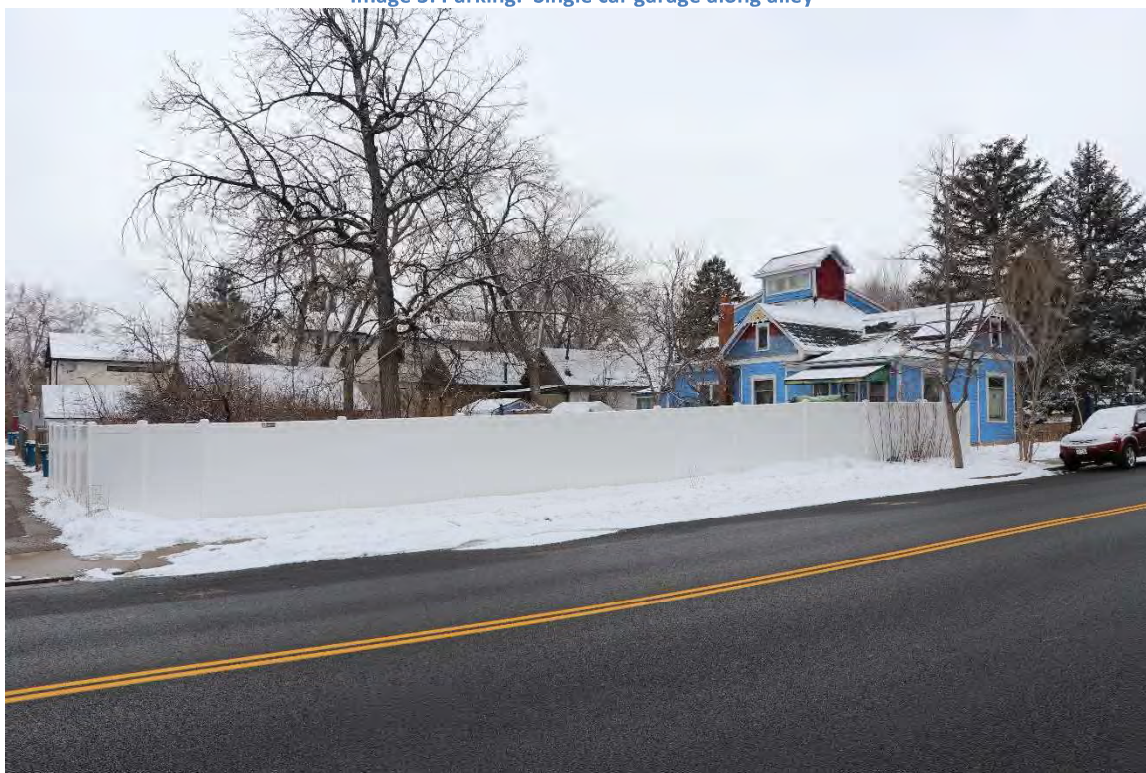
| <i>Element</i> | <i>Description &amp; Condition</i> | <i>Evaluation</i> | <i>Recommendation</i> |
|---|---|---|---|
| Fencing | A white vinyl fence surrounds the rear yard along Pine Street and the Alley. A wood cedar fence divides the yard between the neighboring property. Per permit MISC-8457-2021, the fence was installed in 2022. | Good | No work needed |

Image 4: Vinyl fencing

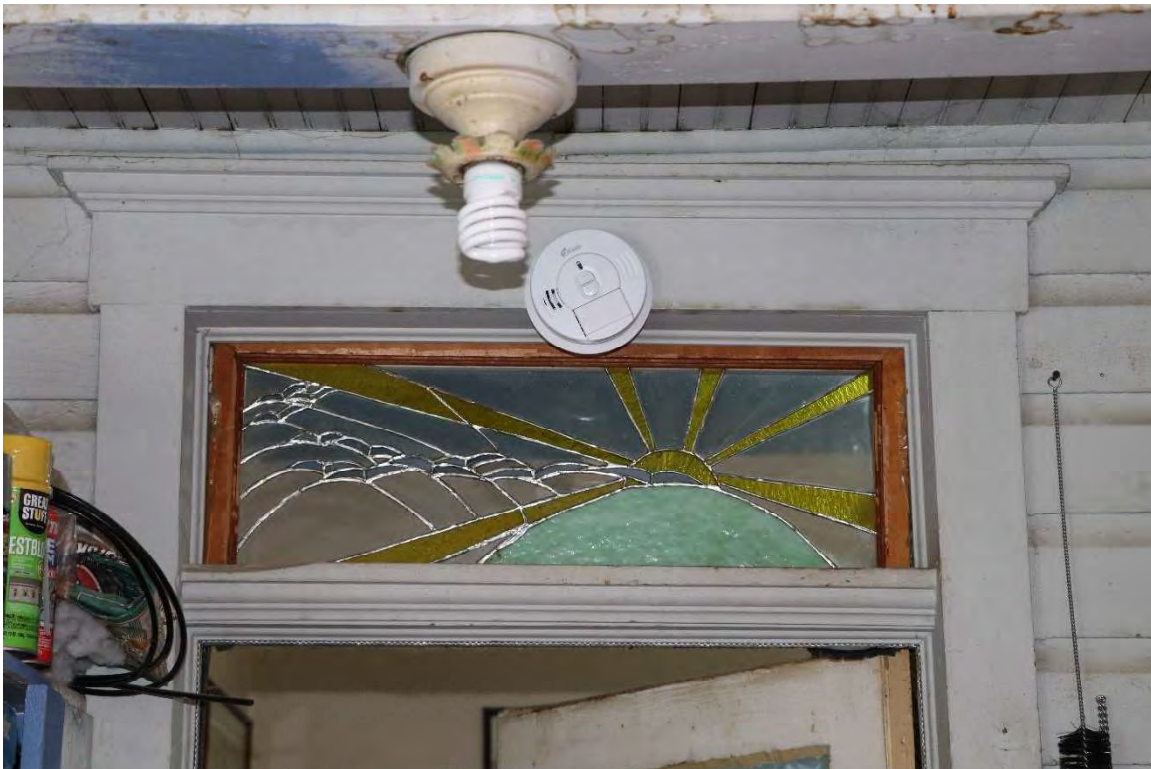
Image 10: Entry porch. Transom and casing detail

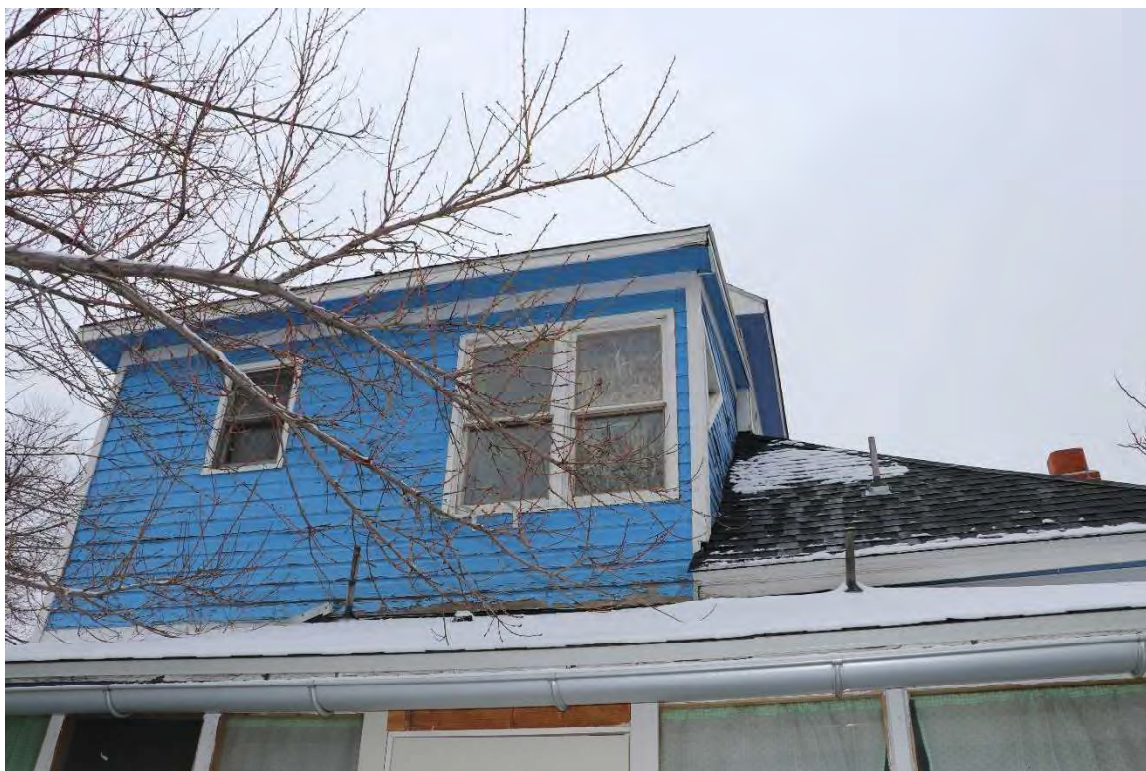
Image 18: Asphalt shingle roofing

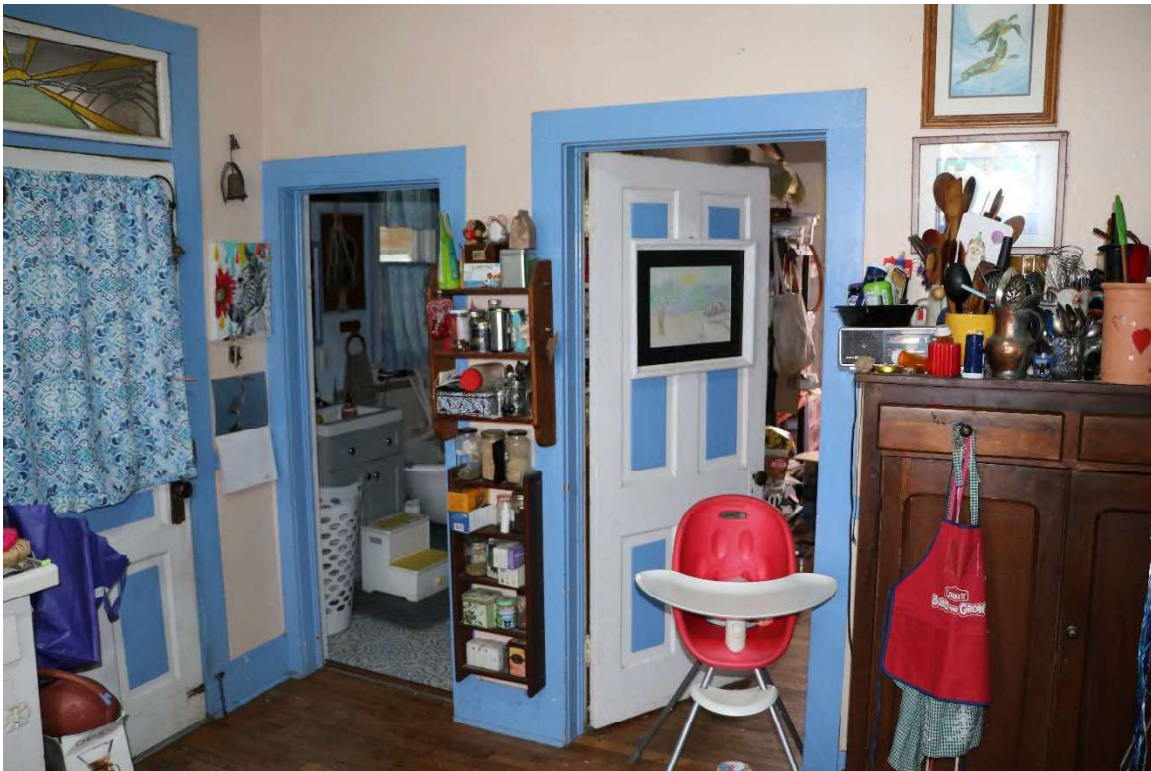
Image 20: Doors. Kitchen

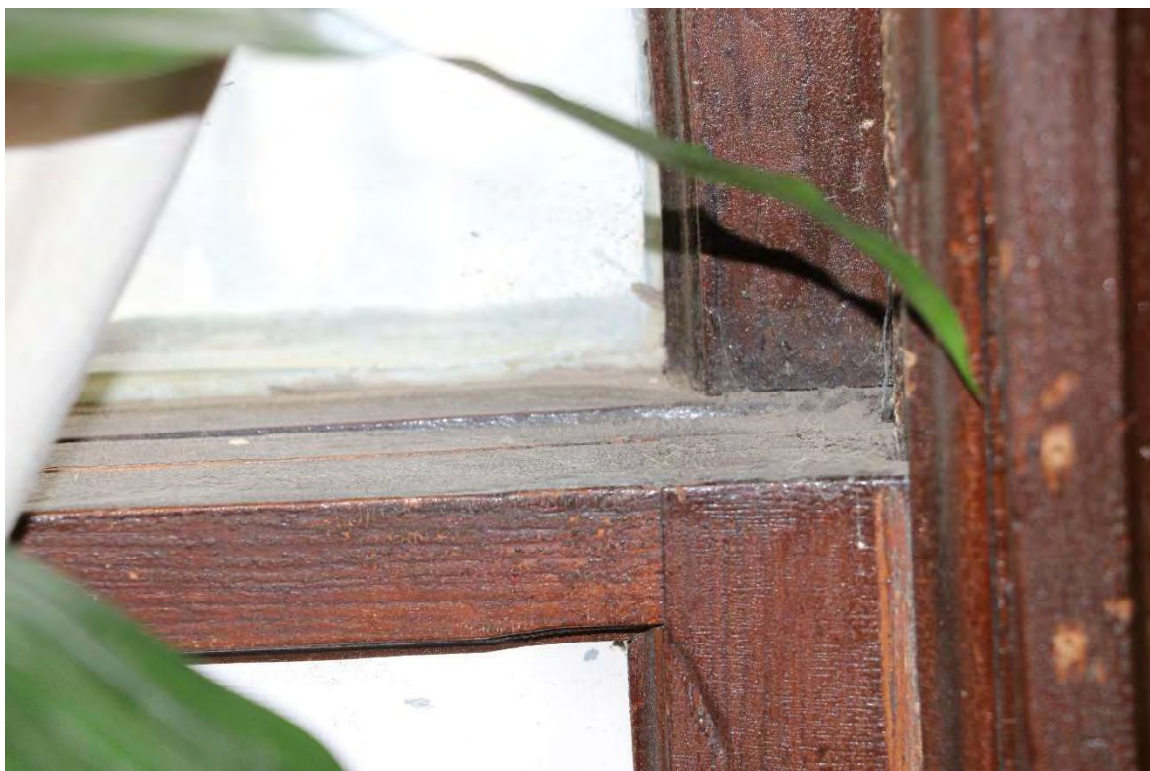
Image 27: Windows. Living Room. Sash detail

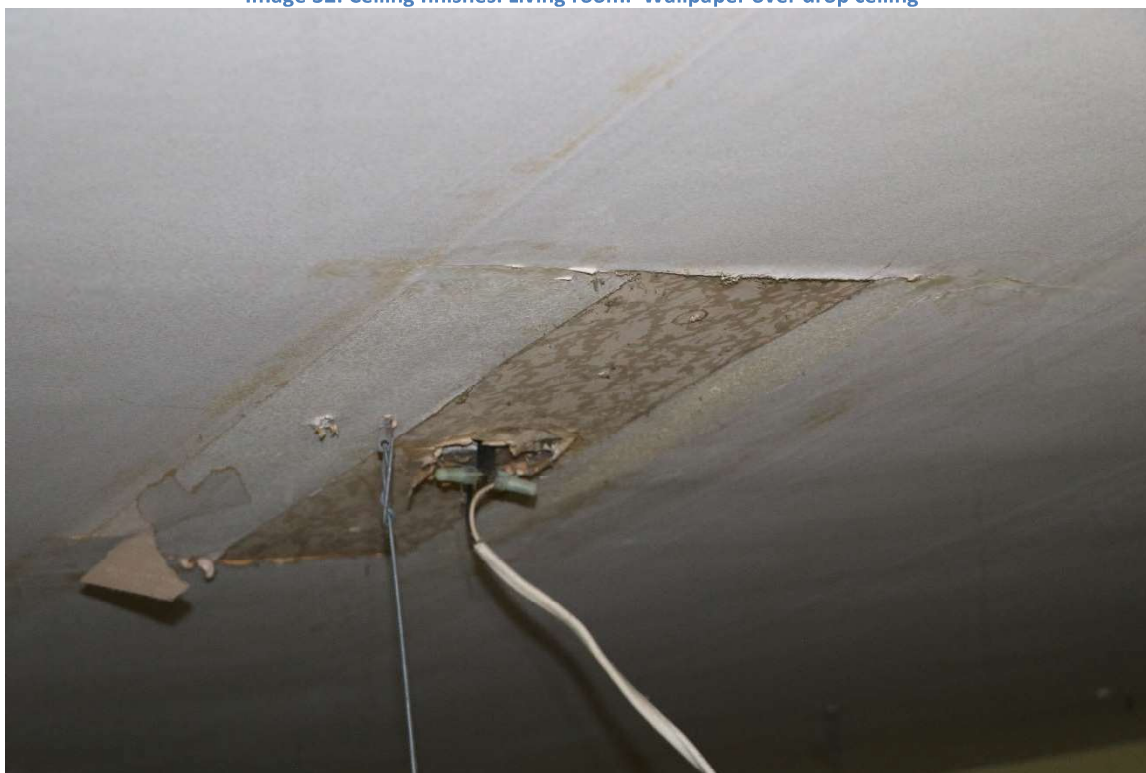
Image 33: Ceiling finishes. Living room. Ceiling wallpaper

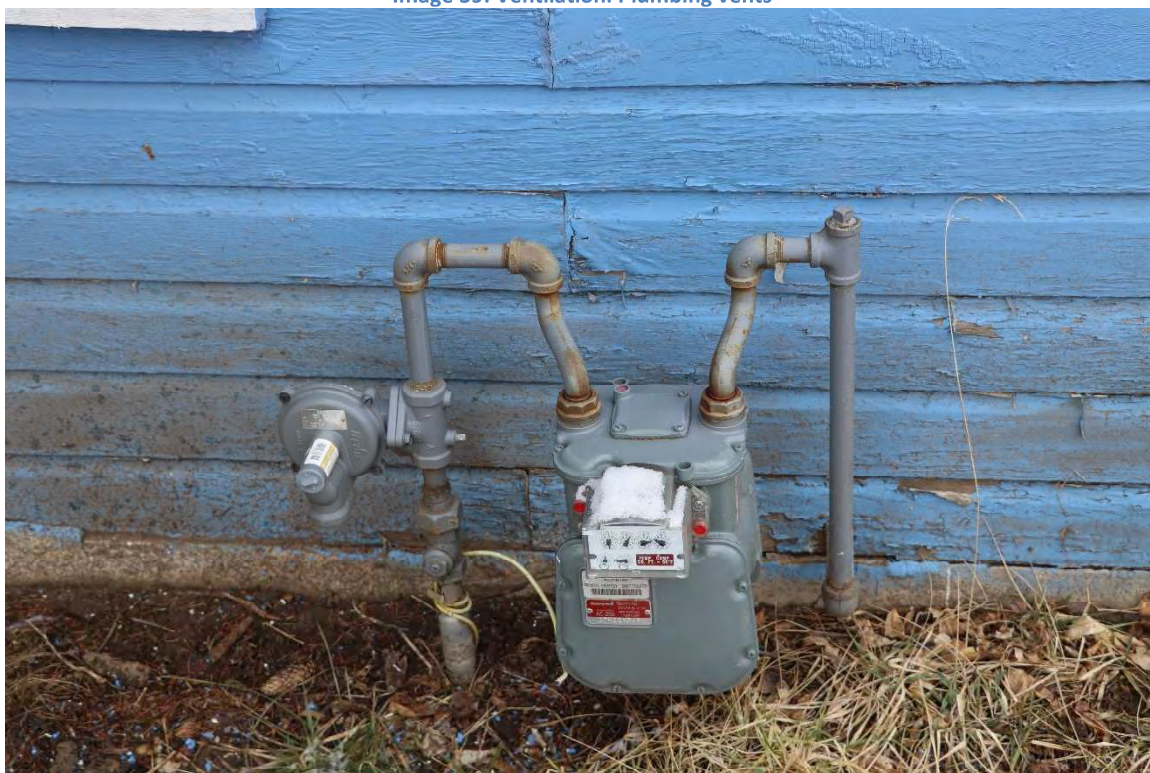
Image 40: Gas meter

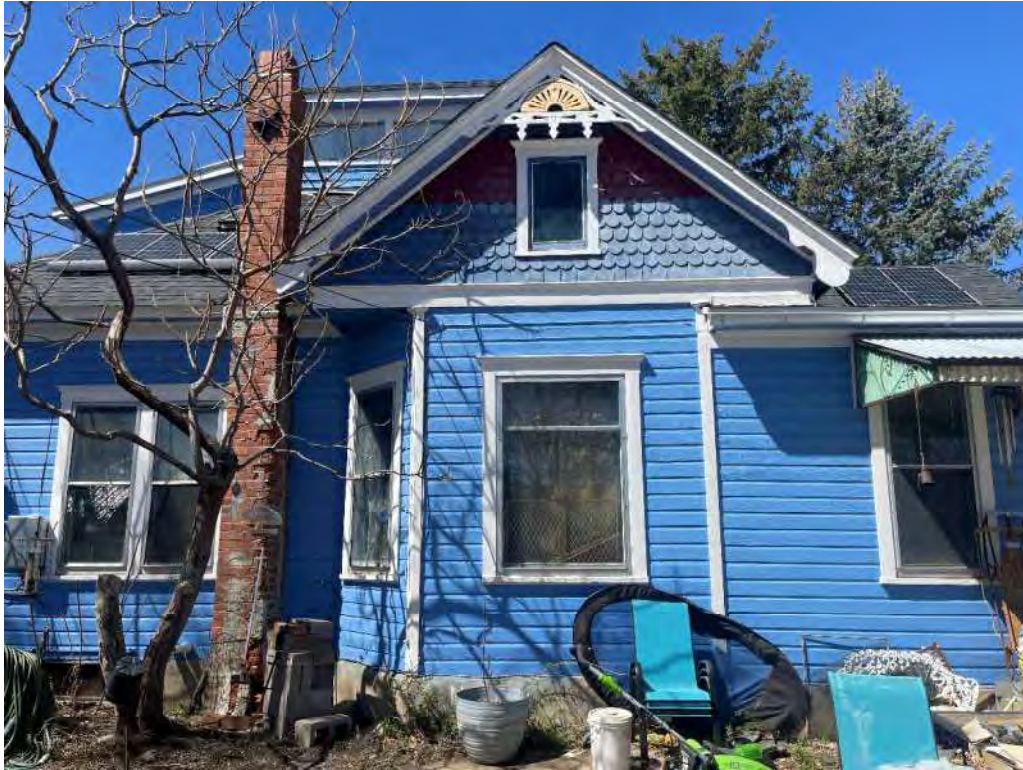
At the northeast corner, there is an addition where there was likely once a front porch (Figure 1). The addition floor appears to be a concrete slab on grade and the walls and roof are wood framed. The addition's roof eave is discernable in the 1948 Real Estate Appraisal Card photograph.

Figure 1: East elevation. Note northeast addition and chimney at roof valley

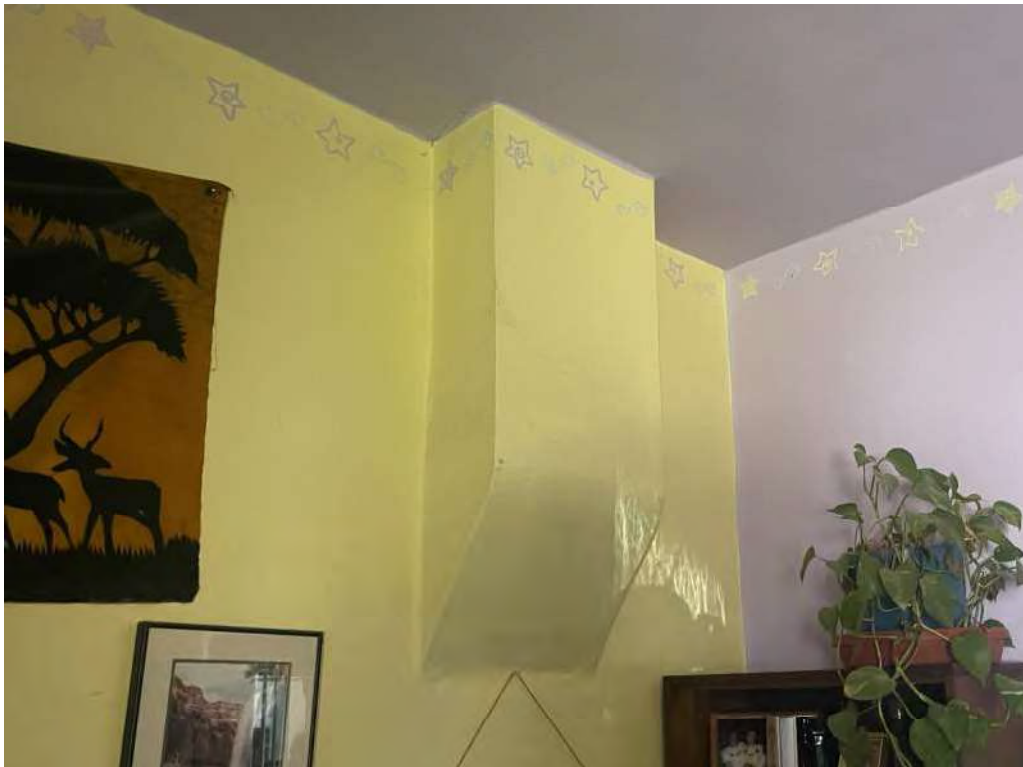
**Interior Chimneys:** The interior chimneys corbel inward to bear on the interior partition walls (Figure 2/Figure 1). The chimneys terminate somewhere in the attic space. There is minor finish staining/damage on the walls near one of the interior chimneys indicating former water leaks at the roof-to-chimney interfaces. There are no cracks in the walls near the chimneys that would indicate insufficient support or rotation.

Figure 2: Interior chimney corbel at partition wall
