**SUBJECT: LANDMARK DESIGNATION & GRANT REQUEST – 600 PINE ST.**

- i. RESOLUTION NO. 26, SERIES 2025– A RESOLUTION APPROVING A LANDMARK DESIGNATION FOR A HISTORICAL RESIDENTIAL PROPERTY LOCATED AT 600 PINE STREET
- ii. RESOLUTION NO. 27, SERIES 2025 – A RESOLUTION APPROVING A PRESERVATION AND RESTORATION GRANT FOR THE MALCOLM HOUSE LOCATED AT 600 PINE STREET

# 600 Pine Street

## Historic Structure Assessment

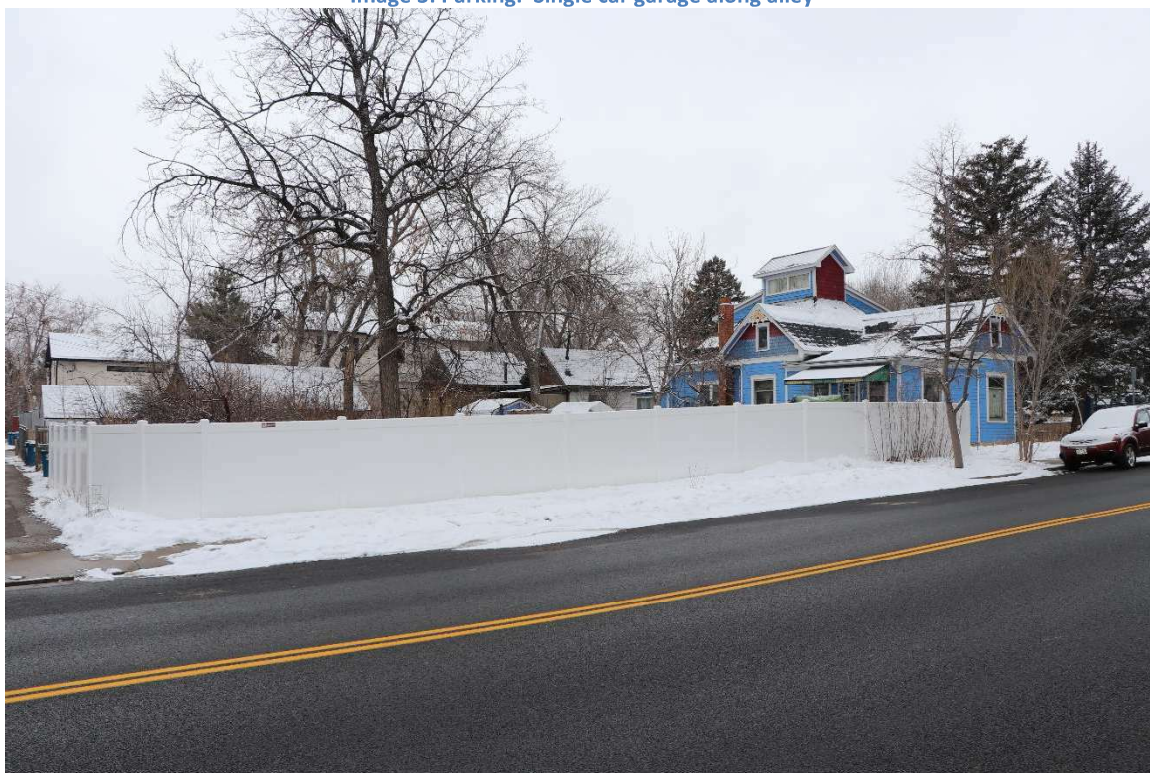
| <i>Element</i> | <i>Description &amp; Condition</i> | <i>Evaluation</i> | <i>Recommendation</i> |
|---|---|---|---|
| Fencing | A white vinyl fence surrounds the rear yard along Pine Street and the Alley. A wood cedar fence divides the yard between the neighboring property. Per permit MISC-8457-2021, the fence was installed in 2022. | Good | No work needed |

Image 4: Vinyl fencing

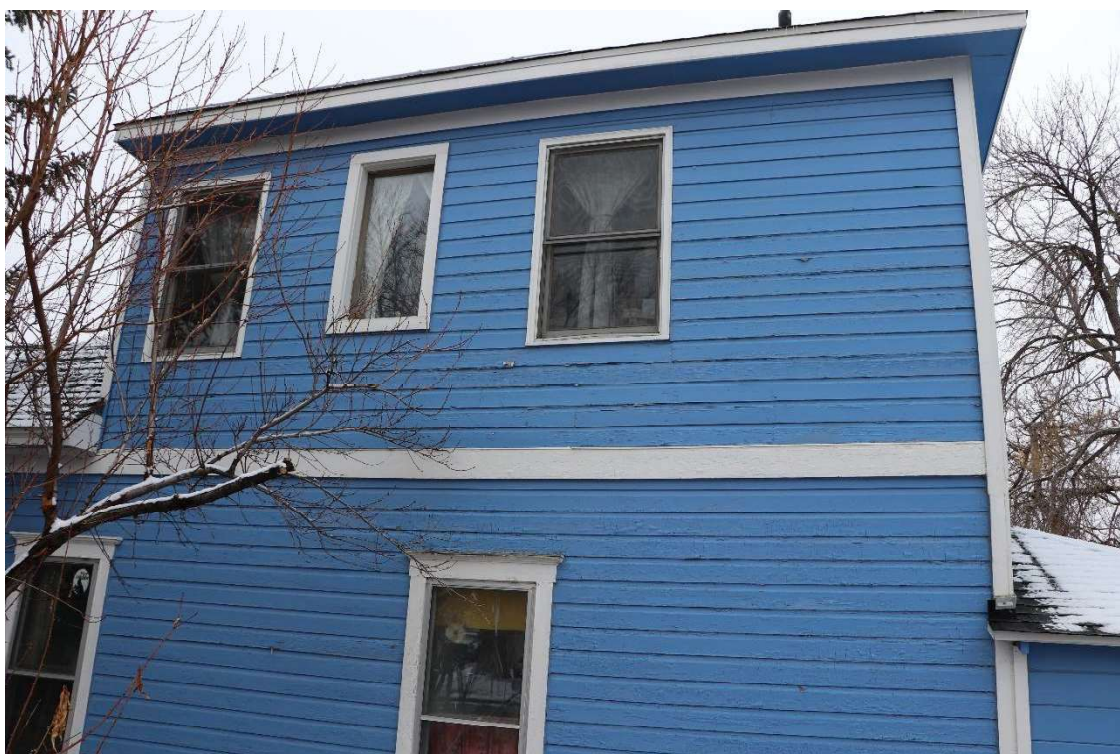
Image 11: Grant Street elevation. The white belt course separates the upper addition from the original first floor. Note the similar but distinct wood siding and window casing on each section

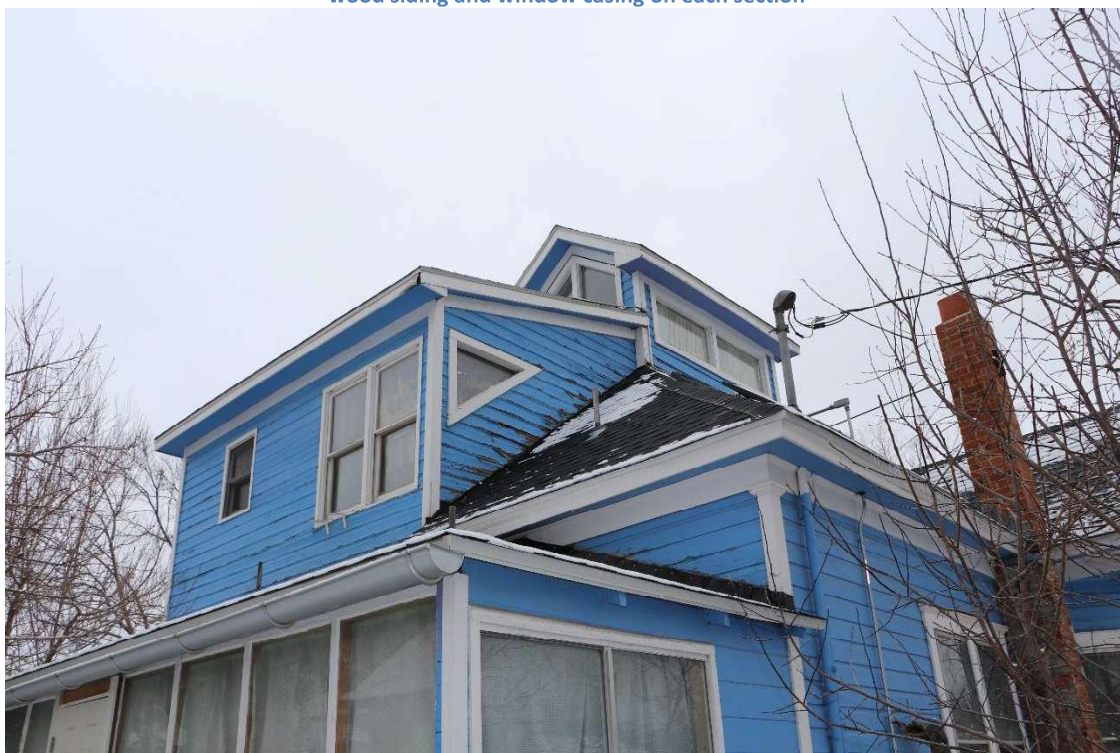
Image 12: South elevation. Original portion of the building is bottom right with corner pilaster. Note the wider siding on the enclosed porch

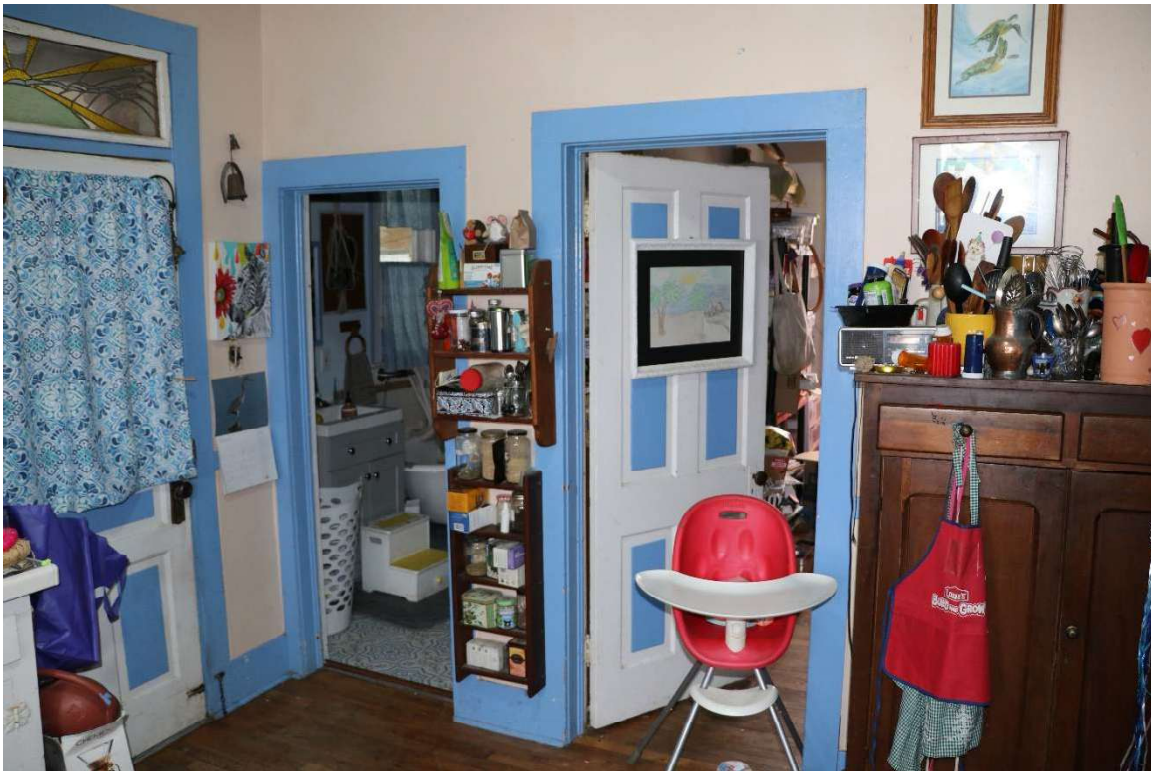
Image 20: Doors. Kitchen

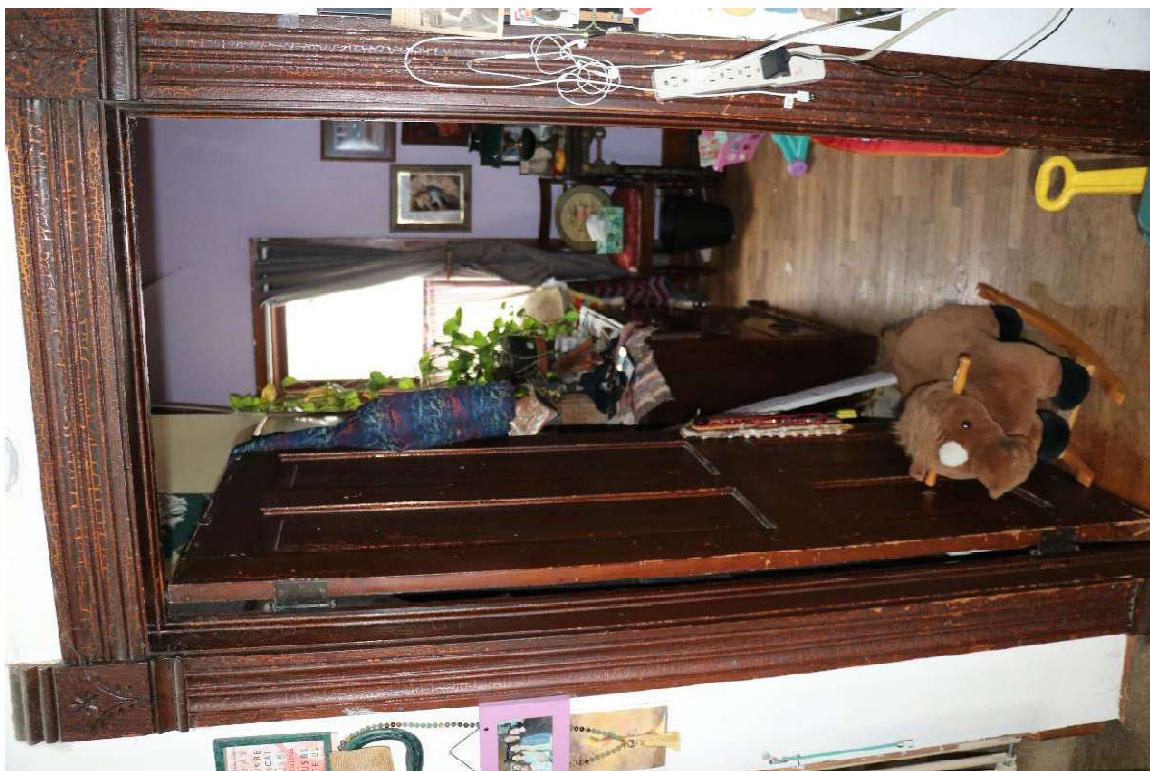
Image 21: Doors. Living Room

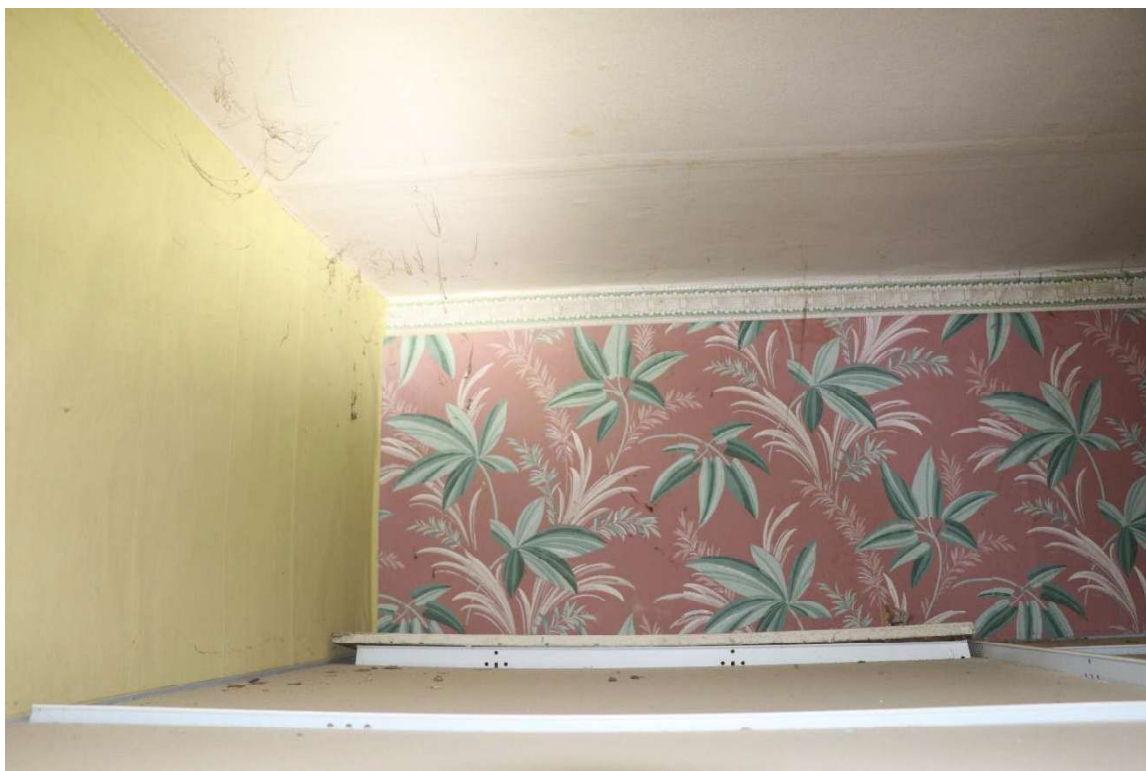
Image 32: Ceiling finishes. Living room. Wallpaper over drop ceiling

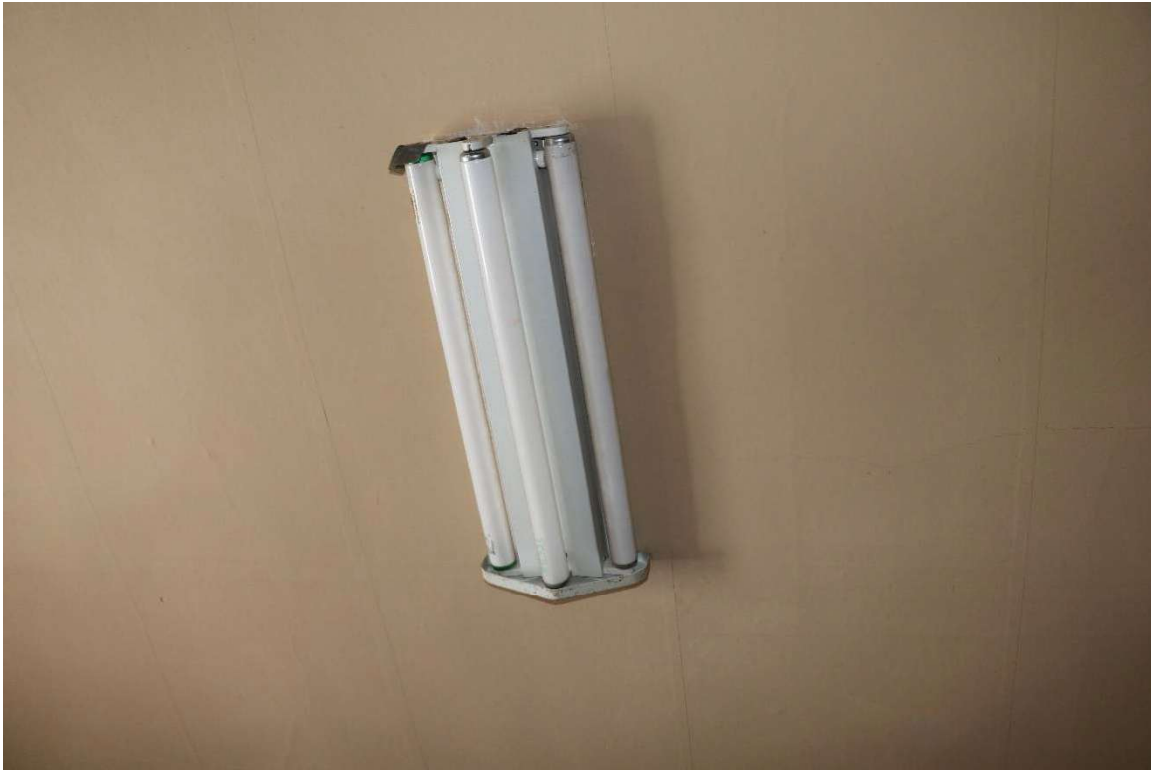
Image 44: Interior Lighting
