**ITEM:** 1155 Pine Street Landmark & Alteration Certificate Request

**REQUEST:** A request to landmark the building at 1155 Pine Street, and request for an alteration certificate.

DAJ Design conducted an Historic Structural Assessment for the structure located at 1155 Pine Street, Louisville, Colorado to determine its feasibility as a candidate for historic landmark designation as defined under the Historic Preservation program of the City of Louisville. The structure is a residential property. The City of Louisville Historic Preservation Commission found probable cause that the building may be eligible for landmarking under criteria in section 15.36.050 of the Louisville Municipal Code. Therefore, the Commission approved the Historic Structural Assessment to be paid for by the Louisville Preservation Fund grant.

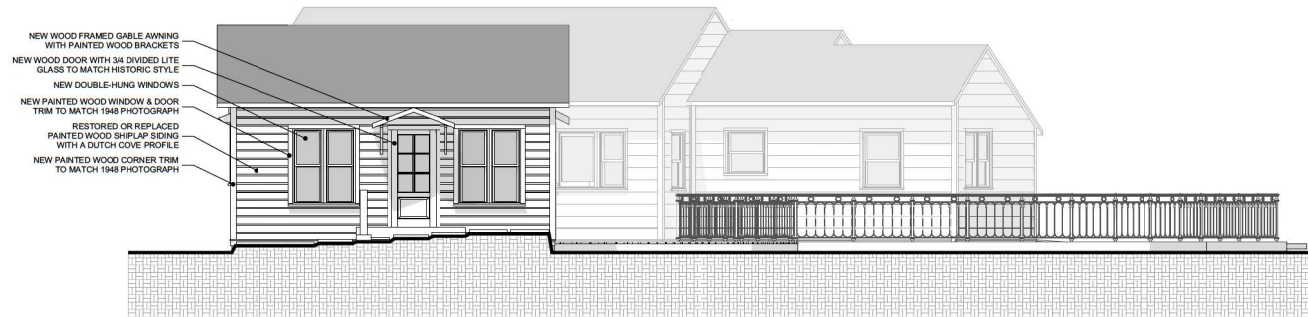
1 SOUTH ELEVATION

THIS SOUTH FACADE OPTION MODIFIES THE CURRENT WINDOW OPENINGS TO USE SIMILAR HISTORIC WINDOWS AS SEEN IN A 1948 PHOTOGRAPH OF THE HOUSE. THE HOUSE AT THAT TIME HAD A SINGLE WINDOW ON EITHER SIDE OF THE SOUTH FACING DOOR. THESE WINDOWS WERE TALL AND NARROW, LIKELY DOUBLE-HUNG WOOD WINDOWS, THAT WERE TYPICAL OF SIMILAR HOUSES THROUGHOUT LOUISVILLE AT THAT TIME. THIS OPTION USES THE HISTORIC WINDOW SIZES BUT ADDS TWO ADDITIONAL WINDOWS. THE CURRENT WINDOW OPENINGS ARE LARGER THAN THE HISTORIC WINDOW OPENINGS AND THIS OPTION USES THOSE LARGER OPENINGS. THIS OPTION ALSO BETTER COMPLIES WITH THE REQUIREMENTS OF THE NEW MU-R ZONING DISTRICT. ADDITIONALLY, A GABLE AWNING OVER THE SOUTH DOOR HAS BEEN RECREATED TO MATCH WHAT IS SEEN IN THE 1948 PHOTOGRAPH. IT IS BELIEVED THAT PART OF THIS AWNING STILL EXISTS AND WAS MOVED TO THE EAST FACING DOOR AT AN UNKNOWN TIME.

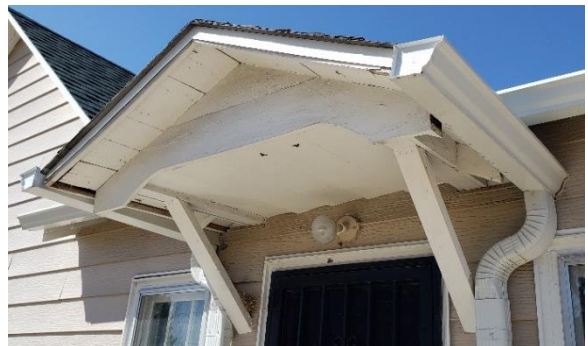
*Side door covering.*
