**ITEM:** 1155 Pine Street Landmark, Alteration Certificate, Grant, and Probable Cause Request

**REQUEST:** A request to landmark 1155 Pine Street, a request for an Alteration Certificate, Preservation & Restoration and New Construction Grant requests, and a Probable Cause request.

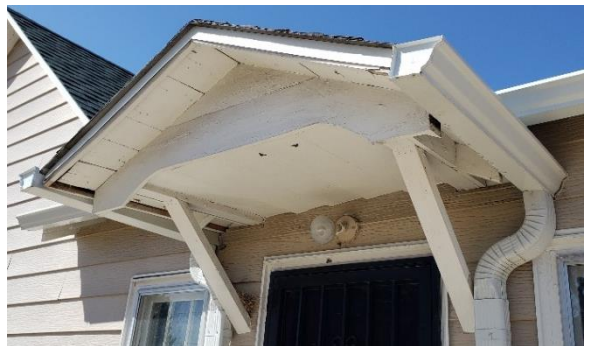
*Side door covering.*

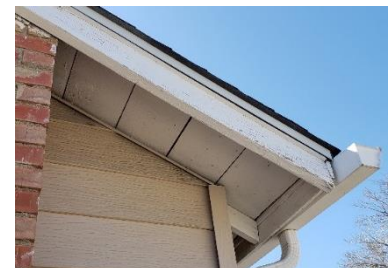
*Exposed roof sheathing and rafter tails.*

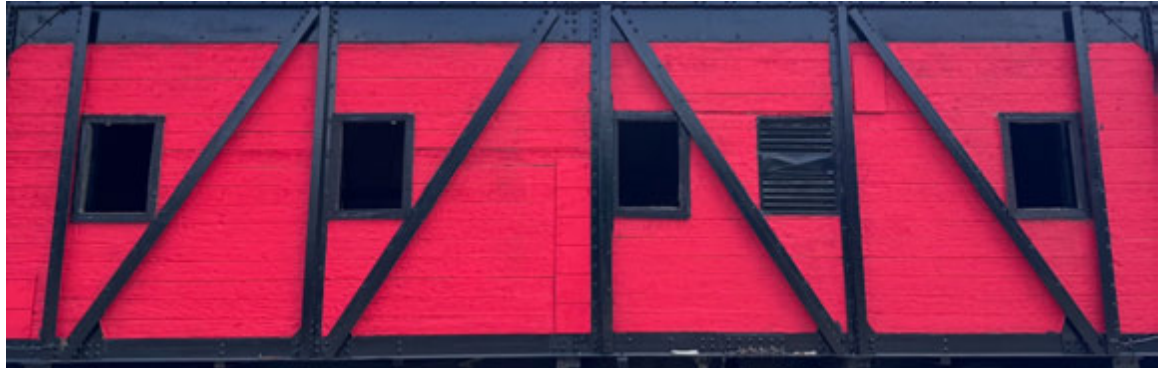
Poor. All windows are missing, and require full reconstruction. While the doors and door frames are generally intact and structurally sound, they also require restoration including refinishing, new windows and reglazing, and hardware replacement.

*(Close up of windows on Northwest side of caboose)*

1. Applicant saved one full, intact window to use as a template, and our recommendation is to use this template to have new windows constructed to emulate the original ones in fit and finish.
2. Also recommend removal and restoration of both doors with new windows and hardware. Use tempered glass where required for both doors and windows.  
Note: Replace windows only after siding is replaced and they are appropriately located as per original specifications. Applicant may consider replacing original fixed-windows with period-correct styled windows that have a functional swing-out ability to better facilitate future adaptive re-use of the structure.

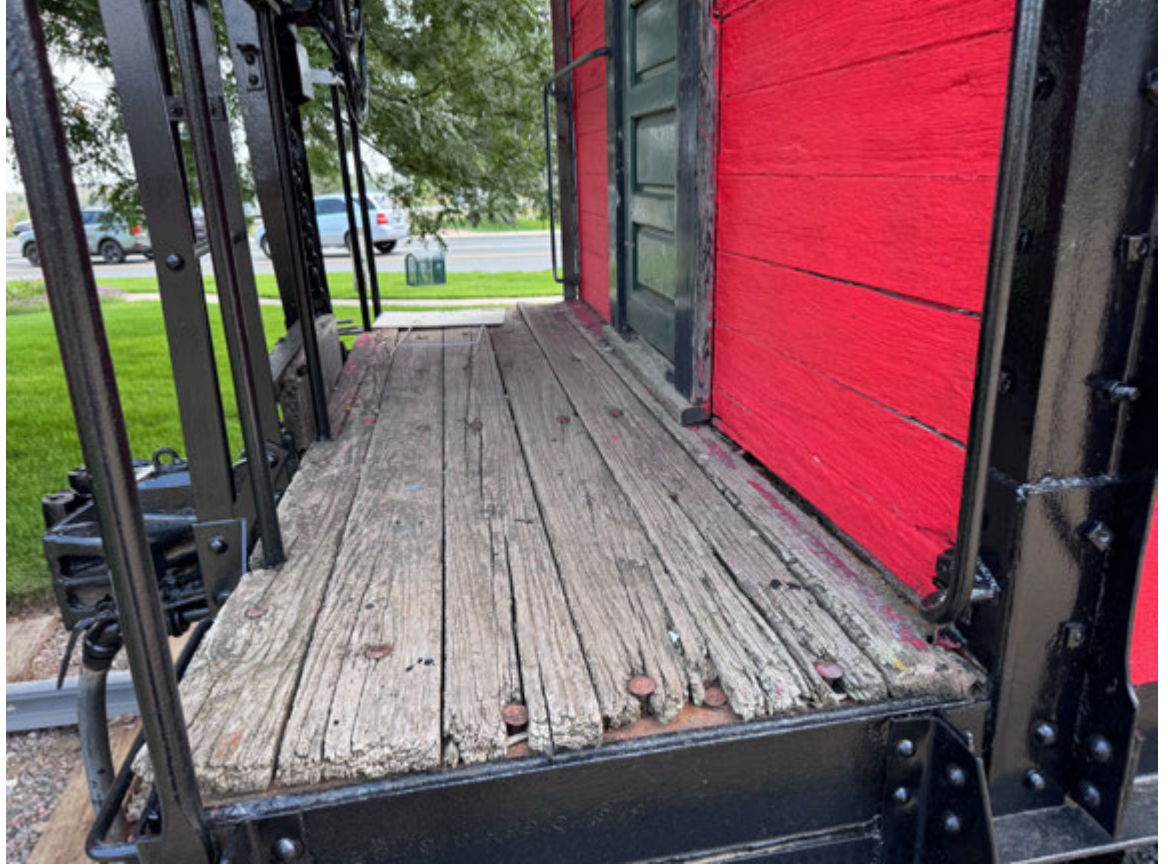
*(Northeast Platform base on The Louisville Caboose)*

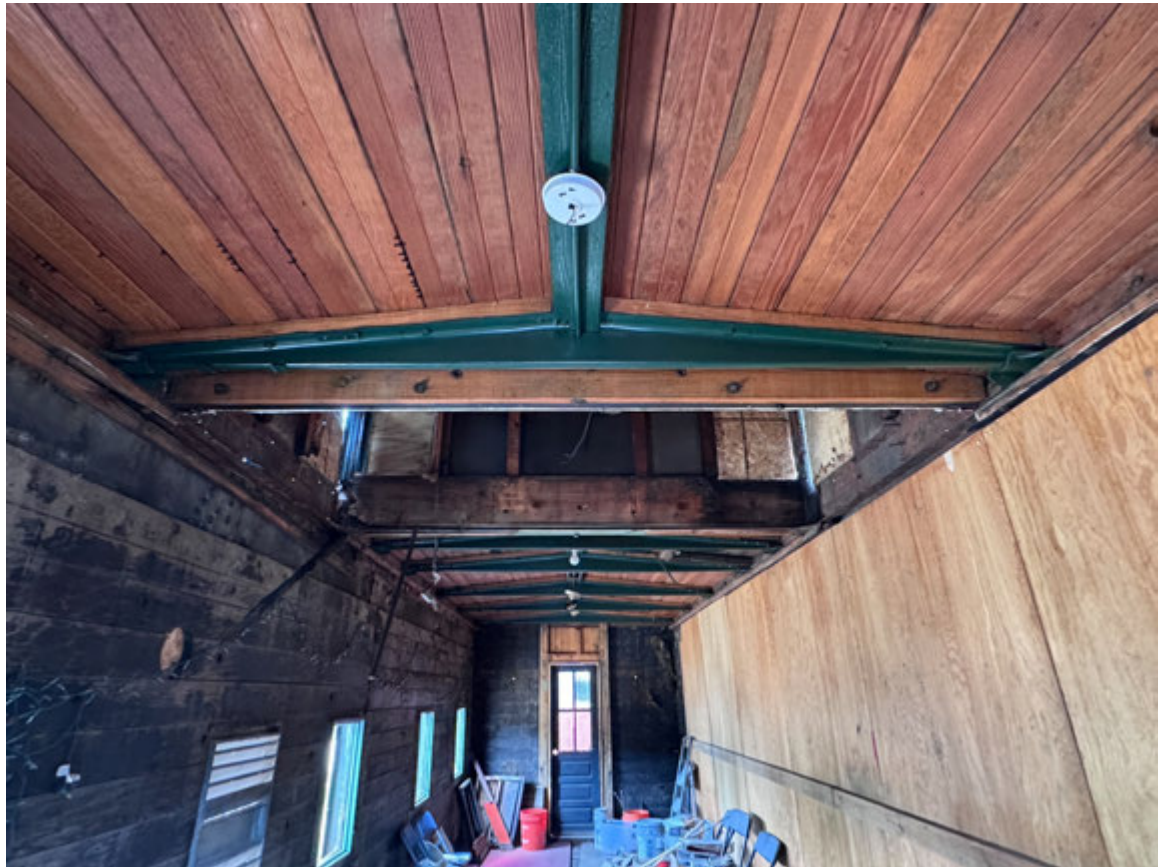
*(Ceiling and interior, facing North, on The Louisville Caboose)*

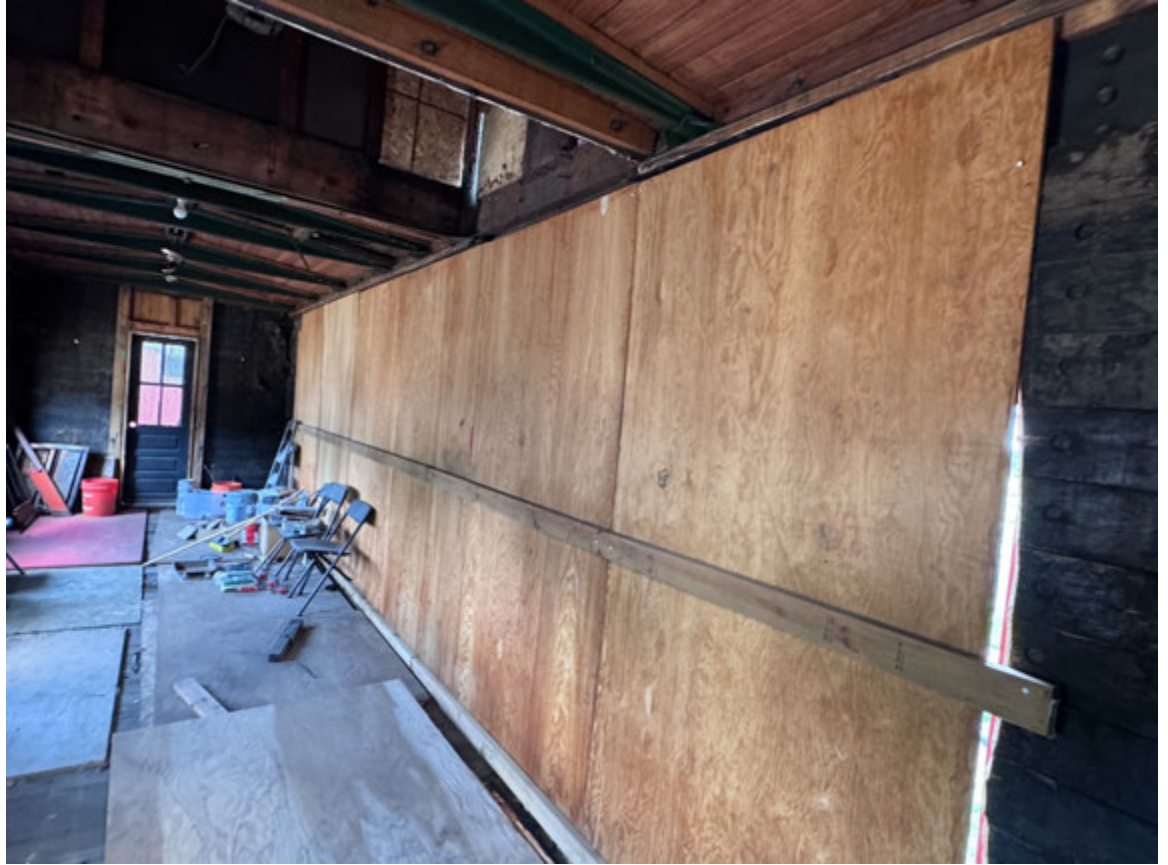
The southeast, street-facing, long-side of the caboose is missing the entirety of its original wood cladding, and has had temporary sheathing consisting of 4x8 plywood panels installed in 2024 in an attempt to better seal the building envelope. All original window glass is missing, and both glass as well as the window frames need to be replaced. Approximately 30% of the floor wood also requires replacement. The wood for the entire exterior as well as ~30% of the flooring interior will need to be replaced, treated, and repainted using historically appropriate materials.

*(Interior shot, southeast wall of The Louisville Caboose)*

1. Replace all wood elements on the entire caboose (excluding original ceiling wood inside), using historically appropriate, clear, vertical grain old-growth Alaskan Yellow Cedar or Douglas Fir 2x6 tongue-and-groove milled lumber, likely from a mill in the Pacific Northwest.
2. Paint with appropriate, oil-based paint.
3. Properly seal all external junctions where water could infiltrate.

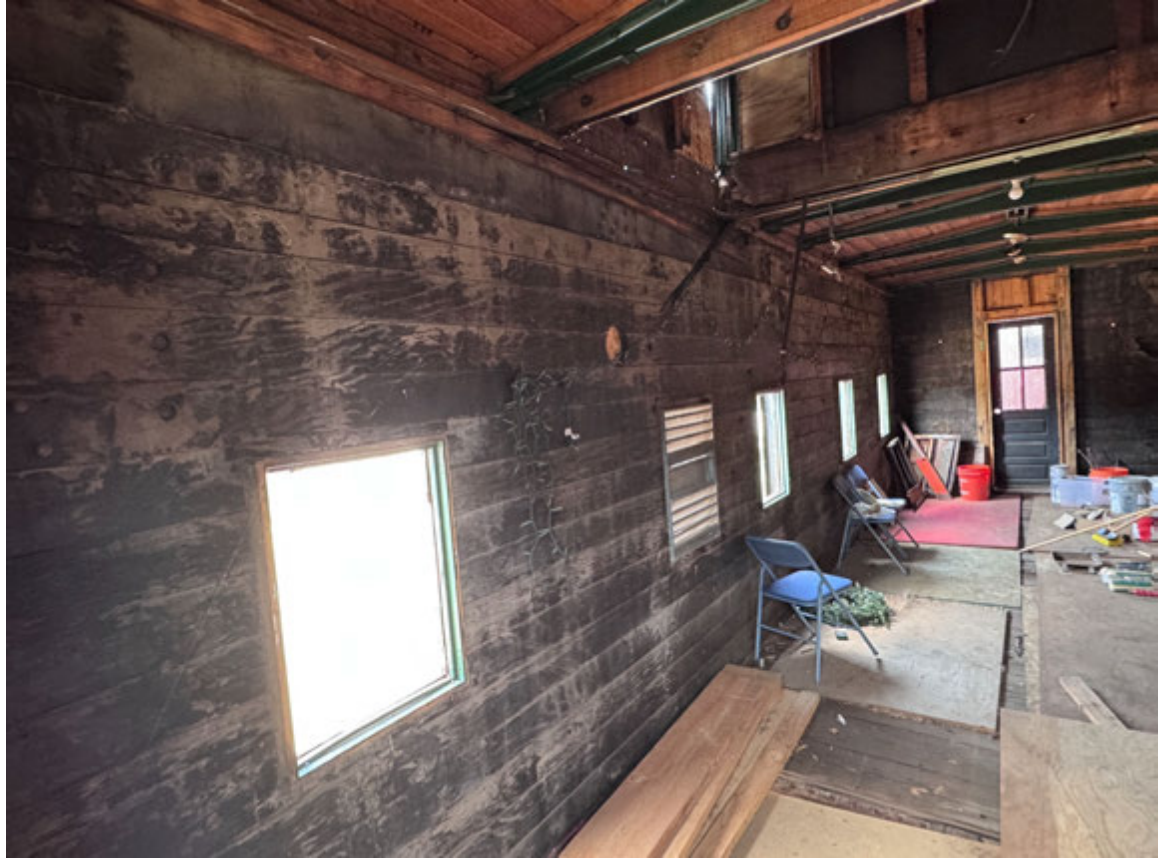
*(Interior shot, Northwest wall of The Louisville Caboose, showing original wood cladding)*

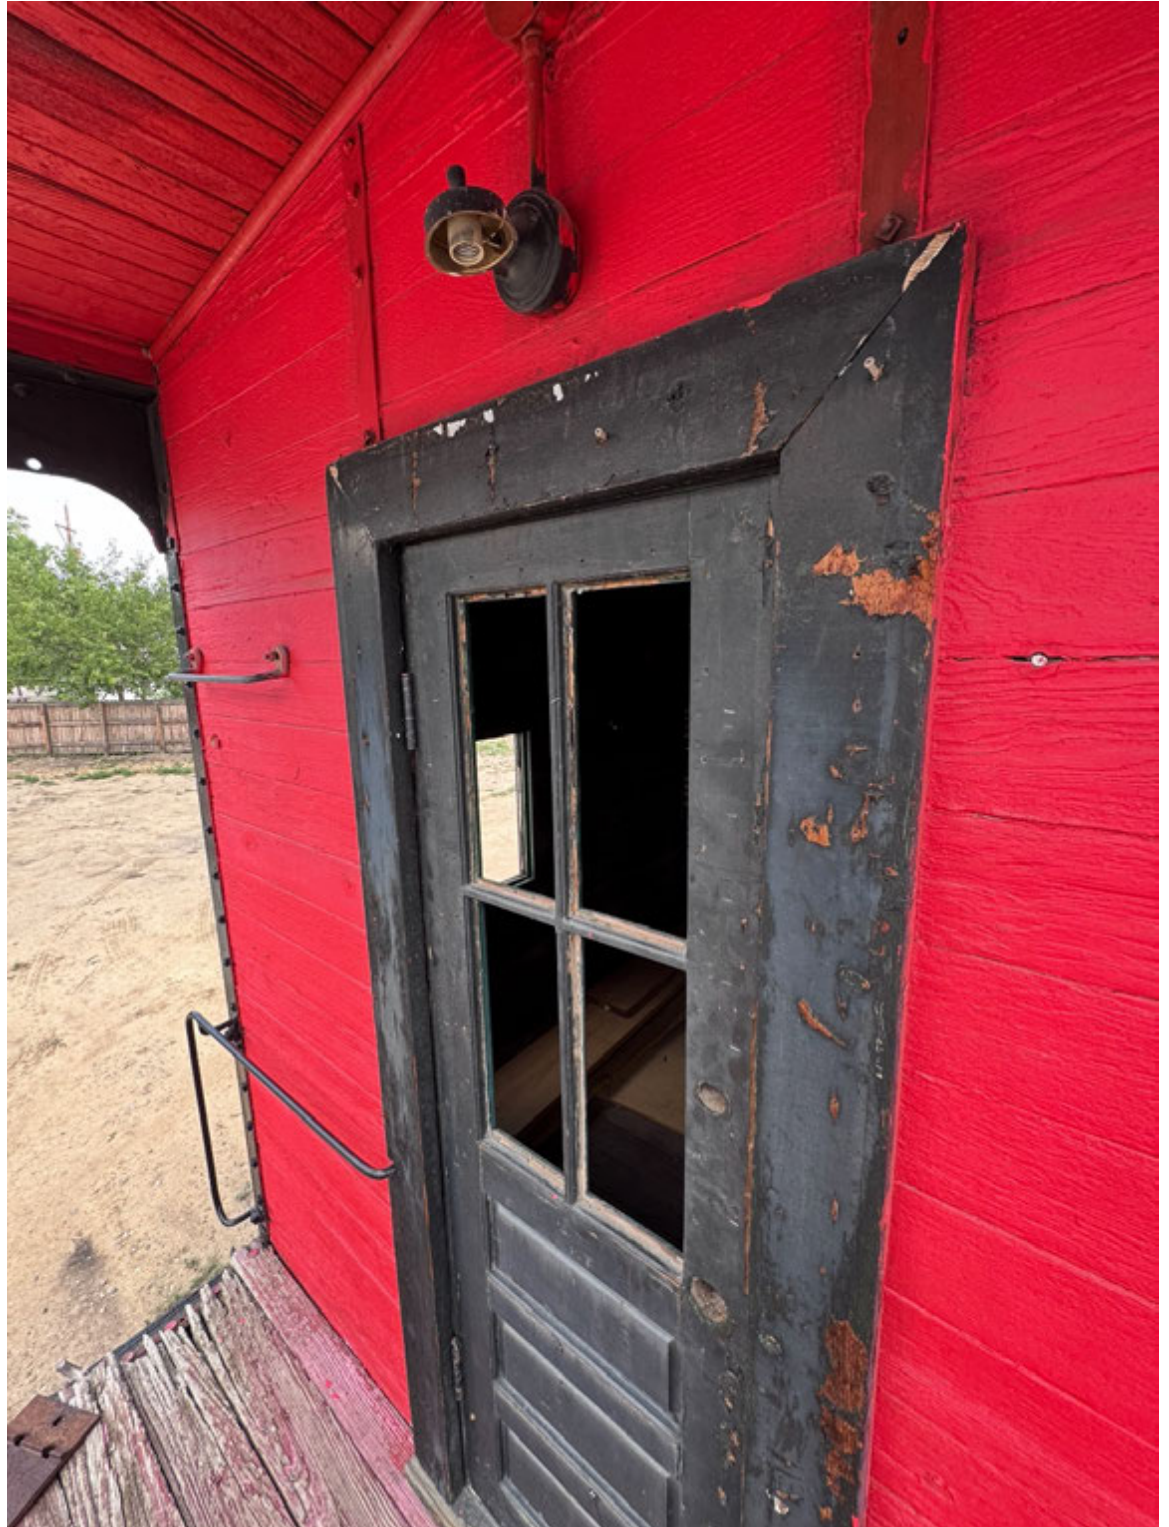
*(Door on South side of The Louisville Caboose)*

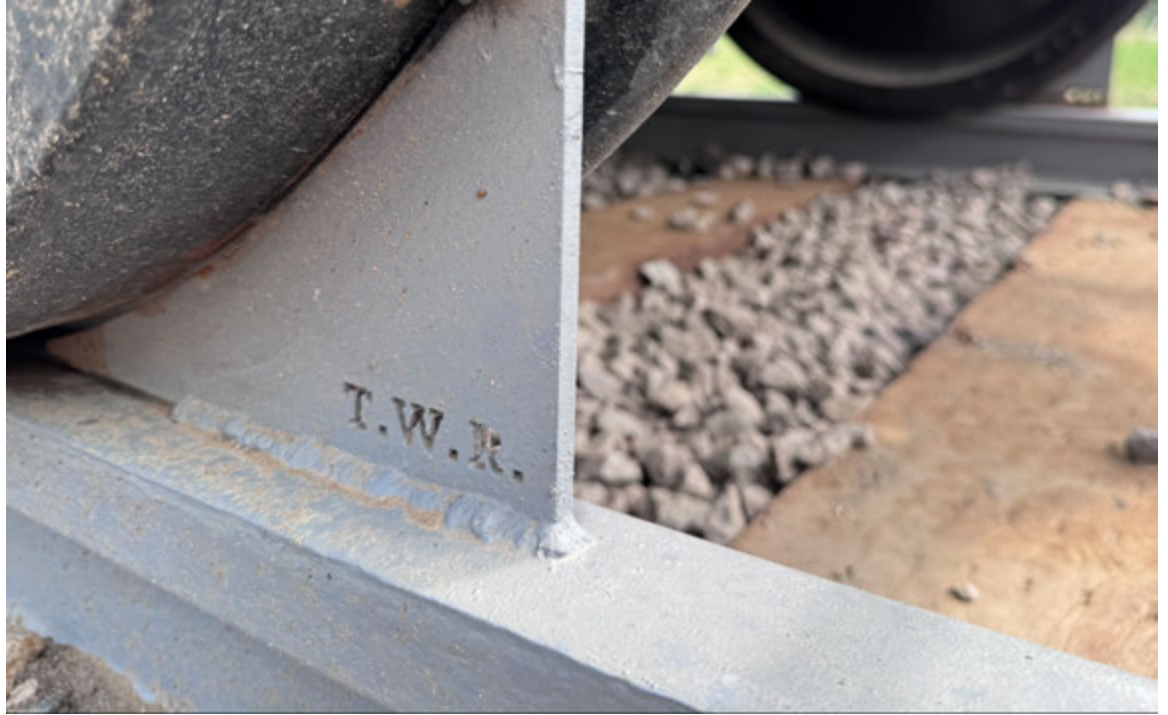
*(Detail showing welded connection between wheels and train tracks of The Louisville Caboose. Applicant had these pieces laser cut with each his children's initials as shown above)*

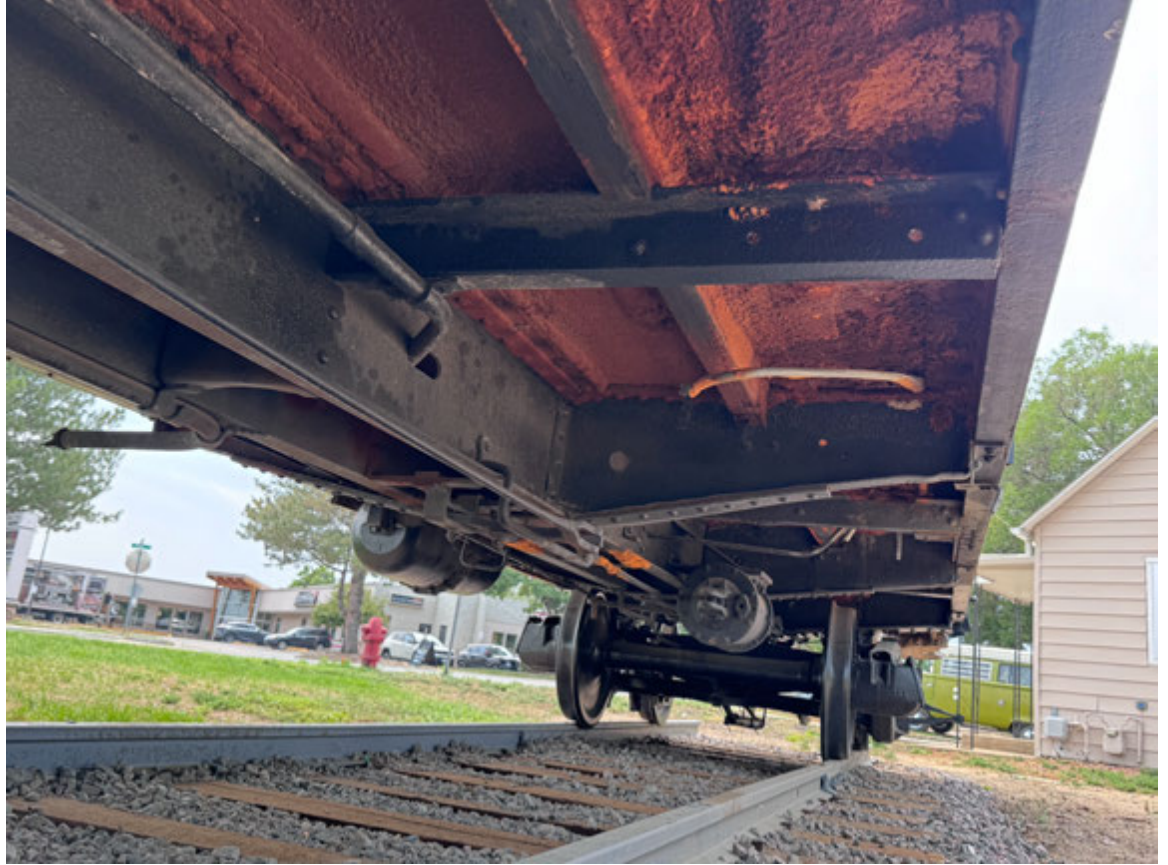
*(Underneath shot of The Louisville Caboose)*

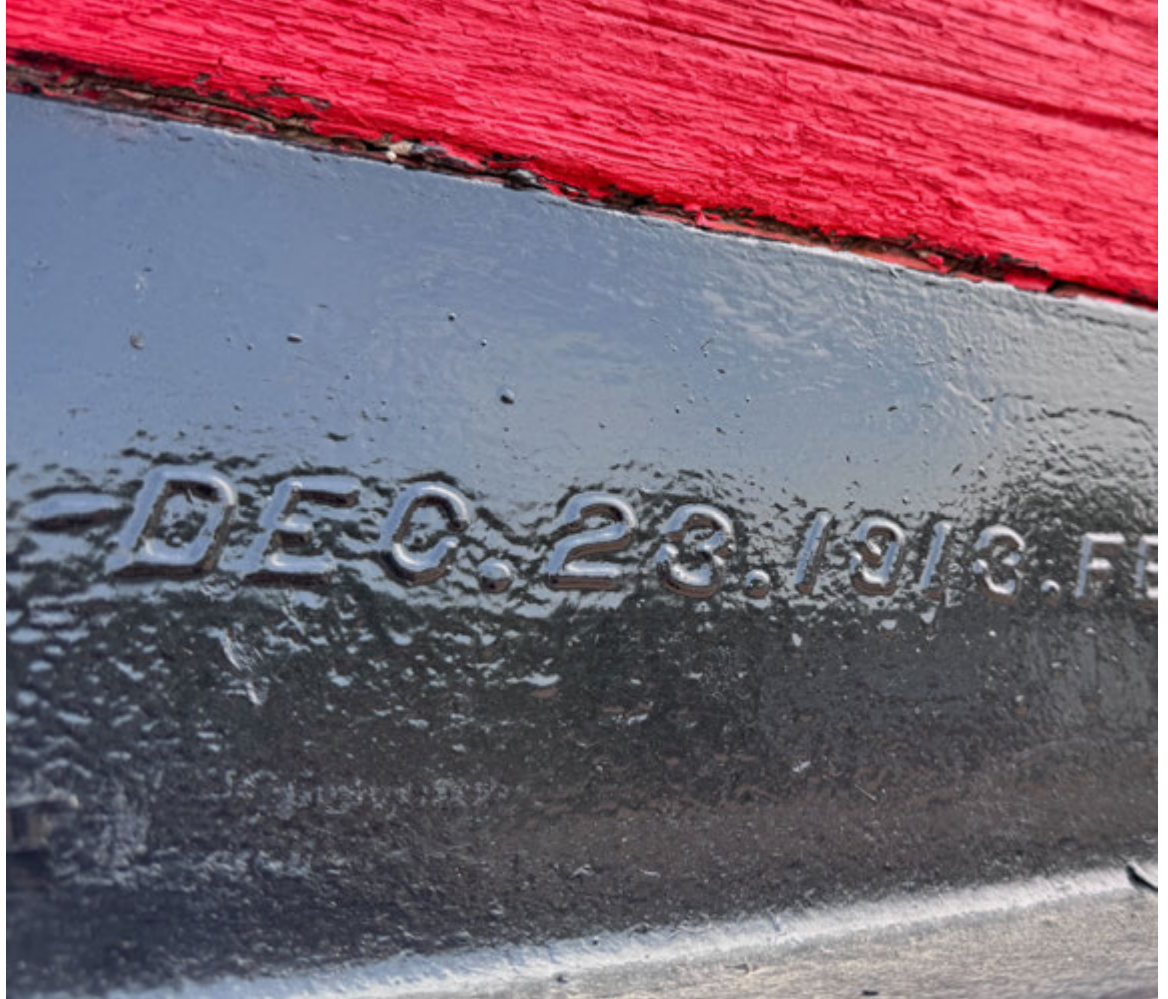
*(Detail on one of the structural beams on the side of The Louisville Caboose, dated Dec. 23, 1913)*

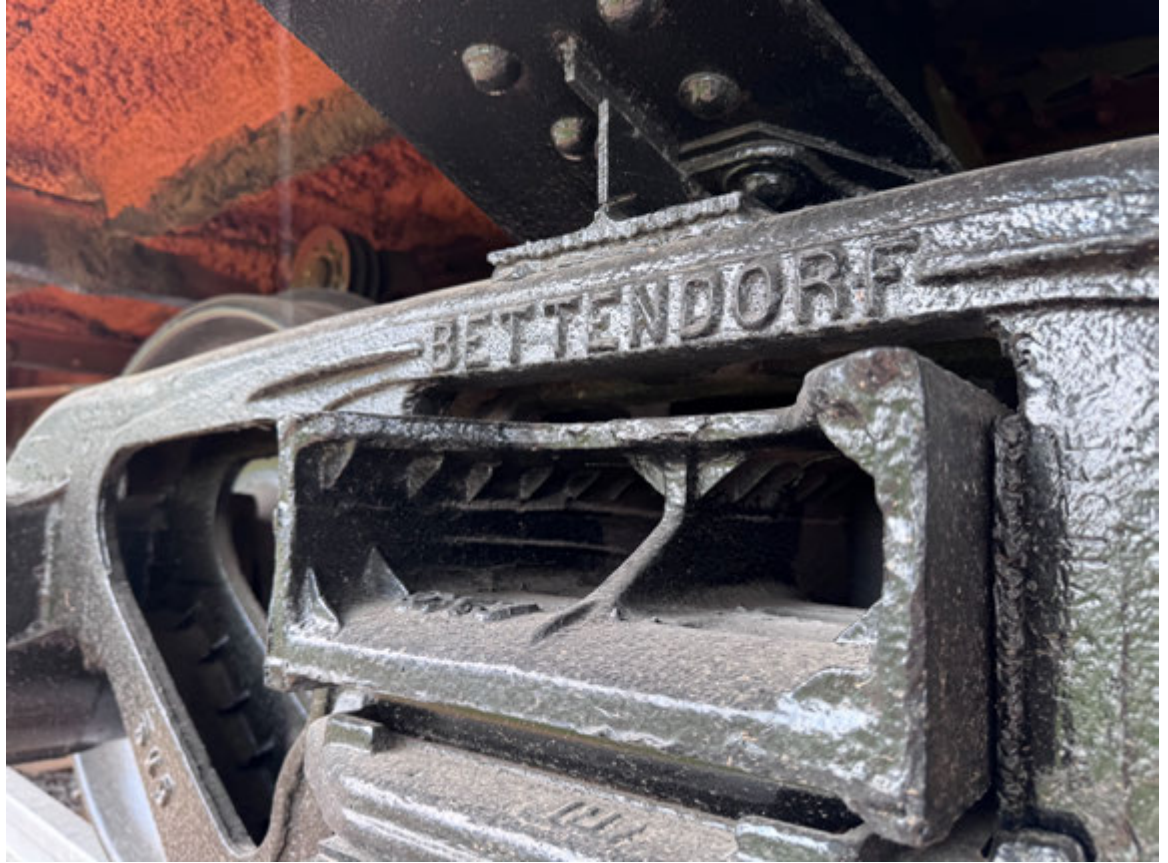
*(Detail of 'Bettendorf' trucks under The Louisville Caboose)*

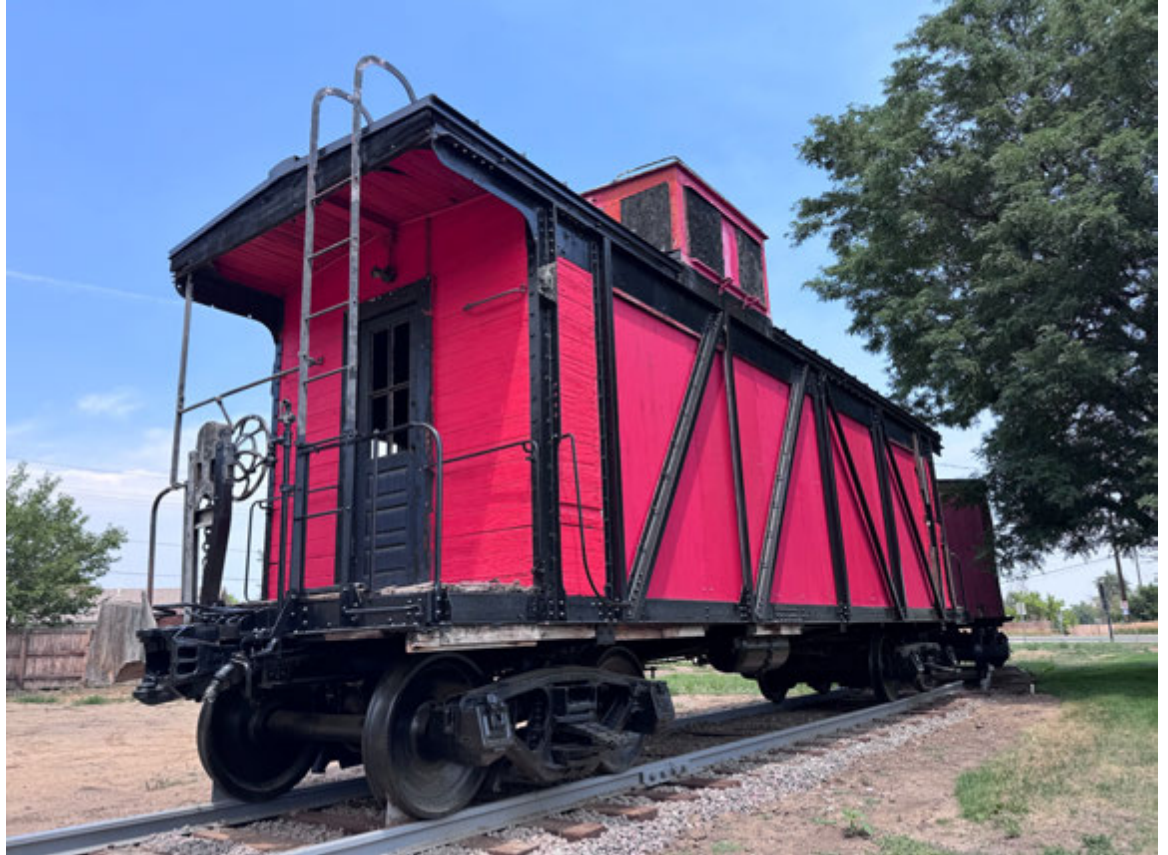
*(View from south of The Louisville Caboose)*
